HISTORICAL DEVELOPMENT OF THE MUNICIPAL LANDFILL IN THE EASTERN BORDER OF THE LUIS PEÑA CANAL RESERVE IN THE MUNICIPALITY OF CULEBRA, PUERTO RICO AND ITS POTENTIAL IMPACT ON THE RESERVE

Final Report submitted to the Department of *Natural and Environmental Resources*
of the Commonwealth of Puerto Rico in fulfillment with Task CRI-9 PR CORAL
REEFS AND WATERSHEDS STRATEGY of the *Conservation and Management*
of Puerto Rico Coral Reefs proposal

José Norat, Ph.D.

September, 2007

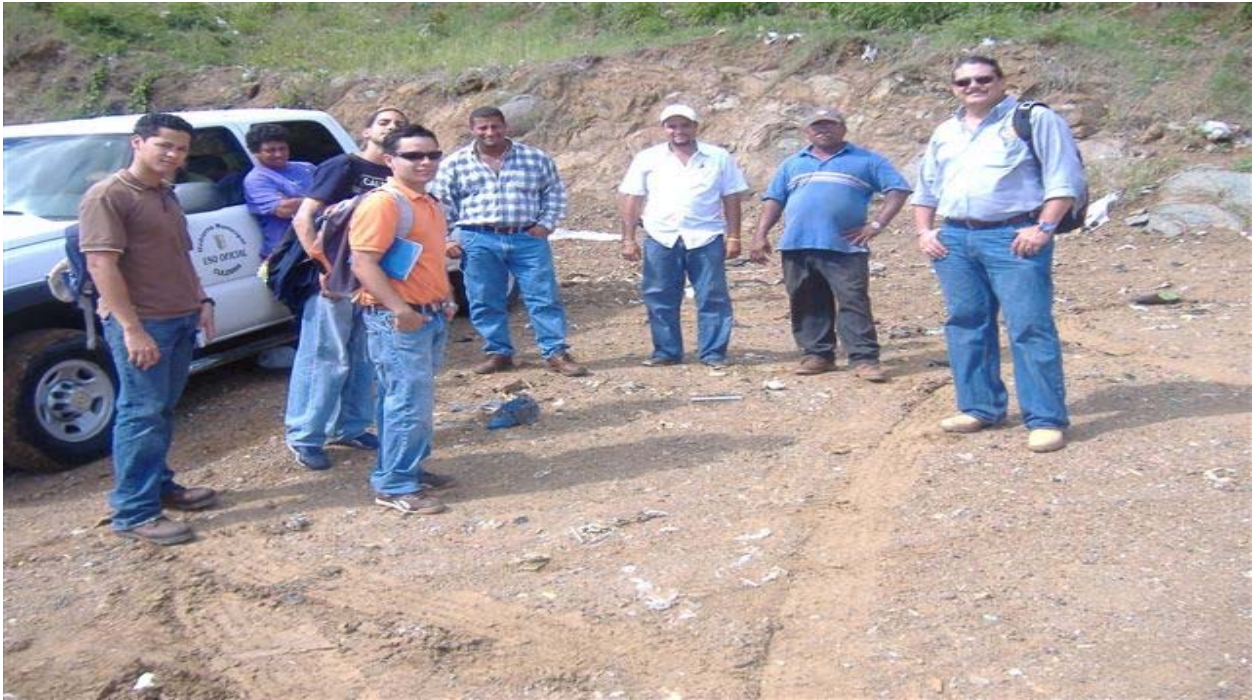
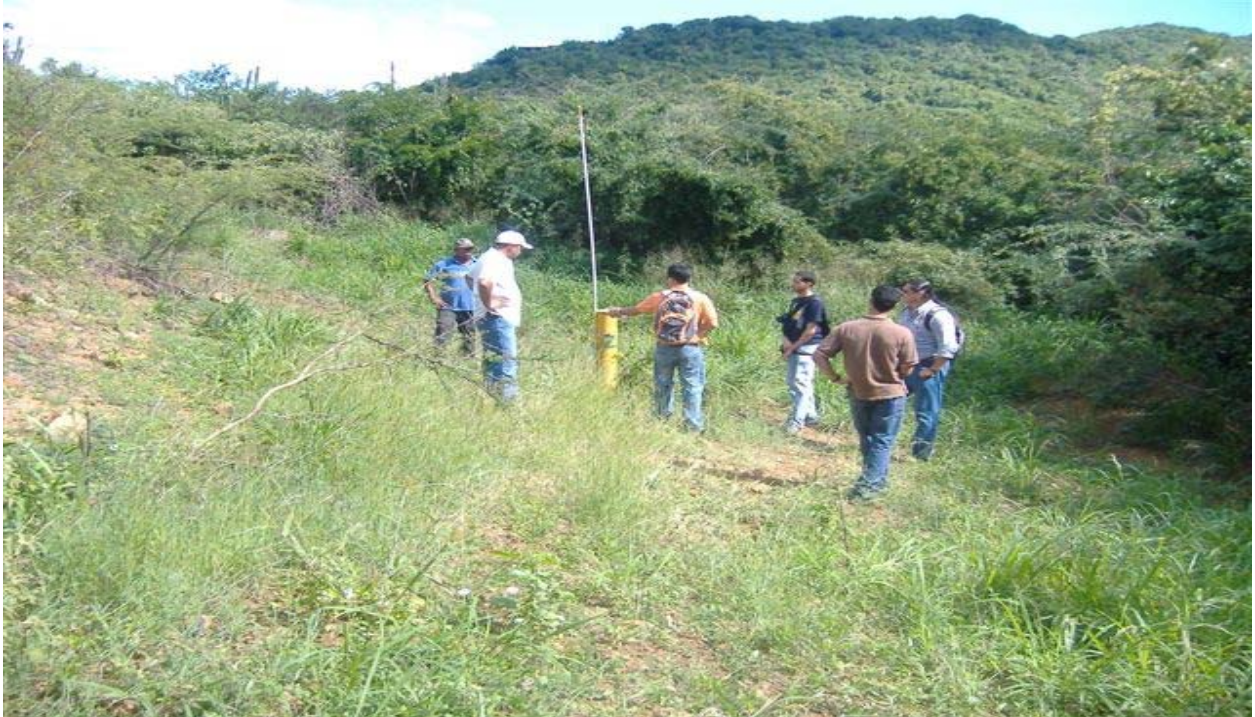
Photograph No. 3 & No.4- Location of Monitoring Well MW-2 (methane gas observation well). Looking to the East

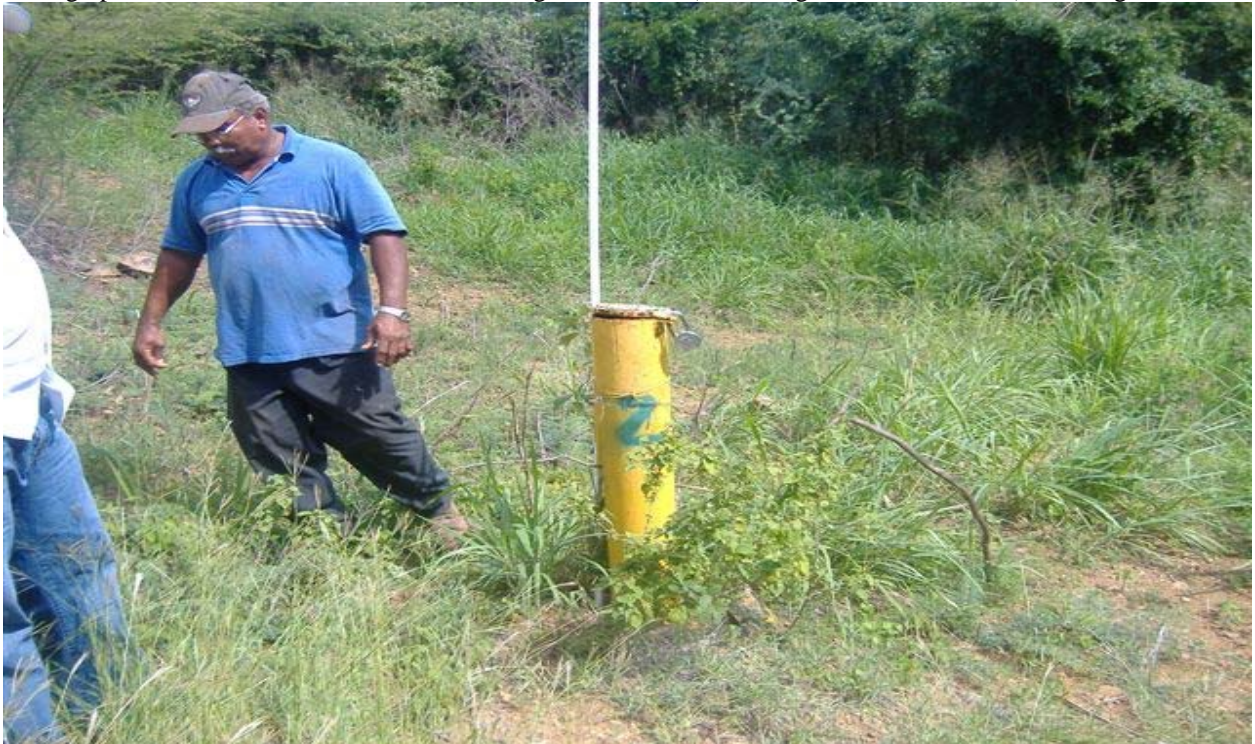
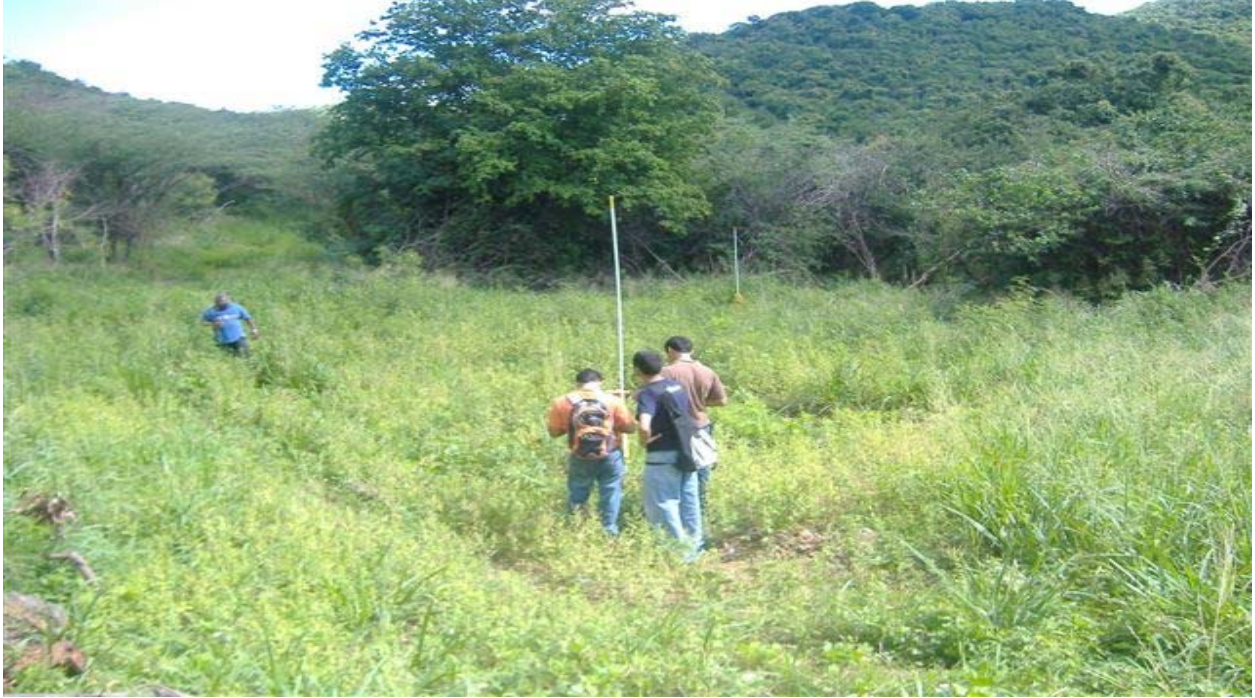
Photograph No. 5 & No.6- Location of Monitoring Wells MW-3 & MW-4 (methane gas and water observation wells, respectively). Looking to the East

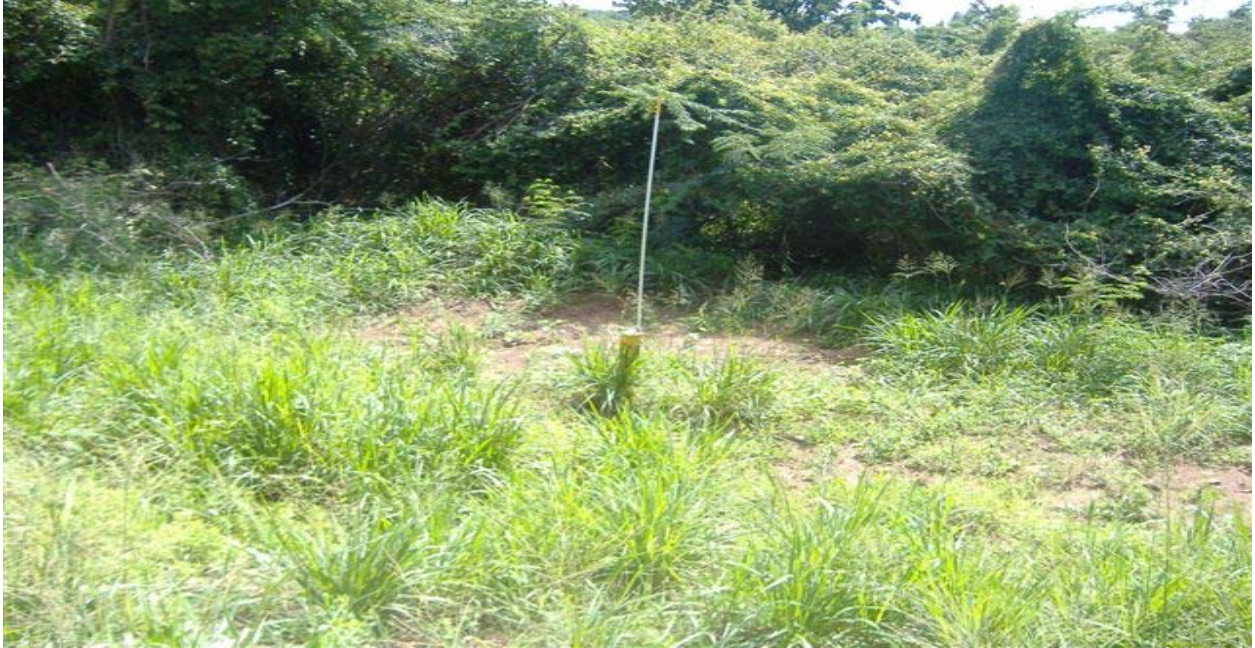
Photograph No. 7- Location of Monitoring Well MW-5 (water monitoring well). Looking to the southeast

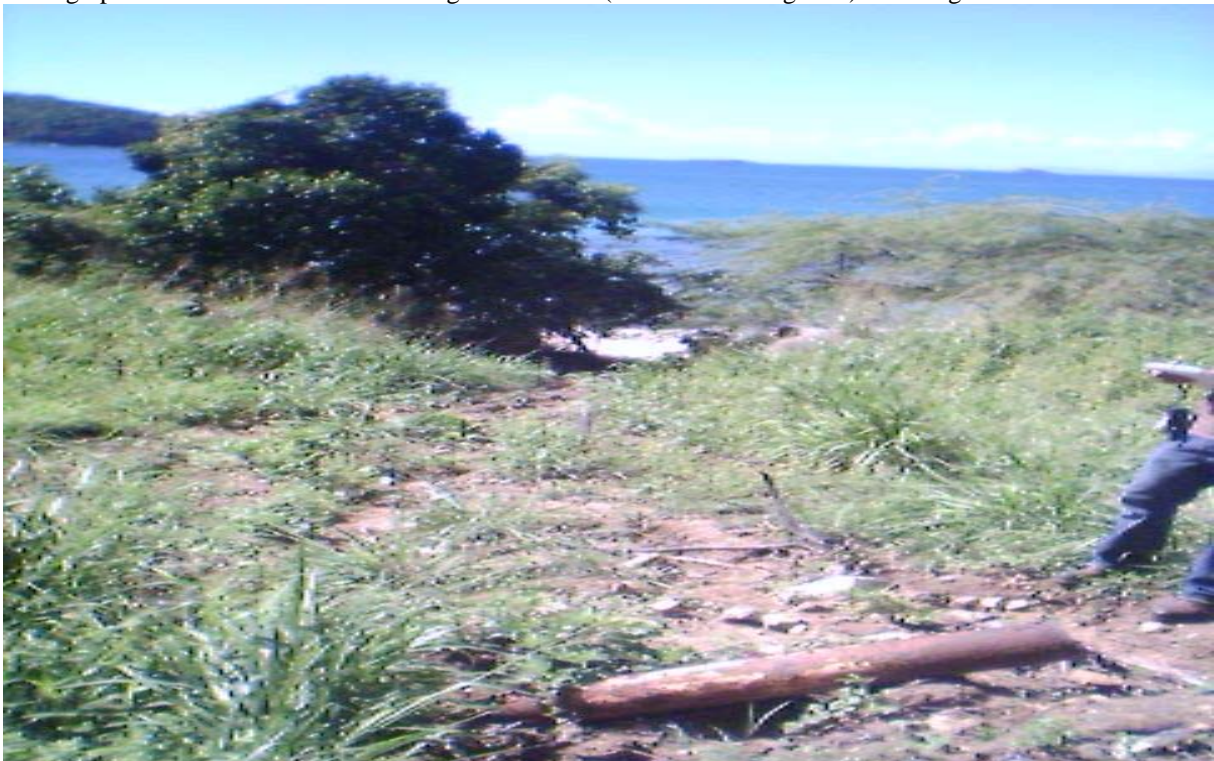
Photograph No. 8- Location of Monitoring Well MW-1 (water monitoring well). Destroyed by Hurricane David. Looking to the West

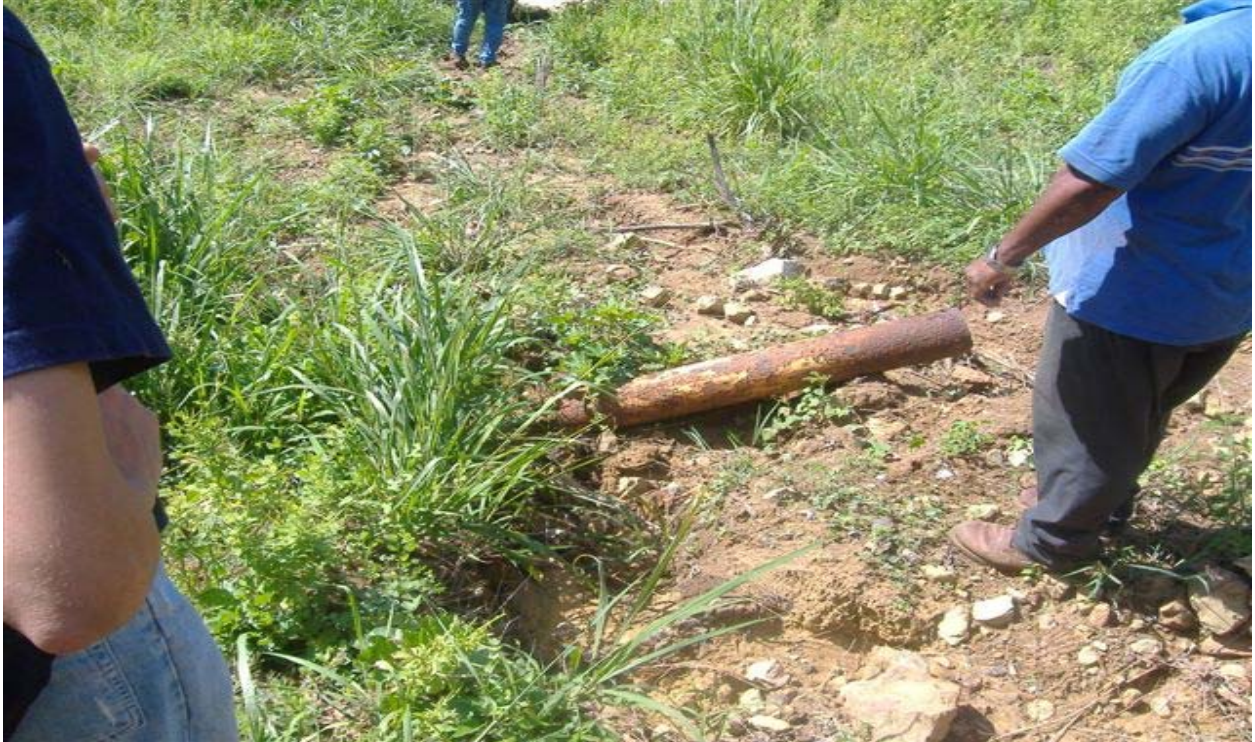
Photographs No. 9 & 10- Monitoring Well MW-1. Looking to the South and North, respectively. It was closed to the Luis Peña Canal Reserve, as far as 25 meters

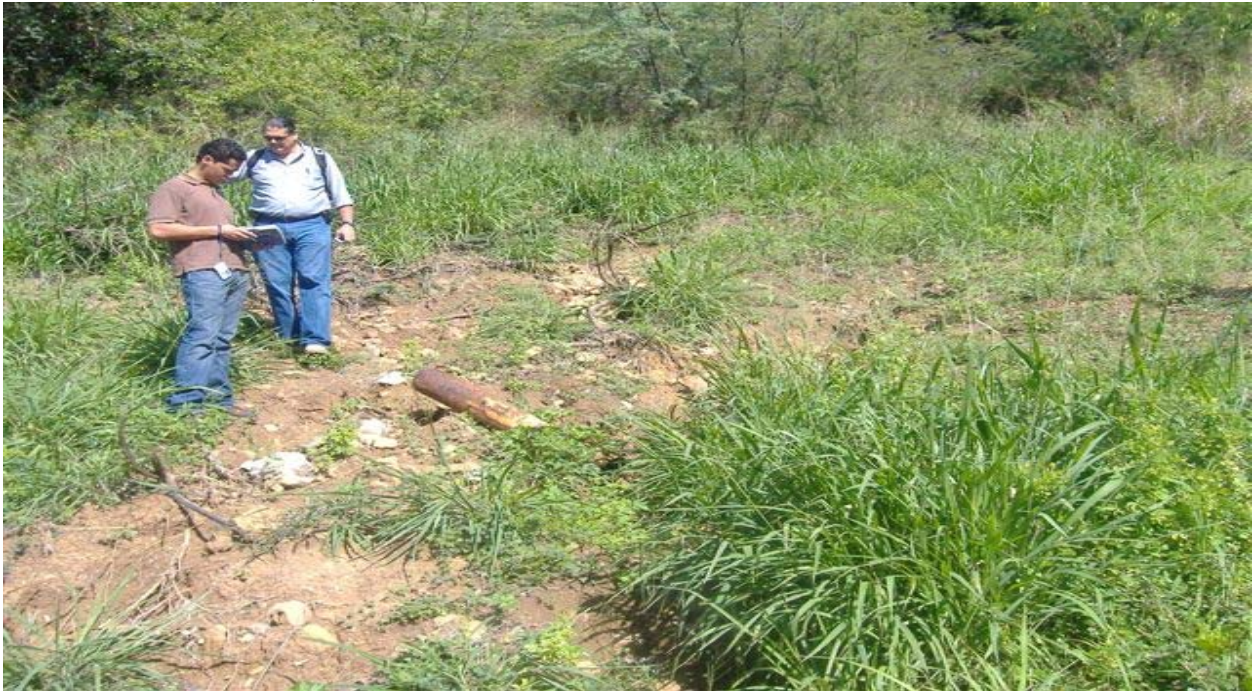
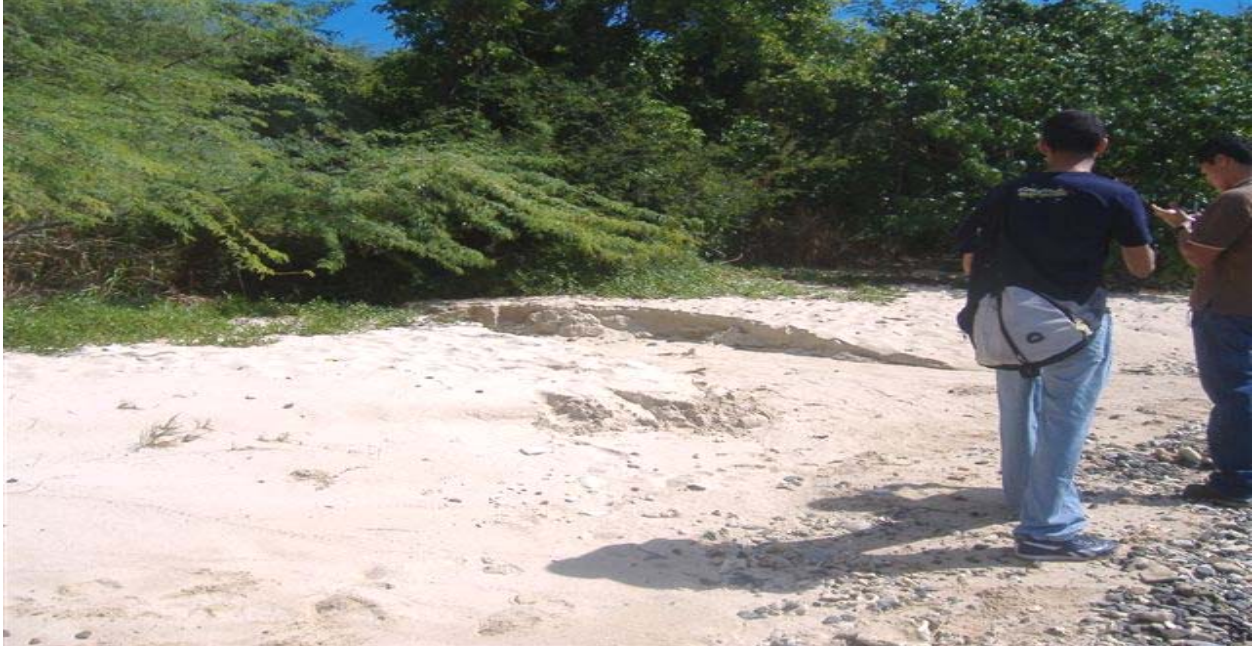
Photographs No. 11 & 12- Showing the exit area of the runoff waters coming from the nearby Monitoring Well MW-1 location to the Luis Peña Canal shore. Looking to the East and North, respectively. No evidence of leachate and any other superficial contaminant are observed along these zones. The very-fine white sand and medium to coarse gravel looks clean.

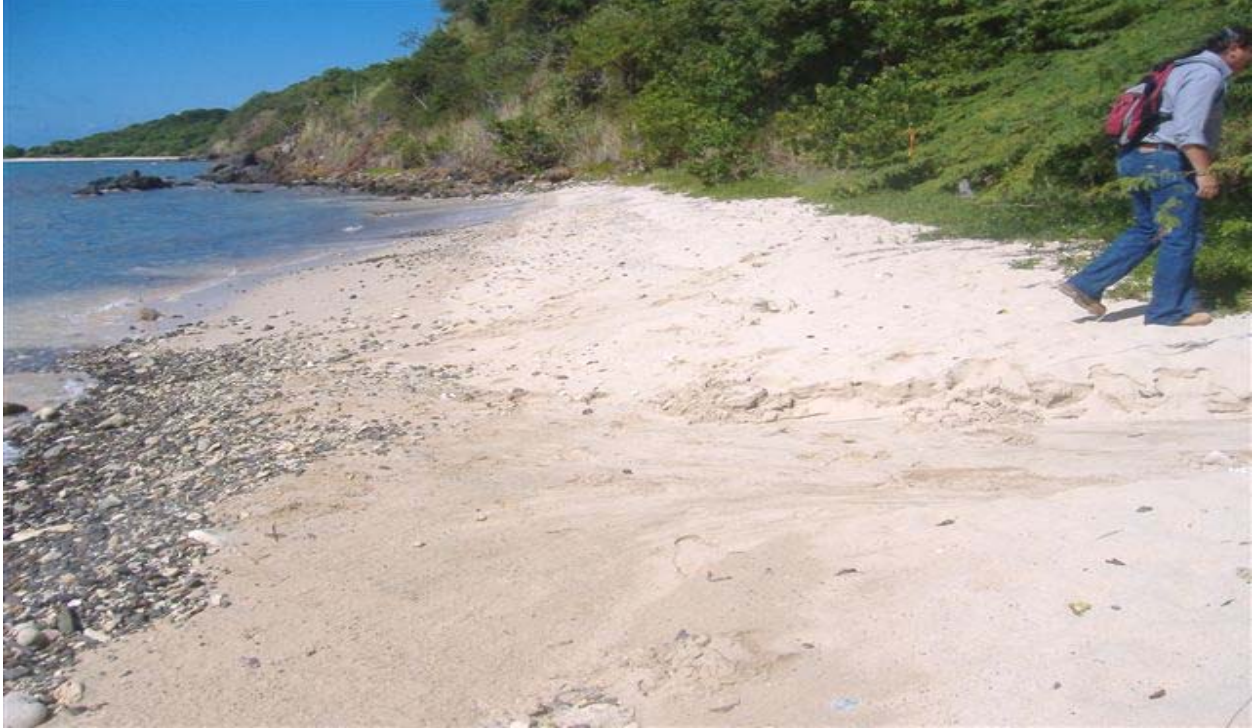
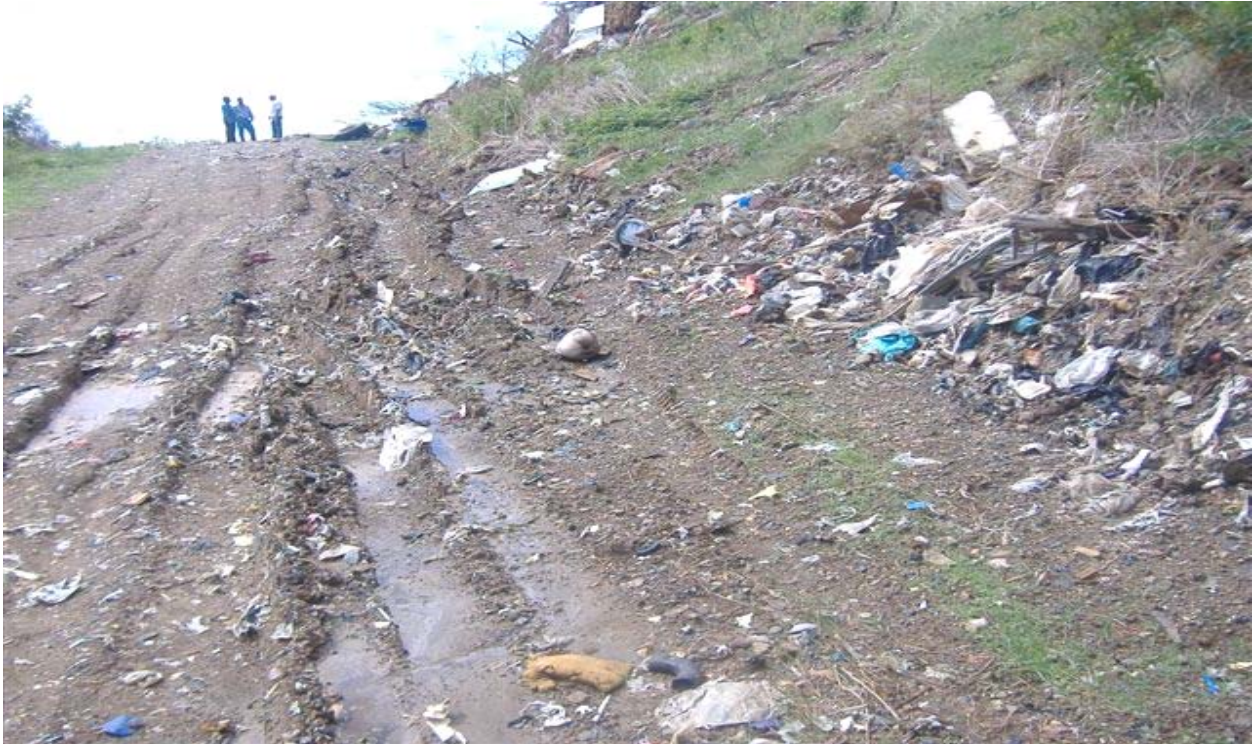
On the basis of field investigation three (3) zones of potential leachate leakage were identified. These zones are identified in a figure as zones Z-1, Z-2 and Z-3. Zone Z-1 is located at the northeast area of the landfill where superficial leachate leakage was identified as evidenced by Photographs. Zones Z-2 and Z-3 are located to the south zone of the landfill and consist of concentrated leachate leakages facing an existing dirt road having a slope inclination of about 35 degrees going down to the east of the landfill. There in some instances it will migrate to the lower areas of the landfill heading to an existing pond close to the Bahia Punta Tamarindo and its coast, as show in Photographs. It is possible that in an event of heavy rains this substance will migrate to these zones creating an environmental impact to the area if some protection measures are ignored.

Photographs No. 13 & 14- Looking to the west showing two leachate-prone surface areas running to the southeast. This area is identified as leachate Zone Z-1

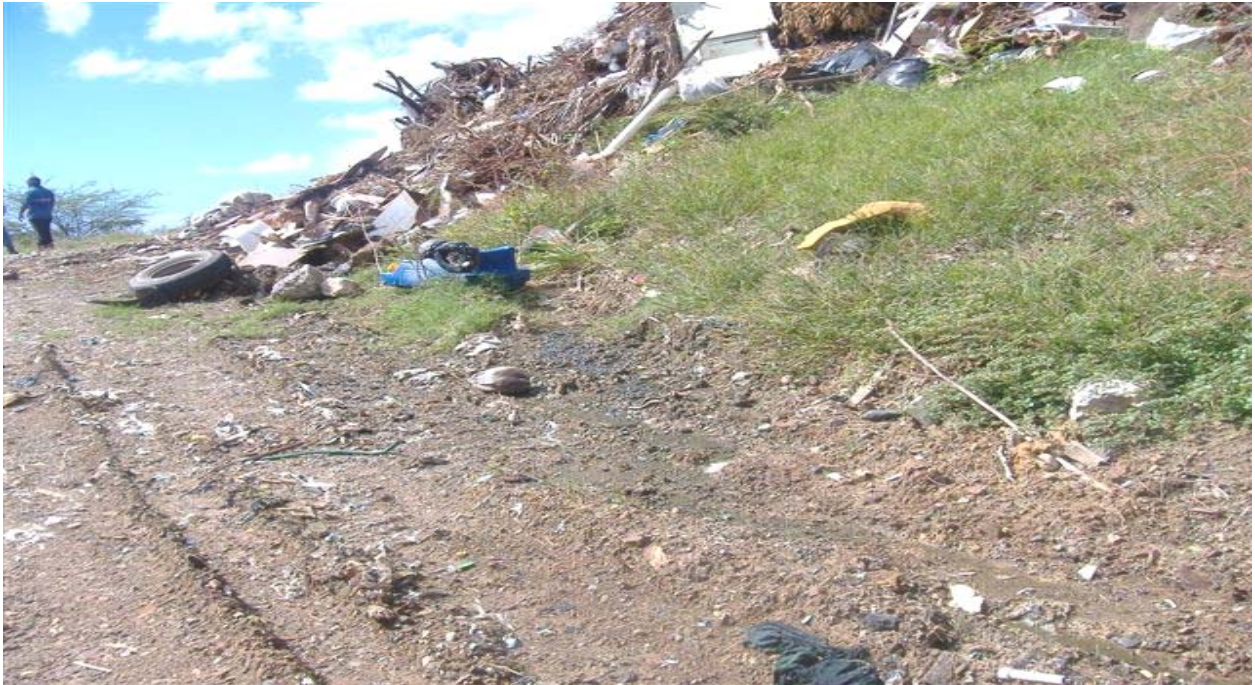
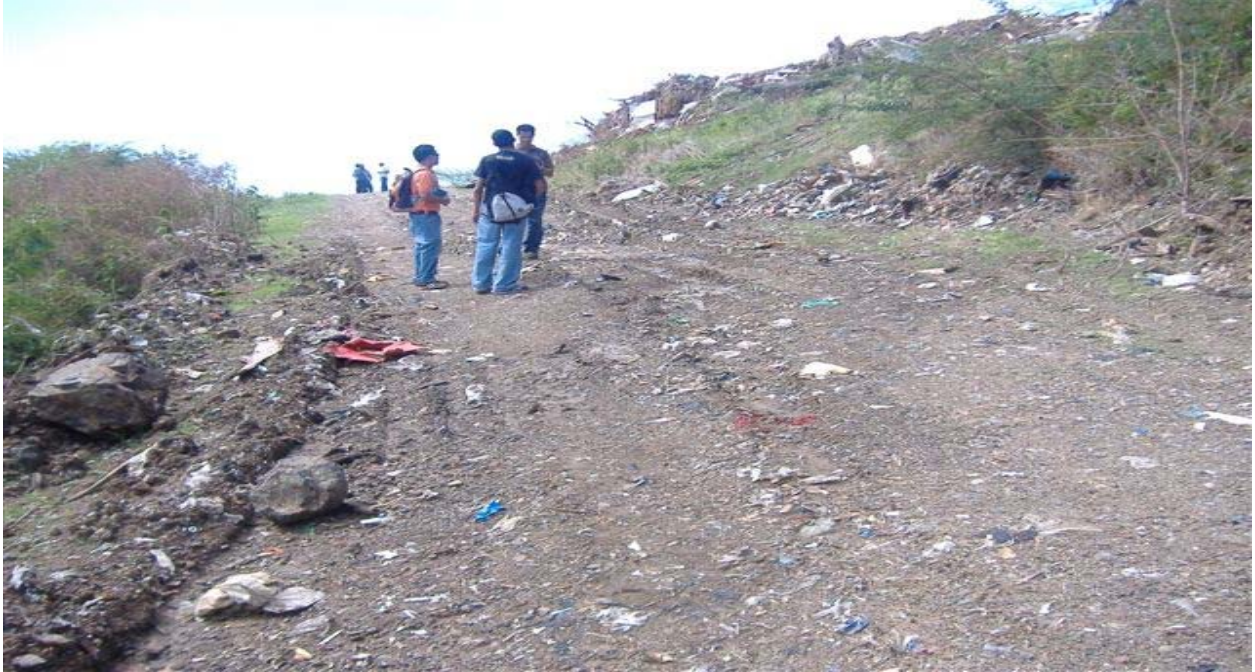
Photographs No. 15 & 16- Looking to the west. Observed the topography of the area which is coming down to the southeast. Any water or leachate barrier are observed along this area. Leachate Zone Z-1

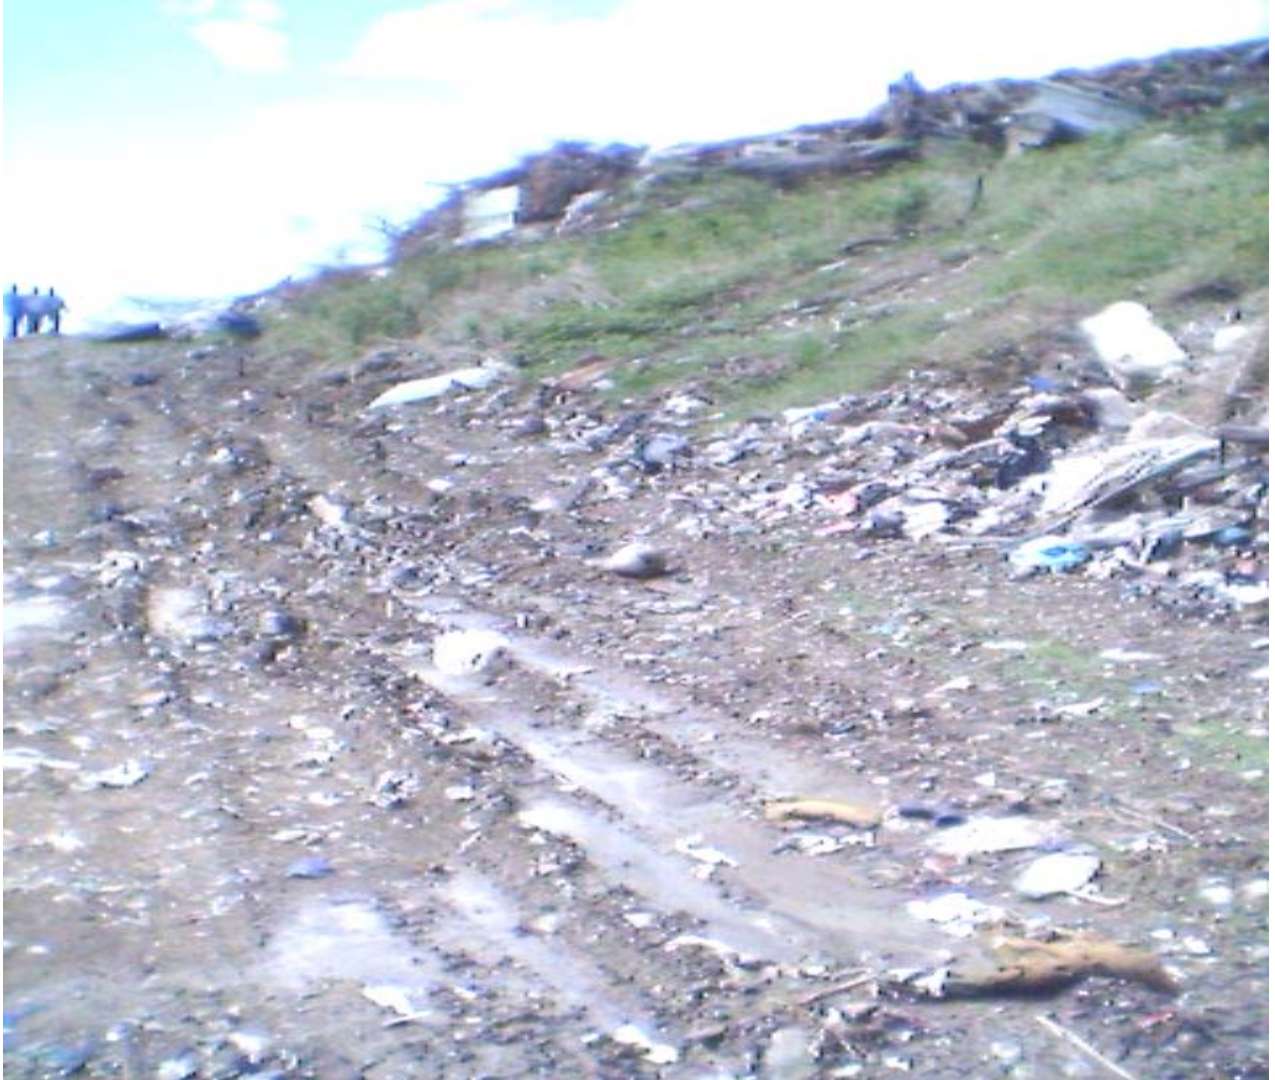
Photographs No. 17- Looking to the northwest. After a heavy rain event occurring a day before our visit. Stagnant waters mixed with leachate was observed along this zone of the landfill. This is part of Leachate Zone Z-1

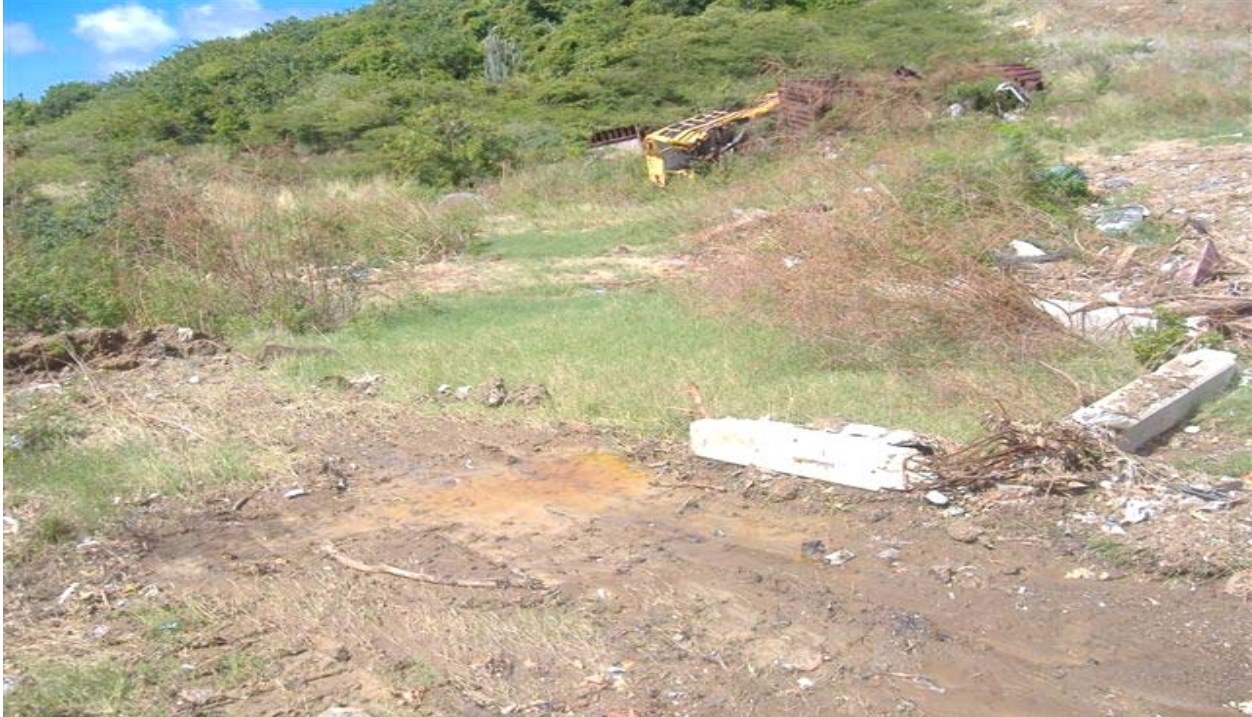
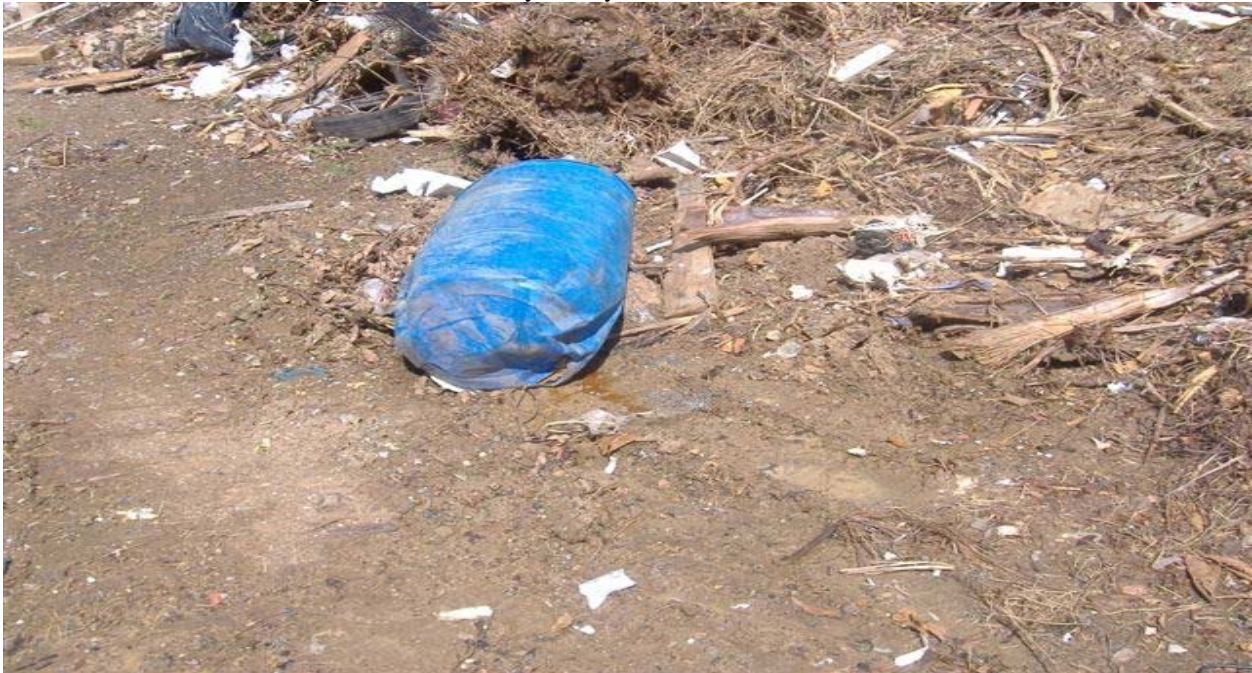
Photographs No. 18 & 19- Looking to the north. Leachate Zone Z-2 which is closed to the area facing the Luis Peña Canal. Any water runoff control was observed along this zone creating the possibility of leachate migration to the Reserve. The leachate leakage was observed very clearly in Photo No. 17 below.

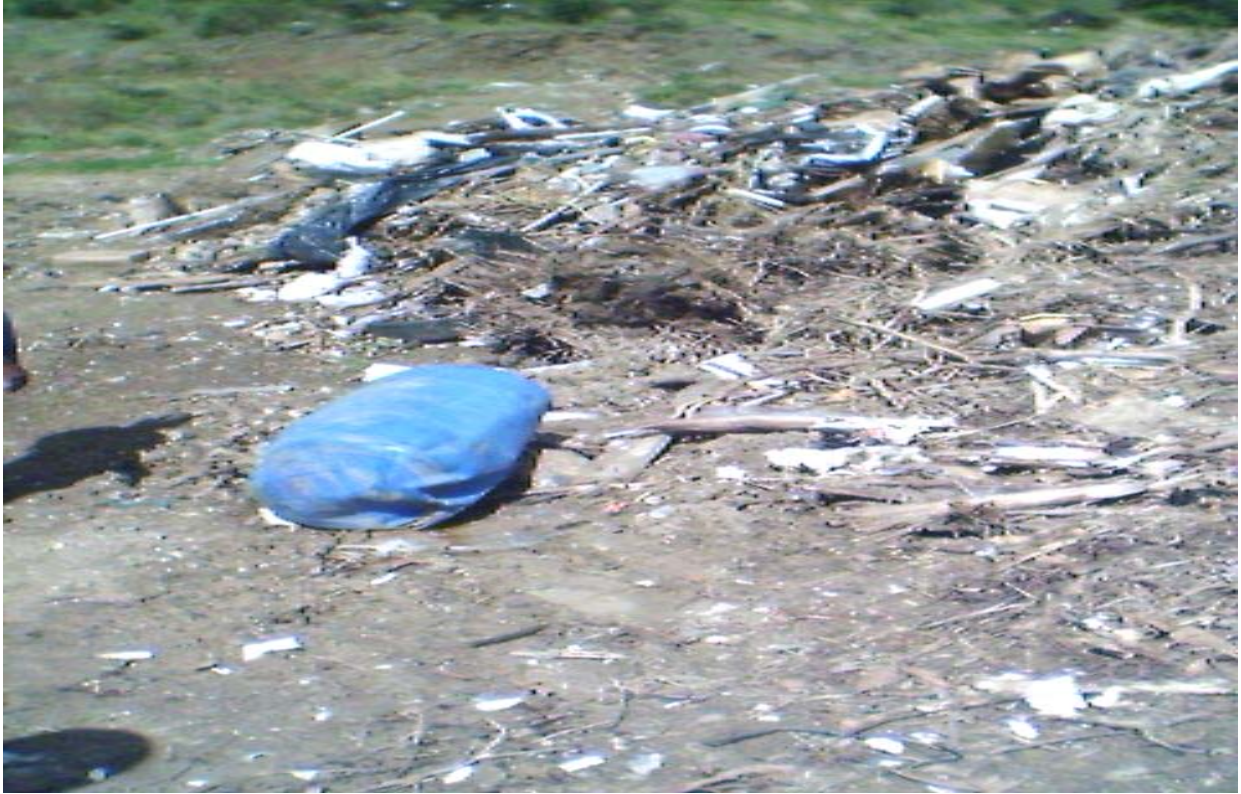
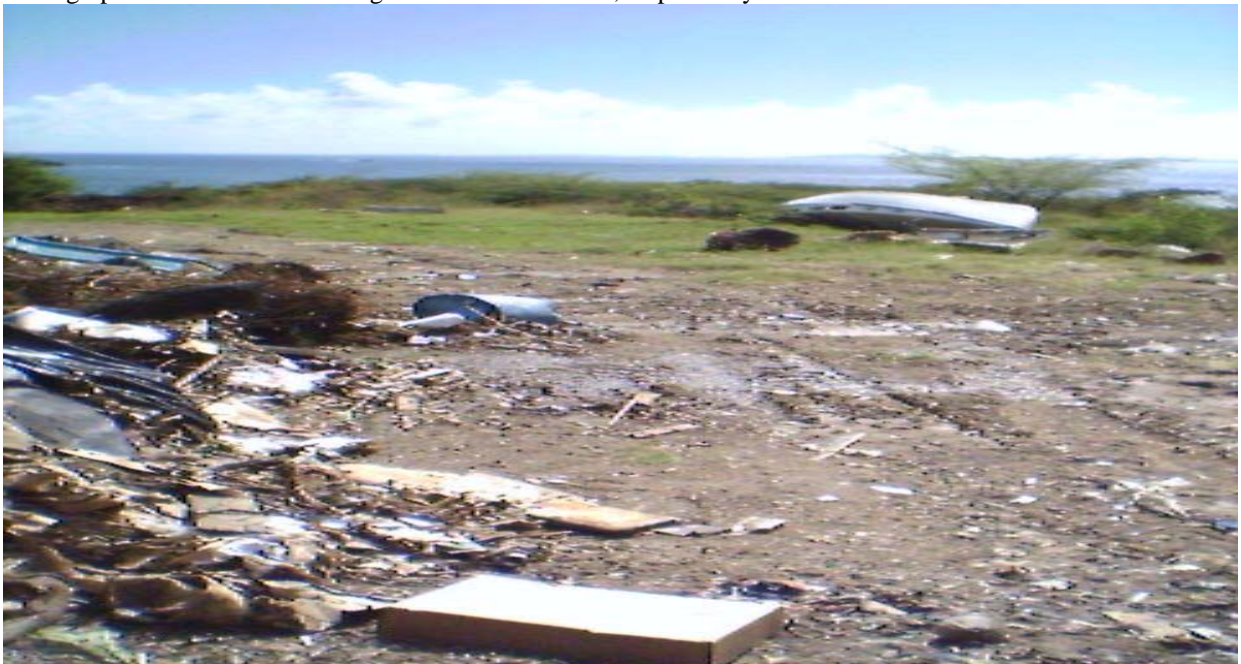
Photographs No. 20 & 21- Looking to the north and west, respectively. Leachate Zone Z-2

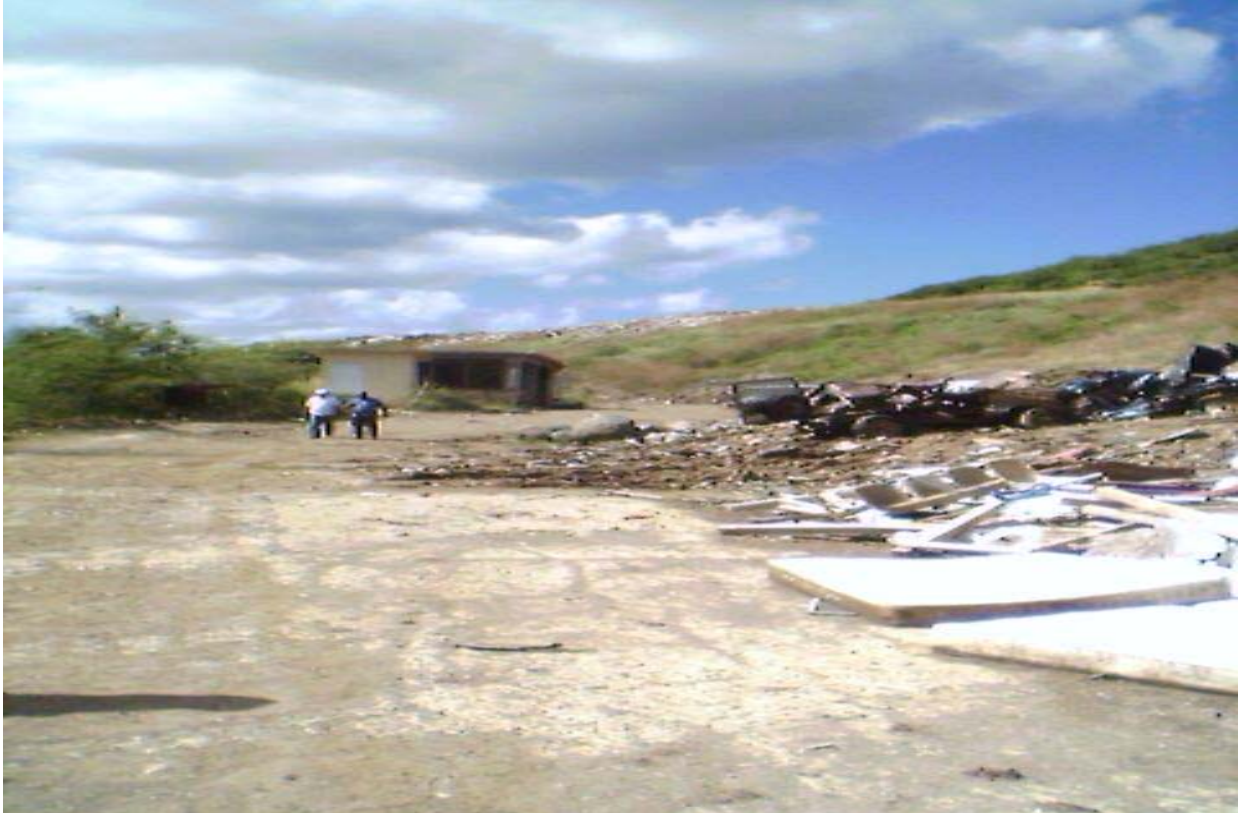
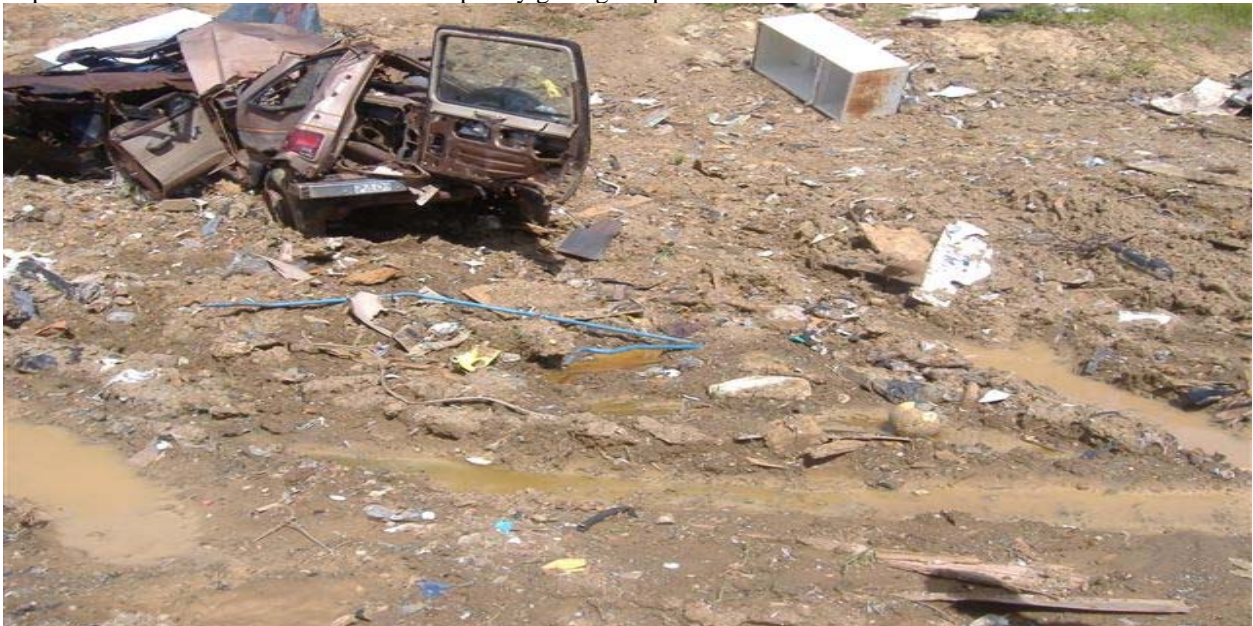
Photographs No. 22 & 23- Looking to the west. Leachate Zone Z-3. This is the lower boundary of the landfill. Superficial leachate is observed at this temporary garbage deposit area.
