**PRIMARY RESTORATION PLAN AND
ENVIRONMENTAL ASSESSMENT
FOR THE 2006 T/V MARGARA GROUNDING
GUAYANILLA, PUERTO RICO**

The Puerto Rico Department of Natural and Environmental Resources
and
the National Oceanic and Atmospheric Administration

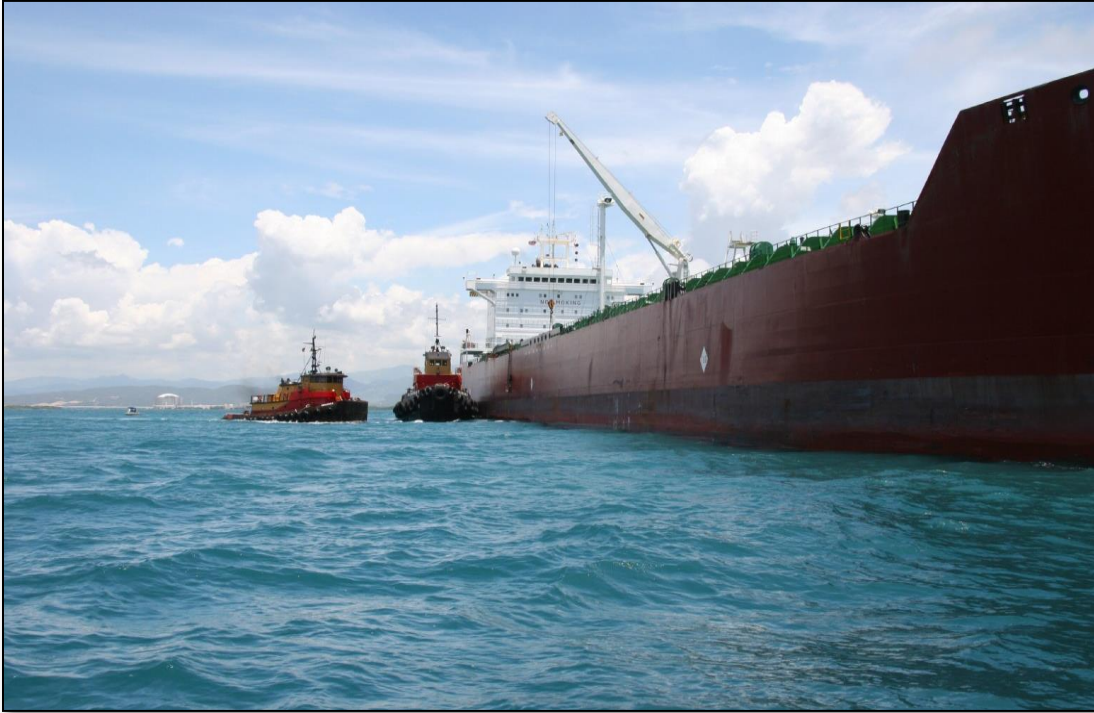
T/V MARGARA aground with tugs alongside on April 27, 2006. Photo courtesy of Puerto Rico Department of Natural and Environmental Resources

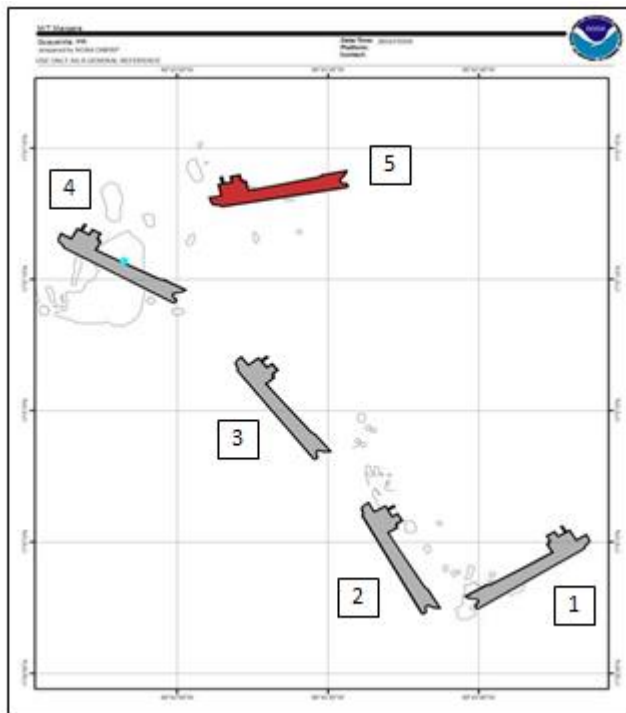
The general path of the vessel is shown in Figure 2. The vessel initially grounded in the eastern portion of the southern impact site (Location #1) and during response actions was rotated 90 degrees and westward moving it further into the southern impact site (Location #2). The nature of this response-related movement makes it not possible to separate the impacts from the initial grounding from the response/removal damage, but it is clear that impacts in Location #1 were exacerbated as a result of the movement. After the vessel came to rest in Location #2 the decision was made by the Captain and the FOSCR to attempt to free the vessel using a combination of vessel power and tug assist. This response

operation did free the vessel for a short period of time but resulted in a wide area of prop-wash damage (Location #3) before the vessel was accidentally re-grounded in Location #4, the northern impact site. Emergency attempts to free the vessel and prevent an oil spill caused rotation and movement over a large continuous reef area within the northern impact site. Eventually the vessel was freed from Location #4 and subsequently impacted a series of smaller reefs in Location #5 before being moved to deeper water. Sporadic damage resulting from the propwash of the T/V MARGARA and/or assisting tug boats was also evident at multiple locations.

Figure 2: T/V MARGARA path during removal with coral reef impact areas outlined in the background. Location #1 indicates the initial grounding site. Location #2 shows how the vessel was rotated during removal causing additional damage in the southern impact. Locations #3-5 show the path of the vessel after it was freed and subsequently re-grounded in the northern impact area.

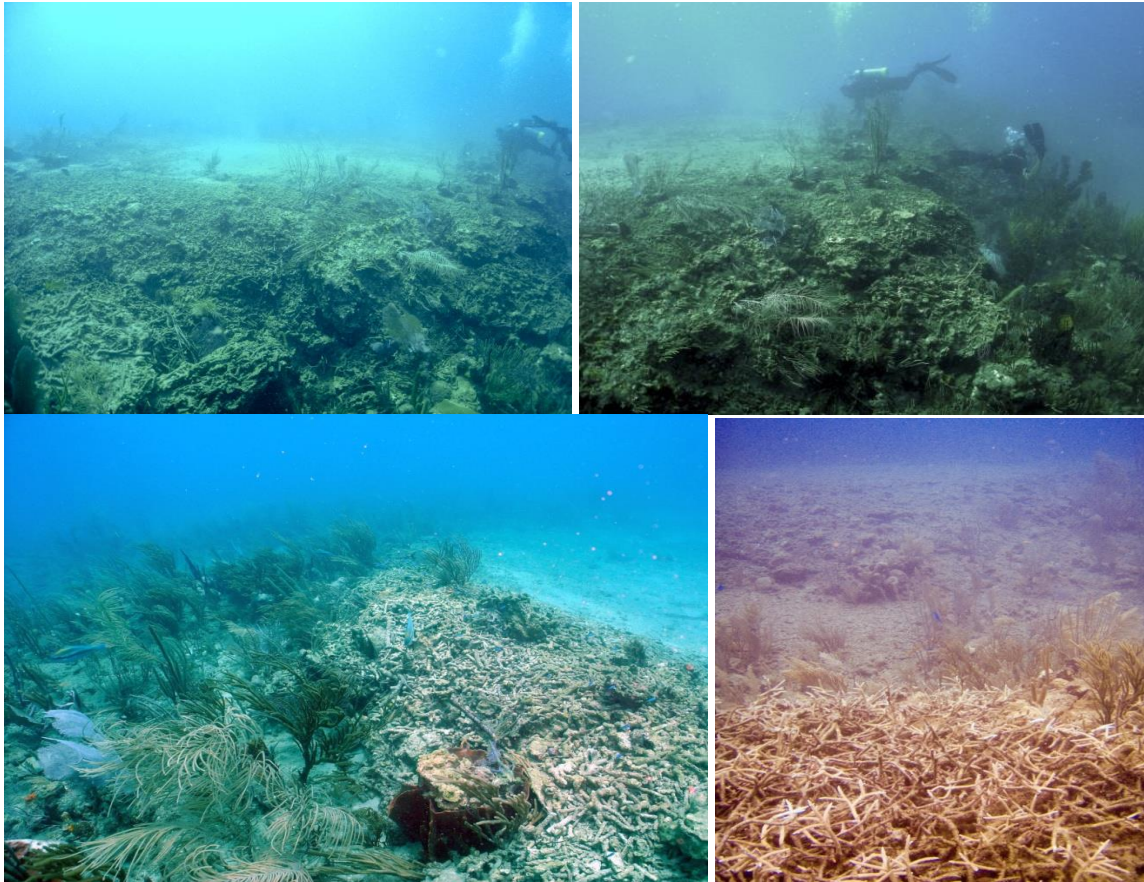
The T/V MARGARA Incident caused significant injuries to coral resources, other reef biota, and reef habitat over a large area (Figure 3). The T/V MARGARA impact site can be separated into a southern impact site (~ 1,204 m² of reef impacted), a northern impact site (~ 5,530 m² of reef impacted), and a deeper central area impacted by prop wash (~ 174 m² of reef impacted). The grounding of the vessel, its subsequent movement and actions undertaken to remove the vessel in order to prevent a significant oil spill caused or contributed to 6,908 m² of damage to the sea floor. Within that area, an estimated 6,393 m² of reef suffered a complete loss of biota. The remaining 515 m² suffered partial resource mortalities.

Figure 3: Photos of impacted areas and adjacent reef at the T/V MARGARA site. Photos taken by NOAA Restoration Center in 2006.

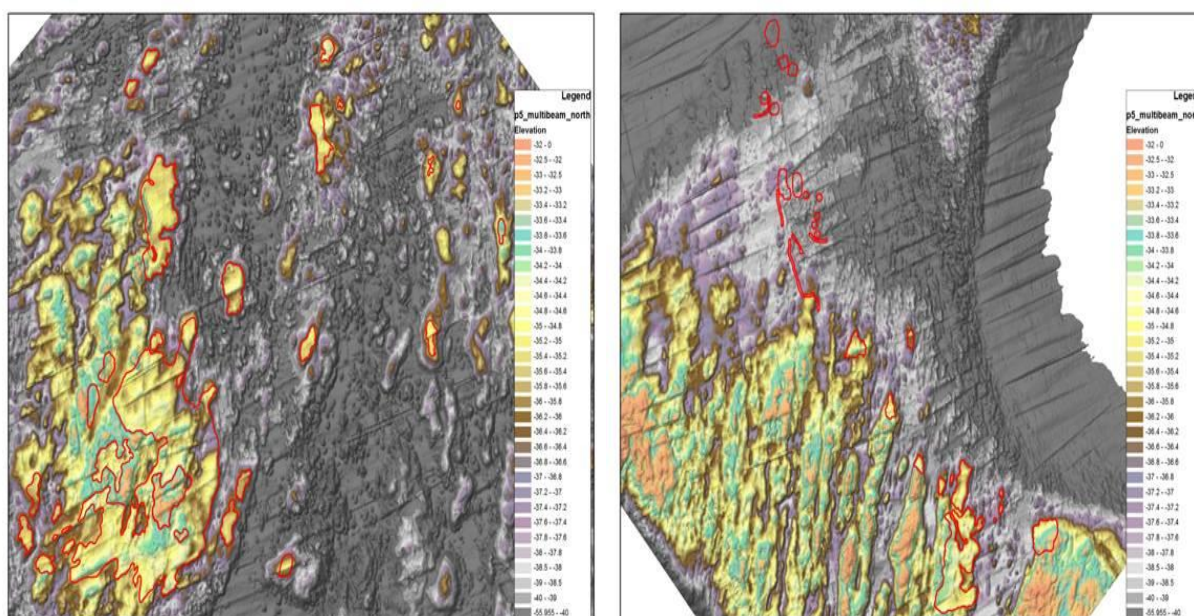
After Hurricane Dean passed near the site in 2007, the injury boundaries on the site map were updated based on the post-Dean Trustee/RP diver observations and measurements of the rubble movement and expanded areas of impacts associated with the storm. The updated mapping data was then used in ARCGIS software to determine the total area of impact in square meters (Table 1). The size of the impacted area increased by 633 m² after Hurricane Dean due to movement of loose rubble during the storm.

Figure 6: Pre-Hurricane Dean multi-beam images of the T/V MARGARA site with impact areas delineated in red. Northern impact area is on the left; southern impact and propwash areas are on the right.

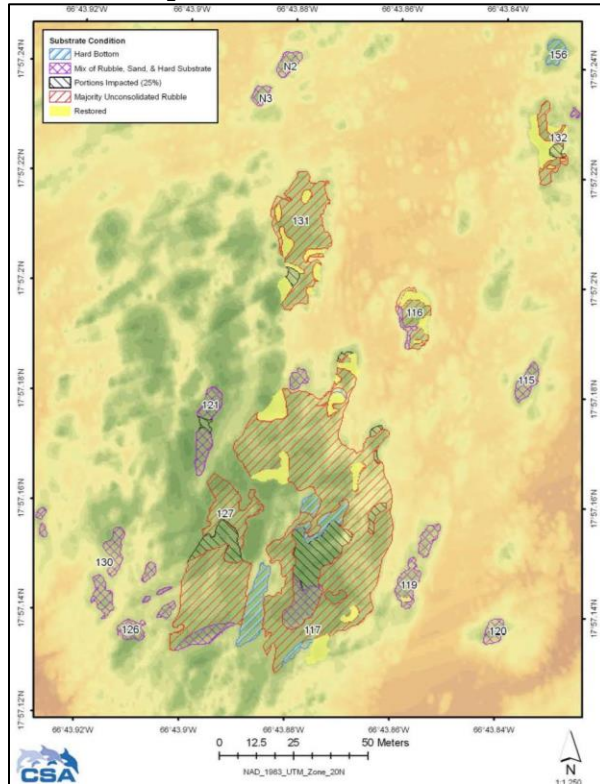
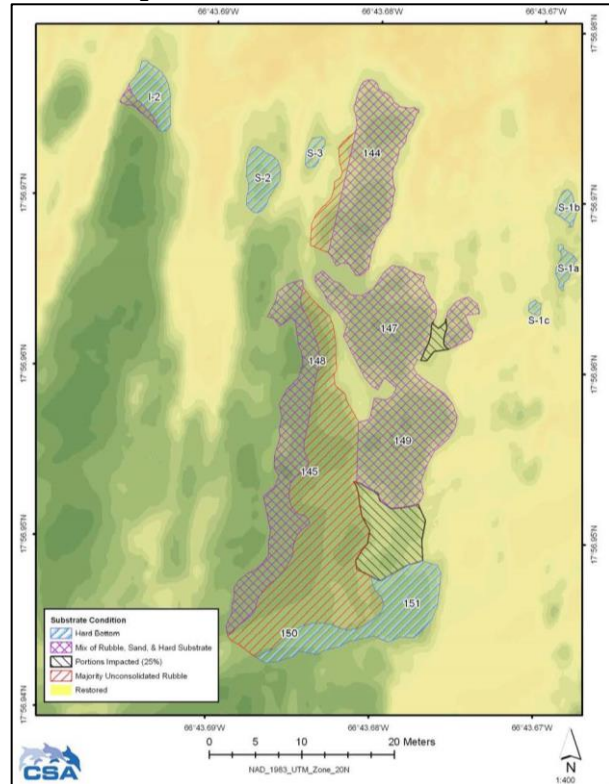
Figure 7: Post-Hurricane Dean T/V MARGARA site maps delineating substrate classifications for the northern impact area (left) and southern impact area (right). Maps produced by Continental Shelf Associates.

In areas classified as “Hard Substrate”, the reef structure was still relatively intact post-grounding even though there was a complete loss of coral biota. Recovery of these areas is viewed as likely to occur over time due to the presence of cryptic spaces for recruitment, the lack of sediment which would inhibit settlement of coral recruits, and minimal amounts of rubble available to damage or smother recruits during high energy events.

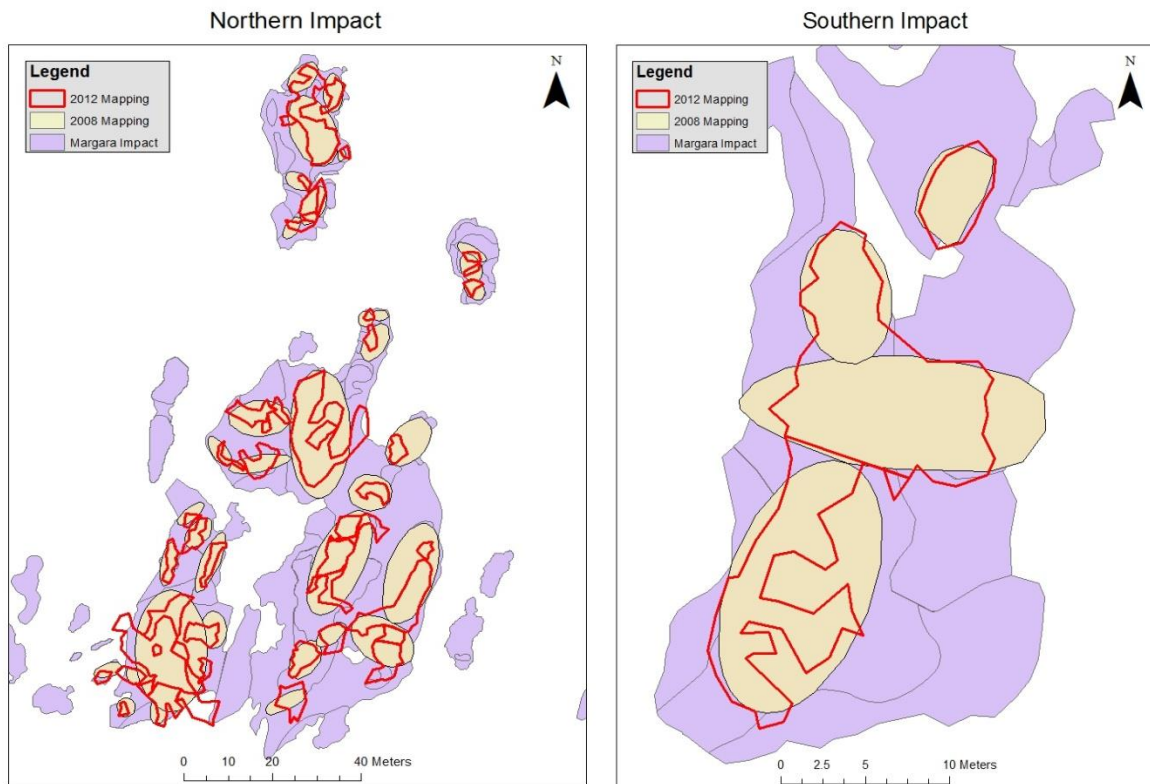
An additional joint site visit and mapping effort was cooperatively undertaken by the Trustees’ and RP’s technical representatives in February 2012 to further refine these areas. Detailed maps were generated using Aquamap (an underwater GPS system). As a result of this effort, the Trustees identified 1,662 m² of rubble areas as requiring or warranting additional stabilization as part of a primary restoration plan. Figure 8 depicts the restoration target areas identified by the Trustees in 2008 (beige ovals) and as refined in 2012 (overlaid red polygons). Figure 9 is a subset of the photos that are representative of the areas of the site that would require or warrant further primary restoration action.

Figure 8: Areas identified for primary restoration by the Trustees in 2008 (beige ovals) and cooperatively by RP and Trustee representatives in 2012 (red polygons) overlaid on map of MARGARA grounding site (purple).

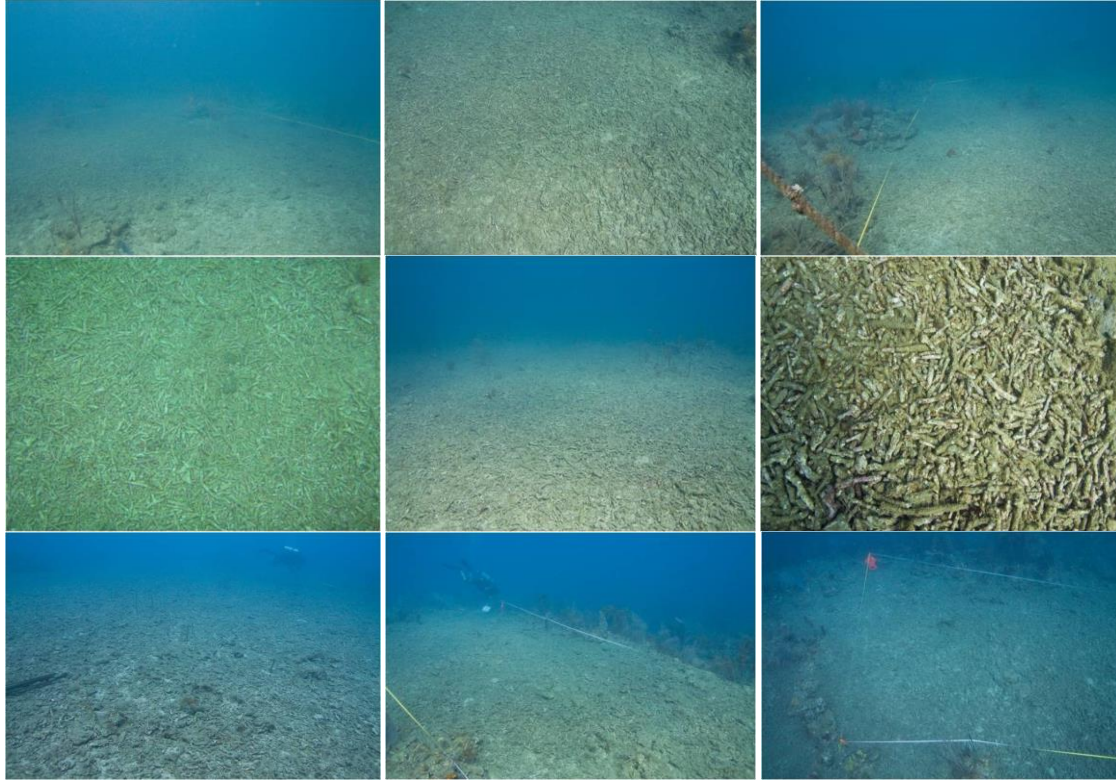
Figure 9: Photos of rubble and some of the areas needing primary restoration at the MARGARA site. Photos by NOAA Restoration Center, December 2008.

The recruitment monitoring data at the T/V MARGARA site from 2008 through 2012 shows that coral recruit survival in the rubble fields is on average between 0-18% compared to survival rates of 58-65% in the reference area and 49-56% in the restored areas. Scleractinian (stony coral) recruitment survival rates were 0% in rubble compared to 83-100% in the reference area and 40-42% in the restored areas. Octocoral recruitment survival was 8-18% in rubble, 58-65% in the reference area and 49-56% in the restored areas. Figures 12 and 13 show the change over time in mean number of corals in the monitoring quads and belt transects at the T/V MARGARA site (injury, restored area and reference) as well as at the nearby T/V SPERCHIOS grounding site (which does not have rubble present like at the T/V MARGARA site). The graphs in Figures 12 and 13 show how the T/V SPERCHIOS site is recovering with time while the T/V MARGARA rubble fields have limited to no recovery seven years after the Incident. In the belt transects, recovered octocoral densities are an order of magnitude greater at T/V SPERCHIOS than at the T/V MARGARA site, and recovered Scleractinian densities are two orders of magnitude greater at the T/V SPERCHIOS than at the T/V MARGARA site. There are almost no Scleractinians present in the rubble at the T/V MARGARA site, and densities of coral recruits at the site are below the 2008 Post-Hurricane Dean levels. The data shows that recovery in the rubble fields at the T/V MARGARA site is not occurring.

This alternative involves creating and placing limestone modules and/or a series of medium and large boulders on top of the rubble. This alternative would stabilize the rubble, return topographic complexity to the site and increase coral recruitment success at the site by providing available substrate on a three dimensional structure with lots of cracks and crevices that favor coral recruits (Maida et al., 1994). This alternative alone does not provide any biological enhancement to jump start recovery at the site.

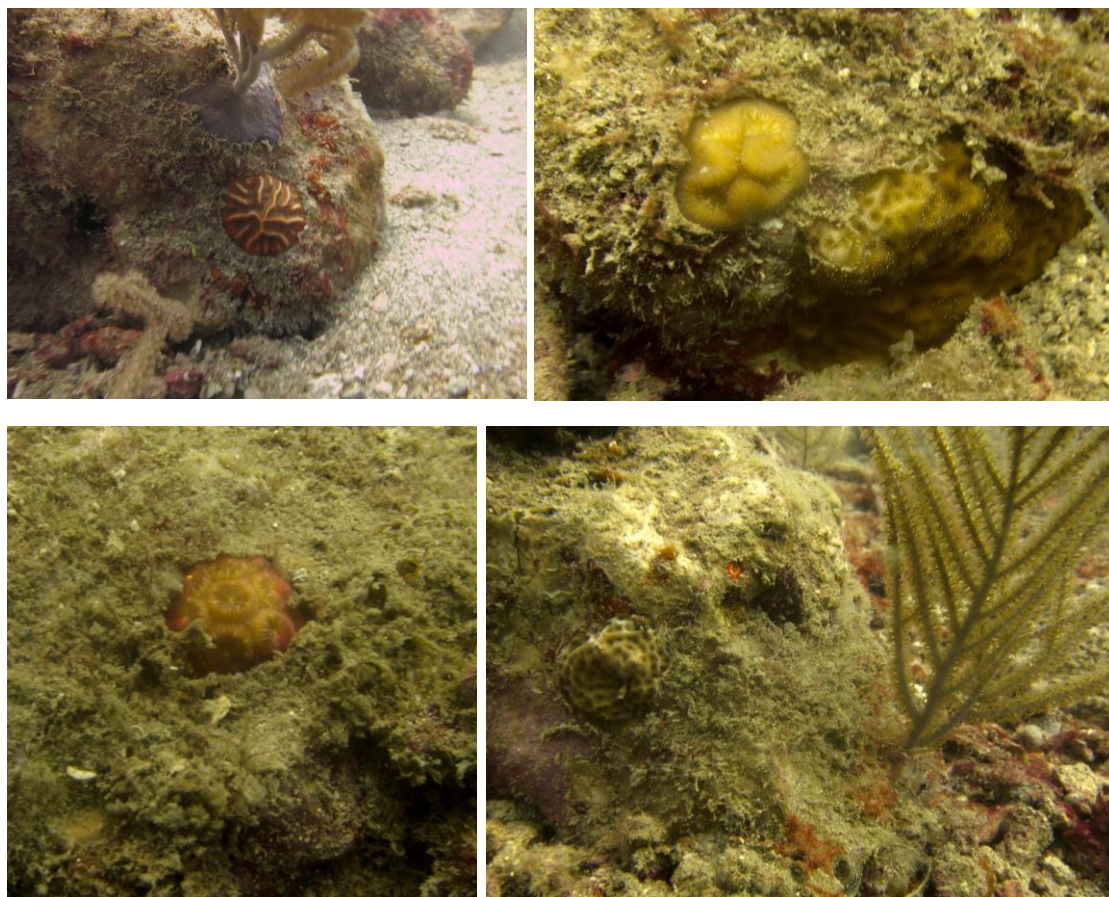
Figure 14: Photos of Scleractinian and Octocoral recruits on limestone deployed at T/V MARGARA site in 2010. Photos by NOAA’s Restoration Center, 2013.

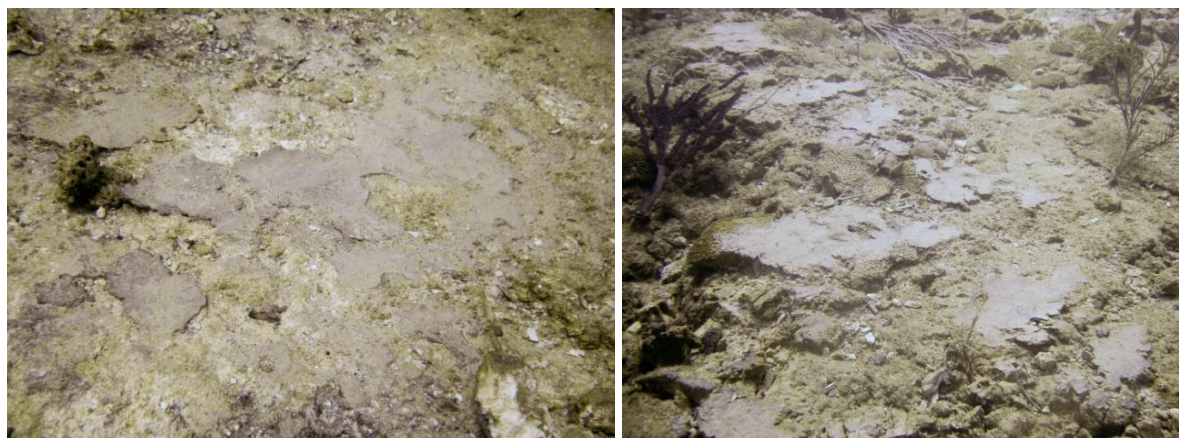
Figure 1: Anti-fouling paint from the hull of the T/V MARGARA found on the reef at the grounding site. Photos by NOAA Restoration Center, 2006.

approximately 55 gallons of anti-fouling paint and contaminated substrate (Figure 1), and stabilization of some large rubble. Tagging and mapping of reattached biota relative to on-site reference markers also occurred to facilitate future monitoring.

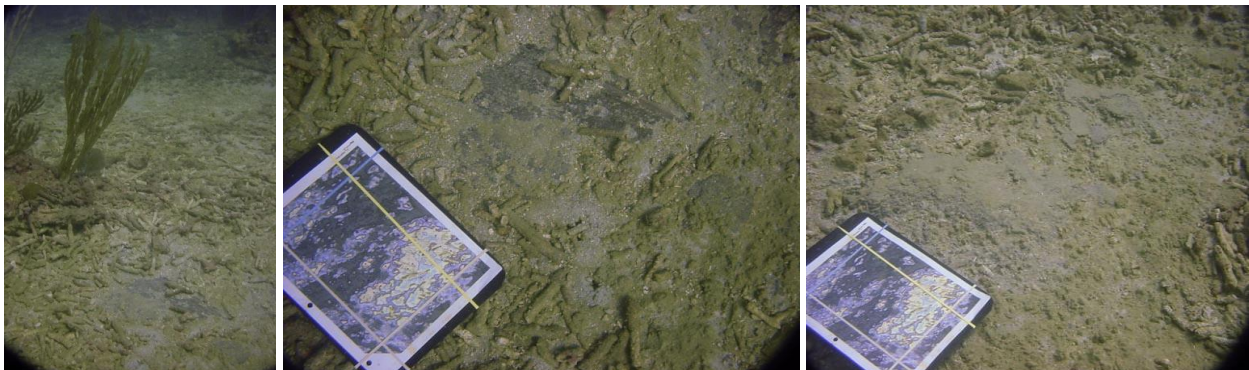
The mid-course corrective actions were initiated in November of 2007 and completed in the spring of 2008. Additional hull paint was also subsequently exposed by the passage of Hurricane Omar in October 2008 and later removed as well, to the extent possible (Figure 2).

Figure 2: Anti-fouling paint at the MARGARA site exposed by Hurricane Omar, October 2008. Photos taken by NOAA Restoration Center in October, 2008.
