DEPARTMENT of
PRIMARY INDUSTRIES,
WATER *and* ENVIRONMENT

Index of River Condition for the Jordan River Catchment

David Horner
Aquatic Ecologist
Water Assessment and Planning Branch
Water Resources Division
DPIWE.

December, 2003

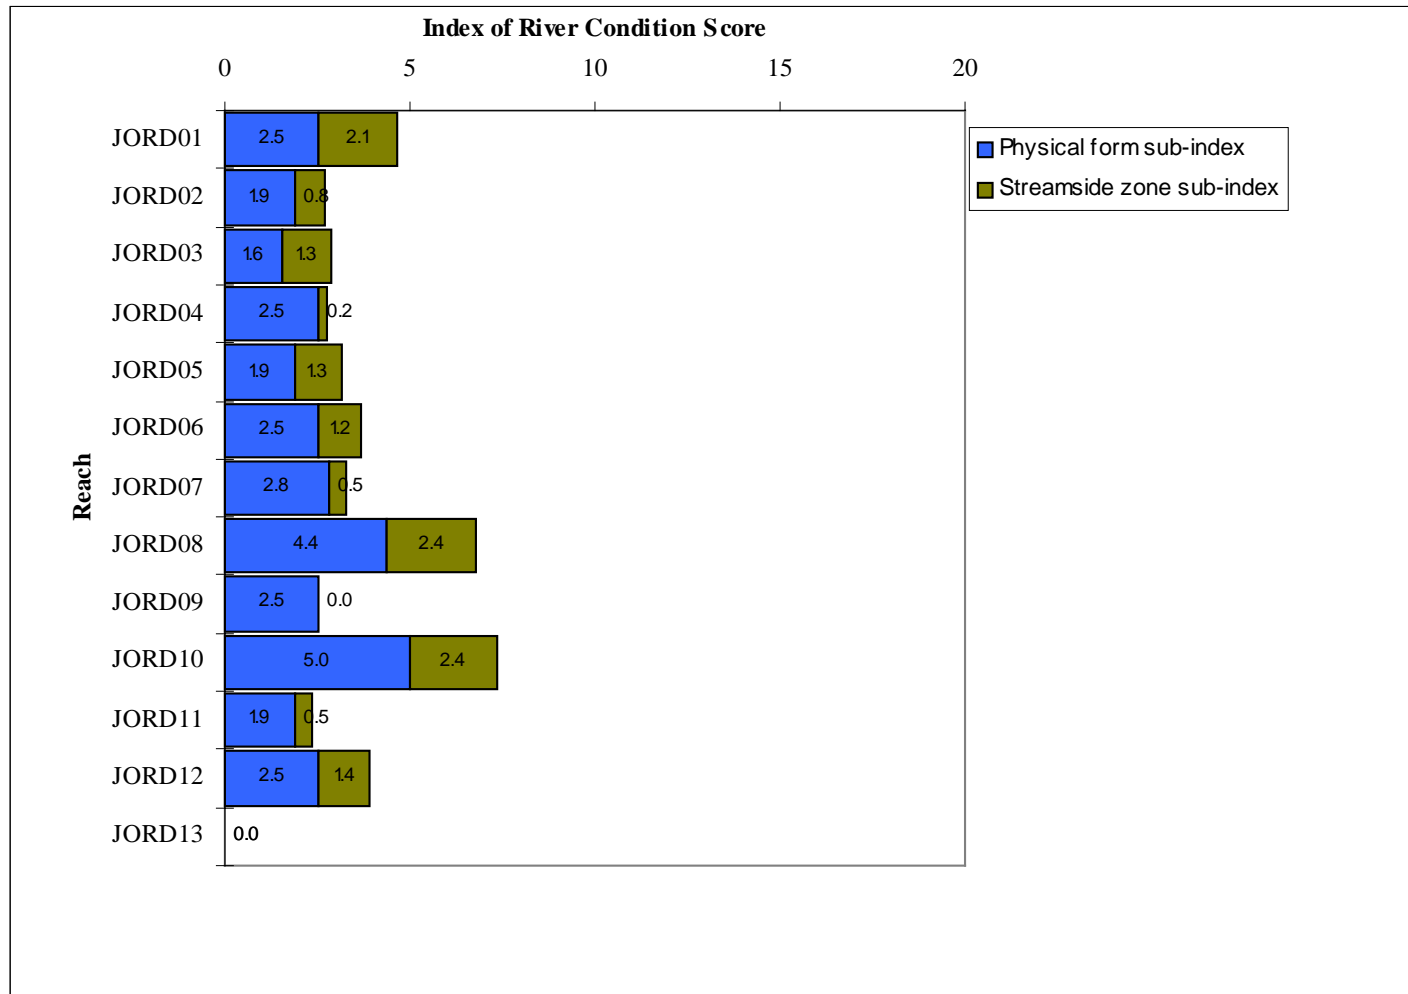
Figure 3. IRC results for the Jordan River mainstream sites.

For the mainstream the rating for physical condition ranged from moderate to very poor condition with the values for individual sites being influenced by the degree of development around the site (Figure 3). The physical form sub-index for two reaches of the Jordan mainstream rated as in moderate condition (Jordan River upstream Donnybrook Rivulet (JORD08), and Jordan River at Glenmore Sugarloaf (JORD10)). The physical form subindex was found to be in poor condition for six mainstream sites (Jordan River at old gauging station (JORD01), Jordan River at Andersons Road (JORD04), Jordan River at Clifton Vale Road (JORD06), Jordan River at Mauriceton (JORD07), Jordan River at Apsley (JORD09) and Jordan River at Burnt Log Gully (JORD12)). The physical form sub-index rated as in very poor condition for five mainstream sites (Jordan River at Pontville Ford (JORD02), Jordan River at Elderslie Road (JORD03), Jordan River at Roydon Road (JORD05), Jordan River at Black Bridge (JORD11), and Jordan River at Jericho (JORD13)). Sub-index rating values of 1.9 for Jordan River at Pontville Ford (JORD02), Jordan River at Roydon Road (JORD05) and Jordan River at Black Bridge (JORD11) indicate that in-stream conditions for these sites border on poor (major modification). Jordan River at Jericho (JORD13) was the most altered of the mainstream sites with a physical form sub-index value of 0.0.

Condition of the stream-side zone ranged from poor to very poor for the mainstream sites. Three sites (Jordan River at old gauging station (JORD01), Jordan River upstream Donnybrook Rivulet (JORD08) and Jordan River at Glenmore Sugarloaf (JORD10)) rated as in poor condition. The remaining 10 mainstream sites (Jordan River at Pontville Ford (JORD02), Jordan River at Elderslie Road (JORD03), Jordan River at Andersons Road (JORD04), Jordan River at Roydon Road (JORD05), Jordan River at Clifton Vale Road (JORD06), Jordan River at Mauriceton (JORD07), Jordan River at Apsley (JORD09), Jordan River at Black Bridge (JORD11), Jordan River at Burnt Log Gully (JORD12) and Jordan River at Jericho (JORD13) were rated as in very poor condition.

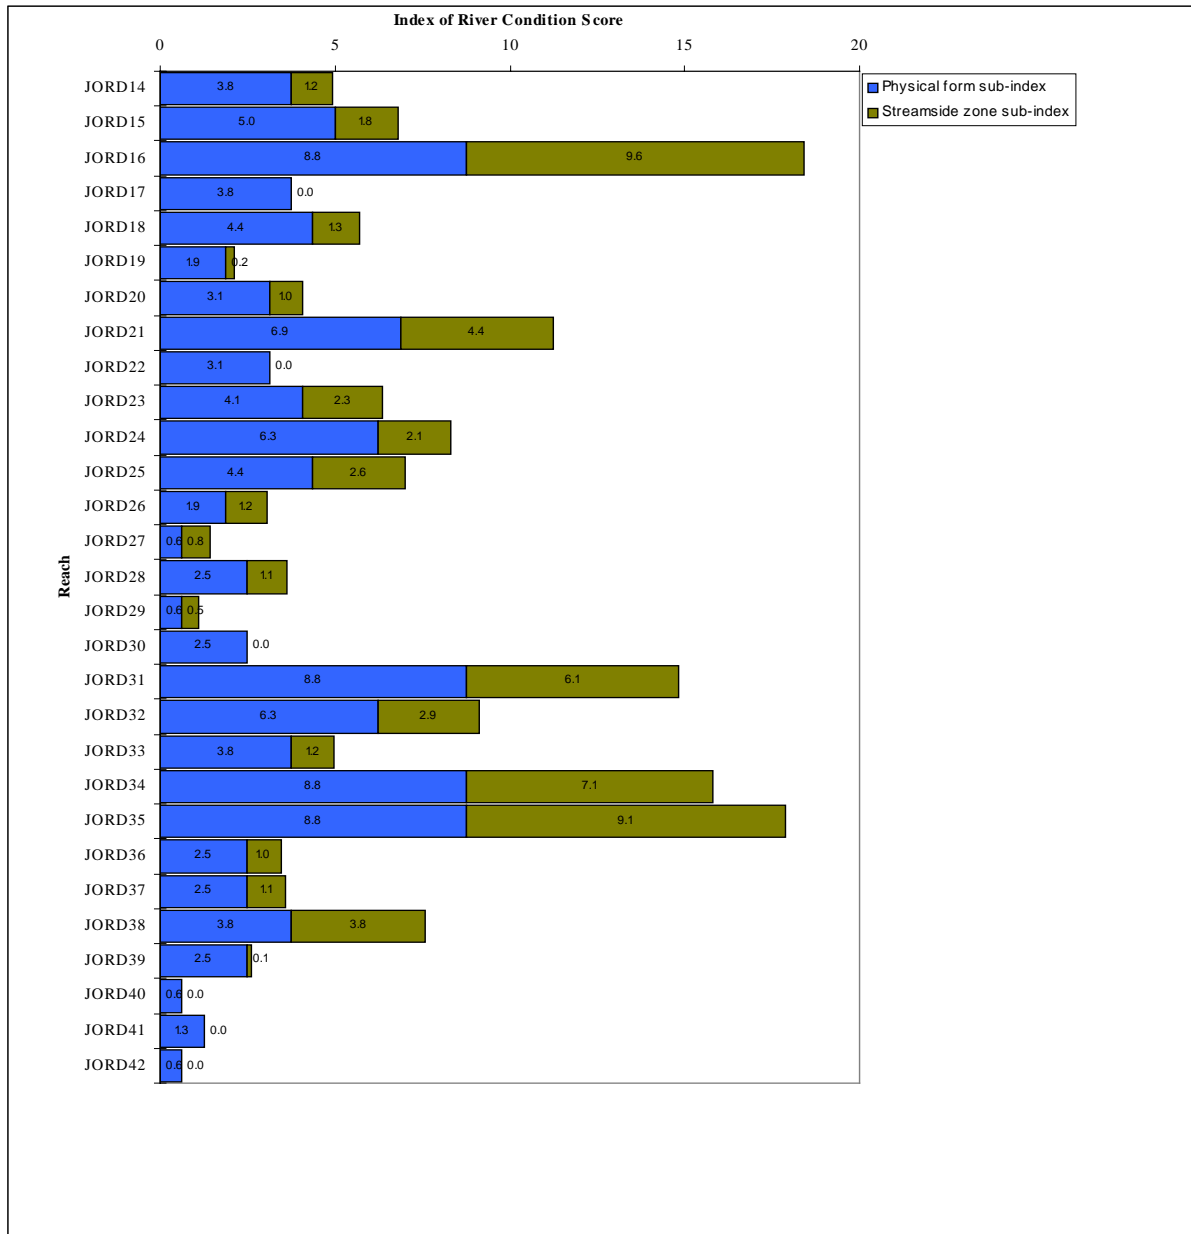
Figure 4. IRC results for the Jordan River tributary sites.

Four tributary sites were found to be in essentially natural (excellent) condition for Physical form (Bagdad Rivulet off Harbach's Road (JORD16), Quoin Rivulet at Colebrook Heights (JORD31), Little Den Creek at Lake Highway (JORD34), and Little Den Creek at Bisdees Road (JORD35)). The Physical form sub-index of three tributary sites (Brown Cave Creek at Chauncy Vale Road (JORD21), Grahams Creek at Elderslie Road (JORD24), and Donnybrook Rivulet at Den Road (JORD32)), rated as in good (near natural) condition. Four tributary sites rated as in moderate condition (Bagdad Rivulet at Eddington Road (JORD15), Strathallan Rivulet at Tea Tree (JORD18), Stoneyhurst Creek off Storeys Road (JORD23), and Grahams Creek off Grahams Creek Road (JORD25)). Eleven tributary sites rated as in poor condition for this sub-index (Bagdad Rivulet upstream of Golf Course (JORD14), Strathallan Rivulet upstream of Golf Course (JORD17), Woodlands Creek upstream of Tea Tree (JORD20), Mangalore Creek at Black Brush Road (JORD22), Espies Creek off Pelham Road (JORD28), Quoin Rivulet at Midlands Highway (JORD30), Donnybrook Rivulet upper at Den Road (JORD33), Springhill Creek at Lower Marshes Road (JORD36), Exe Rivulet at Exe Sugarloaf (JORD37), Green Hill Rivulet off Bowhill Road (JORD38), and Green Hill Rivulet at Bowhill Road (JORD39)). Seven sites rated as in very poor (highly modified) condition for physical form (Tea Tree Rivulet at Back Tea Tree Road (JORD19), Green Valley Rivulet at Cockatoo Valley Road (JORD26), Green Valley Rivulet at Green Valley Road (JORD27), Green Ponds Rivulet at Wilderness Lane (JORD29), Petherton Creek at Bowhill Road (JORD40), Dulverton Rivulet at Bowhill Road (JORD41), and Huntworth Creek at Stonor Road (JORD42)).

Very poor conditions were assessed for the stream-side zone sub-index at 19 tributary sites (Bagdad Rivulet upstream of Golf Course (JORD14), Bagdad Rivulet at Eddington Road (JORD15), Strathallan Rivulet upstream of Golf Course (JORD17), Strathallan Rivulet at Tea Tree (JORD18), Tea Tree Rivulet at Back Tea Tree Road (JORD19), Woodlands Creek upstream of Tea Tree (JORD20), Mangalore Creek at Black Brush Road (JORD22), Green Valley Rivulet at Cockatoo Valley Road (JORD26), Green Valley Rivulet at Green Valley Road (JORD27), Espies Creek off Pelham Road (JORD28), Green Ponds Rivulet at Wilderness Lane (JORD29), Quoin Rivulet at Midlands Highway (JORD30), Donnybrook Rivulet upper at Den Road (JORD33), Springhill Creek at Lower Marshes Road (JORD36), Exe Rivulet at Exe Sugarloaf (JORD37), Green Hill Rivulet at Bowhill Road (JORD39), Petheron Creek at Bowhill Road (JORD40), Dulverton Rivulet at Bowhill Road (JORD41), and Huntworth Creek at Stonor Road (JORD42)).

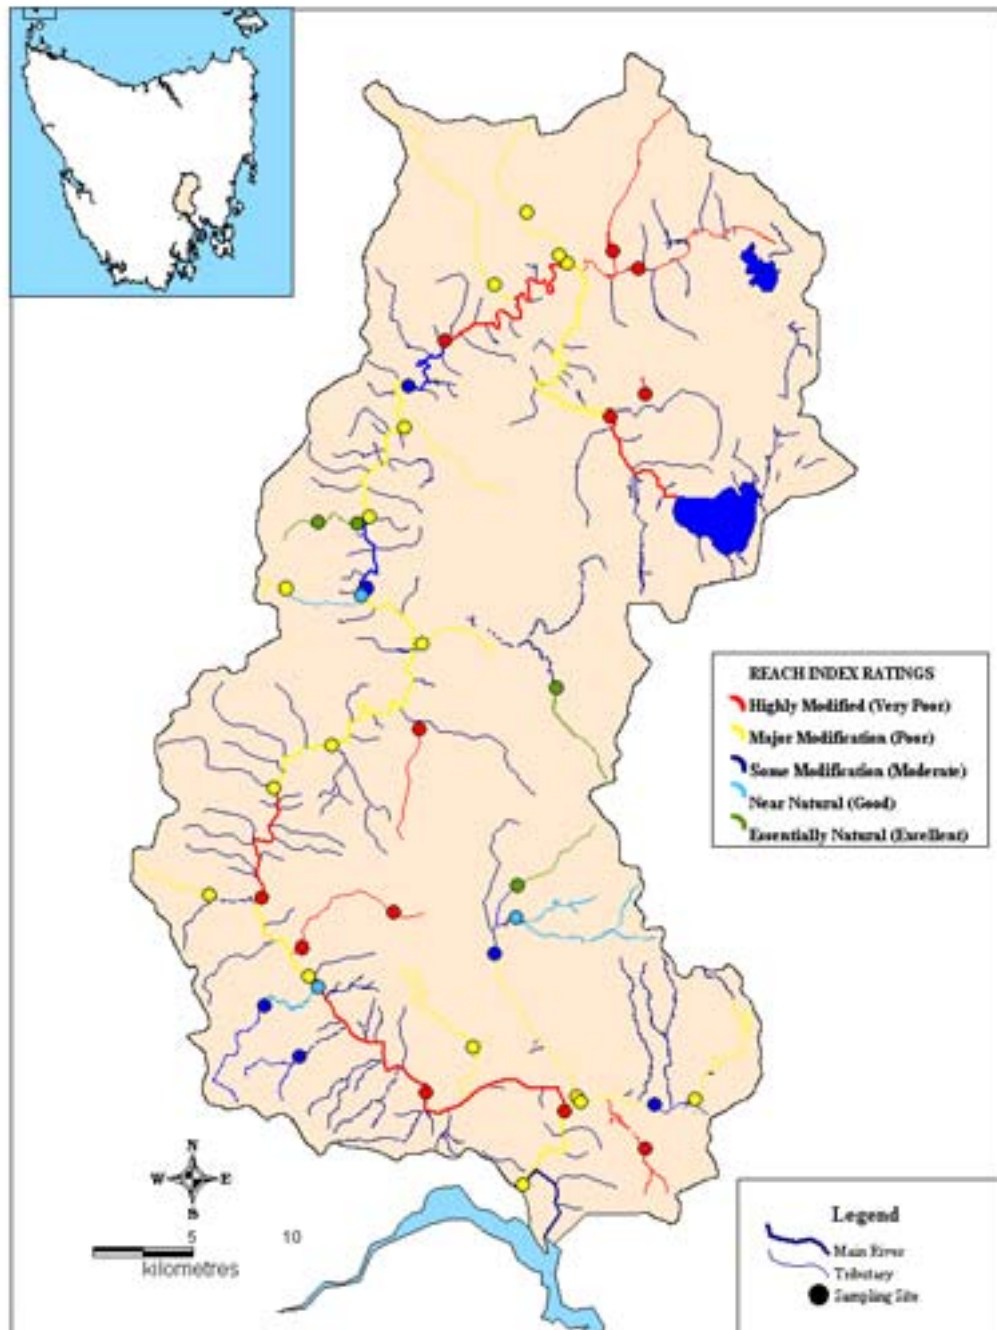
Figure 5: Jordan Catchment. Physical form sub-index ratings.

Like the mainstream, physical form condition deteriorated for the tributary sites within agricultural or urbanised areas. This is clearly reflected in the low ratings of Quoin Rivulet at Midlands Highway (JORD30) and Bagdad Rivulet upstream of Golf Course (JORD14), when compared with tributary sites that occur in less developed zones, such as Quoin Rivulet at Colebrook Heights (JORD31) and Bagdad Rivulet off Harbach's Road (JORD16).

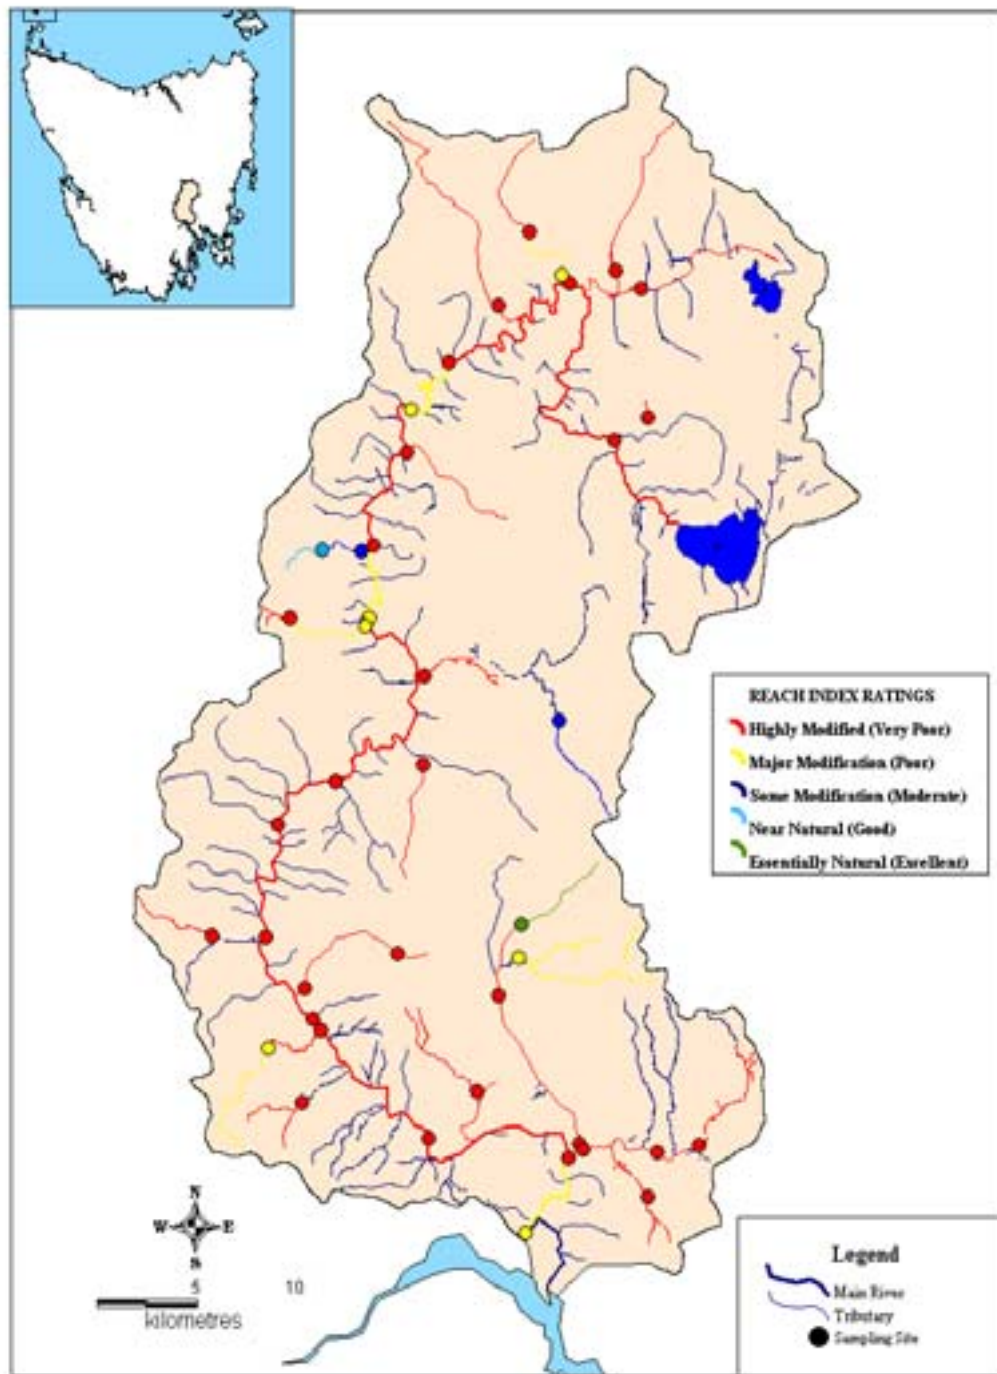
Figure 6: Jordan Catchment. Stream-side zone sub-index ratings.

The stream-side zone sub-index of two tributary site (Bagdad Rivulet off Harbach's Road (JORD16) and Little Den Creek at Bisdees Road (JORD35)), rated as in excellent (essentially natural) condition. Two sites rated as in good (near natural) condition for this sub-index (Quoin Rivulet at Colebrook Heights (JORD31) and Little Den Creek at Lake Highway (JORD34)). A single tributary site rated as in moderate condition (Brown Cave Creek at Chauncy Vale Road (JORD21)). Five tributary sites rated as in poor condition for the stream-side zone sub-index (Stoneyhurst Creek off Storeys Road (JORD23), Grahams Creek at Elderslie Road (JORD24), Grahams Creek off Grahams Creek Road (JORD25), Donnybrook Rivulet at Den Road (JORD32), and Green Hill Rivulet off Bowhill Road (JORD38)).

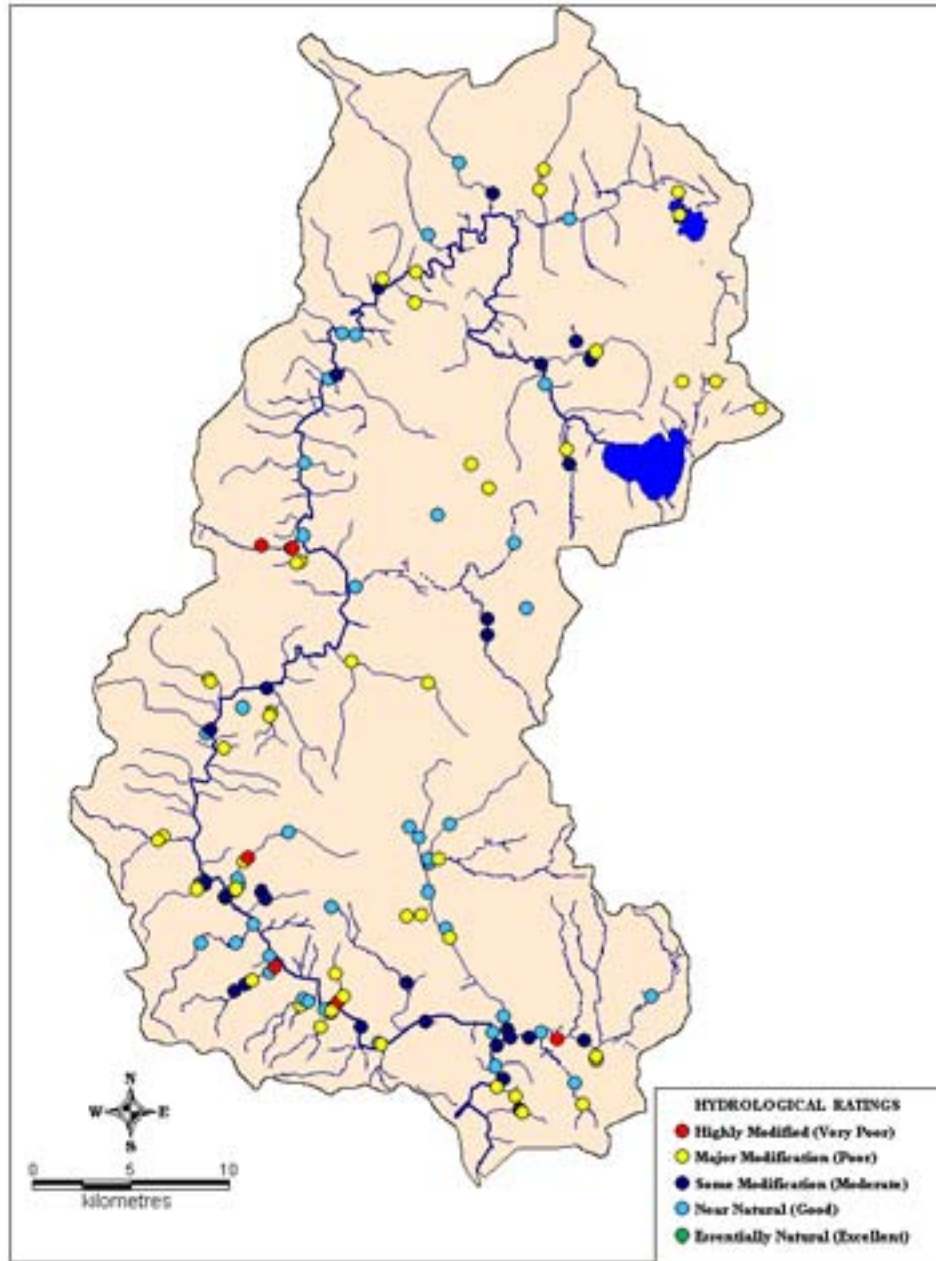
Figure 7: Jordan Catchment. Barrier locations and hydrological connectivity ratings.

Table 6 presents ratings for various types of structures in relation to hydrological connectivity. In the Jordan catchment, bridges (n=42) result in partially modified conditions, culverts (n=19) and weirs (n=2) result in moderately modified conditions, whilst dams (n=67) result in poor conditions for fish passage. Figure 7 shows the distribution of structures and related fish passage values of structures that were surveyed within the catchment. Of the structures assessed, eighty-four result in moderate to extreme modification for fish passage.

Of the barriers assessed, the Elderslie Road weir has the greatest potential to affect fish passage within the Jordan River. This is due in part to the design of the weir and its location on the mainstream within the lower catchment. Improvement of hydrological conditions across the weir should be considered in relation to native fish management within the Jordan catchment.

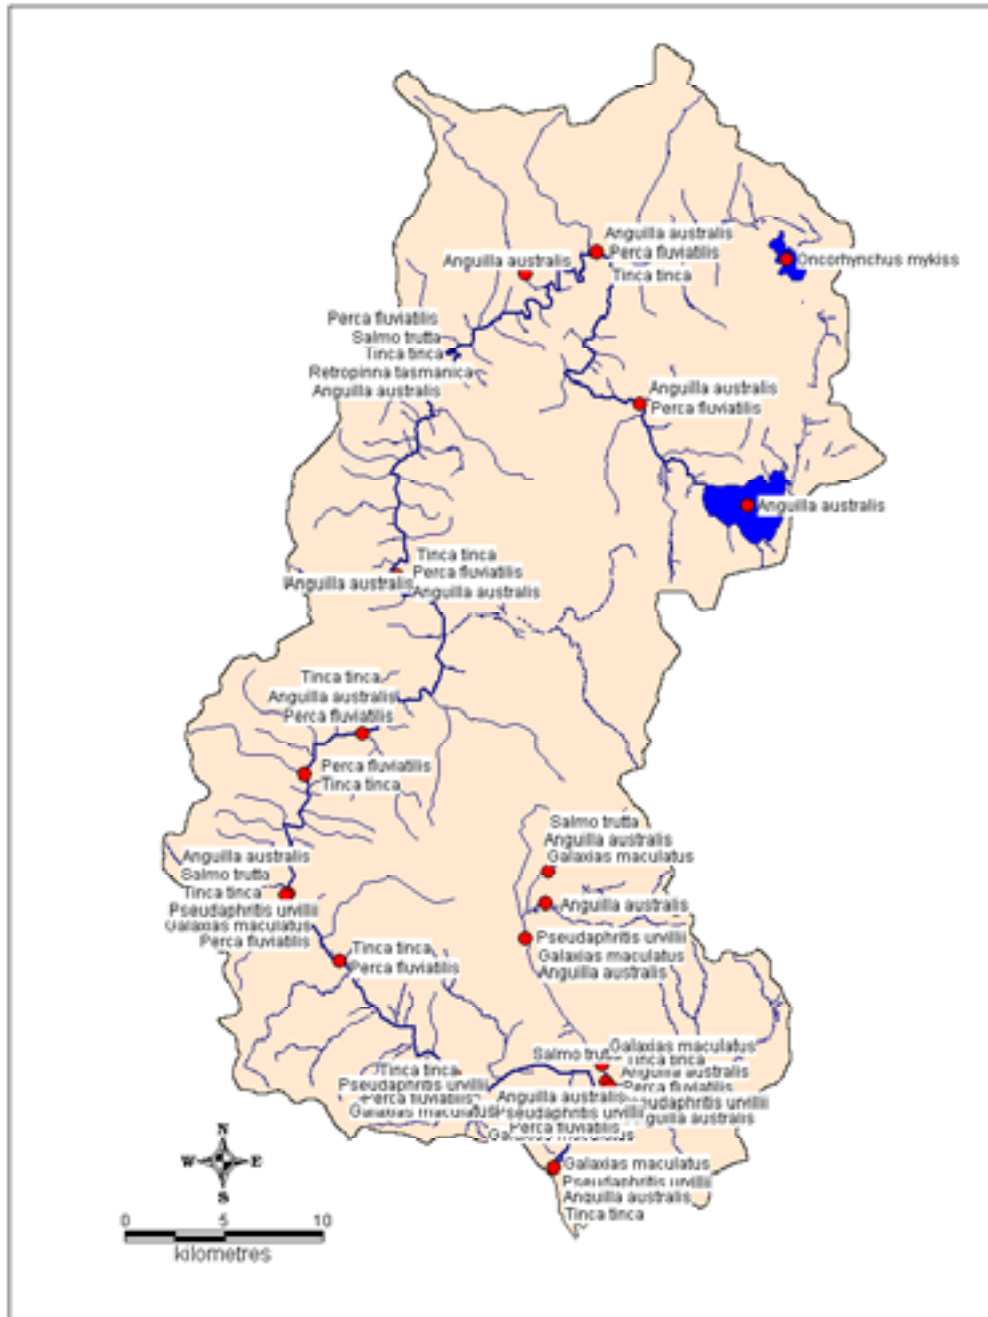
Figure 8: Fish distribution map for the Jordan catchment.

At the majority of mainstream sites *T.tinca* (tench) and/or *P.fluviatilis* (redfin) dominate fish assemblages. In the lower mainstream the converse is the case where *G.maculatus* and *A.australis* dominate the assemblages (JORD01 and JORD02). For all sites surveyed on Bagdad Rivulet, *G.maculatus* are the dominant species. Exotic species account for 14% (redfin and tench) and 18% (brown trout) of the fish numbers at JORD14 and JORD16, respectively with no exotics captured at JORD15. Surveys suggest that Bagdad Rivulet is an important tributary for maintaining native fish populations within the Jordan catchment.
