Assessment of Urban Coastal Wetlands Vulnerability to Hurricanes in Puerto Rico

**Benjamin Branoff MSc, Elvira Cuevas PhD, & Elix Hernández BSc
University of Puerto Rico-Río Piedras**

**With contributions from:
Jon Fripp, PE, Natural Resource Conservation Service
Barry Southerland, PhD, USDA Natural resource Conservation Service**

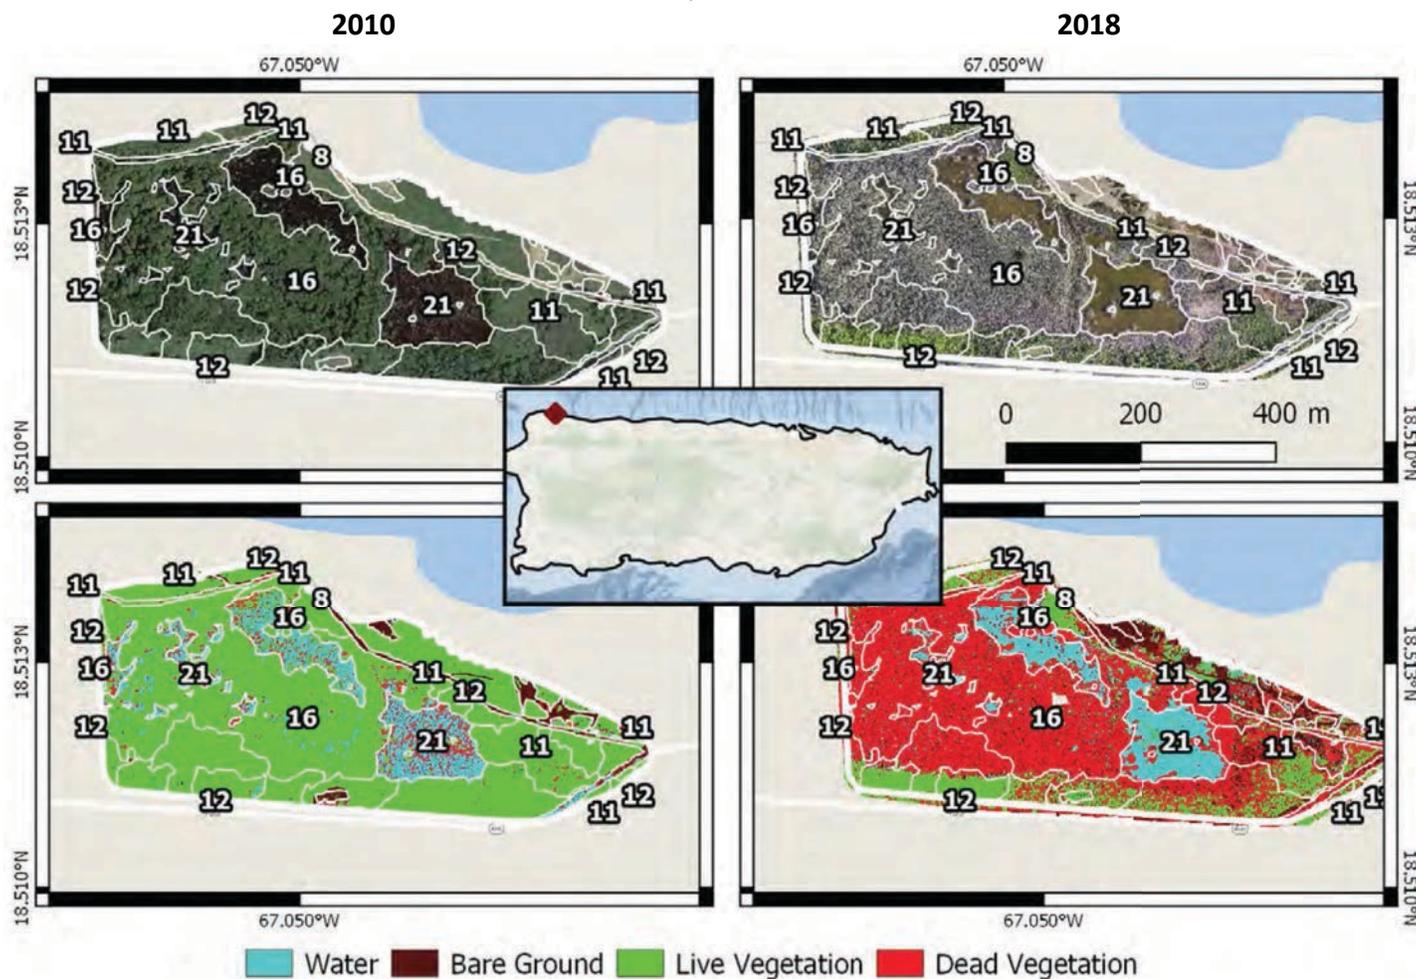
Figure 2 Aerial imagery of the mangroves at Isabela, Puerto Rico from 2010 to 2018, representing pre and post hurricane, respectively. Numbers represent major habitat classes as represented in the below table. Isabela suffered the highest mangrove mortality rate of all sites. Surviving mangroves were concentrated on higher elevations shorelines, suggesting mortality was due to higher than normal water levels for longer than normal duration. Habitat class 21 is open water. Recovery of mangroves at Isabela would benefit from active management.

Table 1 The mangroves at Isabela suffered the highest mortality rate of all included sites, with aerial imagery suggesting 95% mortality, equivalent to nearly 7.5 hectares of forest. Other vegetation also suffered to a lesser extent.

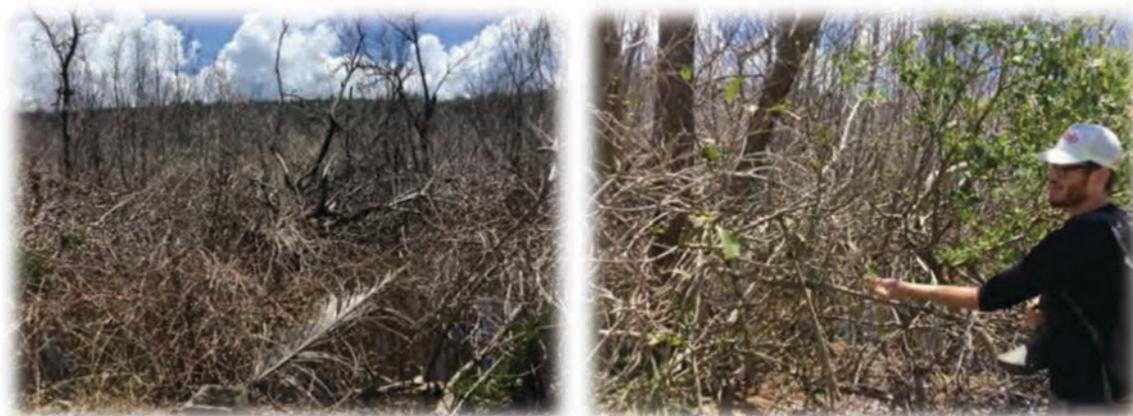
Figure 3 While most of the mangroves at Isabela are dead (left), there are some live trees and seedlings along the higher grounds on wetland shore (right).

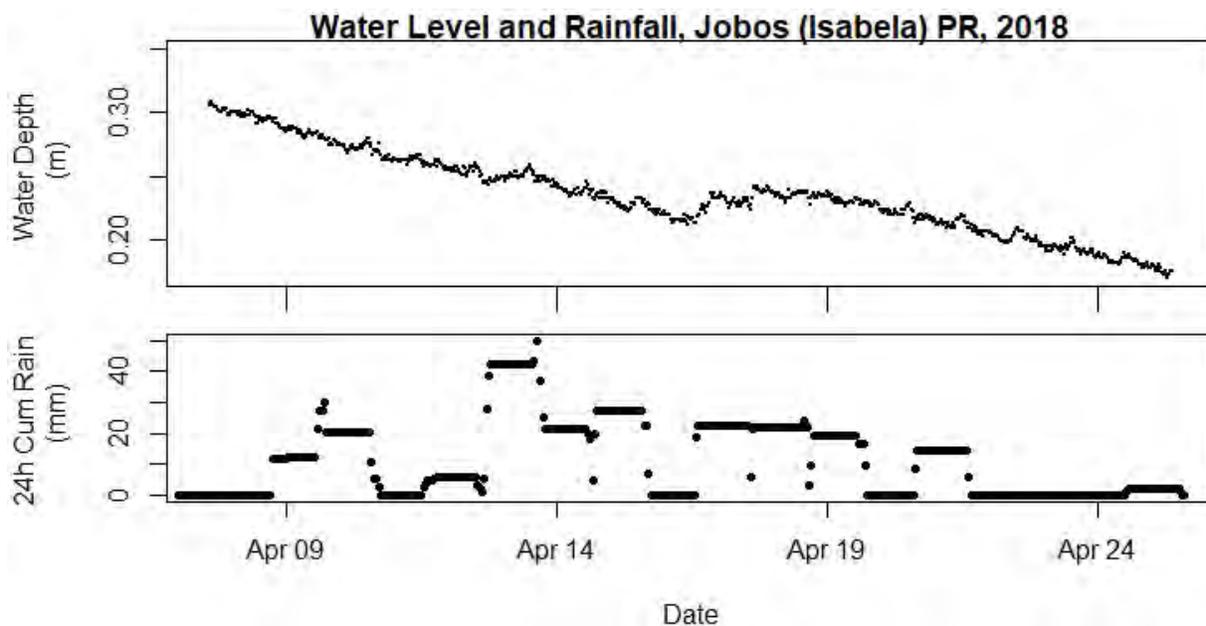
Figure 4 Water levels recorded at Isabela mangroves, Puerto Rico over a two-and-a-half-week period show a reduction of ten centimeters, with some response to local rainfall, and no tidal signature. This suggests the wetland is almost completely dependent on rainfall and thus vulnerable to extreme events like hurricanes. Better drainage would have allowed flood waters to recede quicker and would provide improved tidal connectivity.

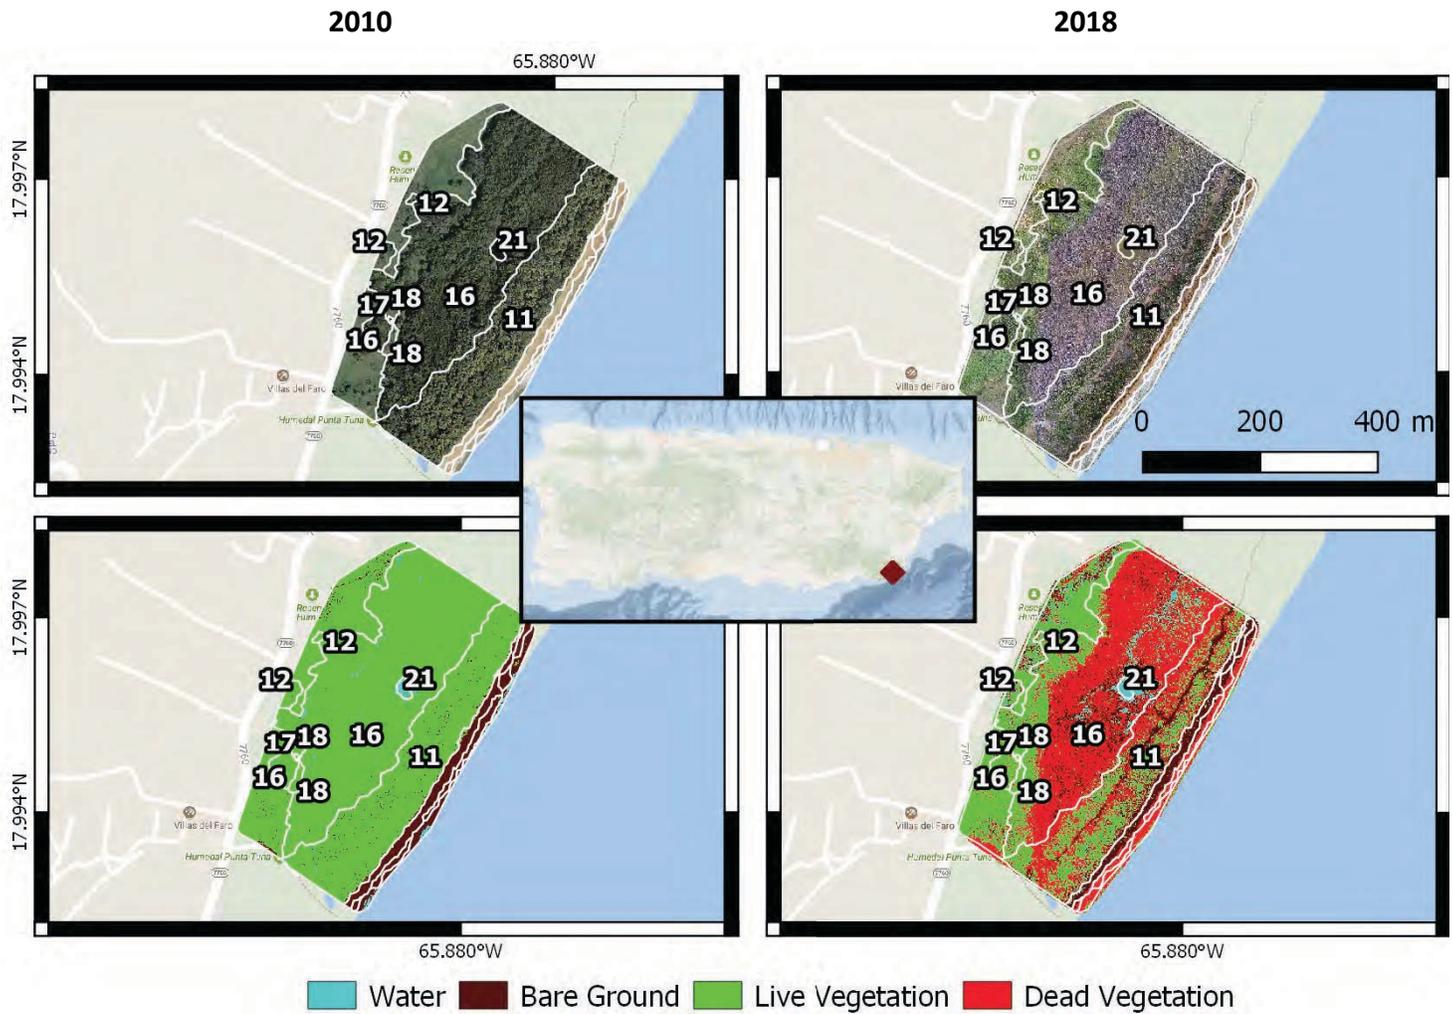
Hydrology was the primary cause of mortality at Punta Tuna and should thus be the focus of any rehabilitation program. Maintaining a consistent and sustainable connection with the ocean will allow for proper drainage in the case of extreme flooding as well as provide the tidal connectivity necessary for long term mangrove health.

Figure 5 Aerial imagery of the mangroves at Punta Tuna, Puerto Rico from 2010 to 2018, representing pre and post hurricane, respectively. Numbers represent major habitat classes as represented in the below table. Punta Tuna suffered among the highest mangrove mortality rates of all sites. Punta Tuna is not expected to recover naturally within the next decade and would benefit significantly from active management.

Table 2 The mangroves at Punta Tuna suffered high mortality, with aerial imagery suggesting 68% mortality, equivalent to nearly 6 hectares of forest. Other vegetation also suffered to a lesser extent.

- 1) The NRCS assessment (Appendix D) recommends ensuring proper communication with USACE and the establishment of a memorandum of understanding (MOU) allowing for channel maintenance to be carried out as needed and deemed necessary by local managers. Only by first ensuring stable and proper hydrology, can vegetative rehabilitation be successful.
- 2) Perform consistent hydrologic monitoring to ensure the establishment of sustainable hydrology in parallel with vegetative rehabilitation.
- 3) Implementation of an active management plan that includes planting of mangrove saplings to restore 100% mangrove cover and structure.
- 4) Re-assessment of vegetation structure and cover every year by on the ground measurements of seedling and tree density and canopy cover and at the landscape level utilizing un-manned aerial vehicles.

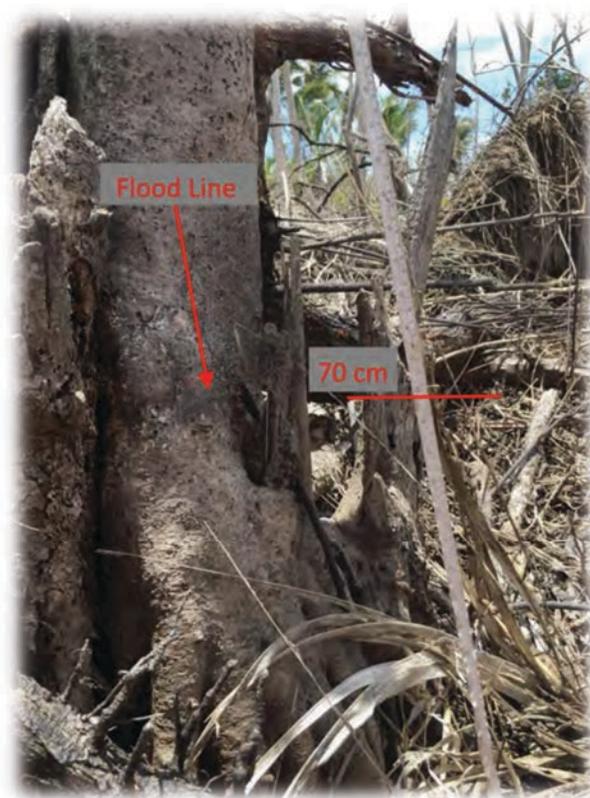
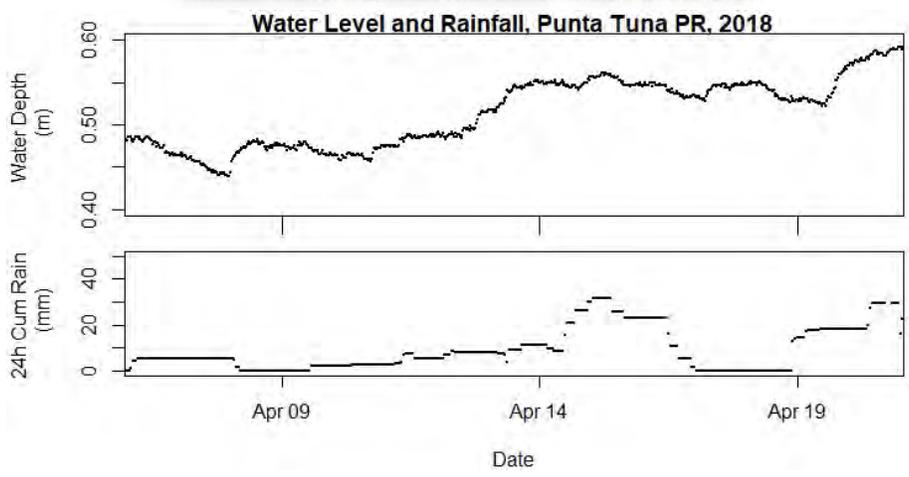
Figure 6 Flood lines on trees at Punta Tuna suggest a sustained water level of 70 cm above the forest floor and locals suggest the wetland was flooded for up to four months (top). These flood waters did not allow for proper oxygen levels in mangrove roots, and effectively drowned them. Water levels recorded at the site show minimal tidal signals and no drainage, with a strong connection to rainfall (bottom). This leaves the wetland vulnerable to flooding from extreme events like hurricanes.

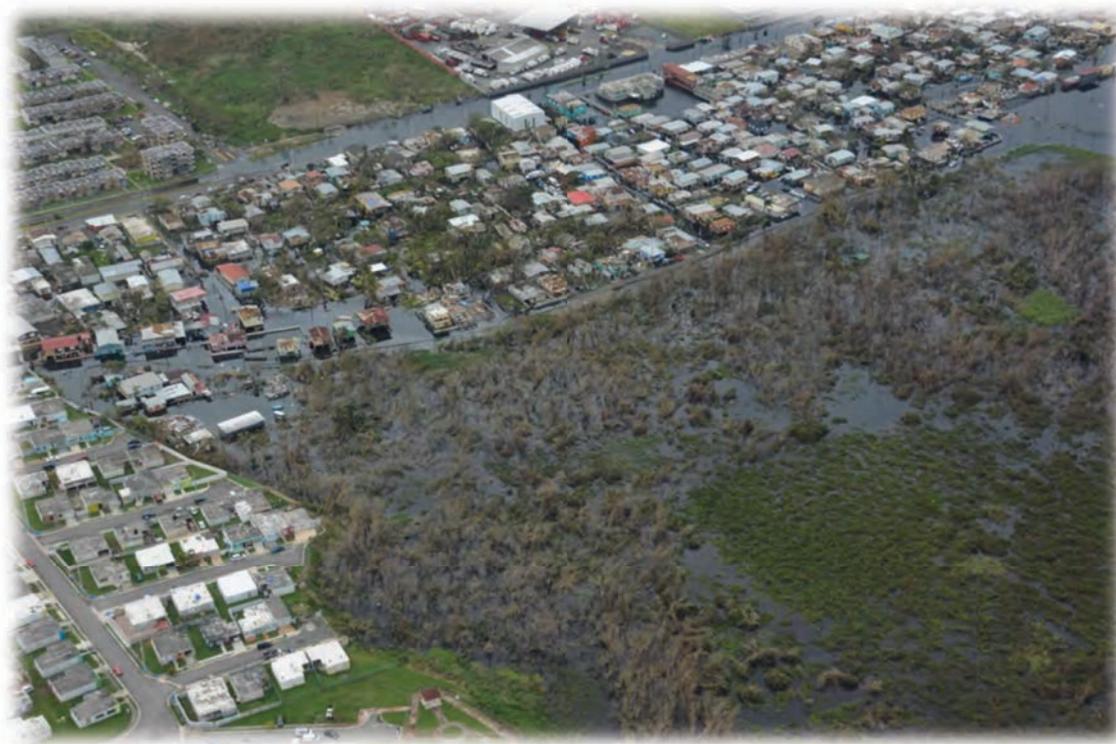
Initial damage and flooding in Ciénaga las Cucharillas was extensive (Figure 7). Ciénaga las Cucharillas contains the highest diversity of wetland habitats relative to the other sites, all of which suffered some mortality as well as significant shifts towards other habitats (Figure 8, Table 3).

Figure 7 Aerial view of Ciénaga Las Cucharillas and surrounding urban and industrial infrastructure immediately after hurricane Maria. Photo Date: 9/23/2017 8:42:33 AM <http://imageryuploader.geoplatform.gov/imageeventspublic/map.html#>

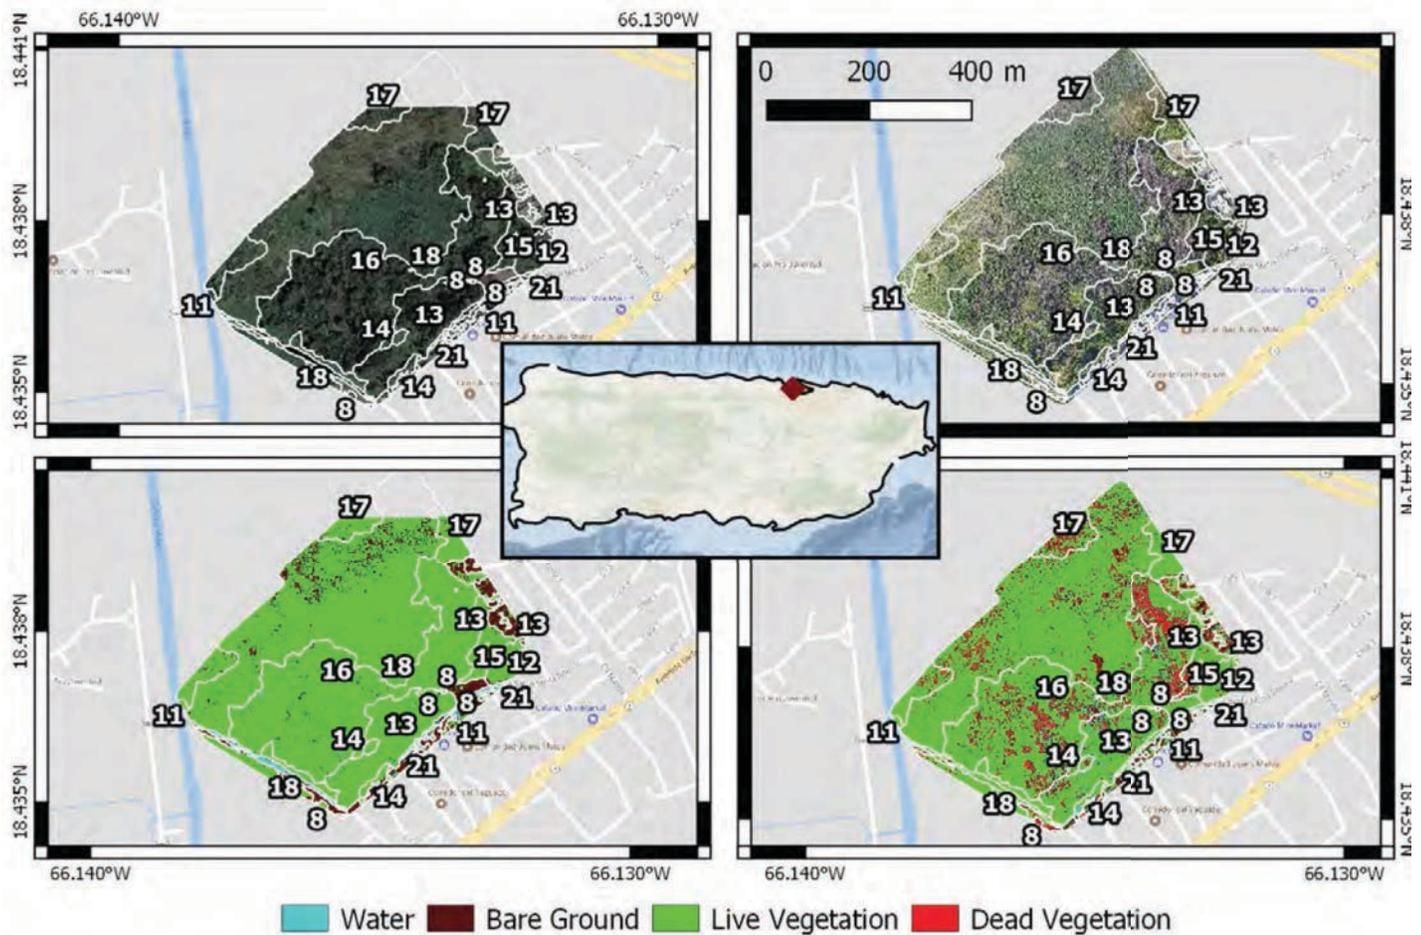
Even if there was initial extensive defoliation and breakage, the site experienced 6% mortality with the highest rates around 14% seen in palustrine (freshwater) emergent wetlands and estuarine (saline) forested wetlands. Viable White mangrove (*Laguncularia racemosa*) seedlings and saplings were observed at the site, suggesting natural regeneration. However, 16% and 8% of palustrine emergent and estuarine forested wetlands, respectively, were also converted to open ground. Additionally, some small sections of bare ground have been colonized by grasslands. These trends signify shifting vegetation habitats that might be in response to altered hydrology from the management of the flood gates and pumps after the hurricane. Altogether, this site lost around 1.6 hectares of vegetated habitat with significant changes in vegetation, from wooded vegetation to freshwater grasses and sedges.

Figure 8 Aerial imagery of the mangroves at Cataño, Puerto Rico from 2010 to 2018, representing pre and post hurricane, respectively. Numbers represent major habitat classes as represented in the below table. Cataño suffered moderate mortality compared to other sites.

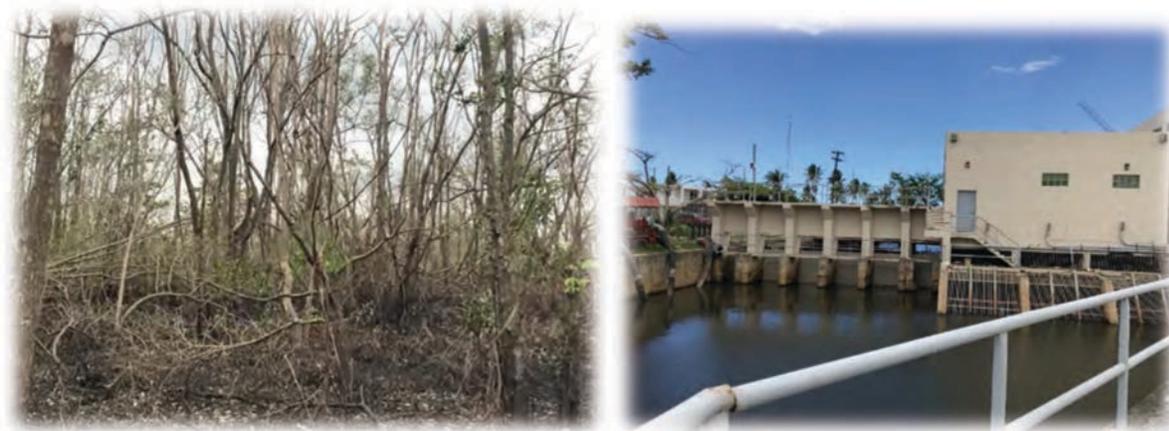
This is due to a change in hydrology, as has been observed in other coastal wetlands with gradual or rapid changes to hydrology (Ball, 1980; Clark and Csiro, 1988). Our assessment based on water depth and salinity measurements for the last four years by the University of Puerto Rico where marine-terrestrial connectivity is maintained by subsurface inflow of the marine water from the coast, as well as that of the report of NRCS hydrology/geomorphology team, see the pump/gate station at the Malaria Channel as a critical component of site hydrology, and thus to rehabilitating site vegetation to provide optimal protective services (Figure 9). This primarily means allowing sufficient tidal exchange in the wetland to promote its natural estuarine (saltwater) and not palustrine (freshwater) conditions. In doing so, the hydrology will naturally favor a forested wetland system over the current herbaceous dominated system. Forested coastal wetlands have been singled out as providing extremely highly valuable protective services against natural disasters (Mazda et al., 1997; Othman, 1994), thus maintaining via rehabilitation and enforcement of established federal and state regulations, these ecosystems would contribute to the goal of increasing the resilience of Puerto Rico's coast against similar natural disasters. As is the case in the other sites, hydrology must be the focus of any intended rehabilitation program. Parallel to establishing a favorable hydrological, vegetative rehabilitation with mangrove plantings need to be carried out for optimal success.

Figure 9 some of the mortality at Ciénaga Cucharillas (left) is likely a result of shifting hydrology due to the pump/gate station at the mouth of the Malaria canal (right). A freshwater hydrology regime is promoted by the operation of the tidal gate at the mouth of the Malaria Channel managed by the Department of Natural Resources and Environment (DRNA), where for the past six years the flood gates have not been opened, restraining the marine-terrestrial connectivity through the channel and favoring freshwater conditions in the area.

- 1) Funding /Repair/ Management improvements at pump station/ tide gates to be carried out by 2019 for reestablishing marine -terrestrial connectivity and prevention of flooding episodes.
- 2) Planting of ten ha with Black mangrove and White mangrove saplings by 2020 to cover and structure.
- 3) Monitoring of water depth, salinity and flooding.
- 4) Re-assessment of vegetation structure and cover every year by on the ground measurements of seedling and tree density and canopy cover and at the landscape level utilizing un-manned aerial vehicles.

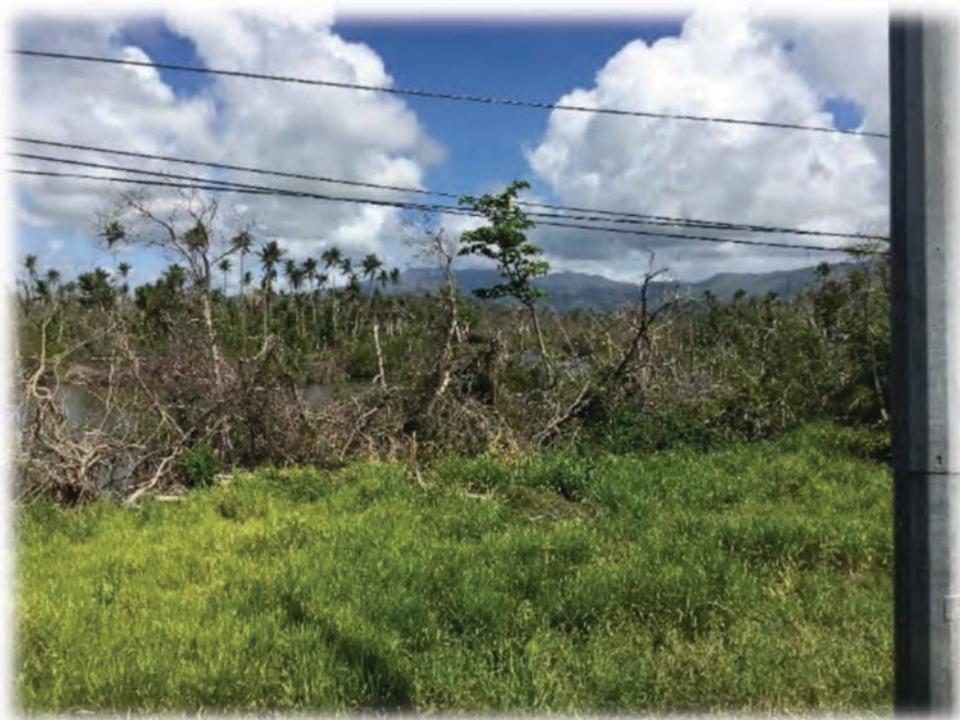
The mangroves at Punta Santiago suffered primarily wind damage, with little evidence for drastically altered hydrology. Overall mortality at Punta Santiago was 34%, with most of the loss occurring in upland forests, not wetlands (Figure 11, Table 4). Wetlands experienced a loss of 34%, corresponding to a loss of around 1.6 hectares. Viable seeds were observed at the sites, suggesting natural regeneration will occur, and no abnormalities in water chemistry were measured. Further, the NRCS hydrology/geomorphology report found no significant alterations to site hydrology. This suggests the primary damage to the vegetation at Punta Santiago was due to wind and that no active management is necessary for rehabilitation. We therefore recommend a passive monitoring program with no active management unless significant changes in recovery are detected.

Figure 10 The mangroves at Punta Santiago suffered a mortality rate of 34%, although natural regeneration, including seed germination and tree re-sprouting has already begun. Recommendations are to passively monitor and allow for natural regeneration.

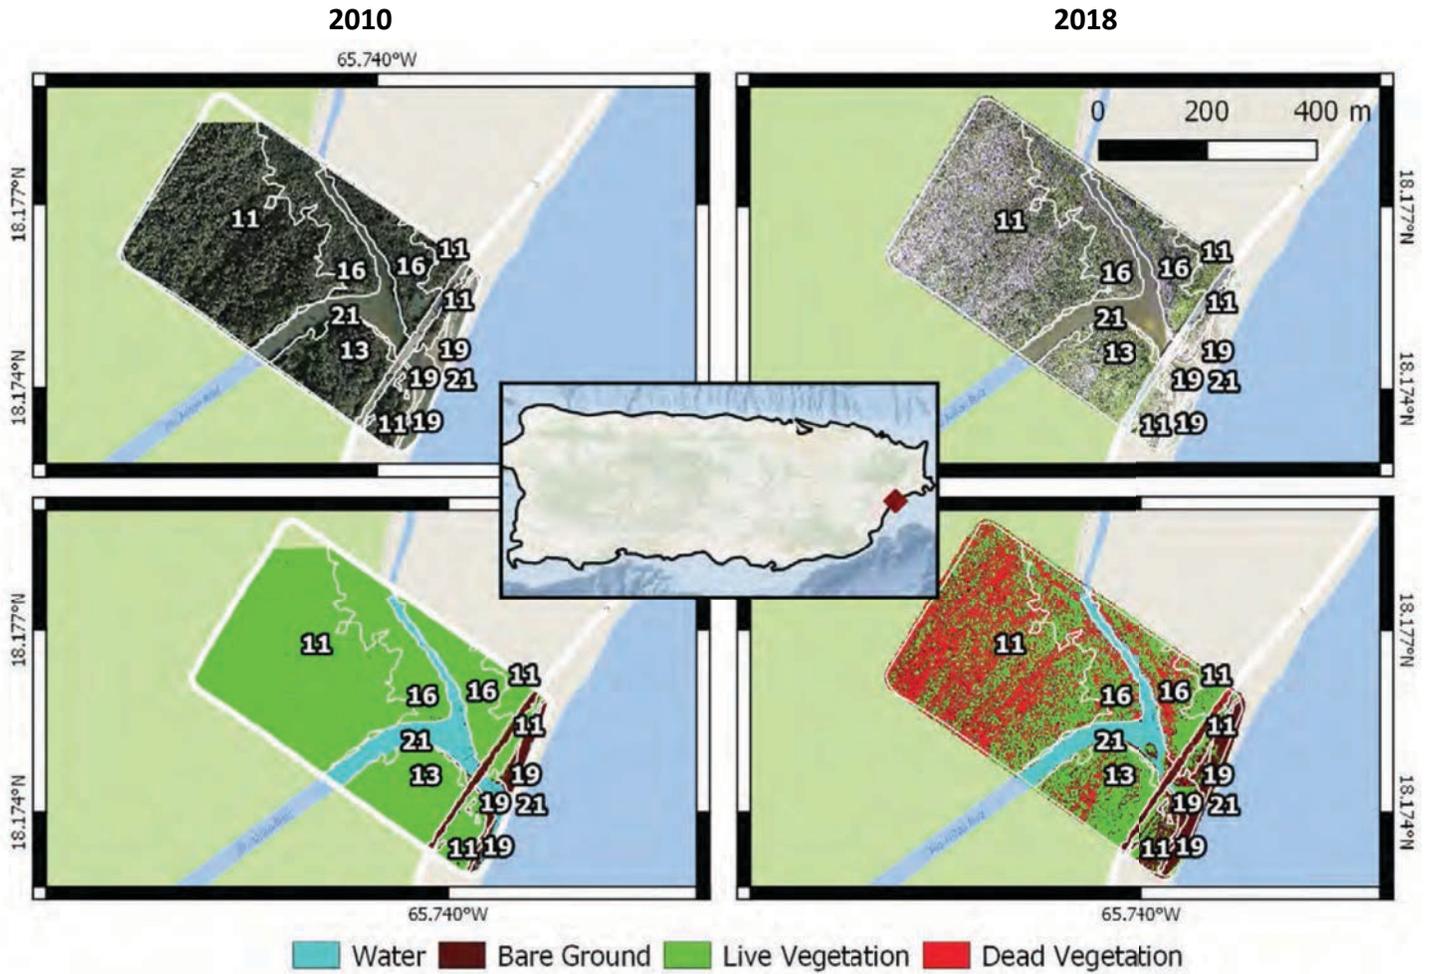
Figure 11 Aerial imagery of the mangroves at Punta Santiago, Puerto Rico from 2010 to 2018, representing pre and post hurricane, respectively. Numbers represent major habitat classes as represented in the below table. Punta Santiago suffered moderate mangrove mortality rates and is expected to recuperate naturally and would not likely benefit significantly from active management.

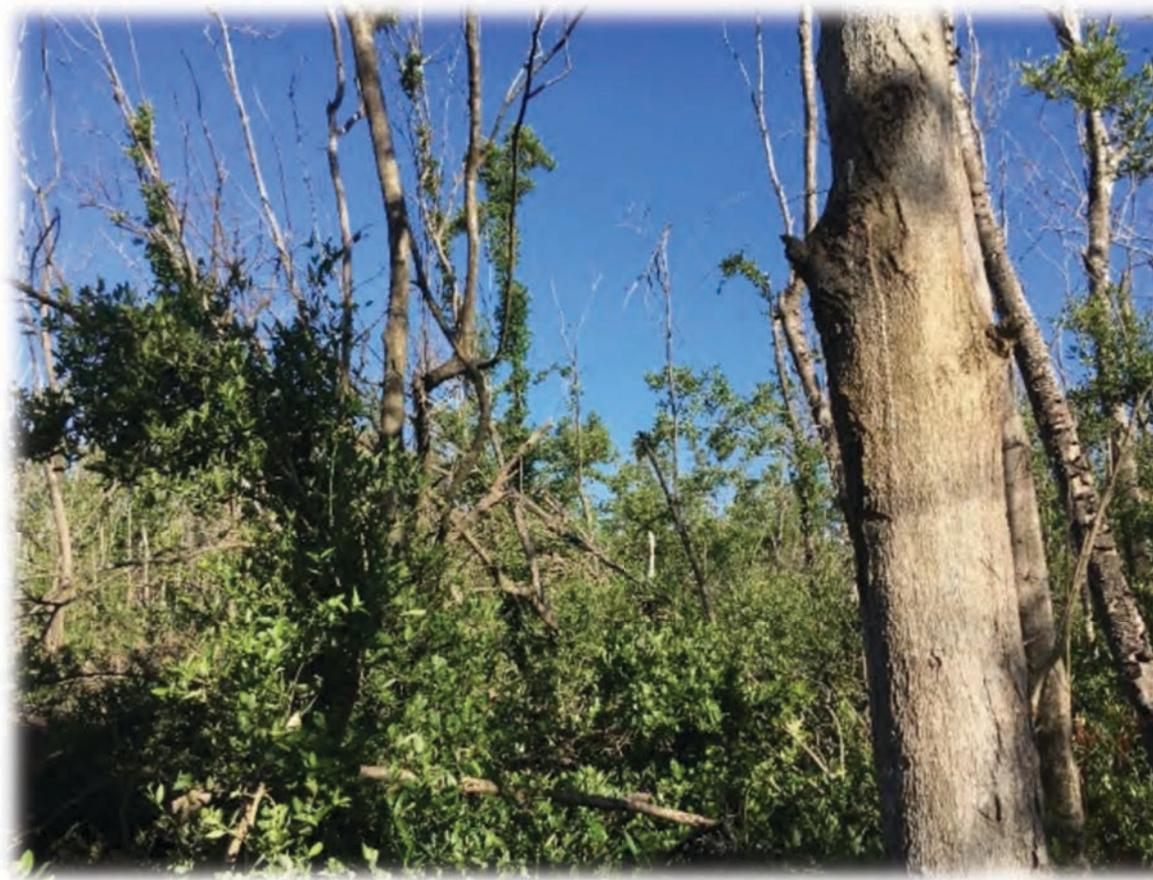
Although no aerial surveys were possible at Piñones due to restrictions from the nearby international airport, we were able to assess the site on the ground (Appendix B). This assessment found 30% mortality in the mangroves, with sufficient live mangrove seedlings and hydrological and water chemistry conditions that did not suggest any imminent threats to ecosystem vitality (Figure 12). We expect natural regeneration and canopy closure to occur over the next five years. Therefore, we recommend only passive monitoring to ensure natural rehabilitation occurs unimpeded and no active vegetation rehabilitation unless significant changes are detected.

Figure 12 The mangroves at Piñones suffered a mortality rate of 30%, although natural regeneration, including seed germination and tree re-sprouting has already begun. Recommendations are to passively monitor and allow for natural regeneration.

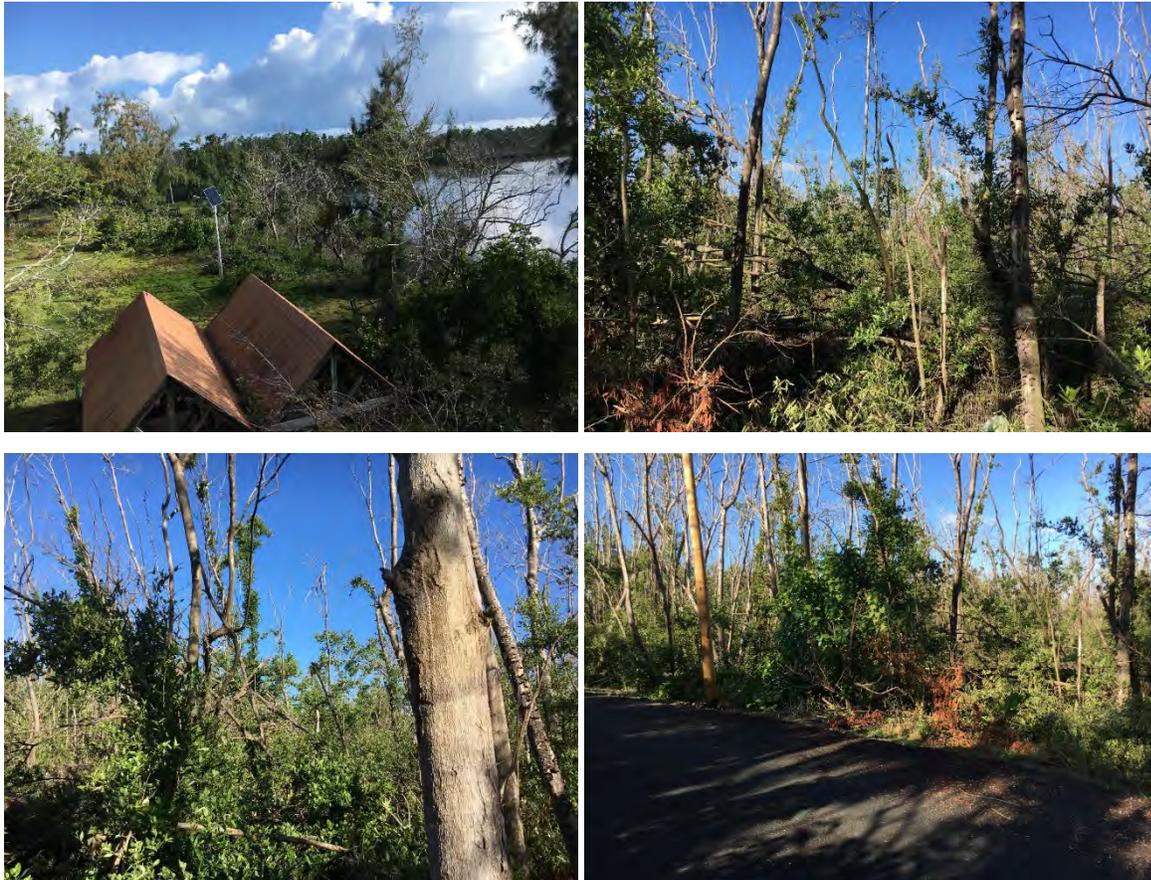
Figure 11: Photographs on Laguna De Pinones area

Much of the leaves have been removed during the storm by the high winds and several of the larger trees have been up-rooted. The upper canopy is nearly gone in areas. However, the team noted that the lower canopy appears to be recovering and healthy growth was observed. The team also visited Suarez Canal at approximate location N18-25.685 W65-59.362 which flows into the site. Photographs of the site are provided in Figure 11. A map image is provided in Figure 12.

Mr. Branoff reported that the area in the Laguna De Pinones had been inundated for approximately 2 weeks after Hurricane Maria but the efficient city drainage system had allowed waters to evacuate before flooding damage had been significant. Water gages installed and monitored as part of Mr. Branoff's research indicate that the hydro-period had largely returned to the pre-storm conditions.

The team suggests that **signage should be updated** to describe the storm and the recovery that is being observed. Some **dead limbs that are overhanging trails and roads should be trimmed** for safety concerns. Finally, it is suggested that the **mangrove area be monitored and studied** as it naturally responds to the storm damage. Big storms have occurred in the past and will occur again in the future. Lessons learned from how the specific trees as well as the system as a whole both responds and recovers from hurricanes will be useful for the analysis of future events.

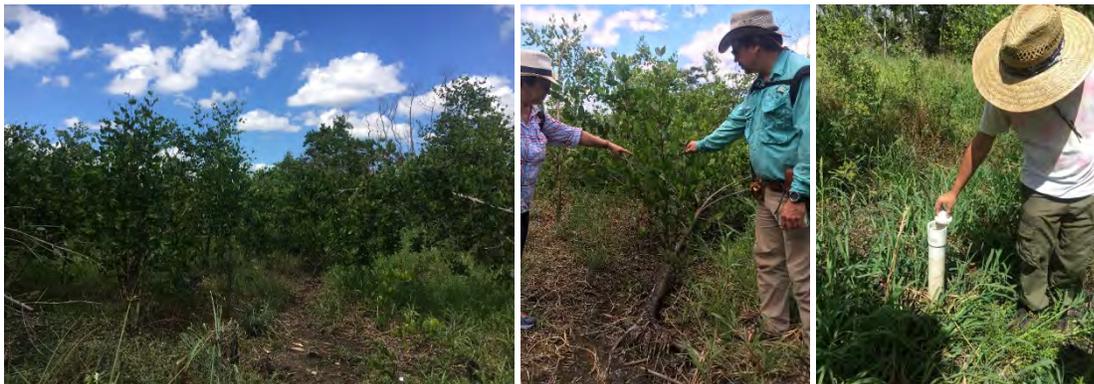
In areas, grasses may be out competing the young mangroves. If this condition is not changed, as the older mangroves die off, there is a concern that they will be replaced by freshwater species such as the grasses. Biologic water quality samples of the upstream area showed high levels (TNTC – Too Numerous to Count) of E Coli in the channel sediments and moderate levels (30 to 40 colonies per ml) in the flows. While these grab samples are not definitive, these high values may indicate that signage warning the public to avoid contact with the sediment is warranted. The coliform pathogen contamination was positive in all samples. Nitrogen was measured at trace. No chlorine was measured at time of the visit. Photographs of the site are shown in Figure 13.

Figure 13: Cucharillas area. Note trees are recovering but grasses are moving in. Photograph at right shows monitoring well

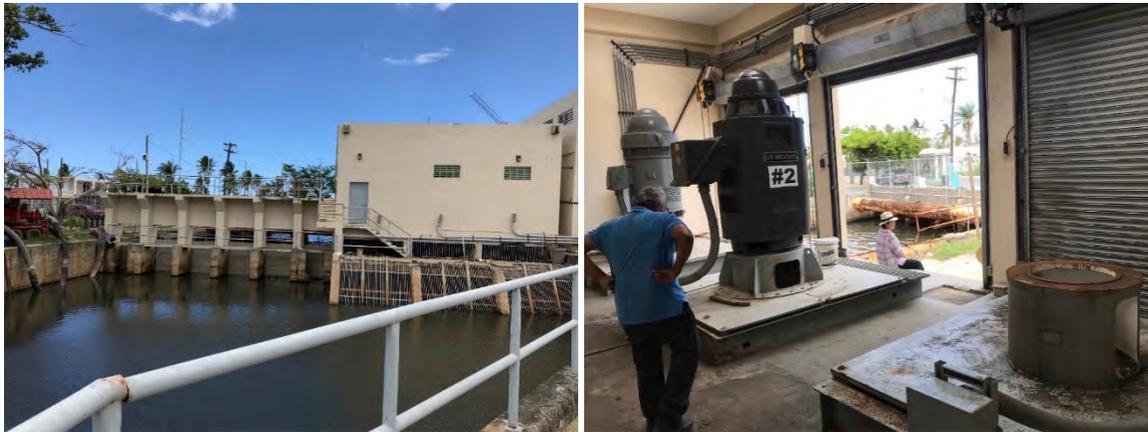
The tide gates were closed during the site visit. The team noted that tide gates are typically open during flow conditions such as present during the site visit to allow for natural tidal exchange. They are closed during storms. The operator stated that the tide gates have not been operated in the last six years because of debris that is present on the sill. The team did not observe excessive debris in the vicinity, but a complete examination was not possible due to water levels. There are slots for stop logs but there are no stop logs on site. The operator is not familiar with any maintenance being accomplished on the gates. The gates themselves show some corrosion indicating that they may have not been operated in some time. The gates are electrically powered but the operator said there is no power available. The team noted that the gates have the capacity to be manually operated. Photographs of the site are provided in Figure 15.

Figure 15: Pump station and tide gates. Note the three pump locations in the photo at right

The team believes that the ecologic function of the Cucharillas mangrove area is limited by the operation of the tide gates and pump station. The current operation of this station is adverse to the recovery and sustainability of the mangrove wetlands. The gates need to be operated so that they mimic as much as possible a natural tidal cycle. In addition, inadequate pump capacity places the upstream area at risk for flooding in populated areas. Finally, the in operation of the tide gates reduces natural flushing and is likely a contributor to adverse water quality and may increase the potential for disease outbreaks.

The pump station appears to be well designed but does not appear to be provided with sufficient man power and financial resources to be effectively operated. The success of any restoration work in the mangrove area is limited without improvements to the pump station. If the pump station is improved, the site may naturally recover. In addition, the current limited operational capacity of the pump station and tide gates may be a risk to life and property. Therefore, the team recommends **that no work be undertaken until the pump station and tide gates are repaired and the station is adequately staffed with personnel who are trained and empowered to maintain and operate the system.** Selective mangrove seedling plantings can be attempted but only on a study basis.

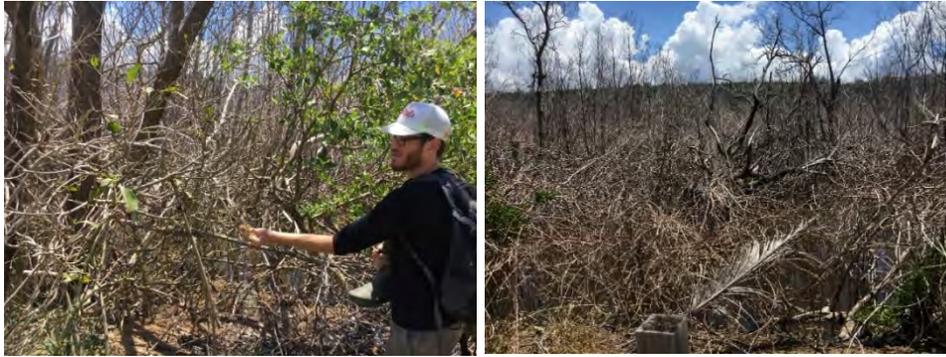
However, the team observed that red mangrove seedlings and some white mangroves along the high ground around the perimeter of the site are leafing out. The team believes that this growth will naturally revegetate and recover the interior if the hydrologic connectivity is improved. **Monitoring and documentation of this natural succession is suggested.** The Photographs of the wetland area are provided in Figure 16.

Figure 16: Photographs of the mangrove wetland in the Jobos Isabella site. Some leafing is observed on high ground along the edges

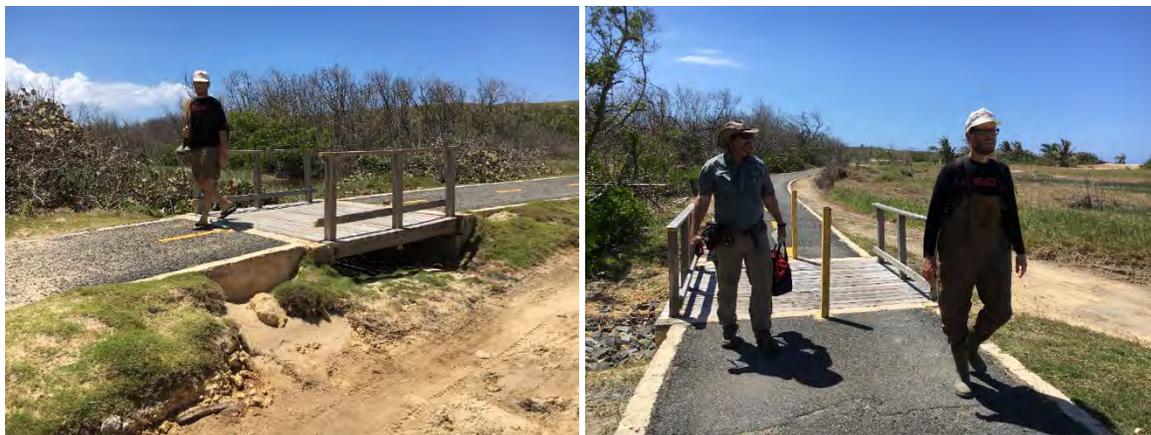
Figure 17: Photographs of the bike trail and foot bridges that limit the hydrologic connectivity

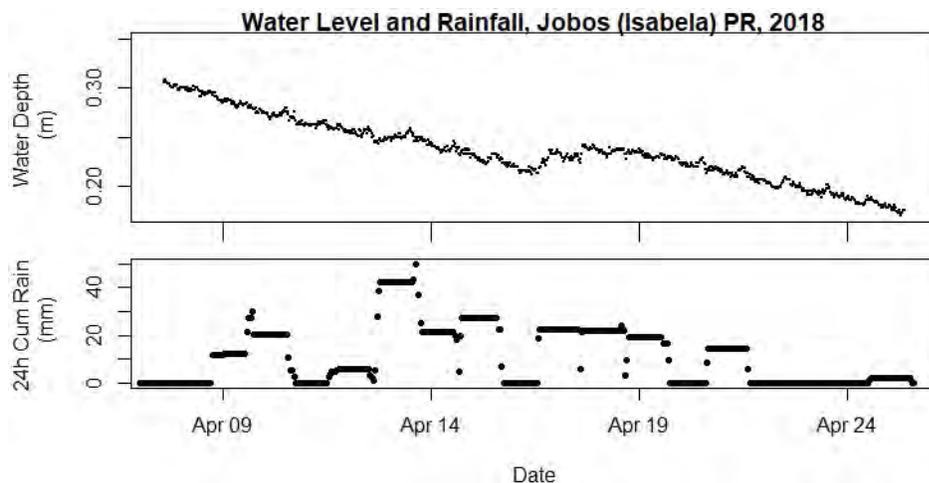
Figure 18: Results of temporary gage correlated with local rainfall

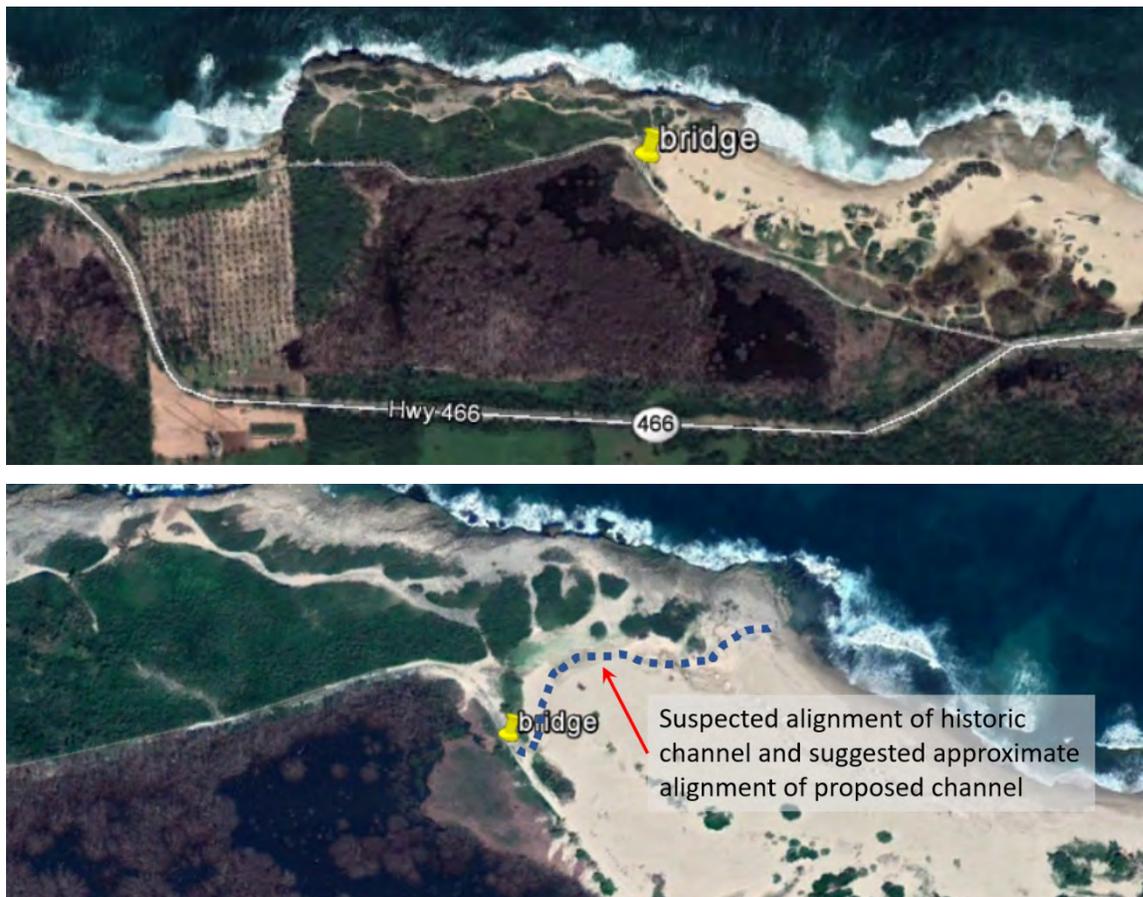
Figure 20: Google Earth image of Jobos Isabella site. Impacted mangrove area is shown with brown area. Pins show bridge where easiest connection could be made. Date of image is 11/2017.

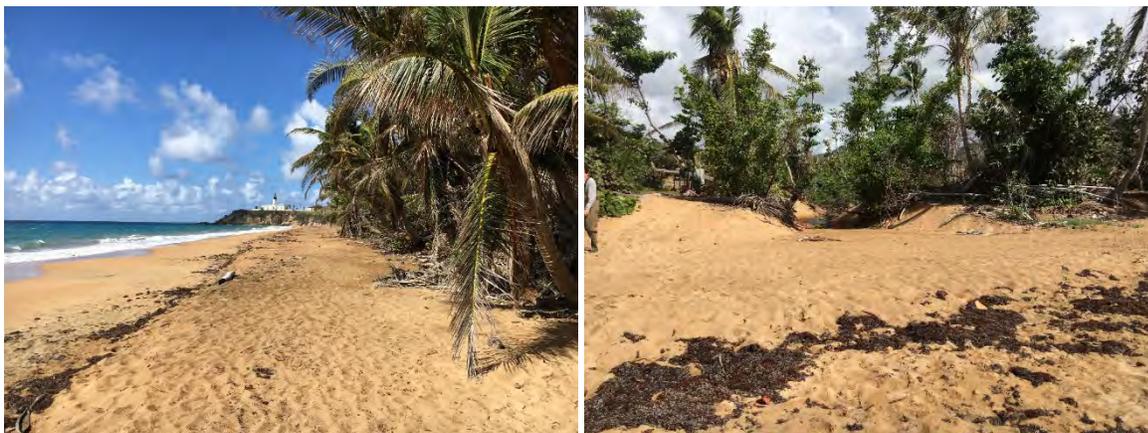
Figure 22: Photographs of the Beach area. Note the palms are recovering. Photo on right shows recently excavated channel area

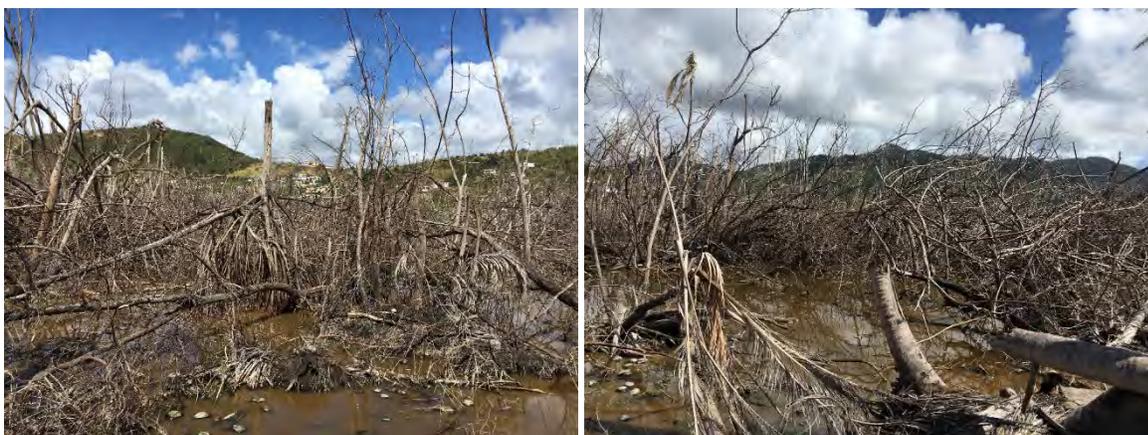
Figure 23: Photographs of the mangrove area. Note the tree damage.

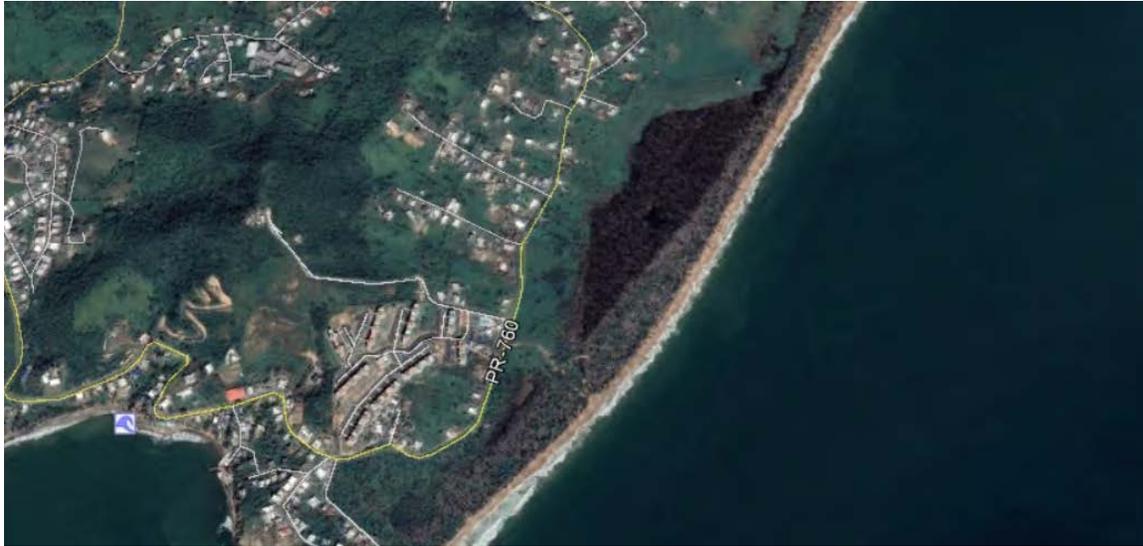
Figure 24: Google Earth image of Punta Tuna_site. Impacted mangrove area is shown with brown area. Date of image is 1/2018.

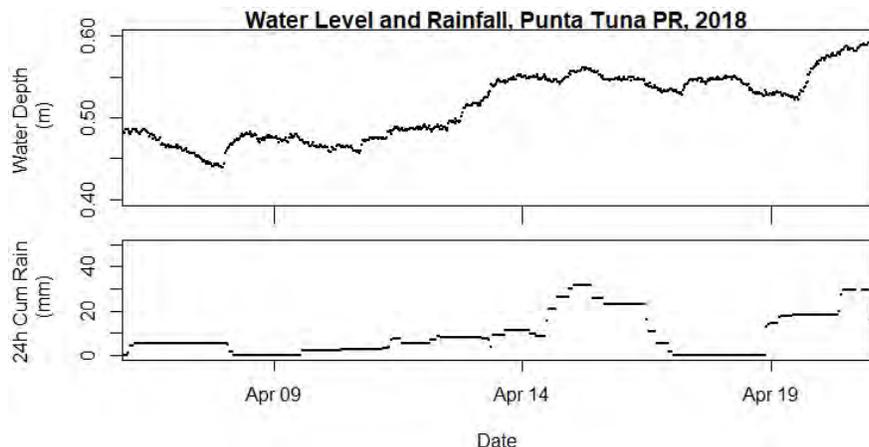
Figure 29: Graph of water levels and rainfall at Punta Tuna

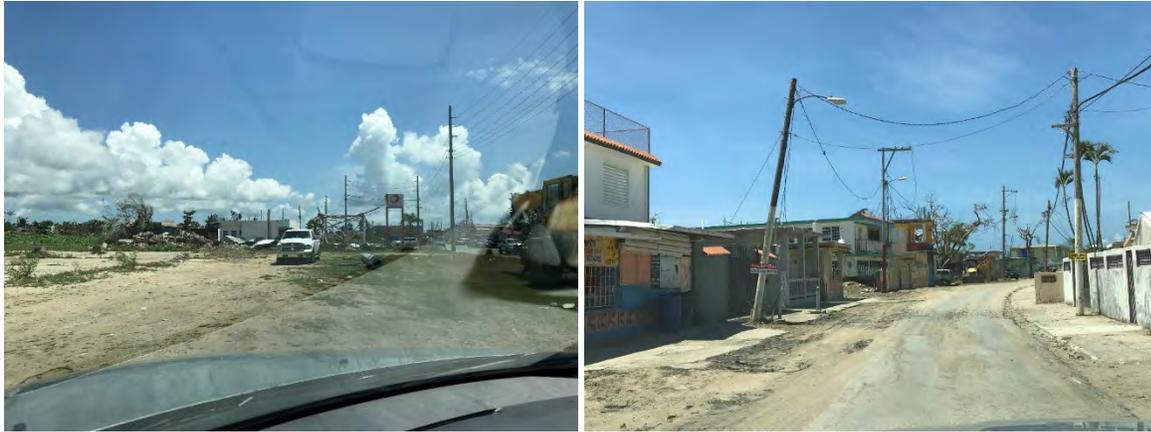
Figure 31: Photographs of hurricane impact damage to community.
