El papel de viveros en restauración después de encallamientos en Guayanilla, Puerto Rico

May 16, 2013

NOAA
Restoration
Center

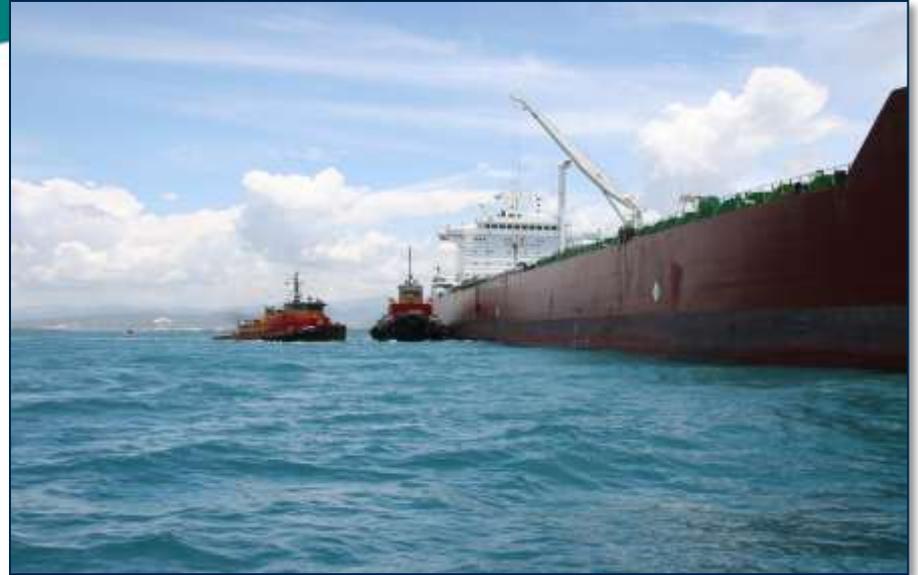
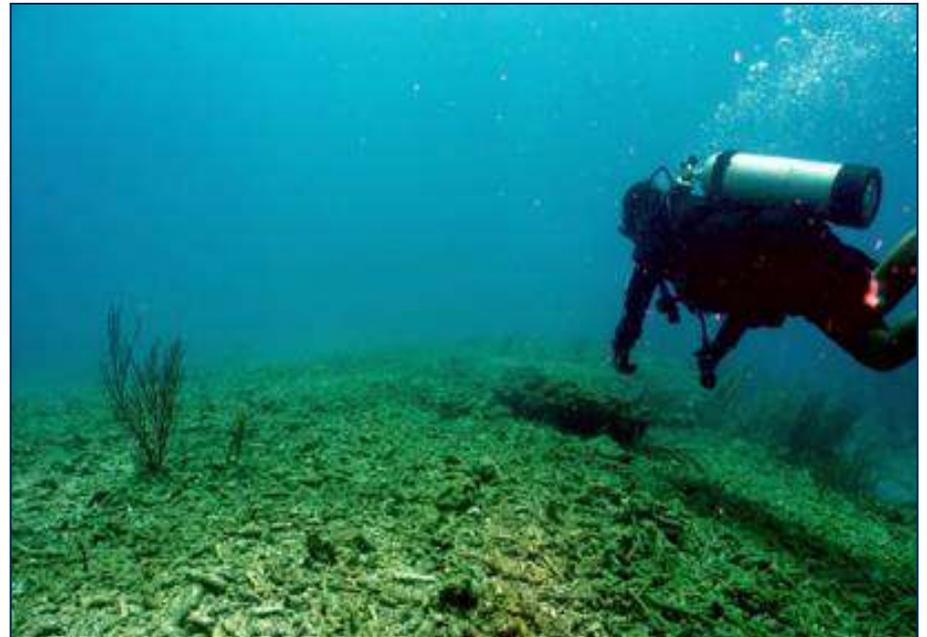
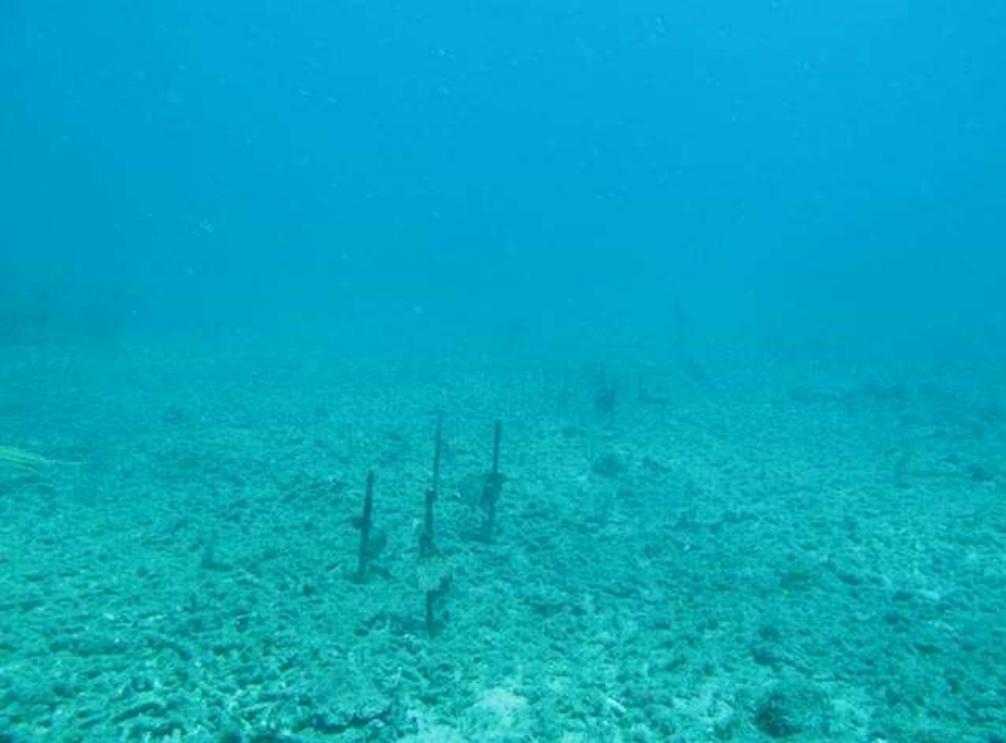
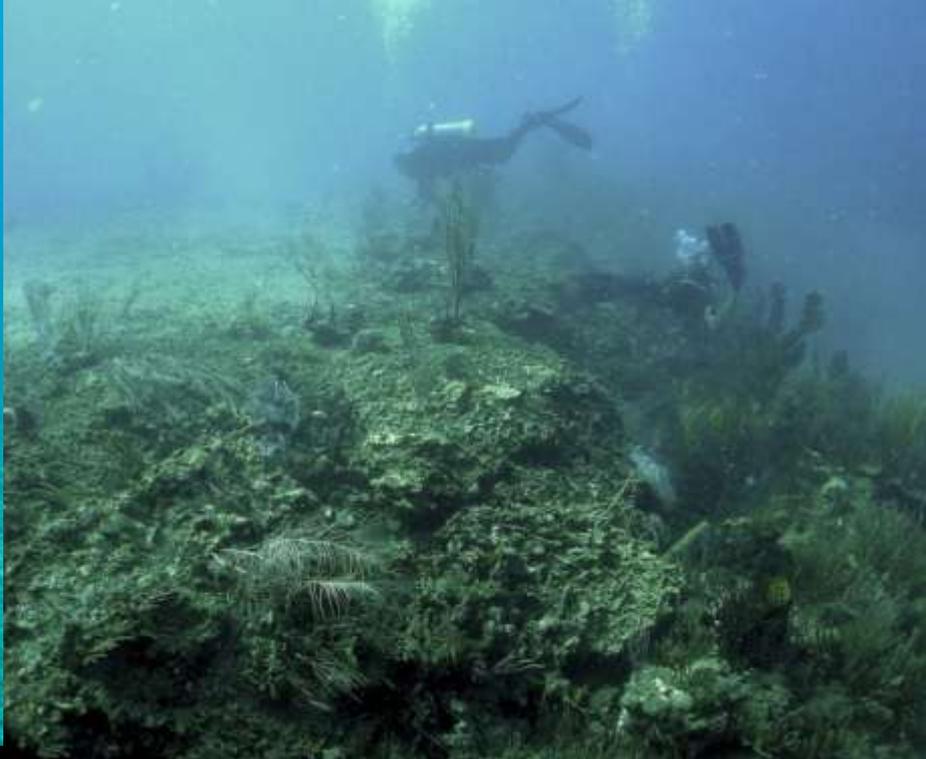
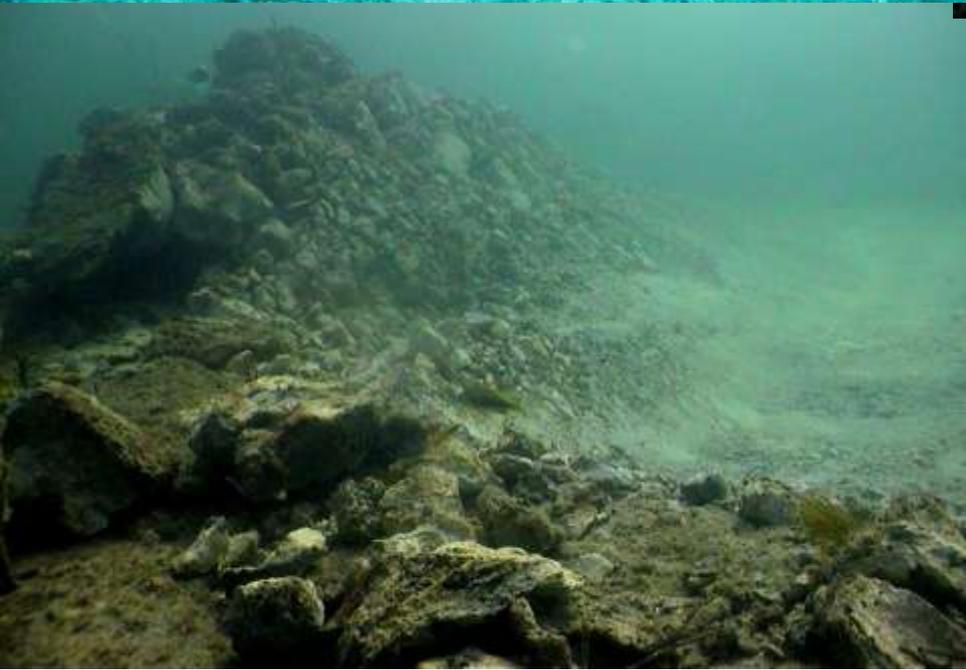
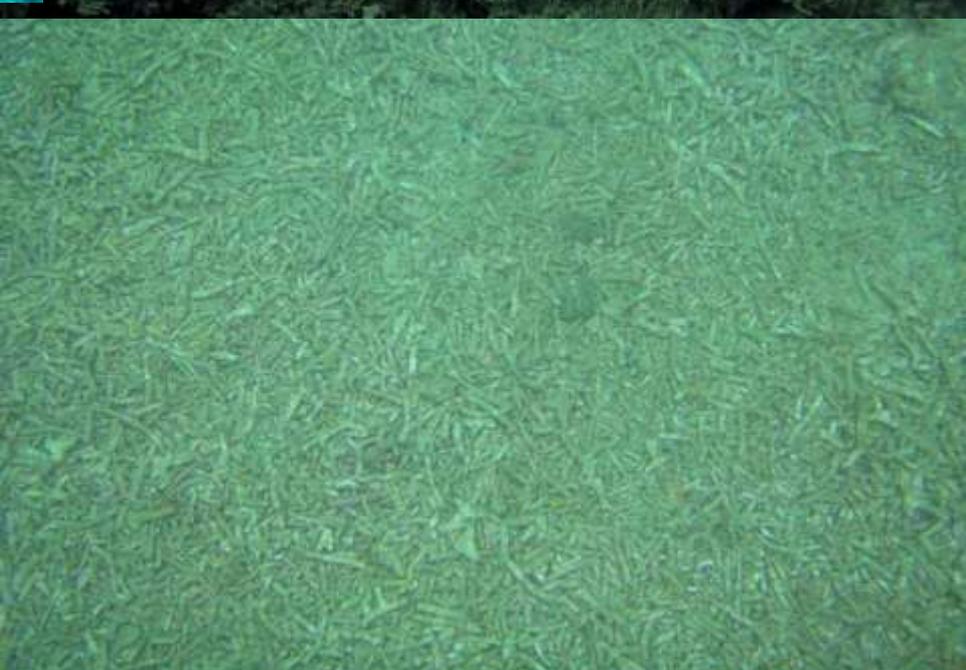
M/V Margara

- Grounding occurred April, 2006.
- Approximately 7,500 m² of reef were damaged. Initial impact was 1,500 m² ; additional 6,000 m² damaged during removal of vessel
- 11,000 corals were reattached during Emergency Restoration
- Approximately 150,000 corals were damaged or lost during the grounding.
- Still awaiting primary restoration to address 1,600 m² of rubble fields that inhibit recovery at the site.

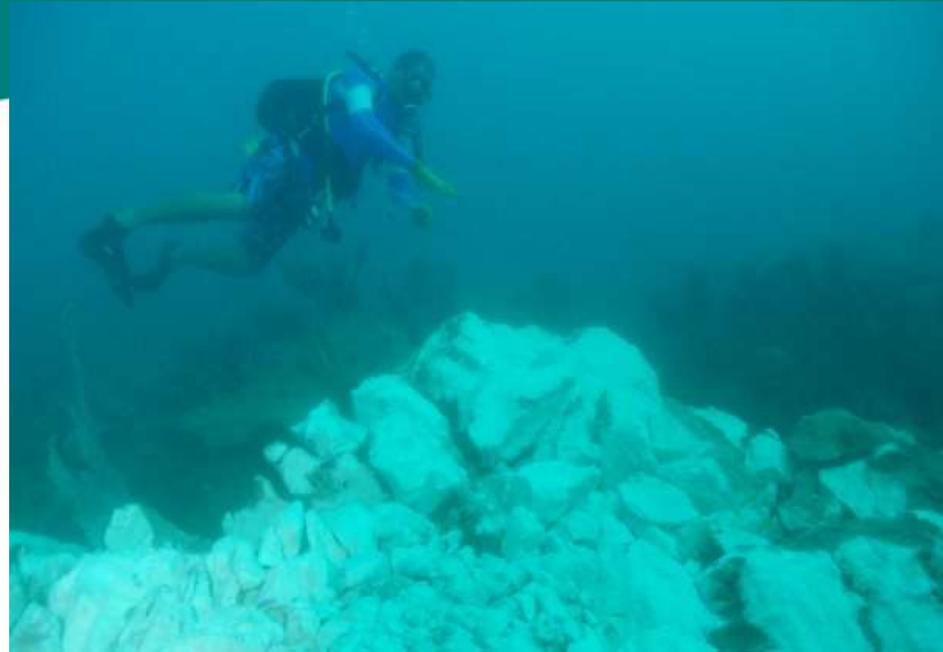
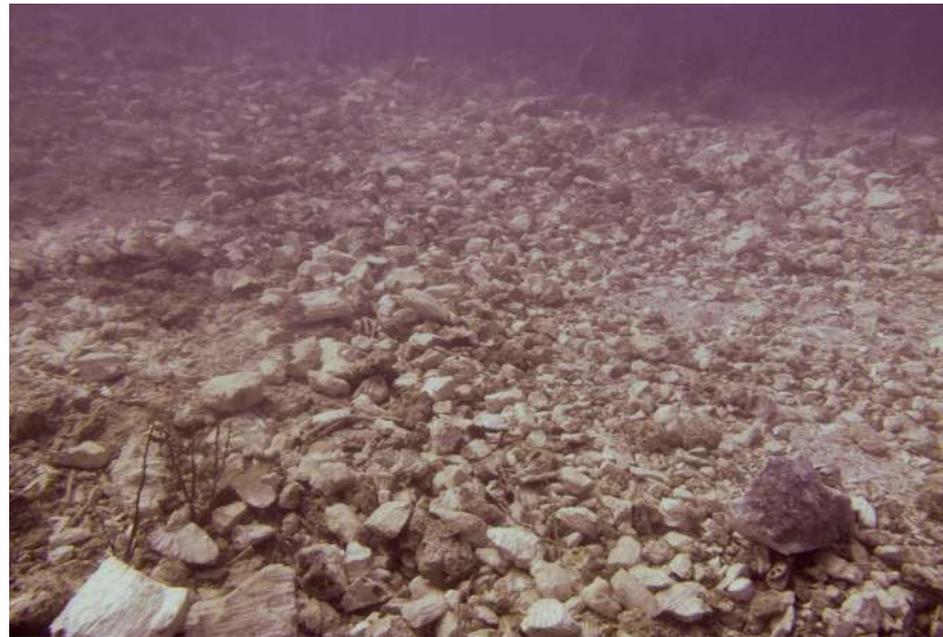
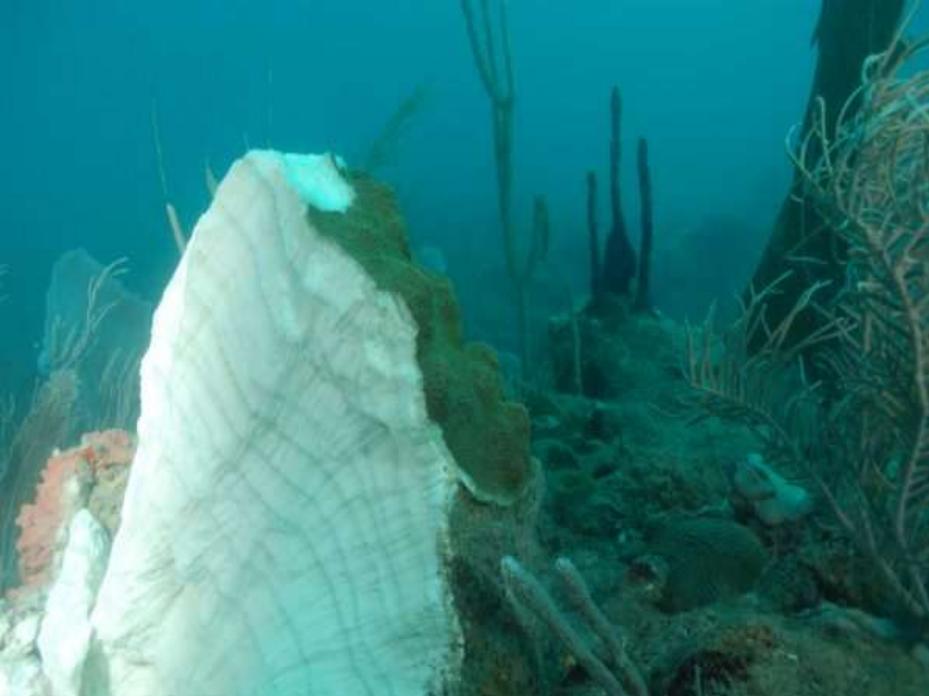
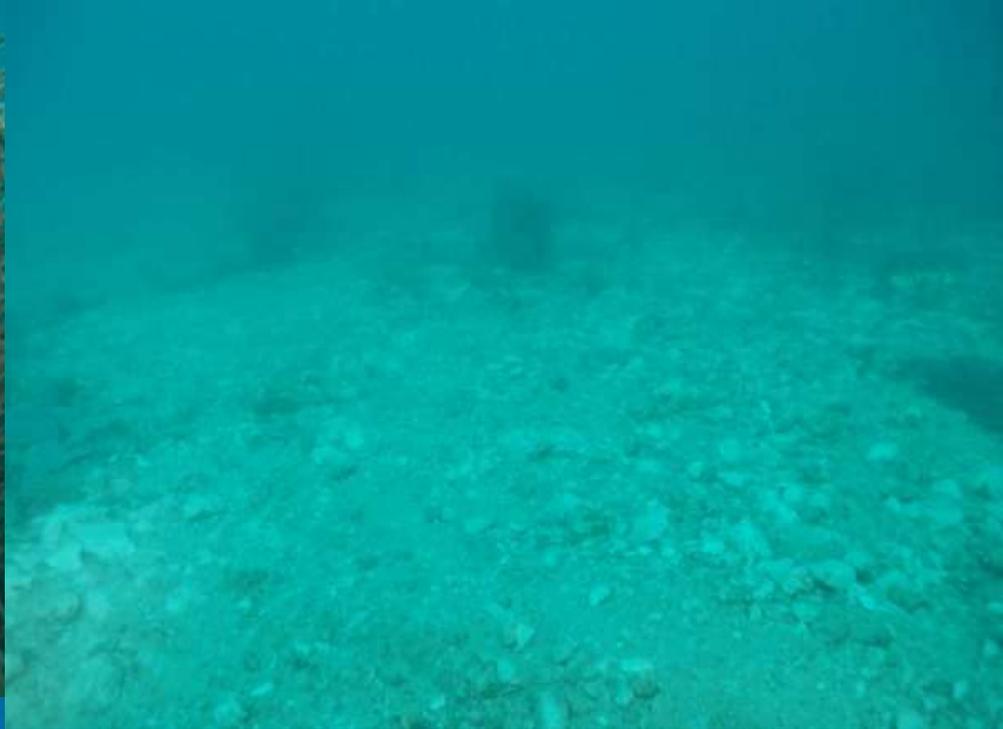
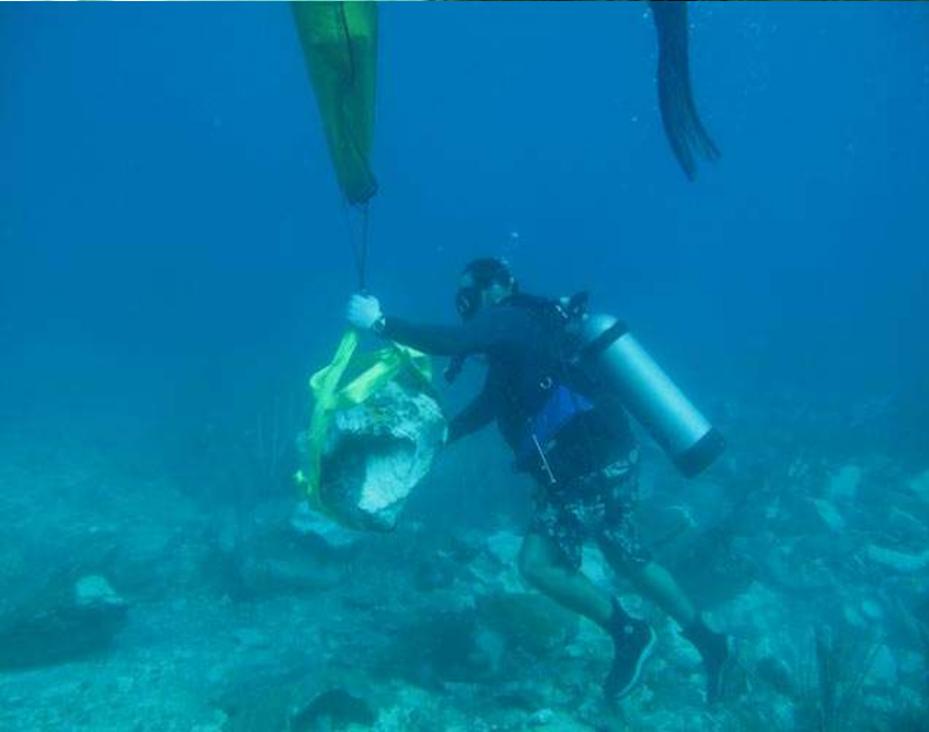
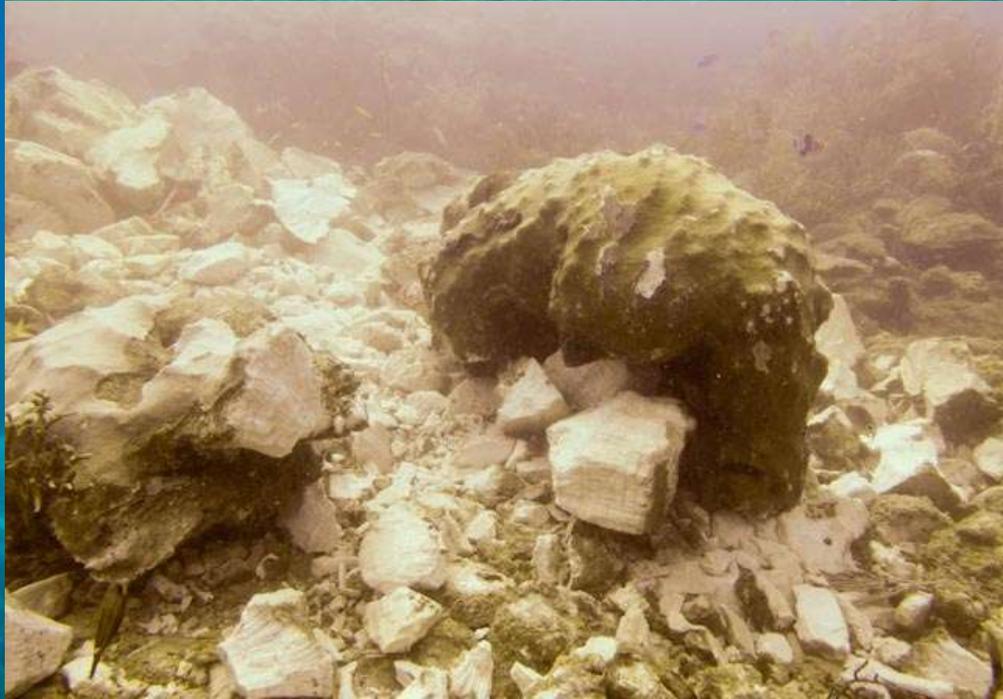
LNG-C Matthews

- Grounding occurred Dec. 2009 in Guayanilla, PR
- 3,200m² of reef were damaged
- 7,000 corals were reattached
- Restoration complete took almost 3 months.
- Some *Acropora* damage. These colonies were reattached *in situ* and some frags brought to Margara nursery to increase genotypic diversity

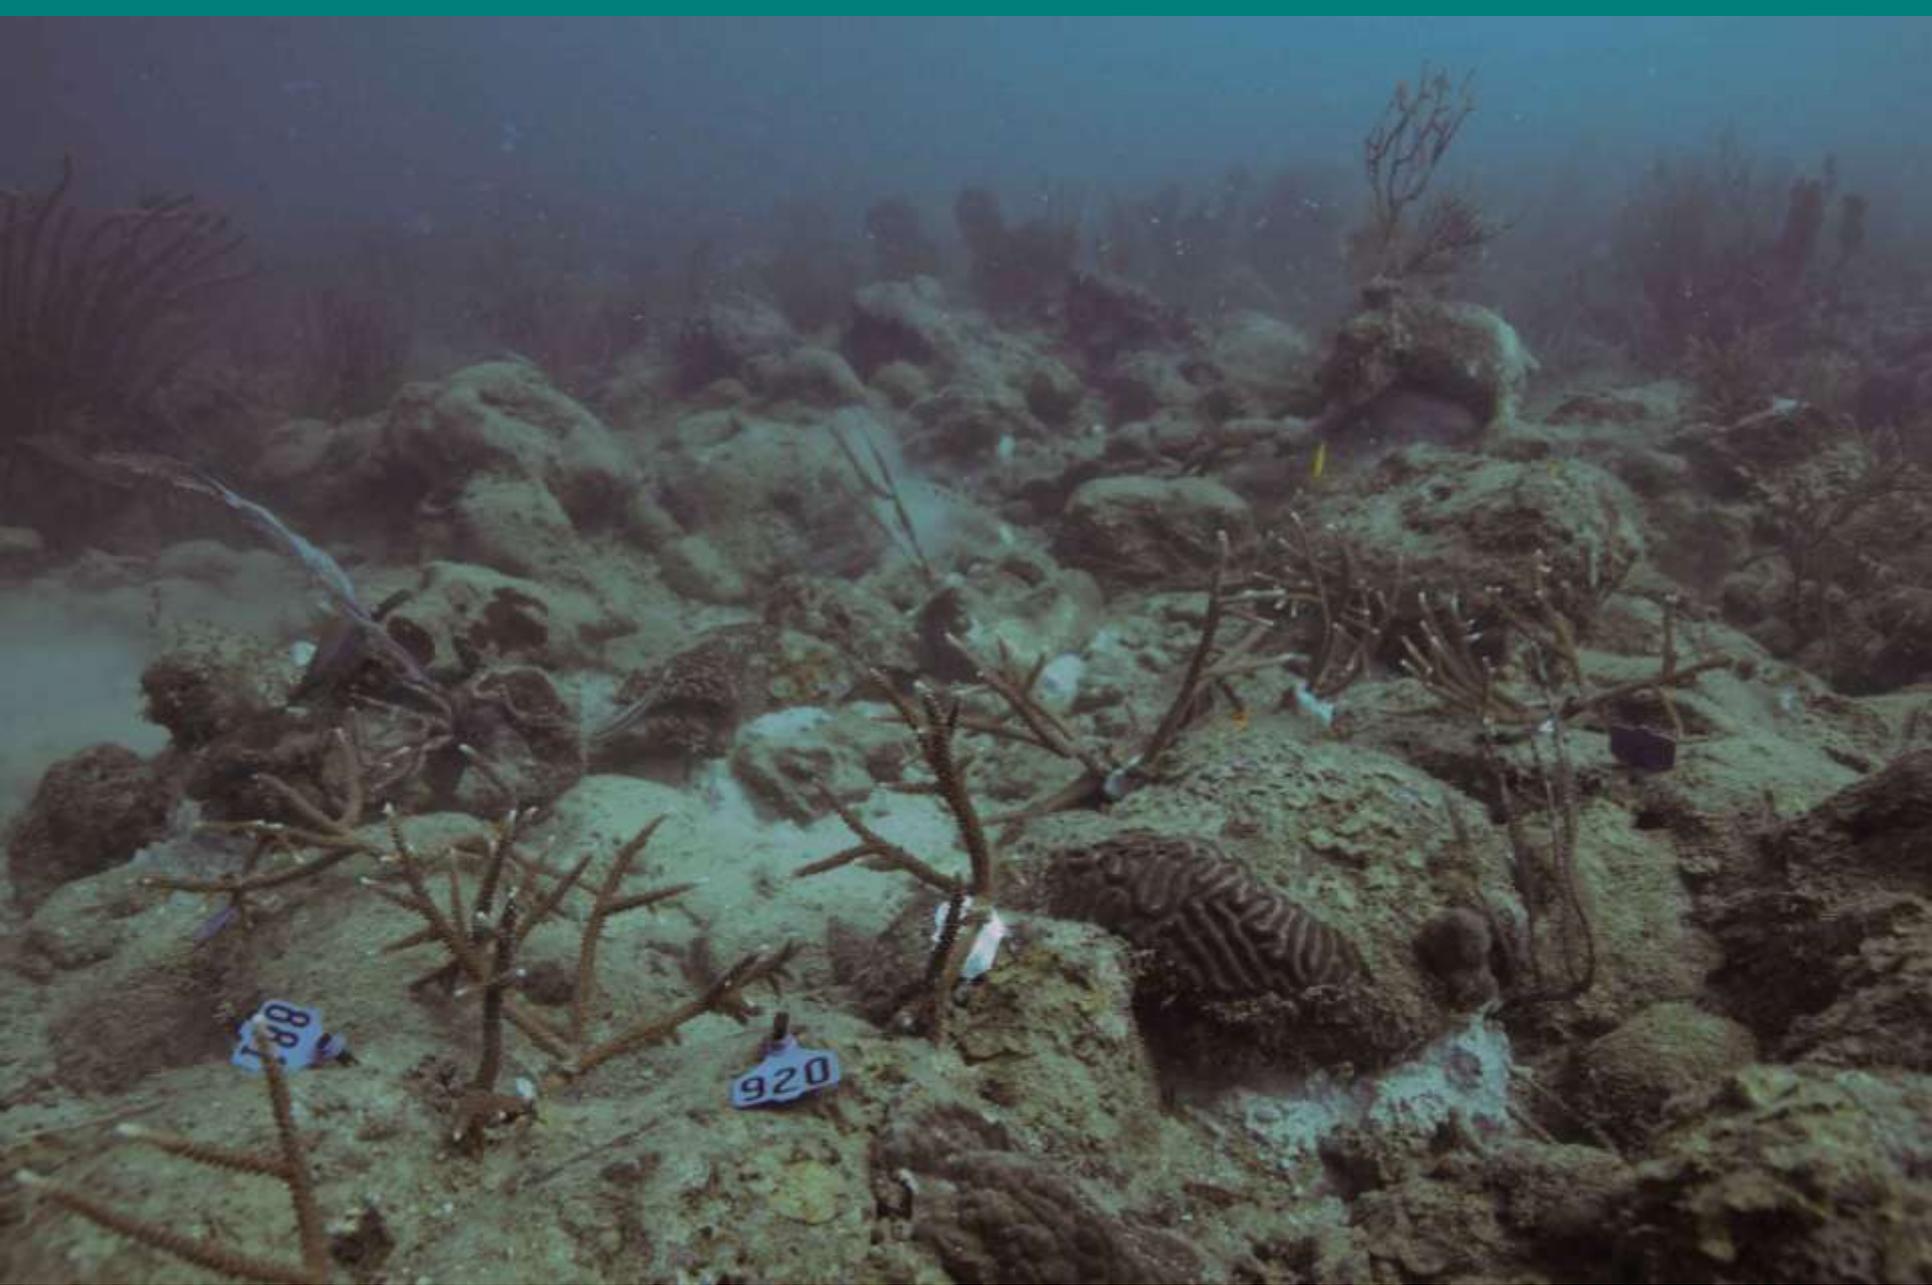
Damage Assessment

Location	Maria Langa	Offshore Tallaboa	Total*
Size of Impact	45.6 m ²	37.5 m ²	83.1 m ²
# of Corals Lost	1,014	964	1,978

*** Rapid response by USCG after notification prevented additional damage to the reef**

132 corals reattached and 16 *A. cervicornis* transplanted during ER

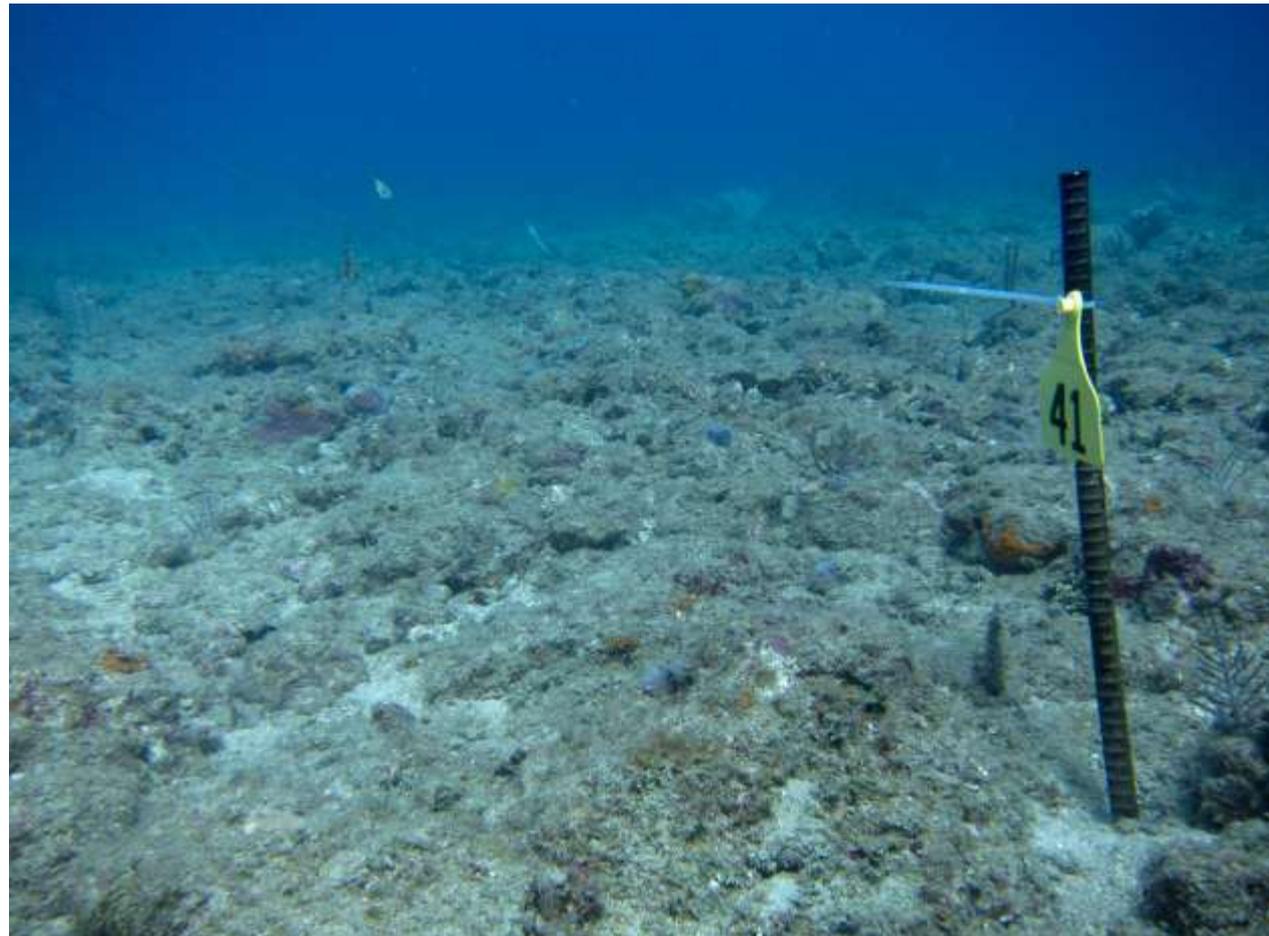
M/V Kapitan Egorov

- Grounding occurred 1998 in Guayanilla, PR
- 7,000m² of reef were damaged
- No Restoration
- Recovery significantly delayed in many areas

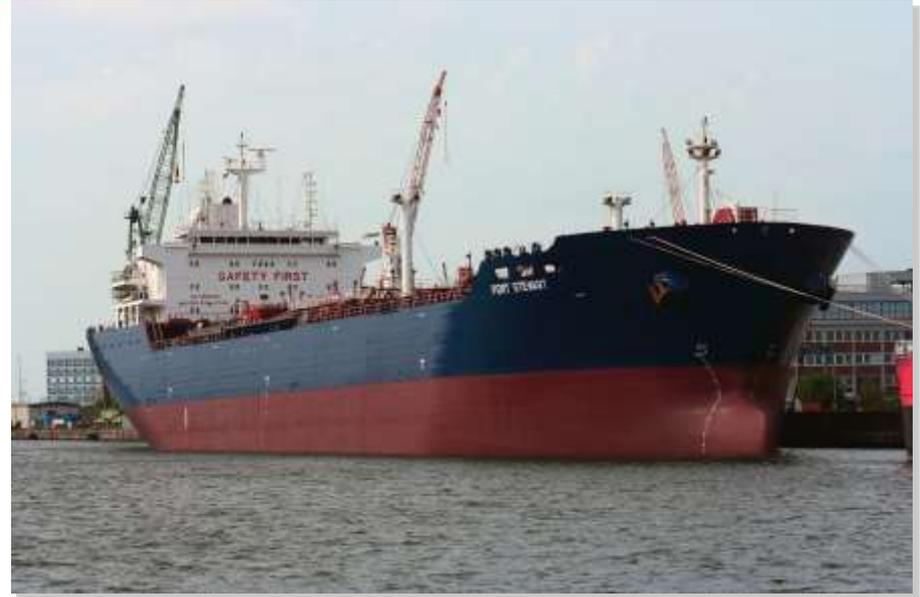
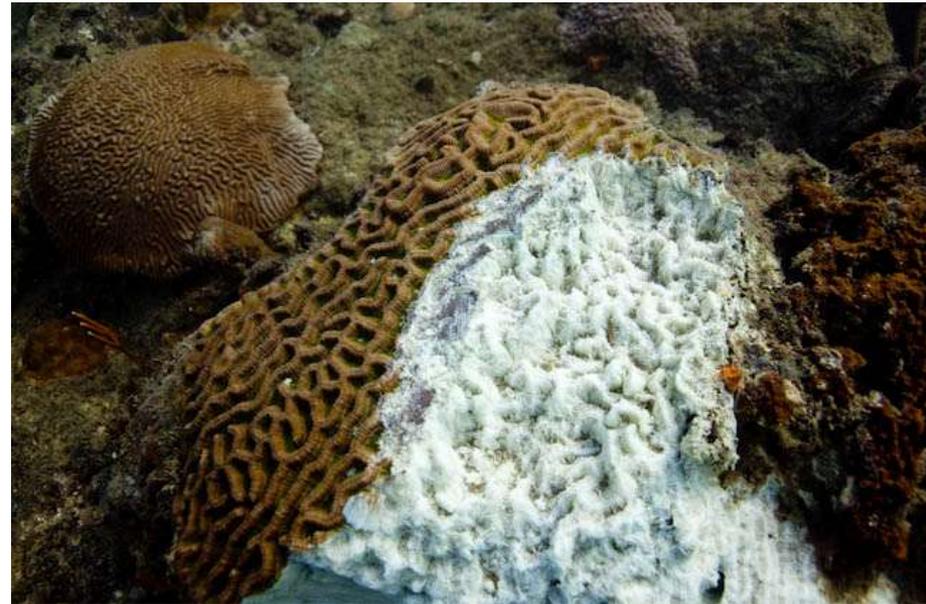
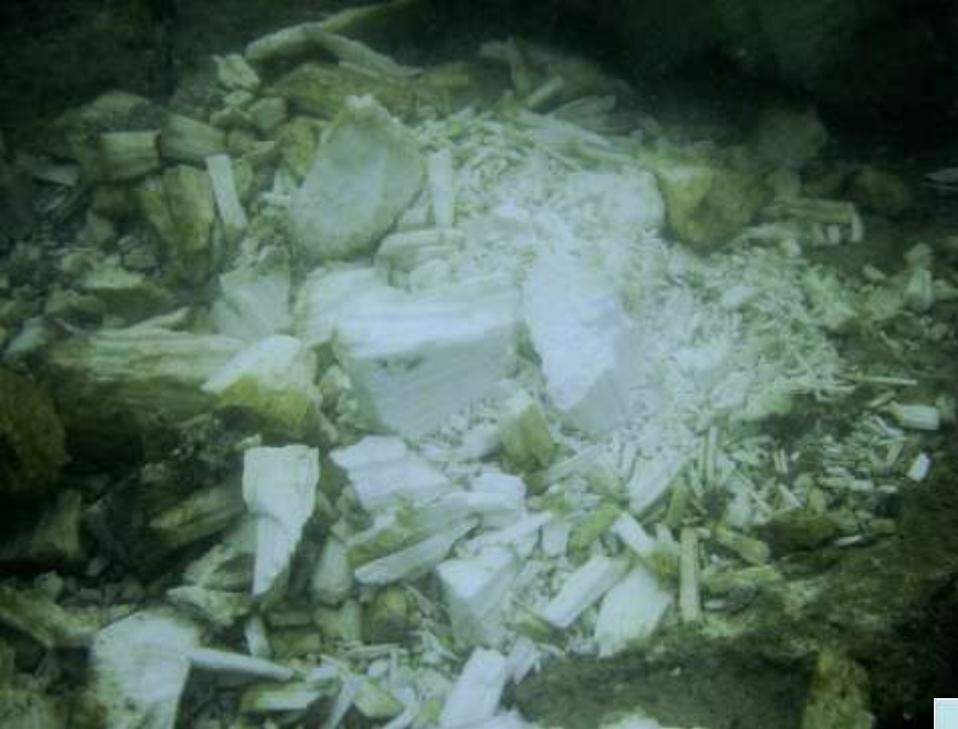
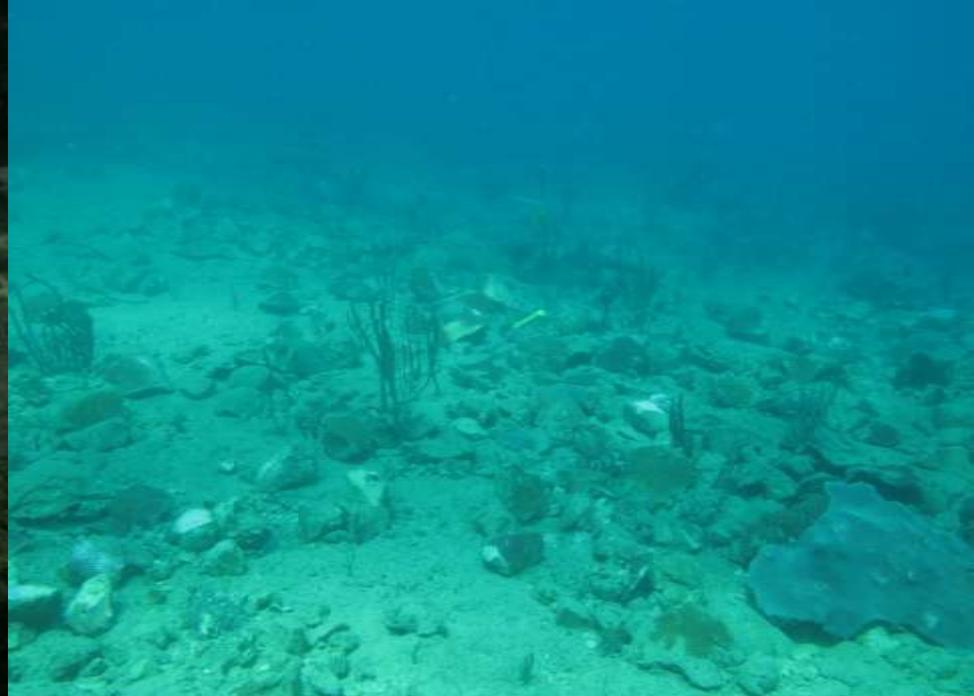
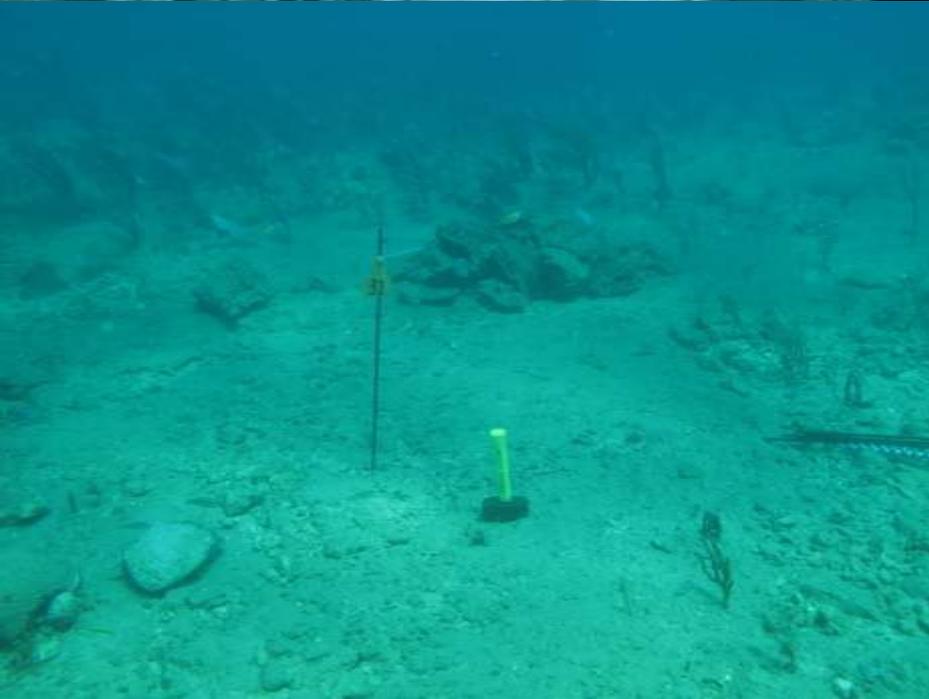
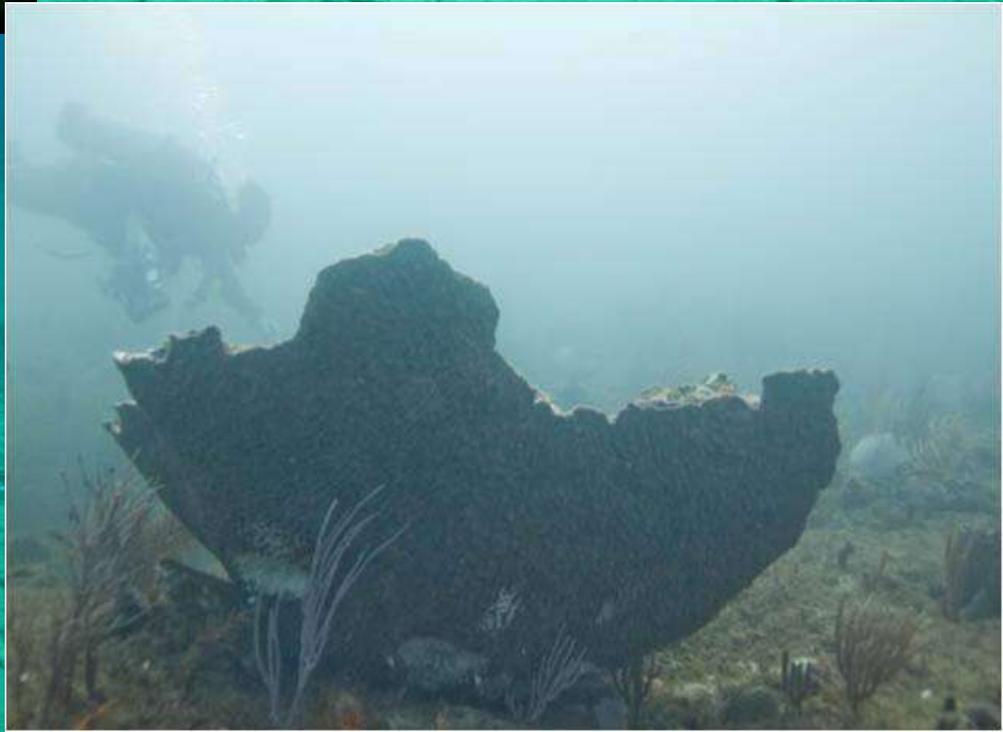
M/V PORT STEWART

- Grounded on Oct. 28, 2009 in Yabucoa, PR
- 500 m² of reef damaged
- 1,000 corals reattached
- 15 m² of limestone used to restore lost rugosity at the site
- Restoration complete

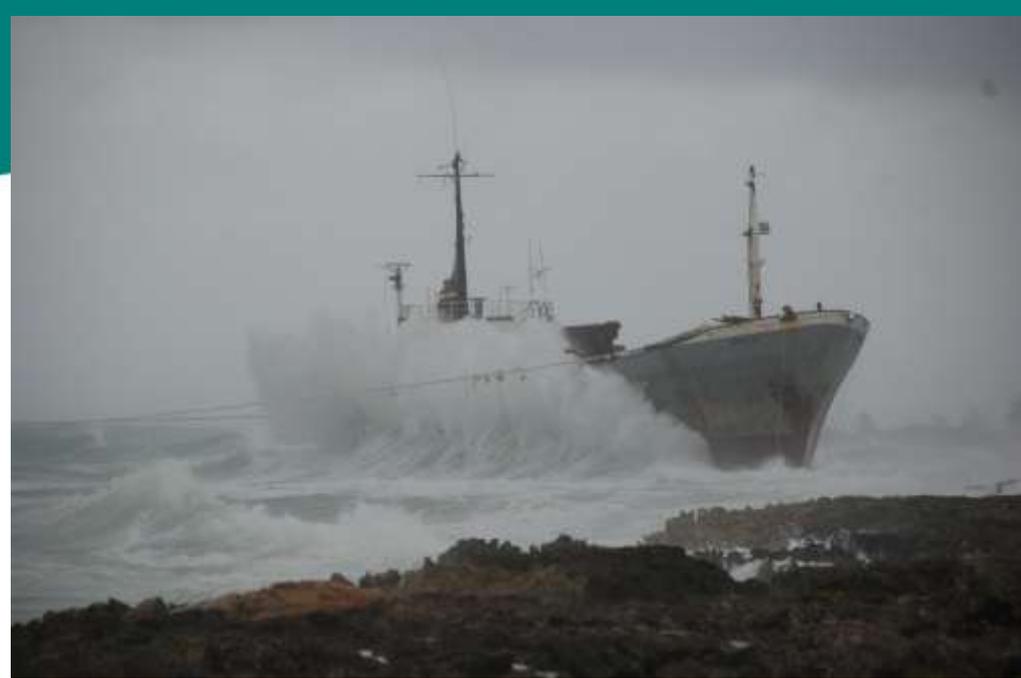
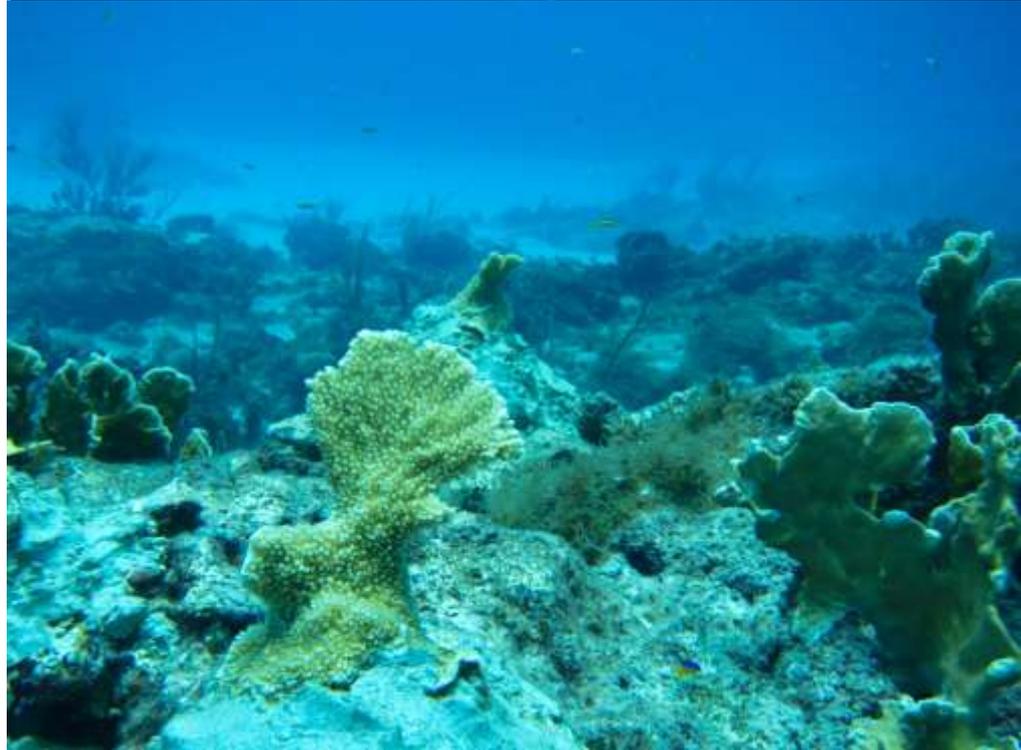
M/V Jireh

- Grounded on June 20, 2012 in Mona
- Last piece of the vessel removed Oct 5
- Colony of *A. palmata* crushed by bow when vessel rotated during hurricanes
- Other colony by hull proactively transplanted
- *A. palmata* colonies from nursery in La Parguera will be transplanted to impact site (May 2013)
