FINAL REPORT

A geomorphologic assessment at selected beach sites using imagery analysis (1936-2007) and beach profiling techniques (2009-2010): as a tool to define coastal indicators for management applications.

Playa Vega Baja, Playa Piñones, Loíza; Playa Fortuna, Luquillo; Playa Punta Santiago, Humacao; Playa Salinas, Salinas and El Maní, Mayagüez

Prepared by Maritza Barreto, Ph.D
12/31/2010

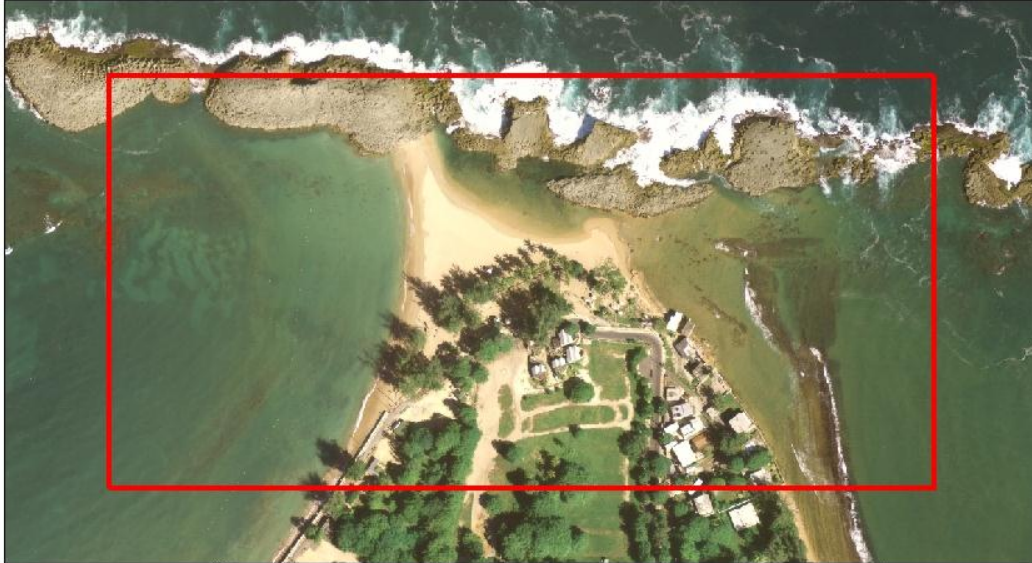
Historical Shoreline Changes: Playa Puerto Nuevo, Vega Baja (1936 to 2007)

Shift from erosion to accretion was observed at Playa Puerto Nuevo. Accretion was measured in beach during 1950 and 1977. Extensive sand deposits were seen in landward site of eolianites. This barrier apparently acts as a barrier that traps sediment inshore. Major morphology changes were identified in the northeast beach site where eolianite were discontinuous. No data was found to identify possible causes of produce extensive sand accumulation in the site but it may related with swells and seas occurrence in the area. Important sand losses in subaerial beach were observed starting from 1987. A decrease in sediment loss was found in 2007. No data are available to identified possible causes of reduction of sand loss.

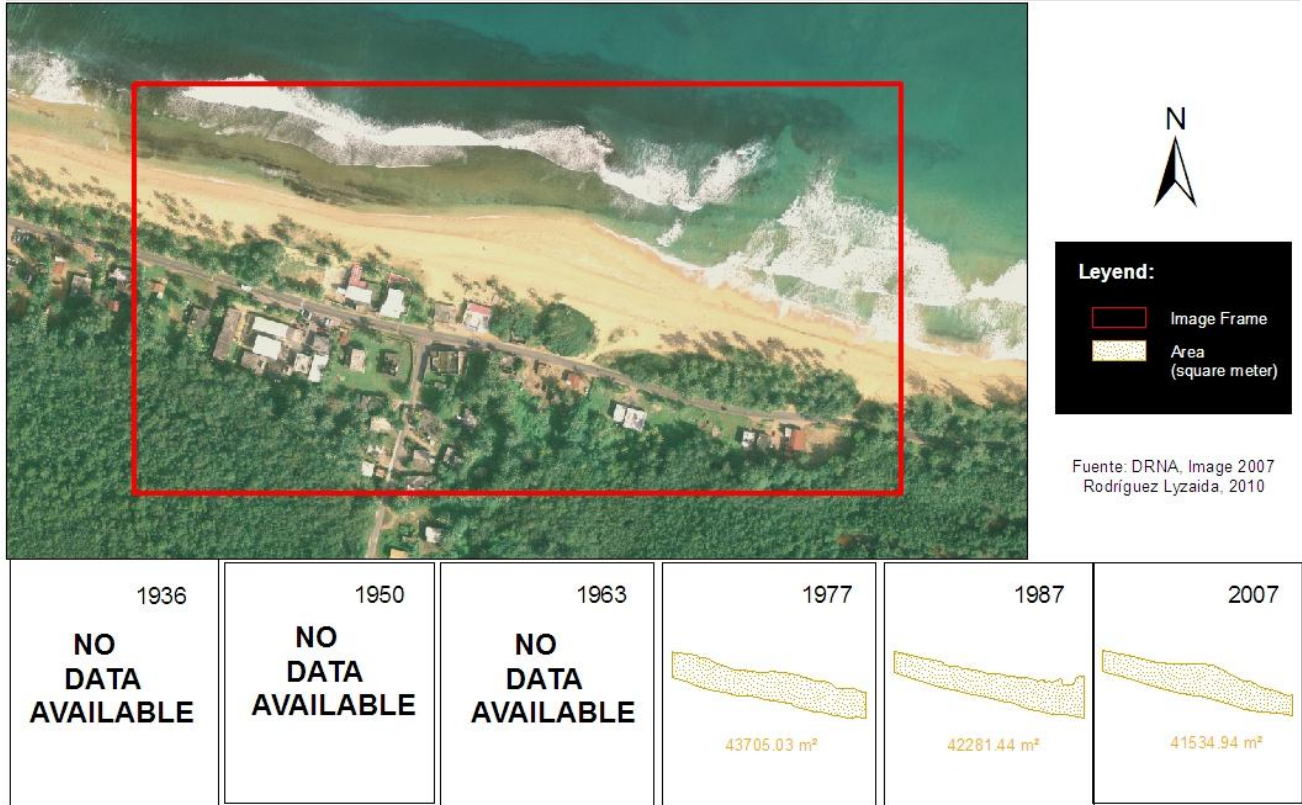
Figure 26. Subaerial beach changes at Playa Piñones.

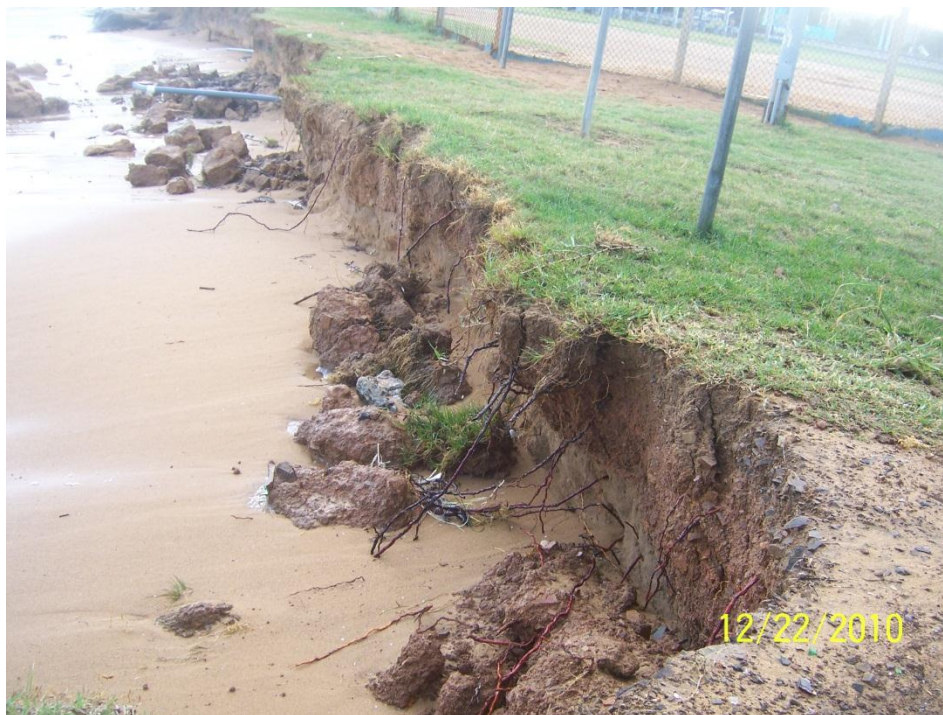
Figure 32. Erosion at Playa Fortuna, Luquillo (December 2010)

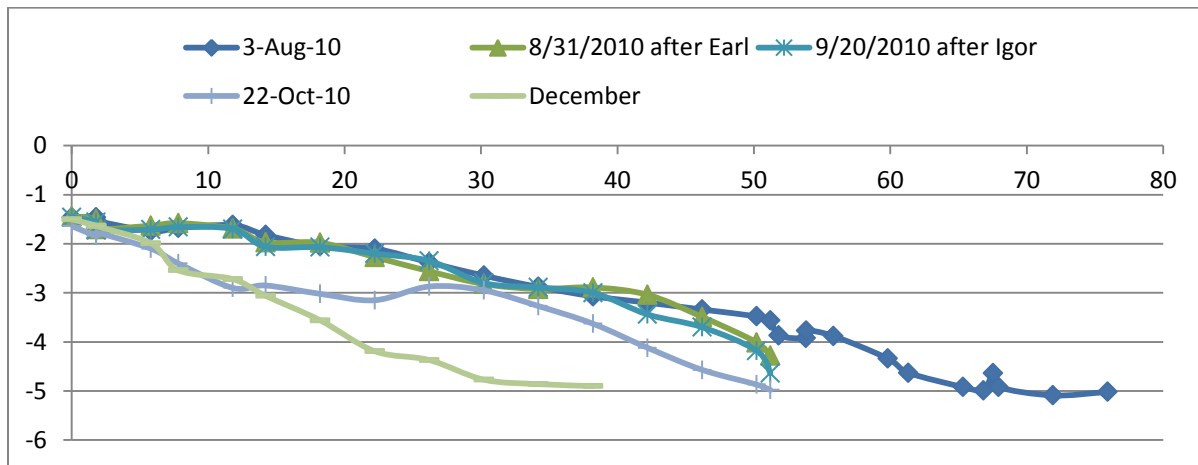
- Beach profile 1: No changes were found in profiles from August to October 2010. Danielle, Earl and Igor do not cause erosion in this site due to the protection done by an eolianite located to the northwest. This eolianite protect the site from storm waves approaching from the northwest. Major profile changes were measured from October to December during a swell event during December. It is possible profile change in this station depends of wave direction due to eolianite location. Storm trajectory may an important variable producing changes profile between stations.

Figure 33. Beach profile 1 at Playa Puerto Nuevo (length in meters)

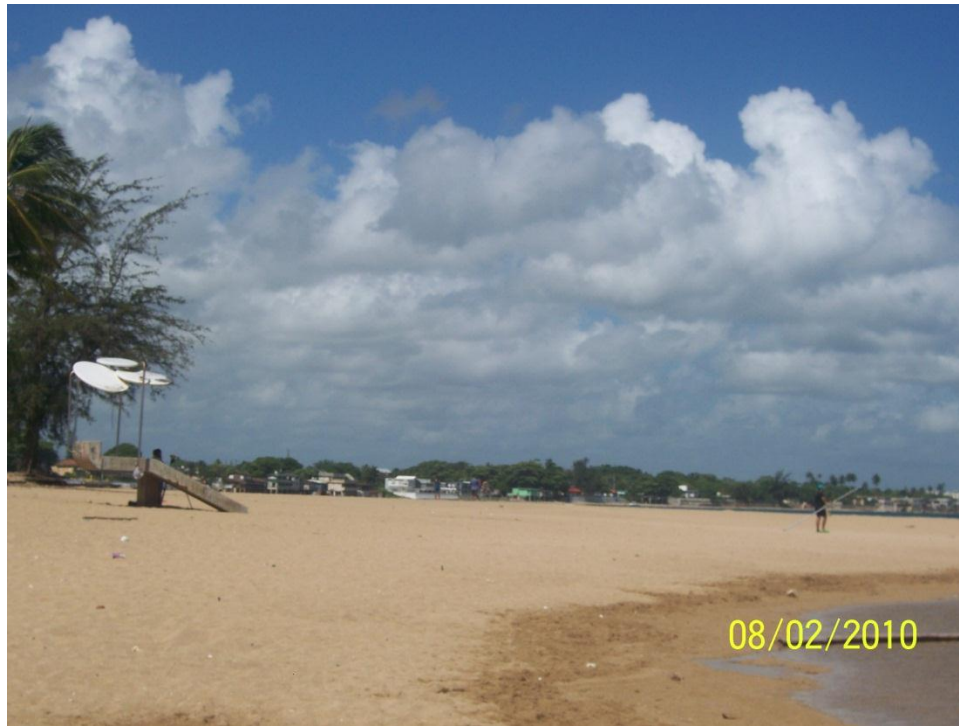
Figure 34. Beach profile 1 at Playa Puerto Nuevo (August 2010). This barrier protects the station from waves approaching from northwest.

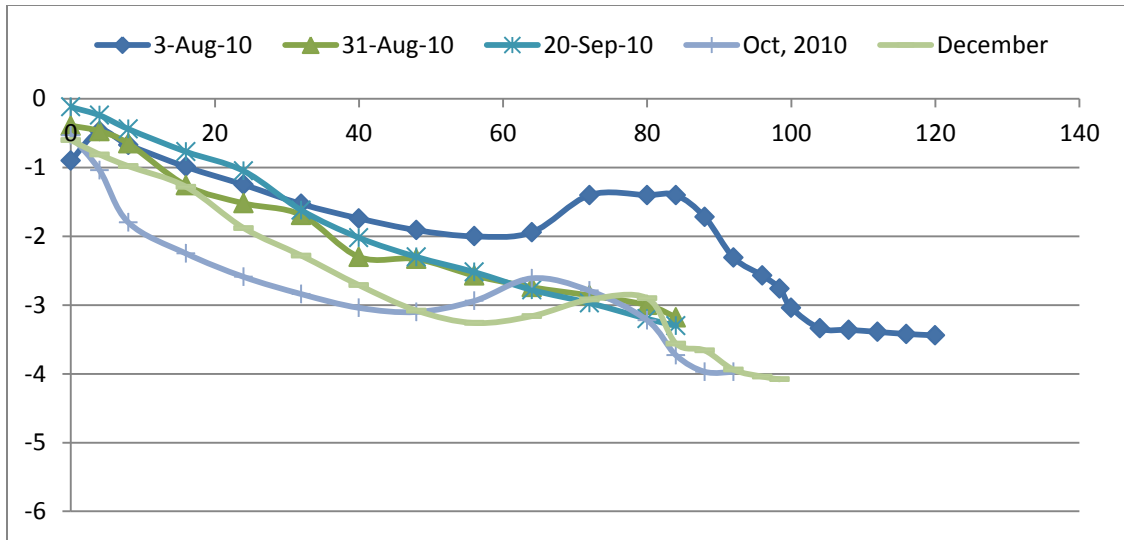
- Beach profile 2: Loss of sand was found in this site except for sand accumulation was observed during the occurrence of Igor in September. Sand accumulation may produce by eolianite during waves approaching from north and northeast. Erosion was mainly occurred during the occurrence of Hurricanes Danielle and Earl. Hurricane Tomas produce erosion after trajectory changes to the northwest (after November 11). Loss of sand may produce of waves approaching from northwest during the period that storms systems where located northwest site of Puerto Rico waters.

Figure 35. Beach profile Station 2 at Playa Puerto Nuevo.

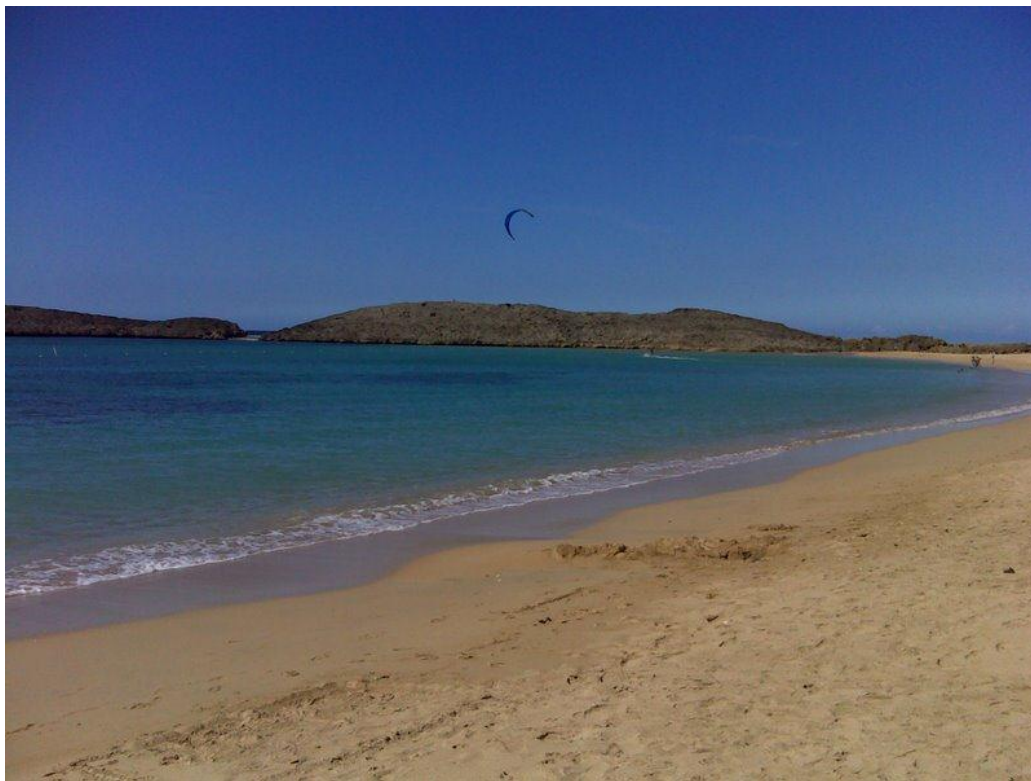
Figure 36. Beach profile 2 at Playa Puerto Nuevo (October 2010). The site is protected by an eolianite system. This barrier protect the profile from waves approaching from north and northeast

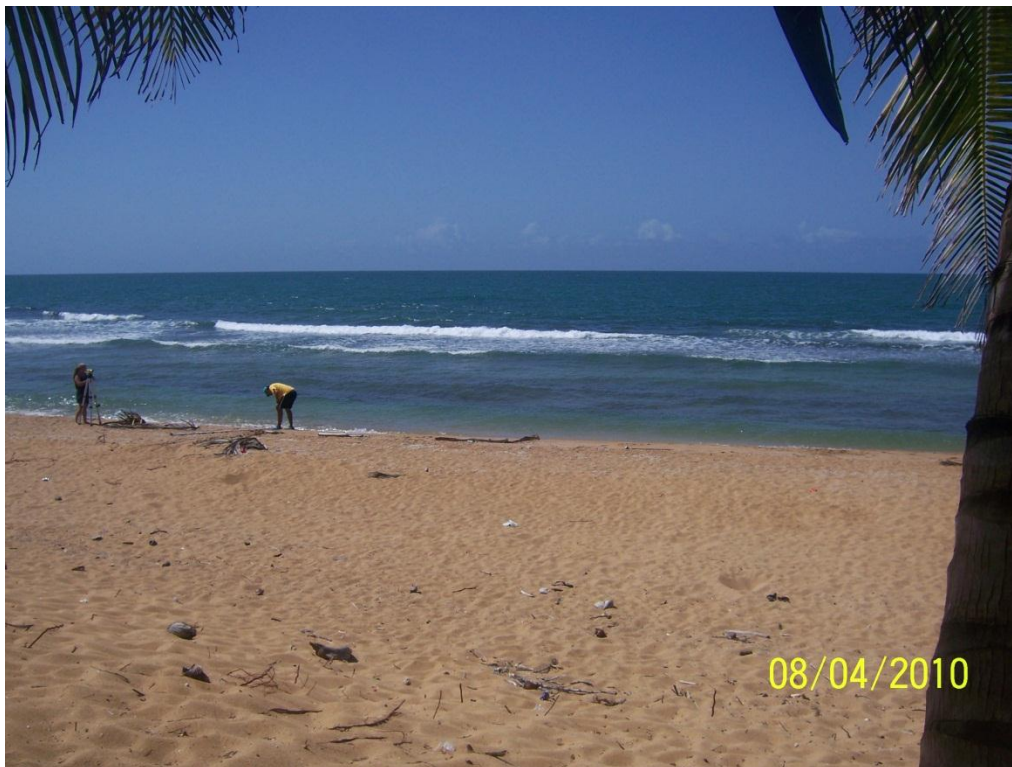
Figure 40 . Beach Profile 1 at Playa Piñones (August). Station showed dunes and beachrock.

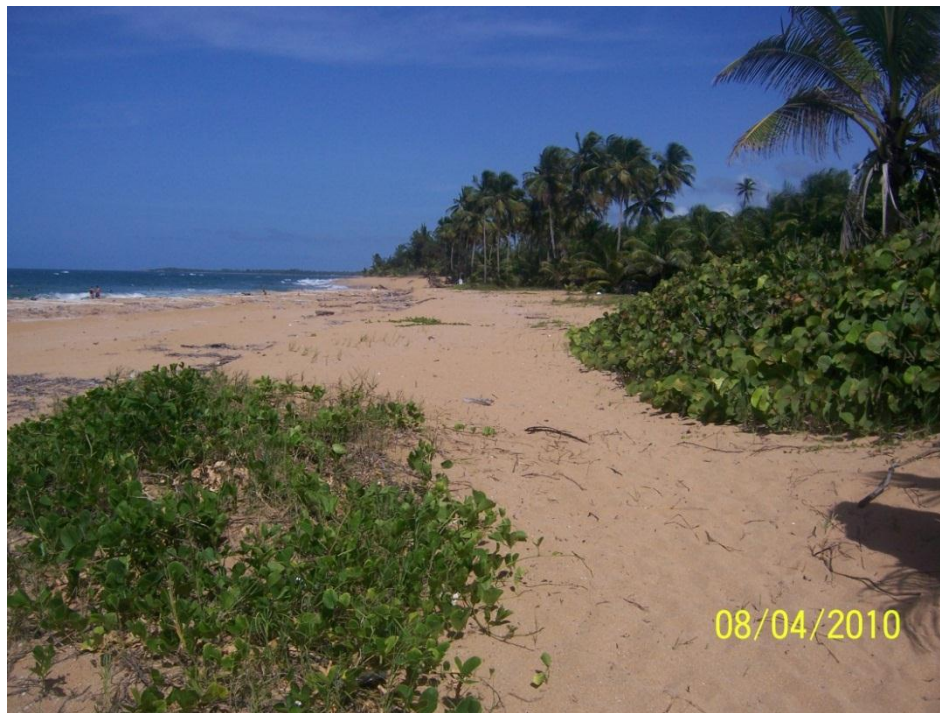
Figure 42. Beach Profile 1 at Playa Piñones (August). Station showed dunes and vegetated dunes and beachrock.

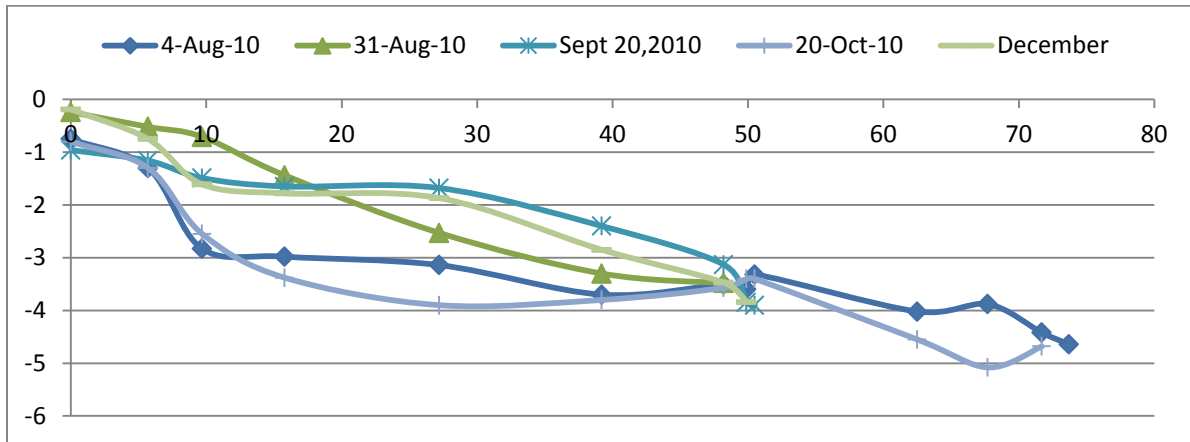
- Beach profile 3: Accretion was measured after occurrence of Hurricanes Danielle and Earl. Loss of sand was continuous until October. Shift from erosion to accretion was observed after the occurrence of swell event. This station is less protected than station 1 and 2.

Figure 43. Playa Piñones, Loíza, Beach Profile 3 (length in meters)

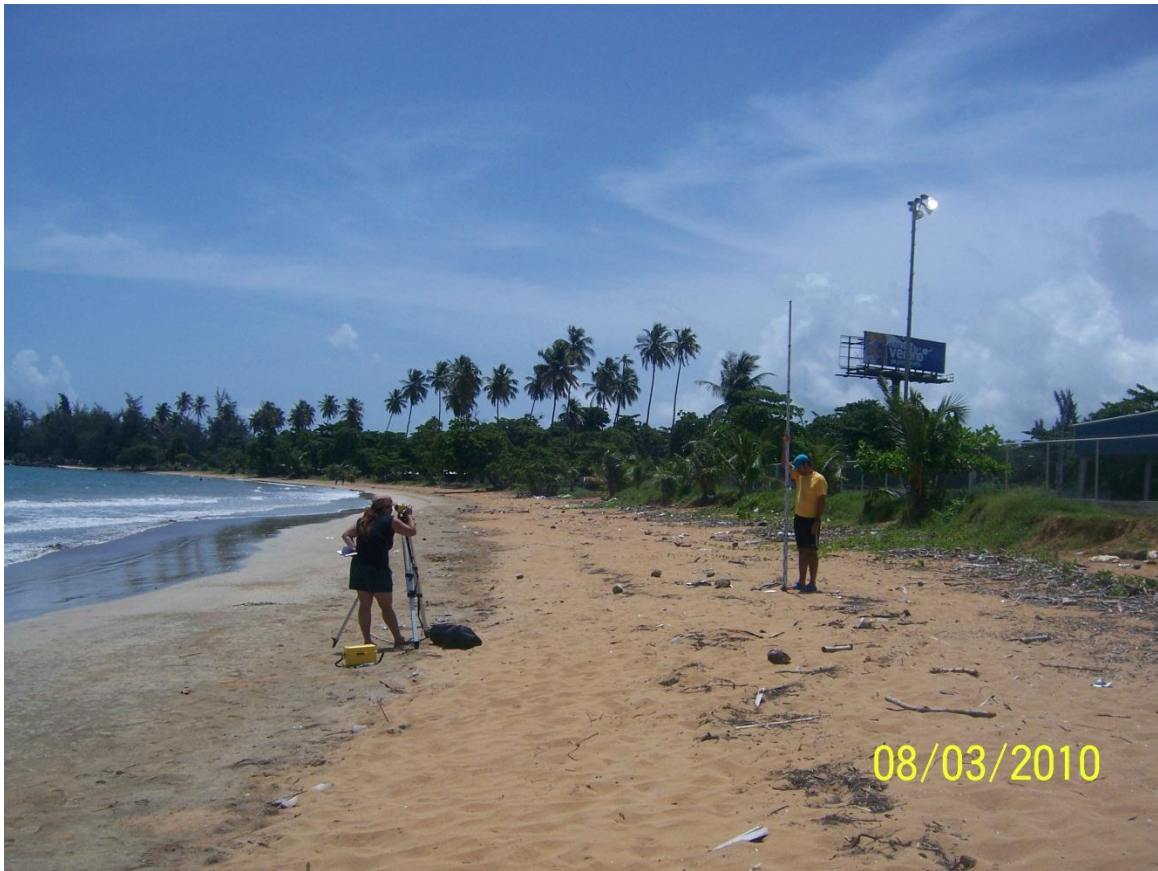
Figure 45. Beach profile 1 at Playa Fortuna. Dissipative profile was observed near to recreational infrastructure in the study site during August 2010.

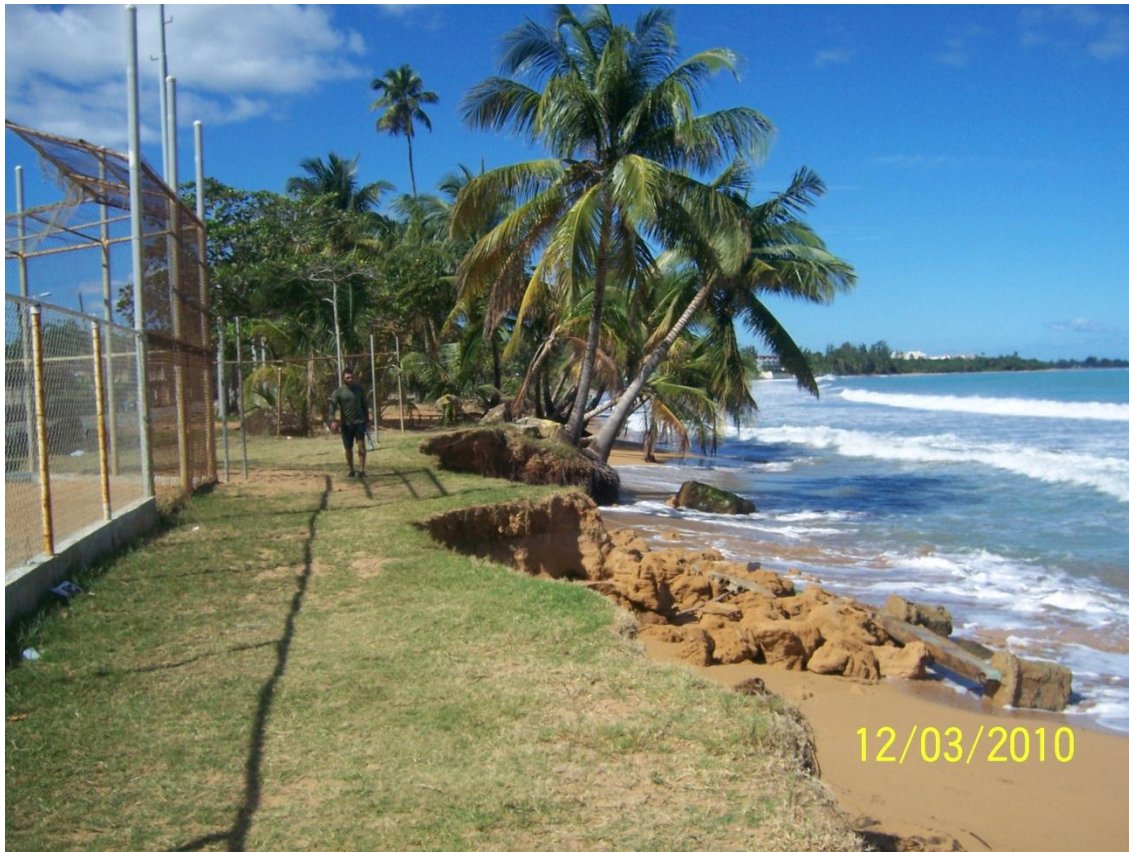
Figure 46. Beach profile 1 at Playa Fortuna. Major erosion was occurred near to recreational infrastructure in the study site.

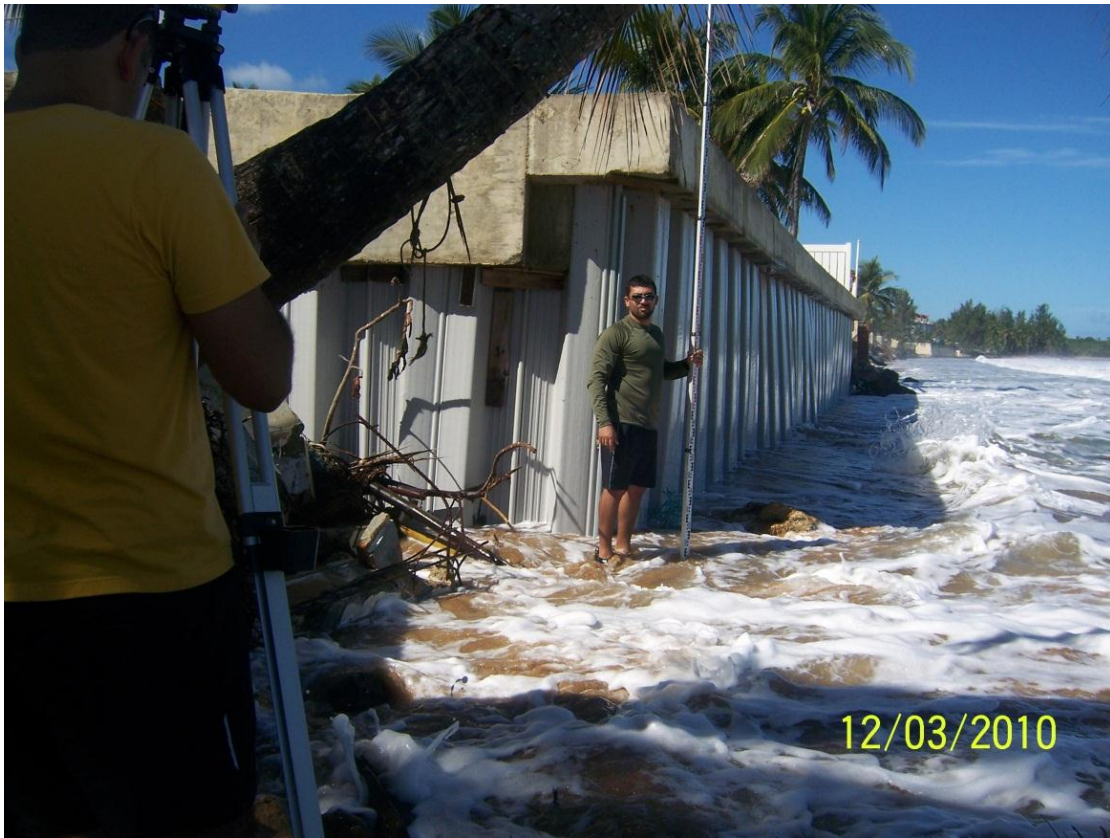
Figure 49. Extreme subaerial beach loss at Playa Fortuna (December 2010).

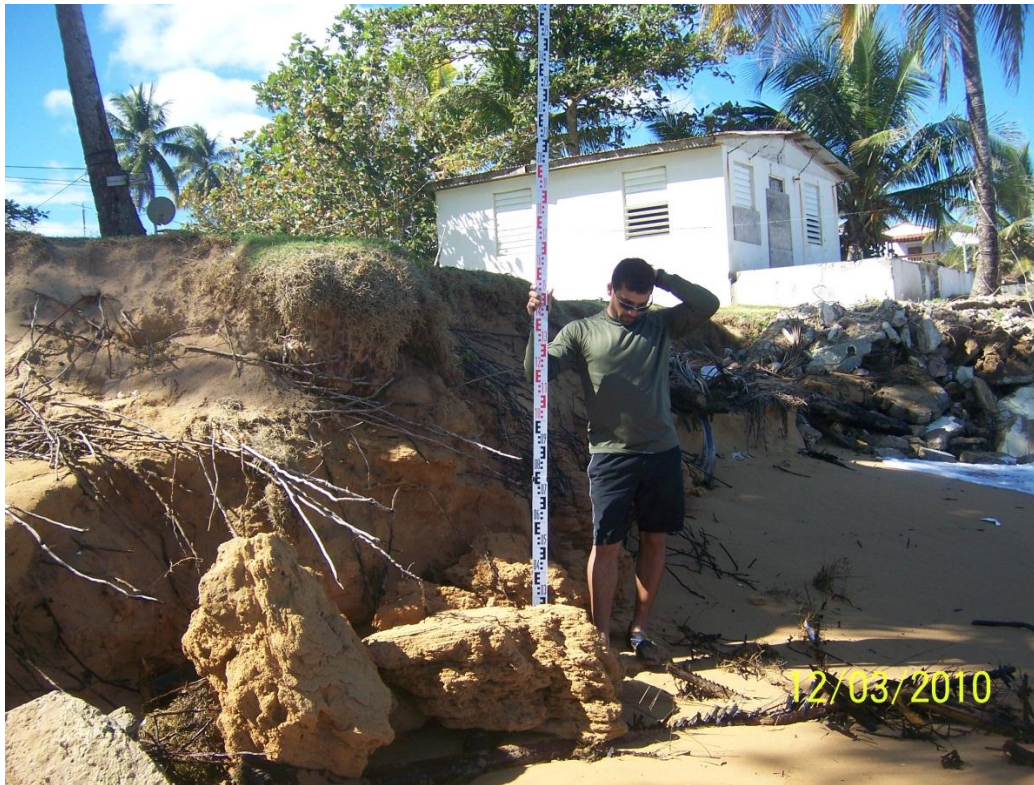
Figure 50. Severe erosion was measured in Playa Fortuna beach during December 2010 due by high swells.

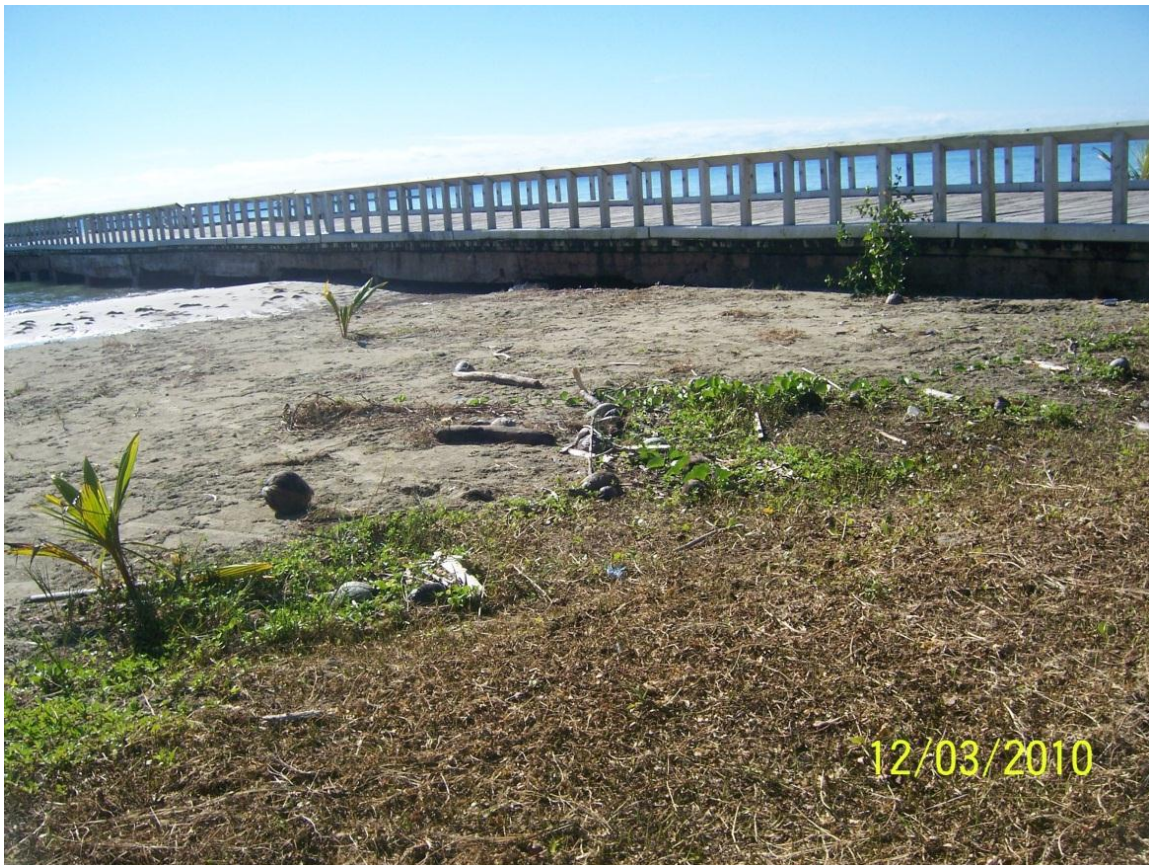
Figure 56. Dock structure located to the southward station 2.

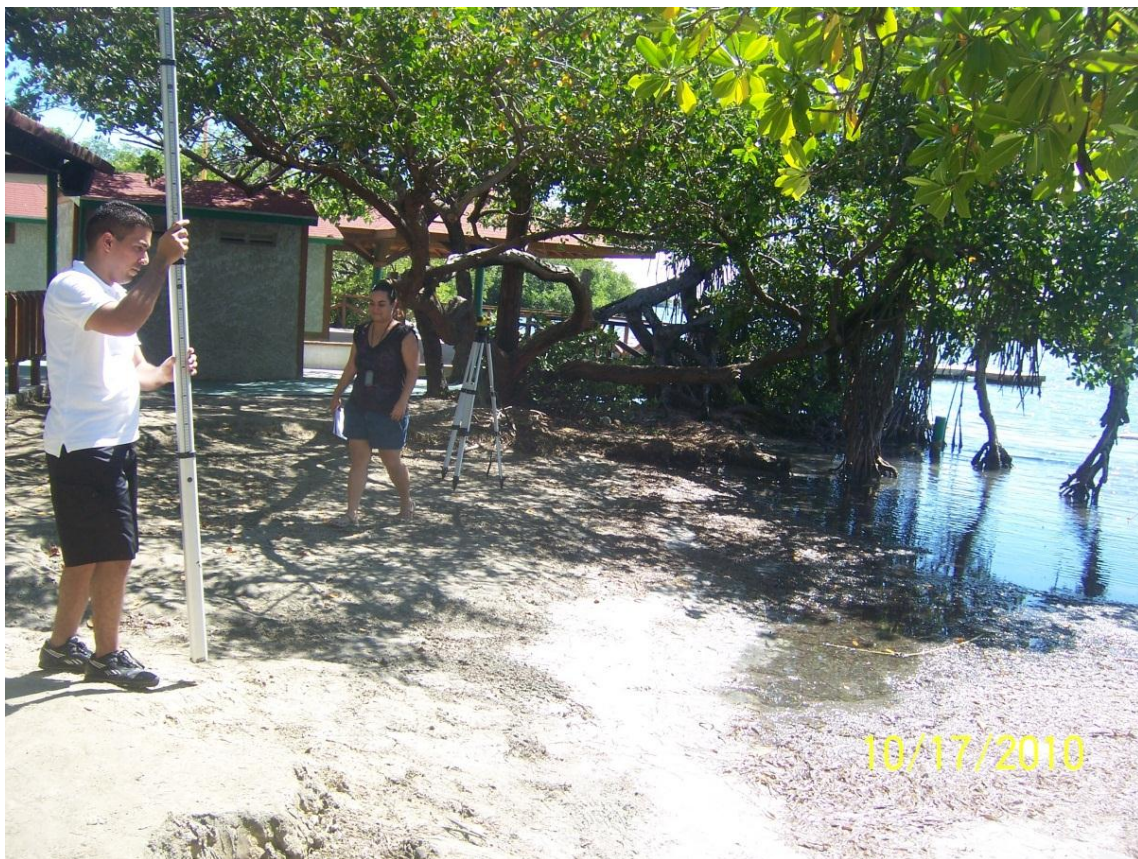
Figure 62. Beach profile 3 at Playa Salinas (October). It is Beach station 3 is protected by mangrove shoreline.

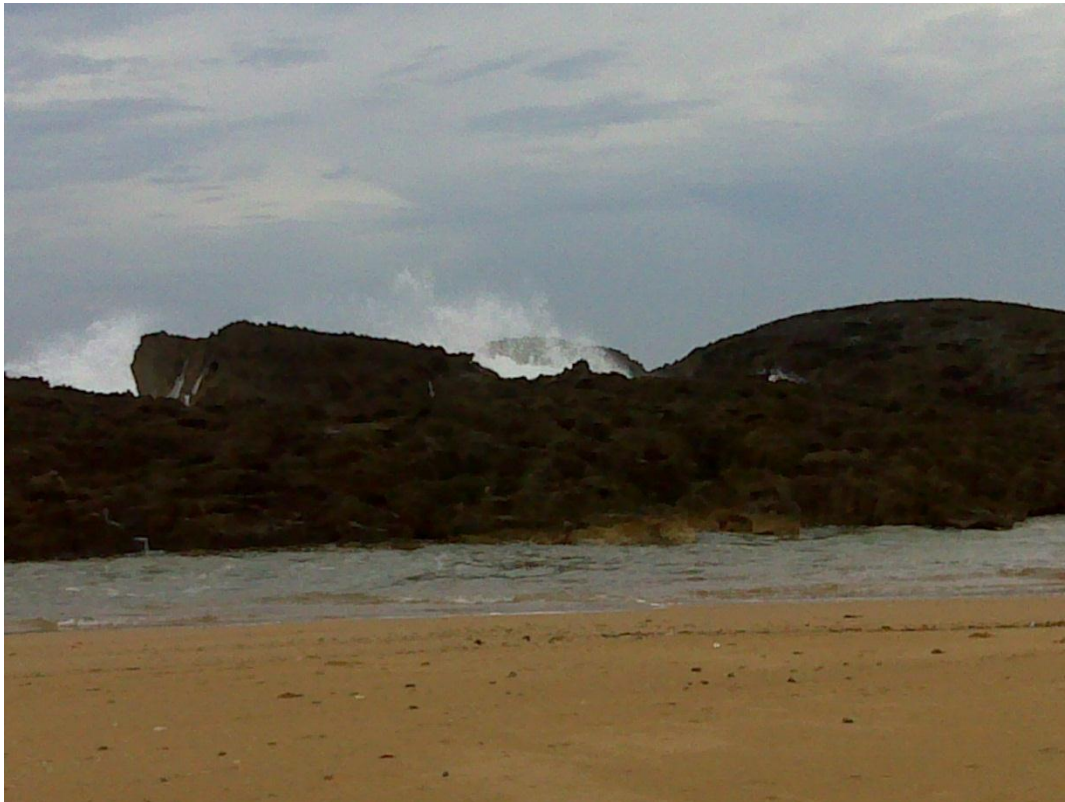
Figure 71. Beach Station 2 at Playa Puerto Nuevo. The beach is protected by an eolianite.

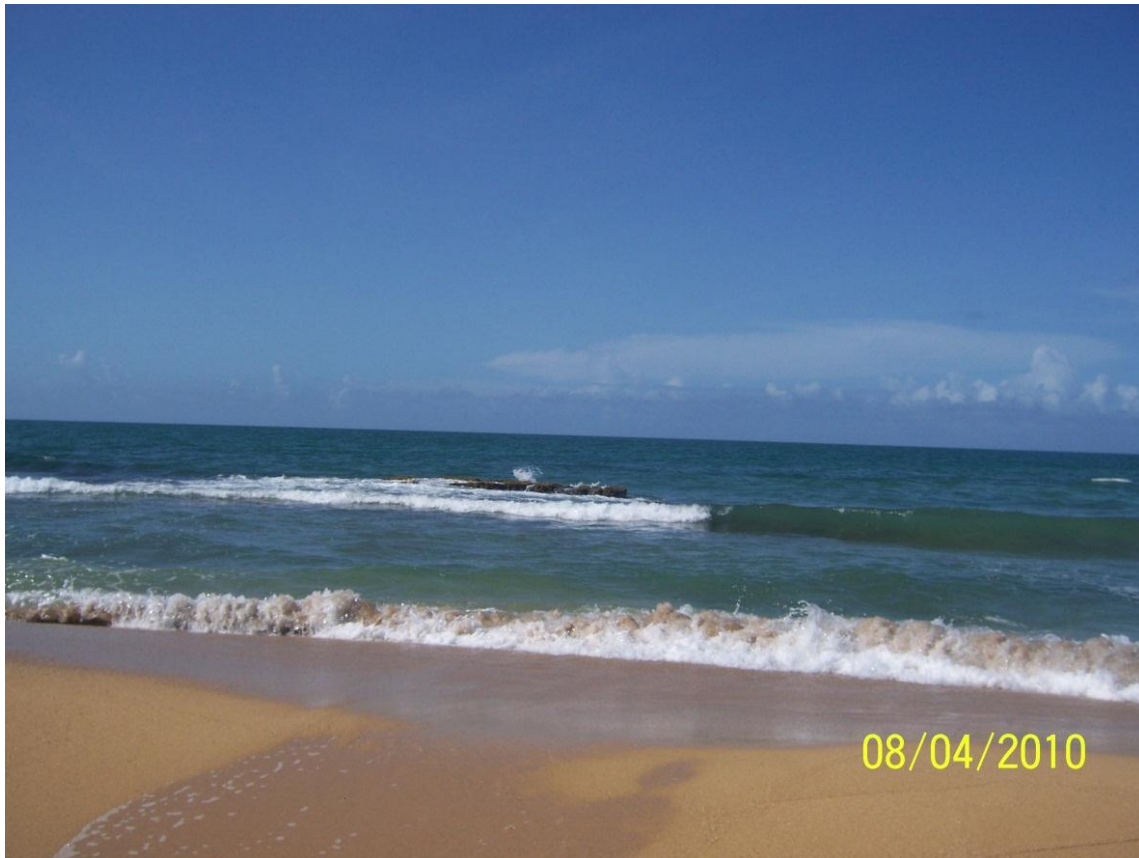
Figure 73. Beach profile Station 1 at Playa Piñones. The beach is protected by beachrock and Eolianites.

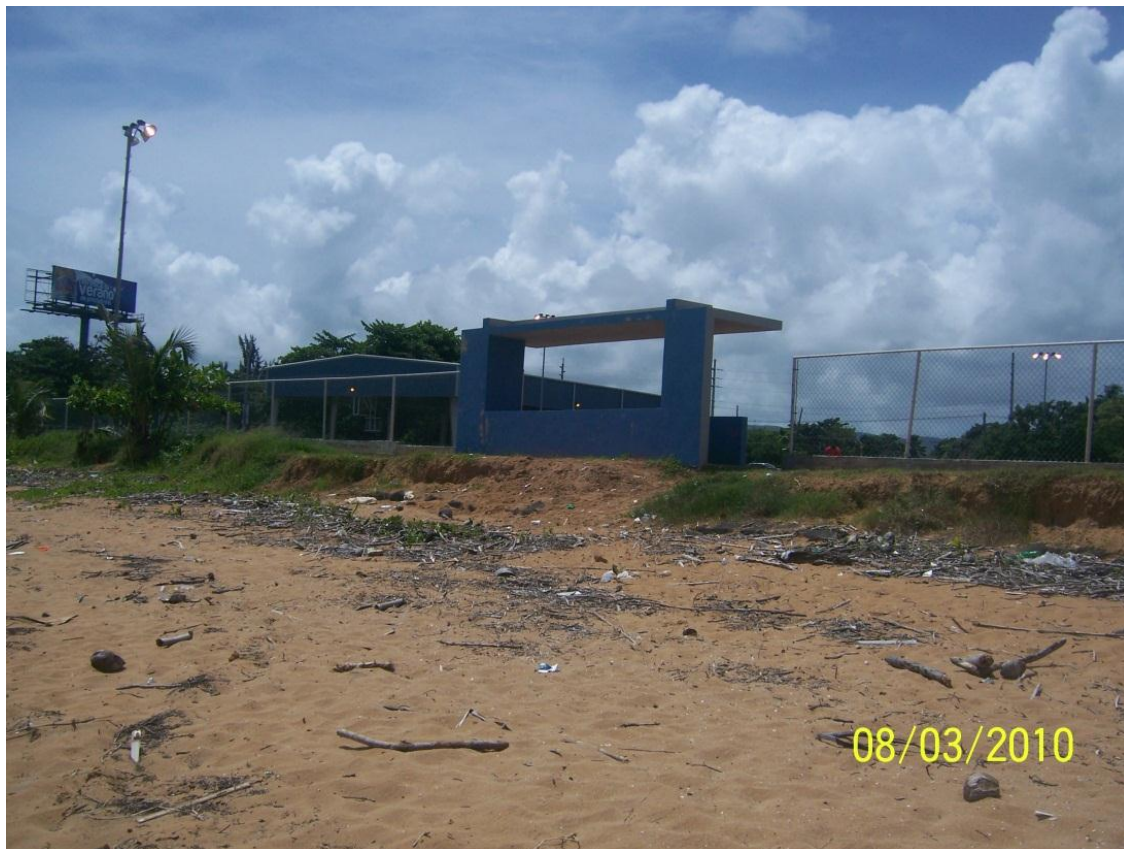
Figure 75. Beach Profile Station 1 at Playa Fortuna before impact of Storm waves.

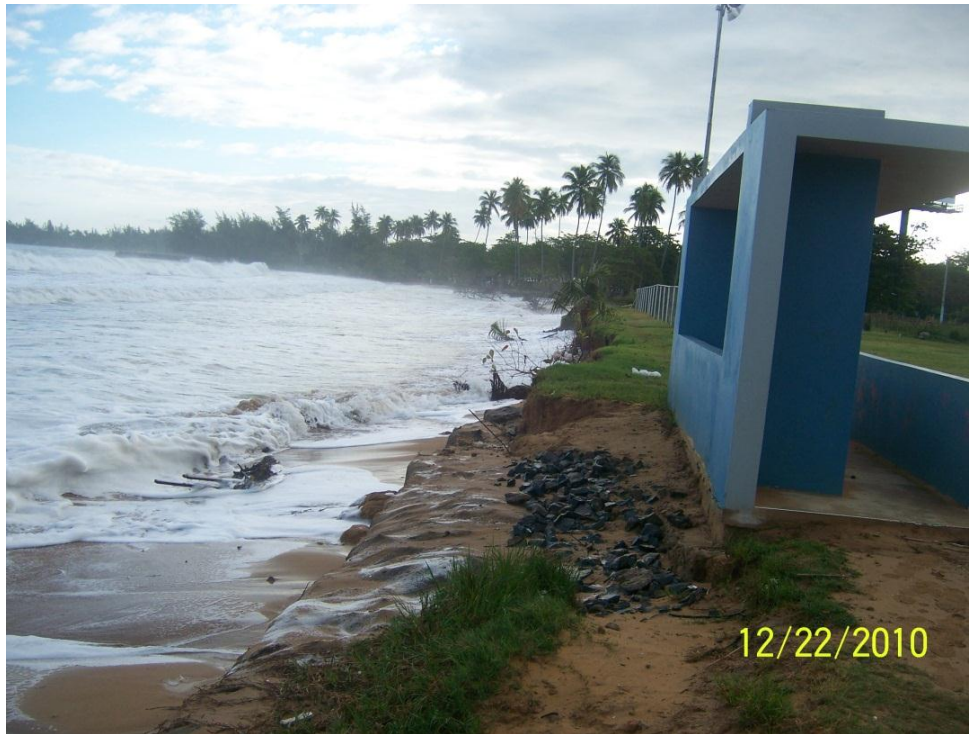
Figure 76. Beach Profile Station 1 at Playa Fortuna after the occurrence of extreme swell event on December 2010.

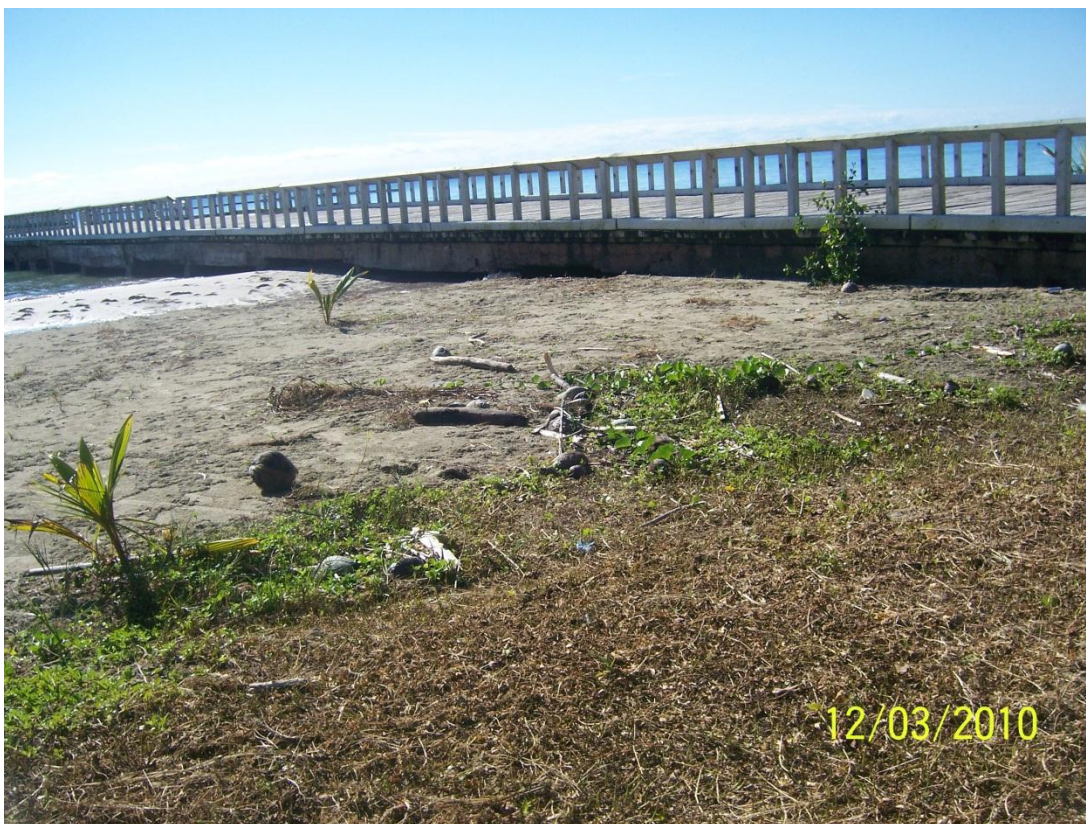
Figure 78. Beach profile Station 2 at Playa Humacao. The dock apparently blocks sediment transport to the south (beach station 1).

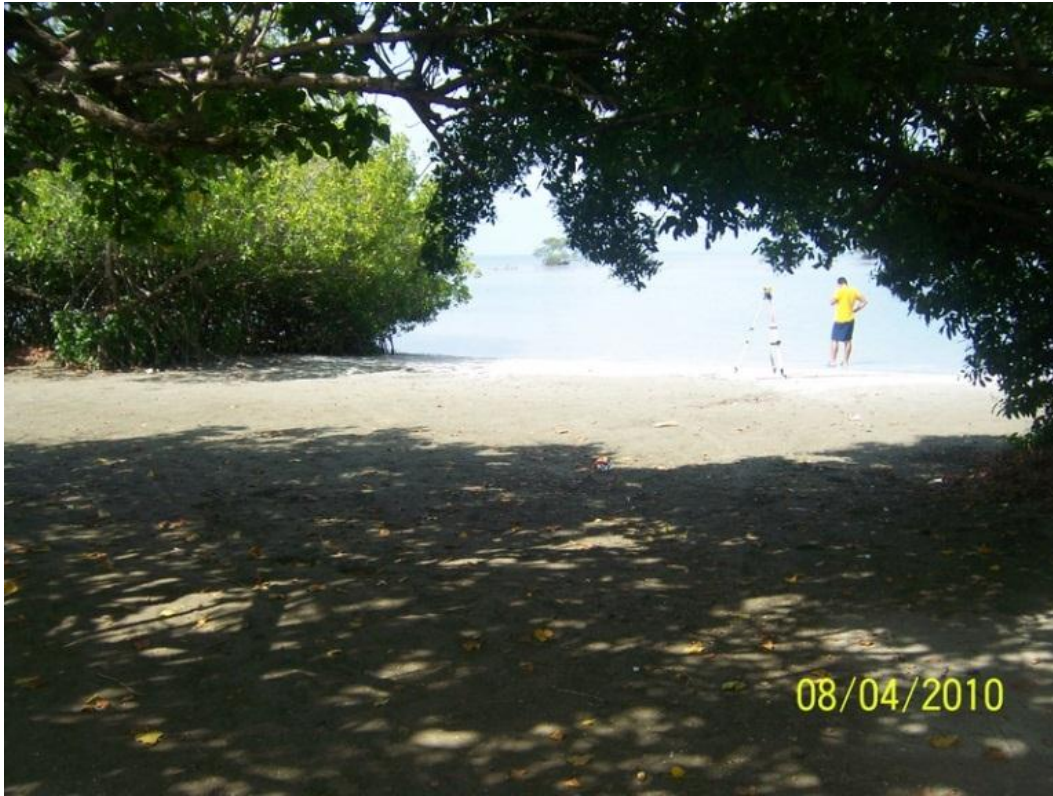
Figure 80. Mangrove shorelines at station 2 at Playa Salinas.

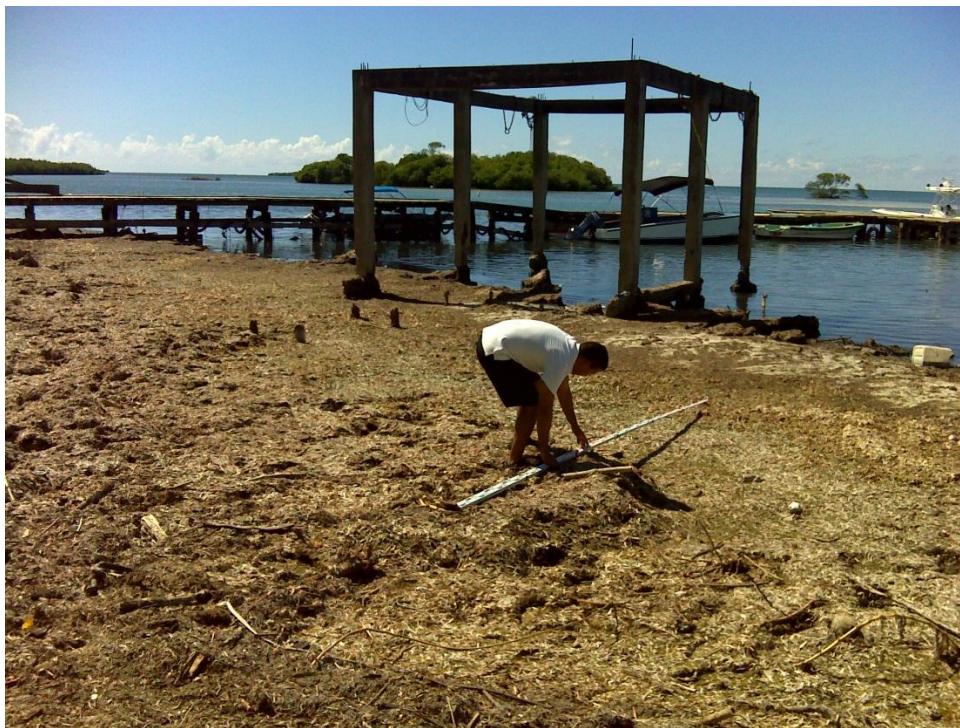
Figure 82. The dock located between station 1 and 2 apparently do not block sediment transport to the west. This dock was build-up with an open base that may do not block sediment transport.
