# Guánica Bay Watershed Management Plan

A Pilot Project for Watershed Planning in Puerto Rico

10/12/08

Center for Watershed Protection  
8390 Main St, 2<sup>nd</sup> Floor  
Ellicott City, MD 21043 USA  
[www.cwp.org](http://www.cwp.org)

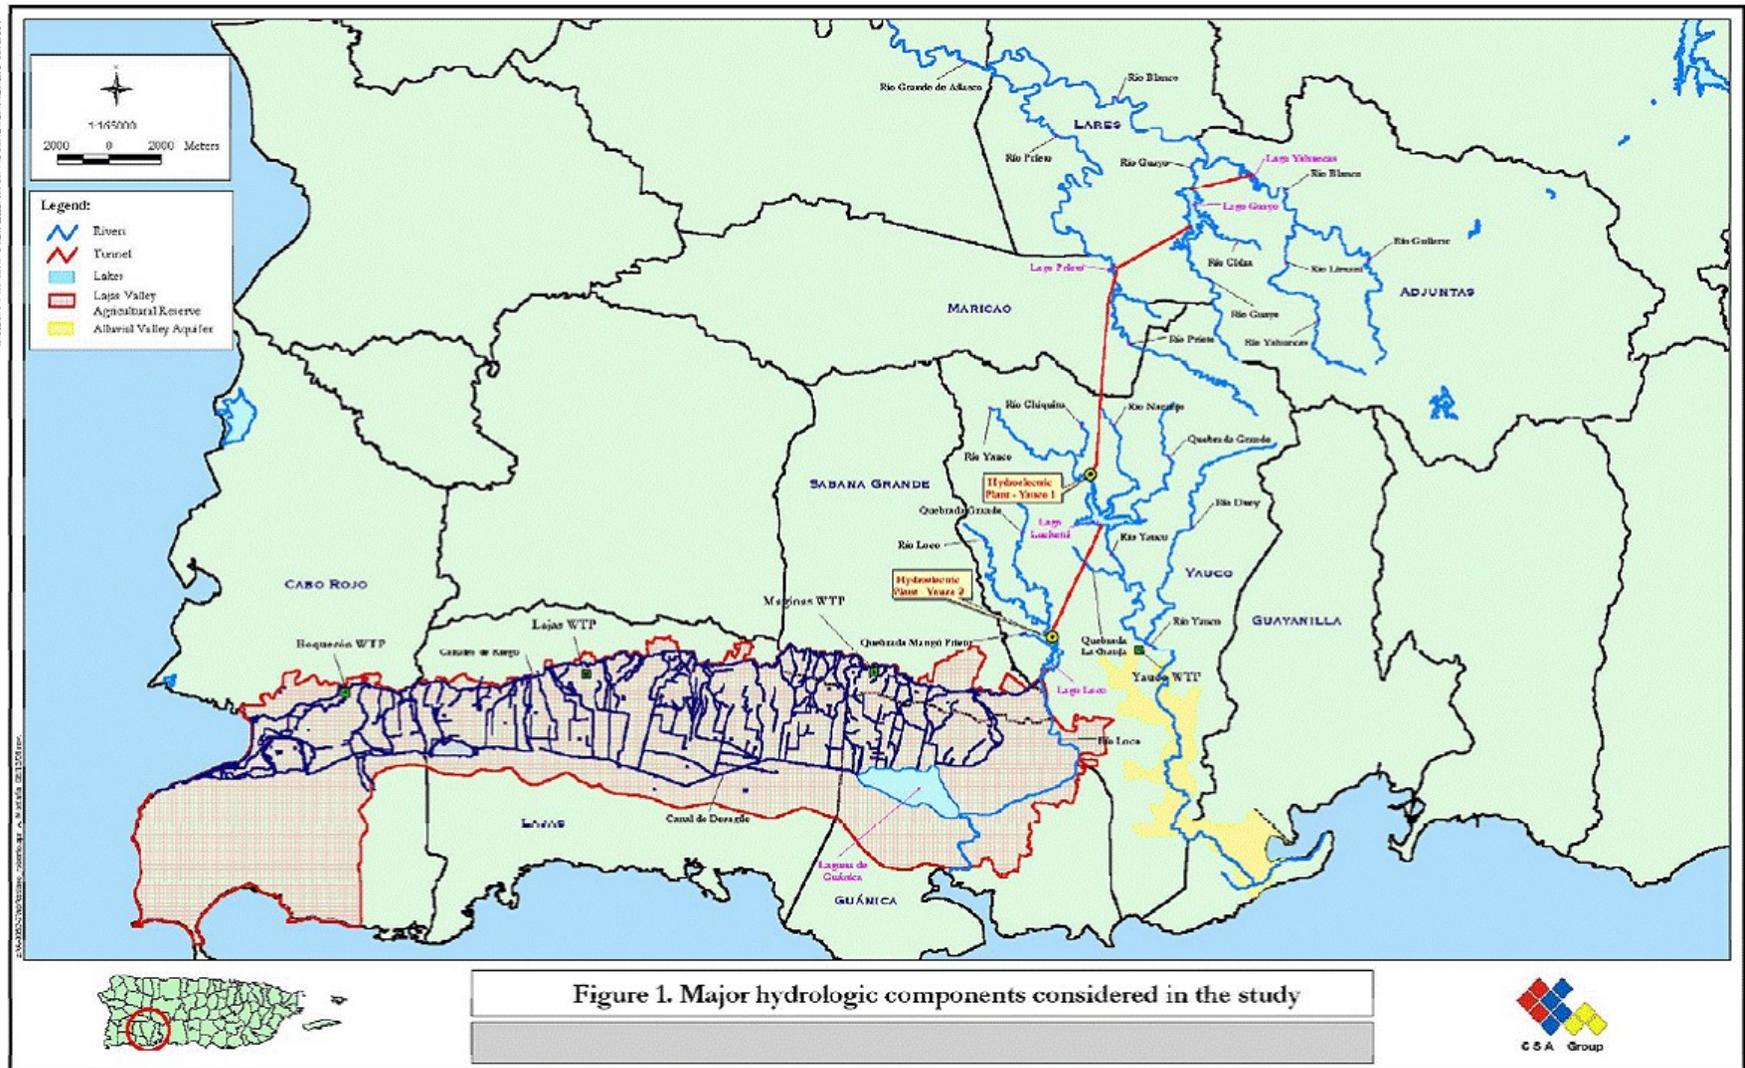
Figure 1. Major hydrologic components considered in the study

Figure 1: Shows the Guánica Bay watershed, which is drained to the north by the drainage basins of Lakes Yahuecas, Guayo, Prieto, Lucchetti, and Loco as a result of the Southwest Puerto Rico Project. To the south, the study area includes the drainage areas of Río Loco. Finally, the study area

**includes roughly half of the Lajas Valley, including historic Laguna de Guánica (Guánica Lagoon) and the Lajas Irrigation Canal within the Valle de Lajas (Lajas Valley) Agricultural Reserve. (Map from Ortiz-Zayas & Terrasa-Soler. 2001)**

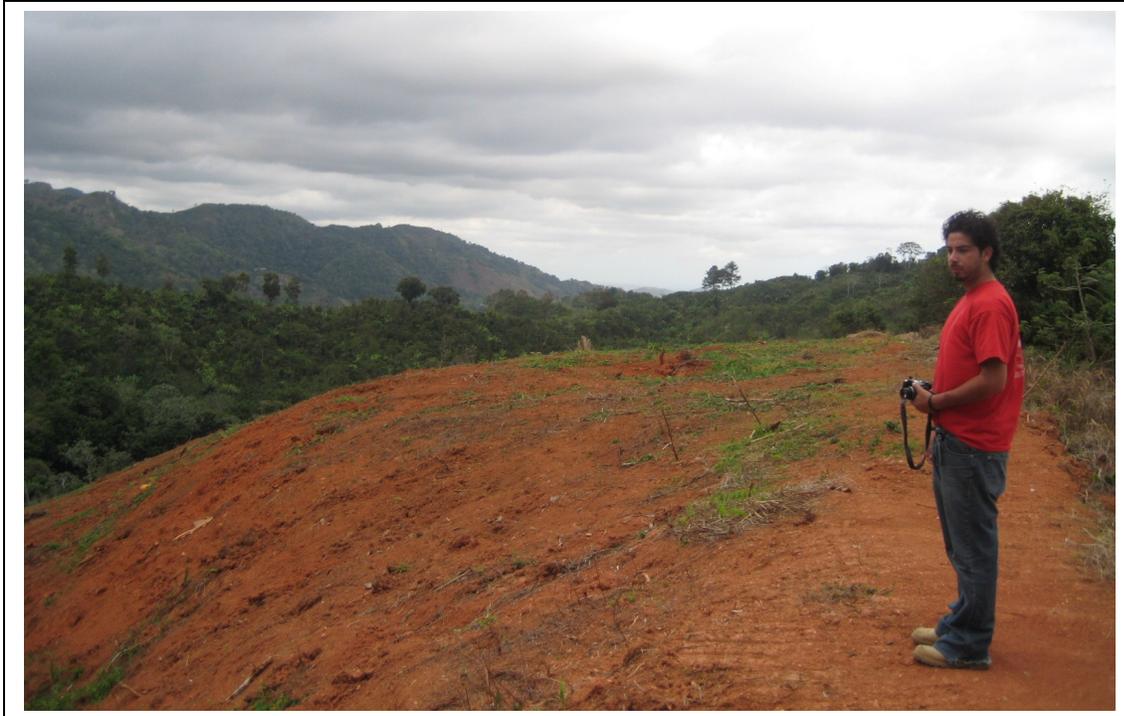
**Figure 2. Typical clearing associated with sun grown coffee plantations**

Field investigations in the high elevation agricultural areas near reservoir (“Lago”) Lucchetti and the Rio Loco watersheds revealed clearing for coffee and other agricultural crops, including bananas, with very little evidence of conservation practices. Mass clearing, poor soils (Humatas Clay) and runoff associated with roads has resulted in numerous areas with completely exposed soils with very limited natural re-vegetation due to the high clay content and low fertility of the soils. Promotion of sun grown coffee over historically grown shade grown coffee at the very least accelerates sediment transport during the crop establishment phase. There is an estimated 3.5 times more erosion associated with sun grown coffee than shade grown coffee over the first several years after establishment (Hartemink, 2006).

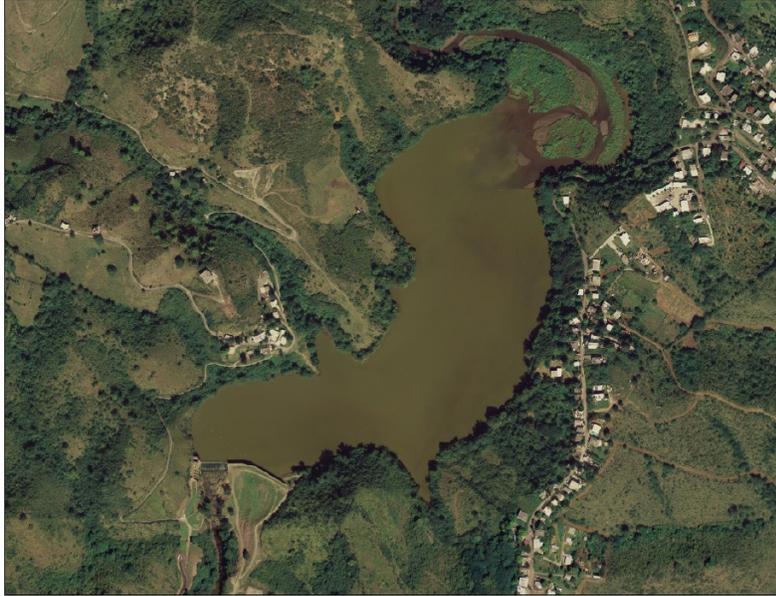
**Figure 3. Snapshot of sediment accumulation and flow through Loco Reservoir.**

A review of orthophotography with DRNA biologists at Guanica forest reserve clearly showed that sediment was passing through the Rio Loco Reservoir (Figure 3) through the watershed and into Guánica Bay. Even closer inspection revealed at least some of the sediment laden water was being discharged from the pump/flow house draining from Lucchetti Reservoir into Loco (Figure 4). The reddish clay colored water was clearly visible in the Rio Loco below the dam and extending down to the Guánica Bay and out to the near shore coral reefs.

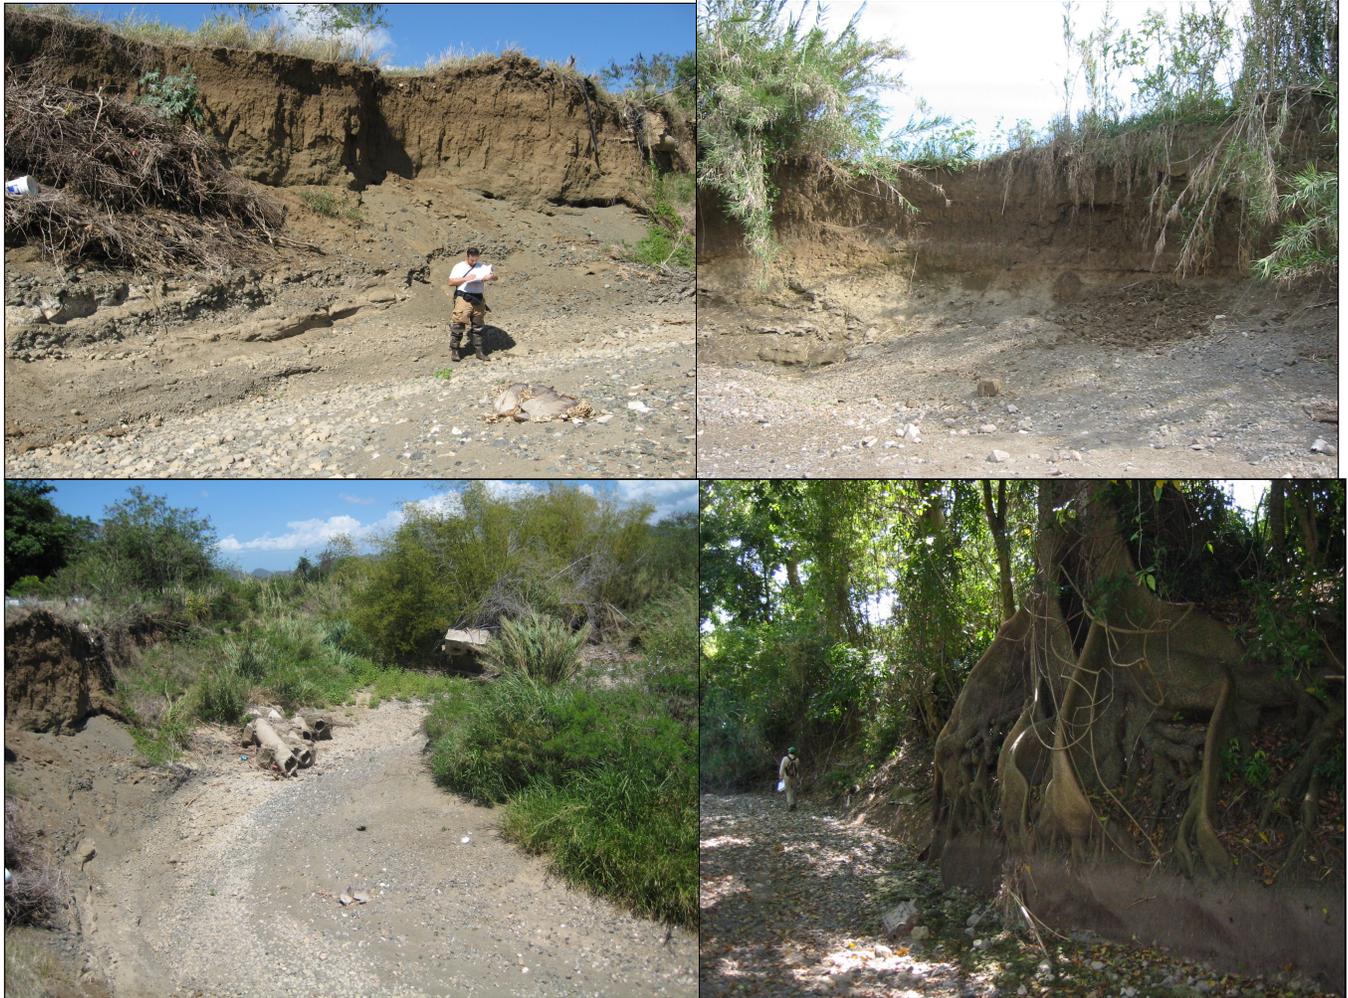
**Figure 5. Channel erosion in the Rio Loco due in part to old irrigation infrastructure, invasive species and the loss of Guánica Lagoon. The picture on the lower right shows the potential role of trees in this ecosystem to help to fortify streambanks and reduce erosion**

Channel erosion on the mainstem of Rio Loco was clearly another major issue in the watershed as documented in the stream channel assessments. Severe erosion was associated with areas that lacked mature riparian trees, particularly those areas that contained non-native species that seemed to exacerbate erosion as well as areas with historic irrigation infrastructure which created downstream scour (Figure 5). These low head dams, concrete footers, and other structures continue to act as strainers and constrictions in the channel causing debris to become lodged and changes in erosive forces to destabilize banks, increasing channel erosion, bed scour and sediment transport. Both Warne et. al. (2004) and Clark and Wilcox (2000) noted the continued importance of transport of historically deposited valley sediments and its likely impact on coral reef systems.

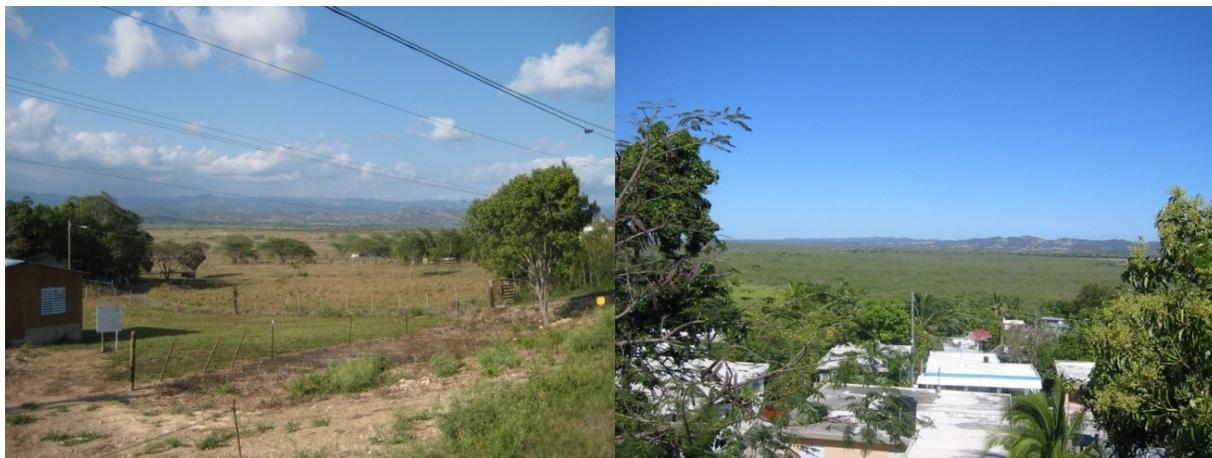
Figure 8. Section of the Lajas valley (left); Historic Guánica lagoon in the distance (right).

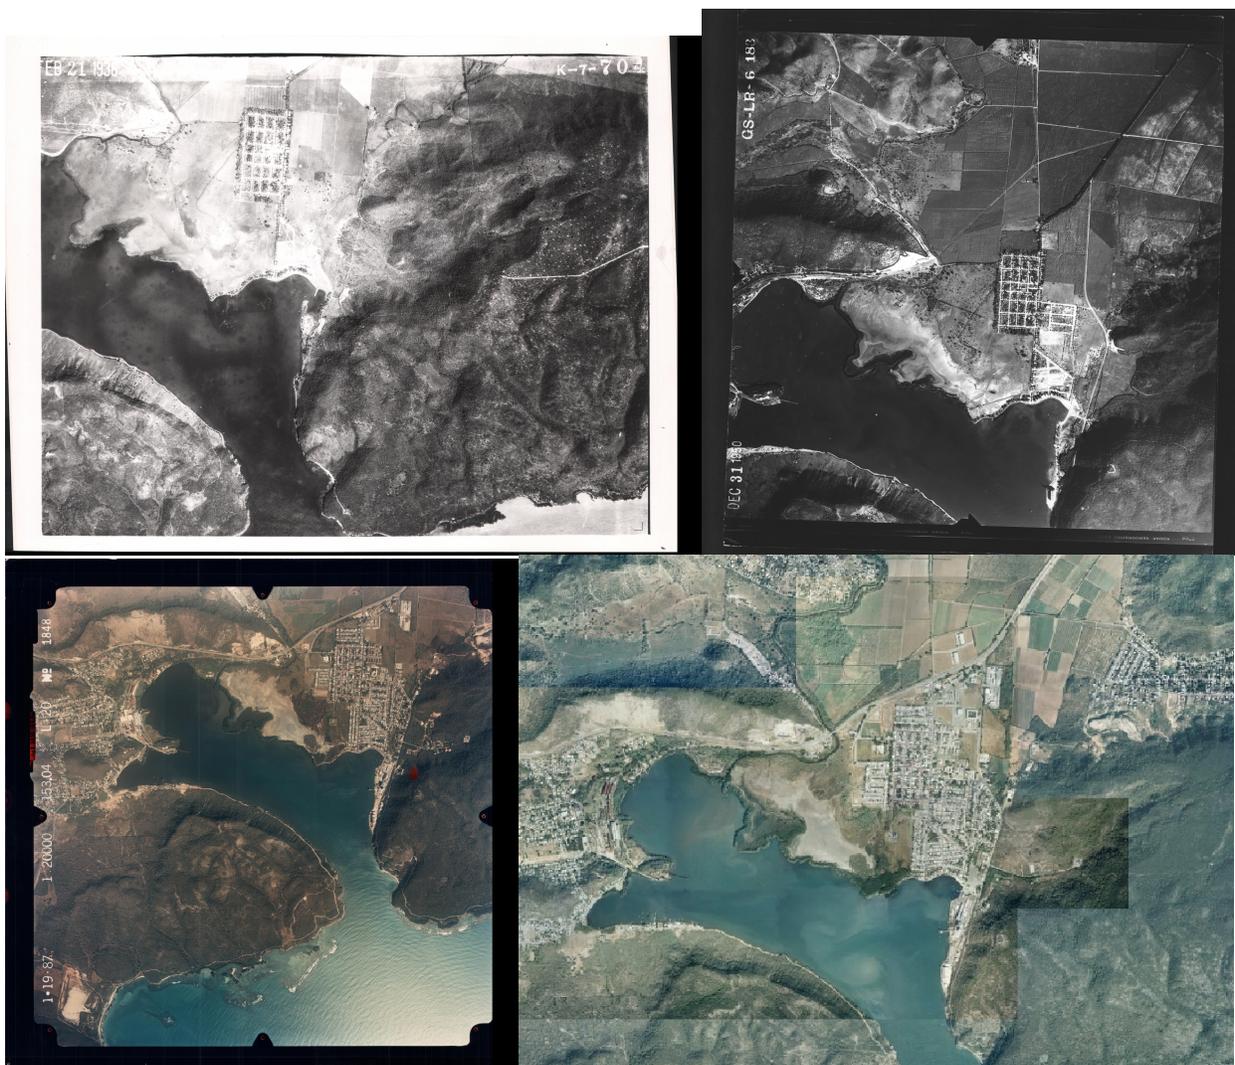
**Figure 9: Aerial photographs of Guánica Bay and the near shore area taken in 1936 (top left), in 1950 (top right) in 1987 (bottom left) and again in 1996 (bottom right). Notice the significant increase in urbanization along northeastern shore nearer to mouth of the Bay sometime after 1950.**

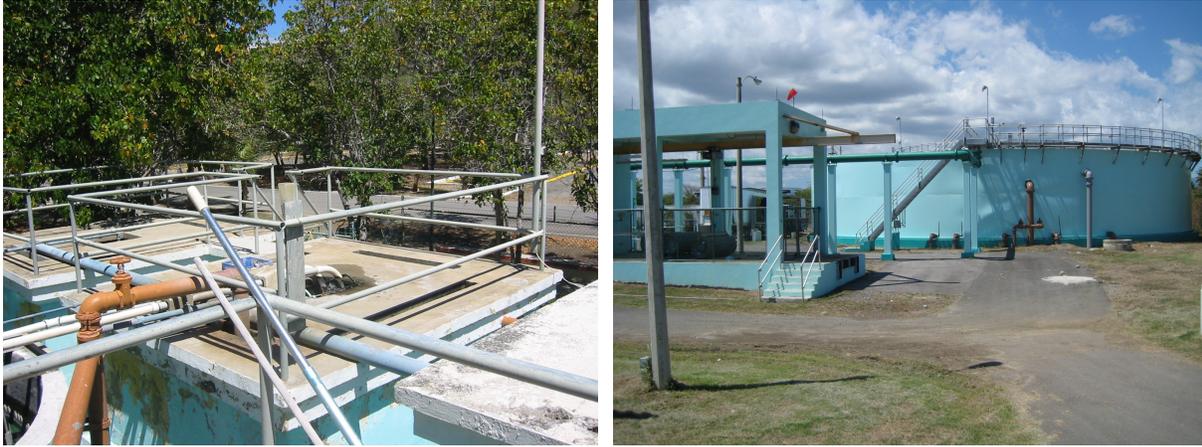
**Figure 10. Small 3000 gpd sewage treatment plant at Cana Gorda Beach (left), one750,000 gallon treatment tank within Guánica waste water treatment plant.**

Two treatment plants (shown in Figure 10) are located in tidal areas in the watershed. A summary of their capacity and return flow are located in Table 4. Guánica Sewage Treatment Plant (STP) which currently receives 460,000 gallons per day from Guánica proper and but is capable of accepting 750,000 gallons per day for secondary treatment (Guanica STP operators personal communication, 2007). This same treatment plant has been recently upgraded with three additional treatment tanks with a total additional capacity of 2 million gallon per day of secondary-advanced treatment as part of additional proposed development in Guánica. The second much smaller treatment plant is located at Cana Gorda Beach and handles about 3000 gallons per day but has a treatment regime dictated by use of the public beach and associated facilities which is of course seasonal.
