Coastal Dune and Erosion Assessment of the North Coast of Puerto Rico

Final Report

**DOI-FEMA Natural and Cultural Resources
Recovery Support Function (NCR RSF)**

**Universidad de Puerto Rico en Aguadilla
Vida Marina: Centro de Conservación y Restauración Ecológica Costera**

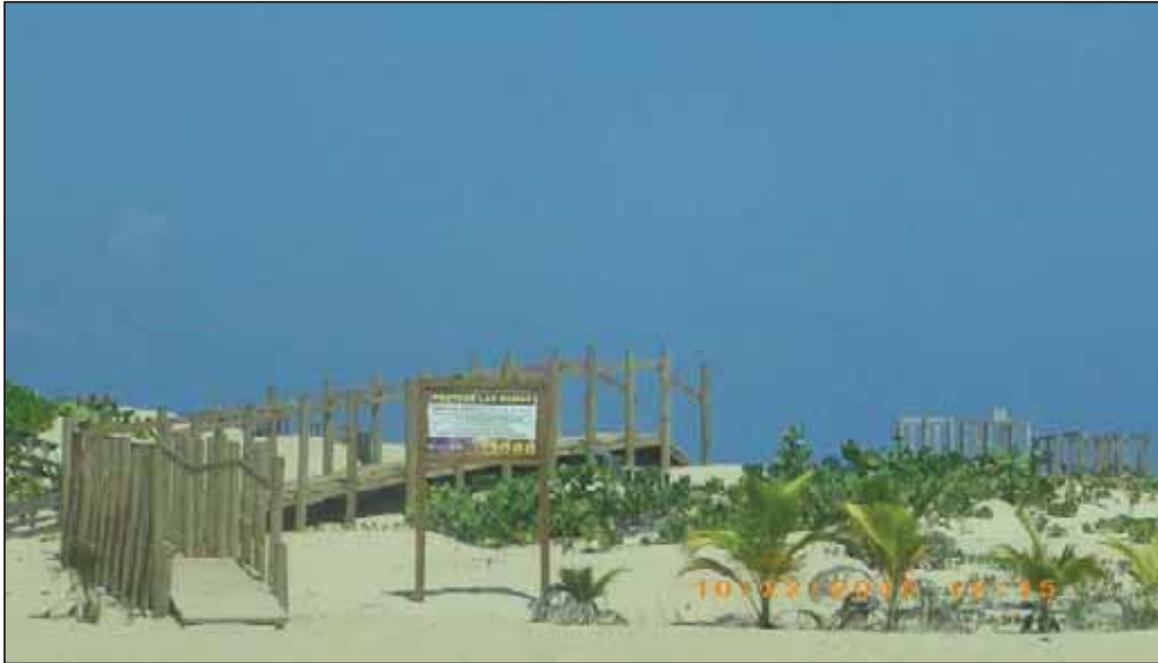
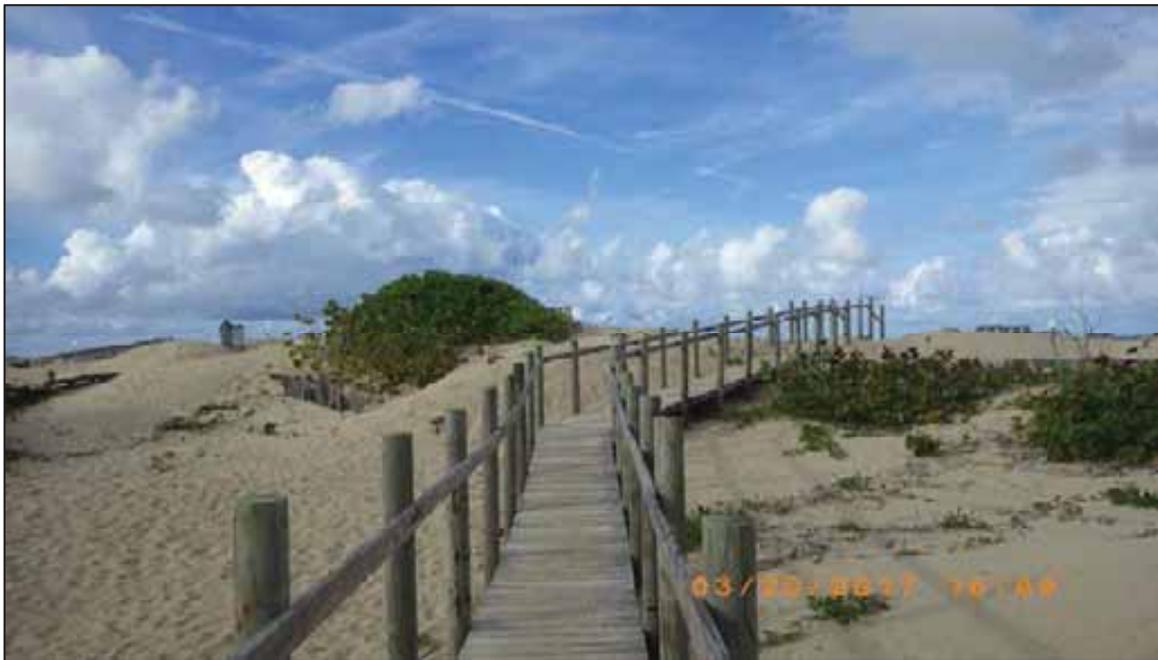
Figure 1. Wooden boardwalk in ecological restoration site on the Teodoro Beach in Isabela, Puerto Rico.

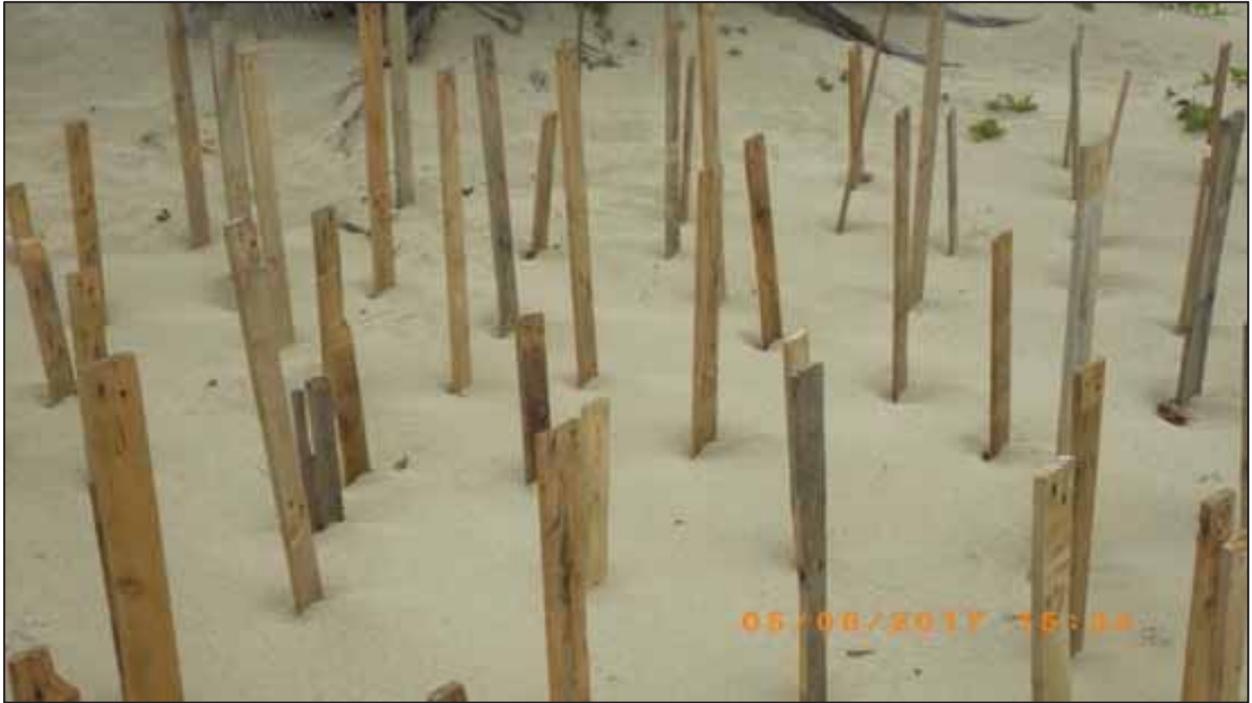
Figure 2. Biomimicry matrix in Teodoro Beach in Isabela.

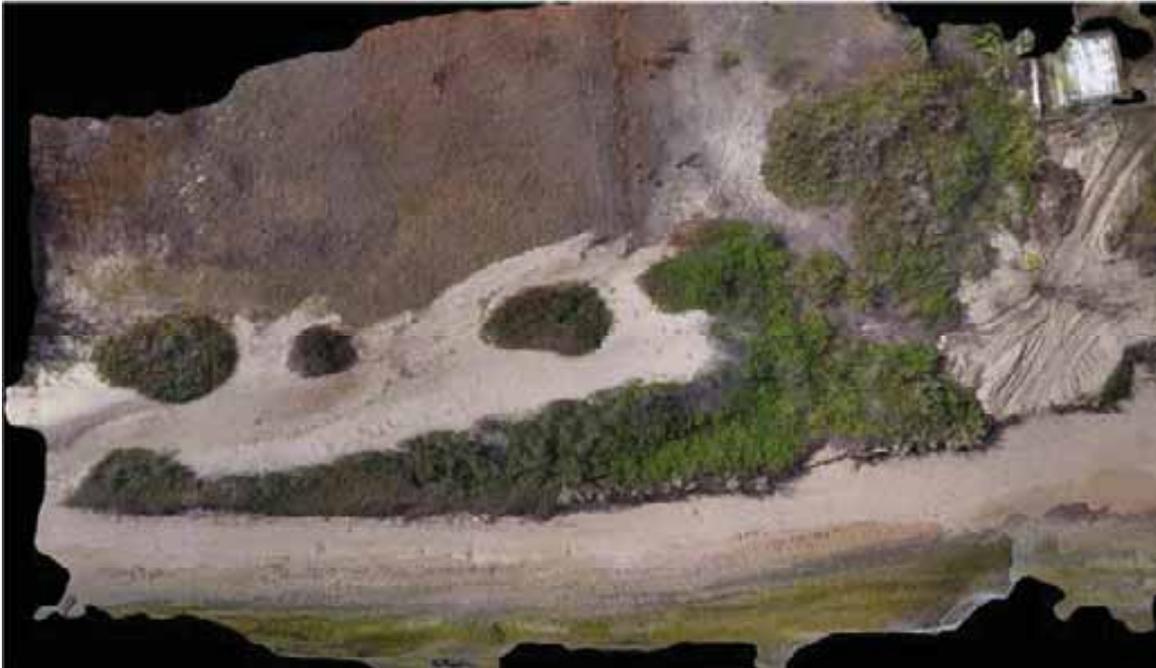
Figure 4. Aerial 3D image of the area to the east of the end of Pedro Albizu Street in Barrio Bajuras, Isabela.

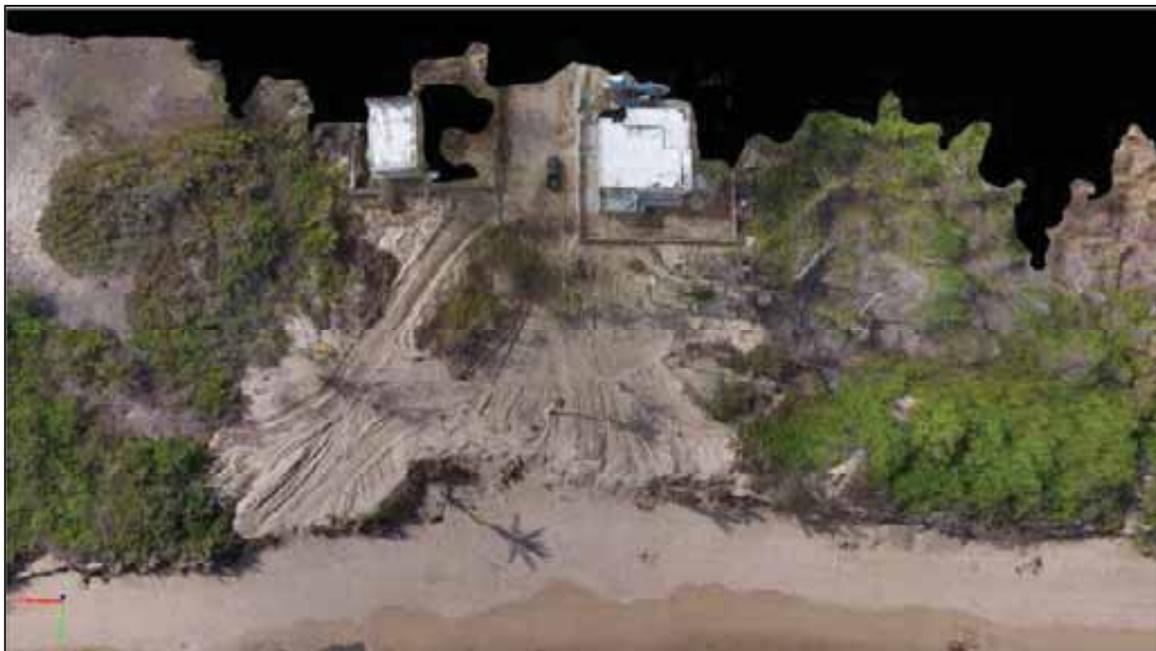
Figure 5. Aerial 3D image at the end of Pedro Albizu Street in Barrio Bajuras, Isabela. Note the heavy equipment tracks on the sand.

A program for the **relocation of displaced sand** needs to be created and put in effect as soon as possible in order to reduce the amount of sand lost from the beach during extreme weather events.

An effective **law enforcement plan** needs to be created in order to prevent the illegal extraction of sand from this area. It is very important to create a plan that is not predictable since most of the people that extract sand illegally do so during a time when no DNER law enforcement officers are patrolling the areas.

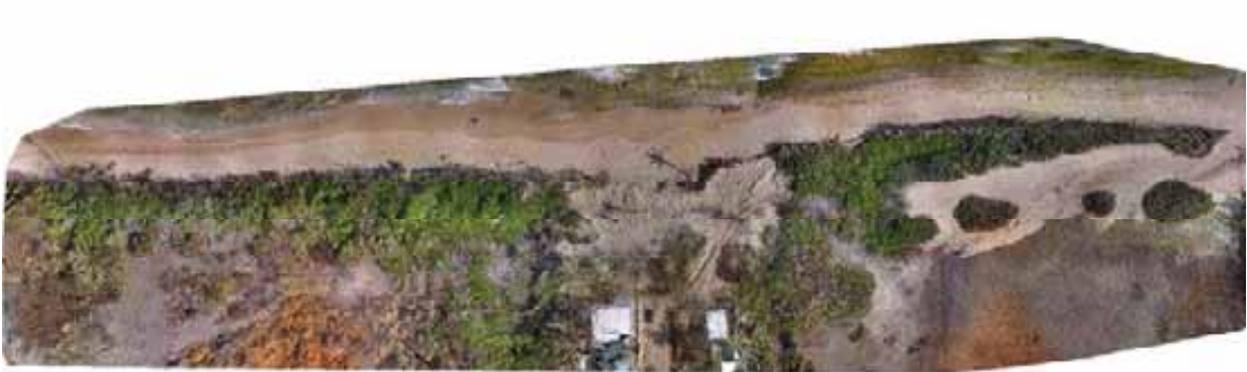
Figure 7. Orthomosaic image of the end of Pedro Albizu Campos St. in Barrio Bajuras in Isabela.

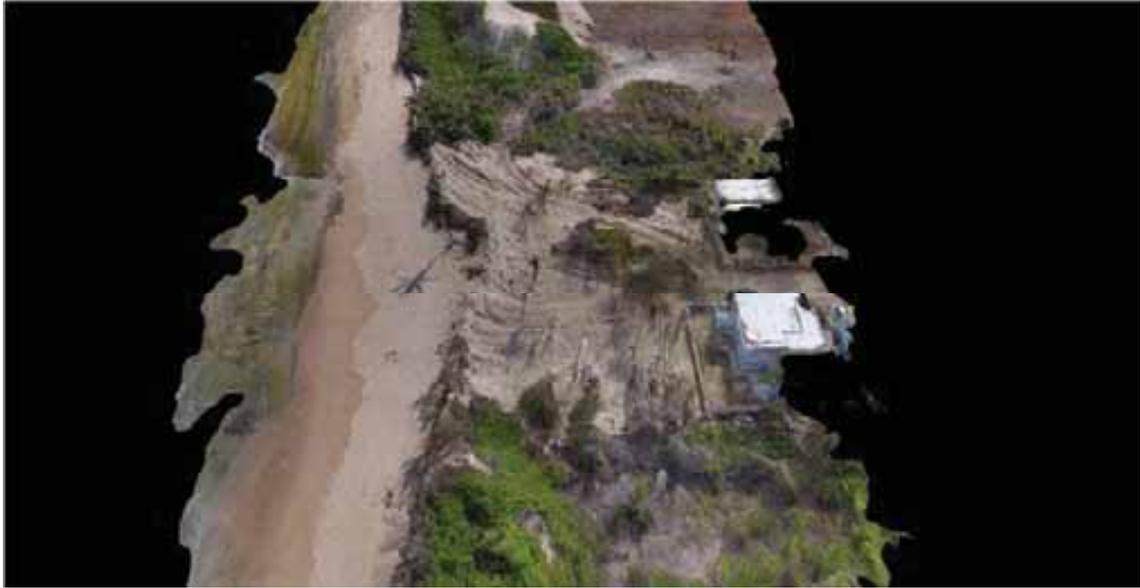
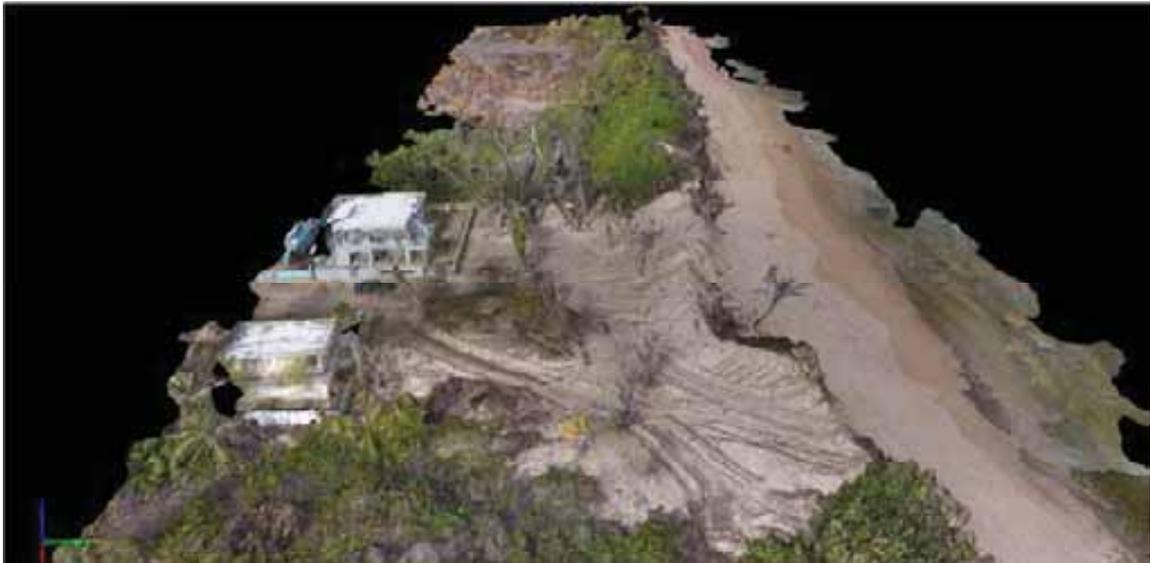
Figure 13. Three dimensional RGB images of the end of Pedro Albizu Campos St. in Barrio Bajuras, Isabela. View from the west (top) and from the east (bottom). Note the tracks of heavy equipment that was used to relocate sand that was displaced during the 2017 hurricane season and the strong northeasterly event of March of 2018.

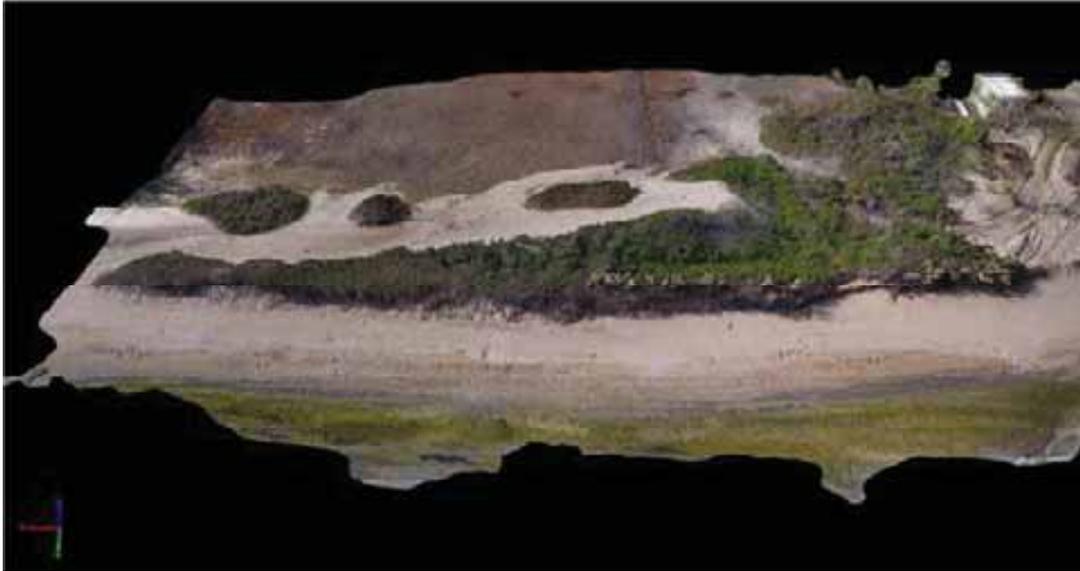
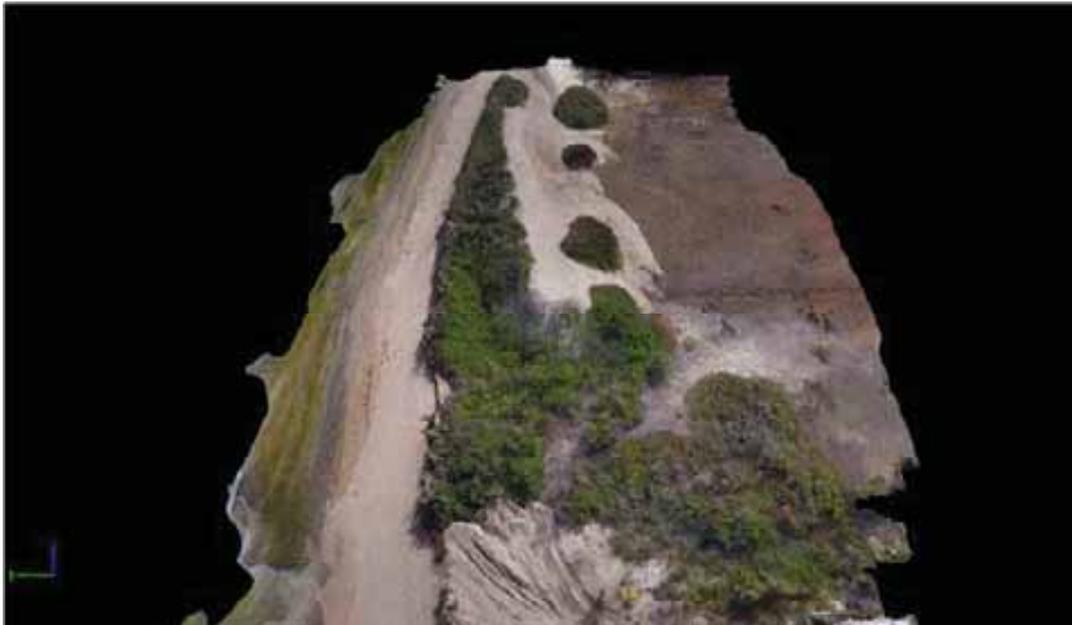
Figure 14. Three dimensional RGB images of the dune to the east of the end of Pedro Albizu Campos St. in Barrio Bajuras, Isabela. View from the north (top) and from the west (bottom).

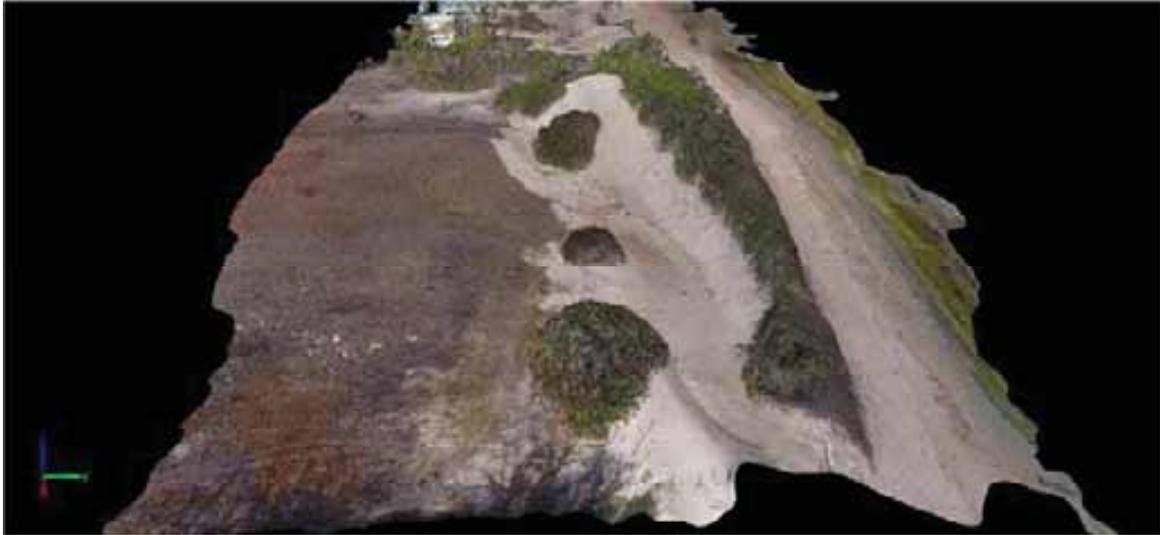
Figure 15. Three dimensional RGB images of the dune to the east of the end of Pedro Albizu Campos St. in Barrio Bajuras, Isabela.

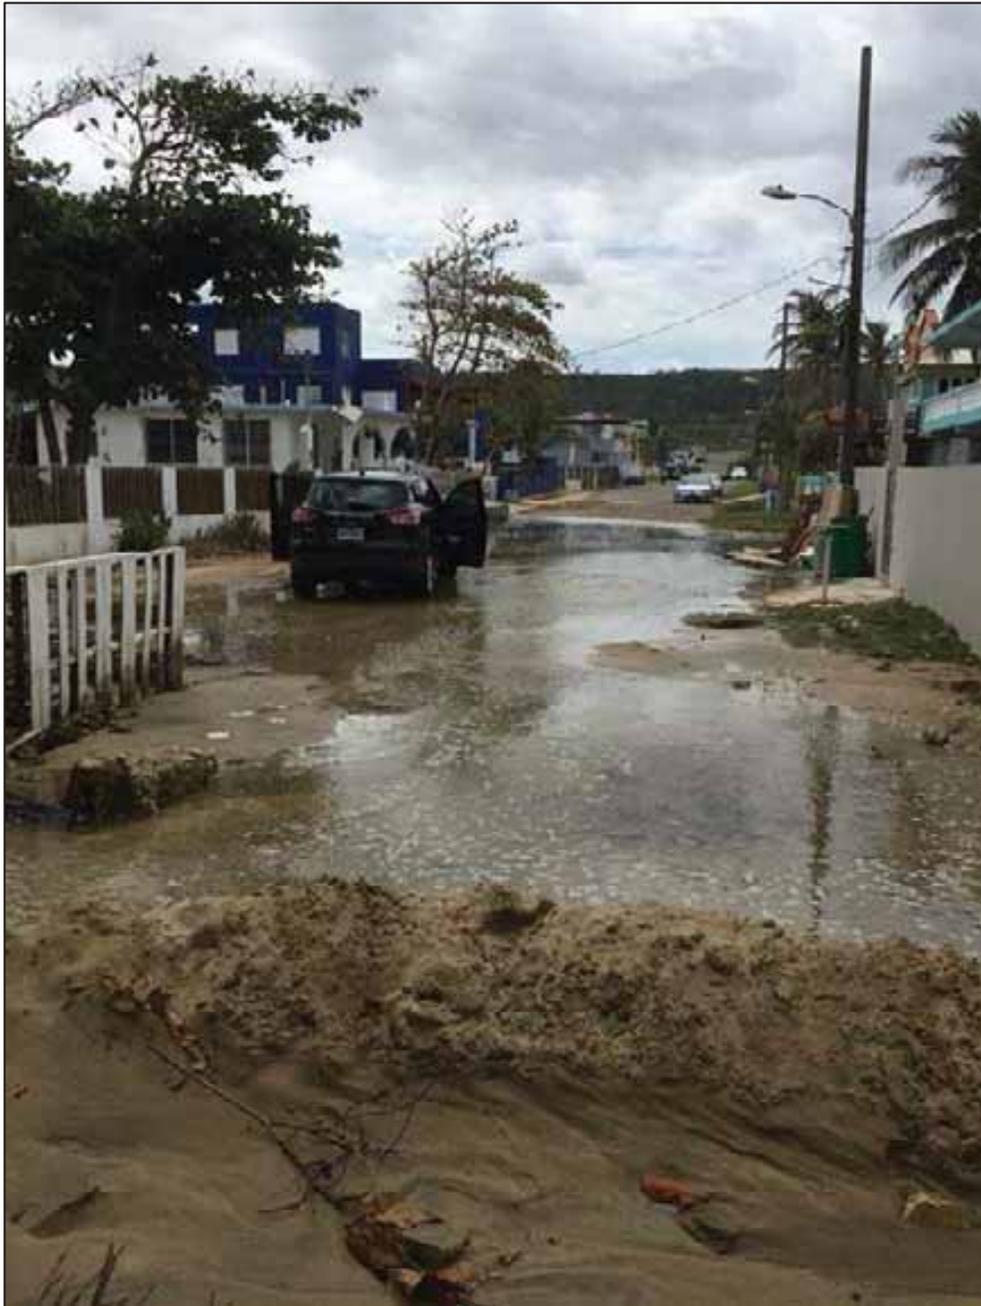
Figure 19. Accumulation of sand and sea water displaced by hurricane María at the end of Pedro Albizu Campos Street. The picture was taken on September 21, 2018.

The main conservation threats of this area are **foot and vehicular traffic**. The area of dunes at the end of the street did not resist the effects of the strong waves during the 2017 hurricane season and the northeasterly swell of March of 2018 while adjacent areas on the same dune did resist. This portion of the dune was breached and a wash-over fan was created probably because of the lack of vegetation caused by the heavy foot traffic of people walking from the end of the street to the road. There is not wooden boardwalk in this area and foot traffic is heavy especially during weekends and holidays.

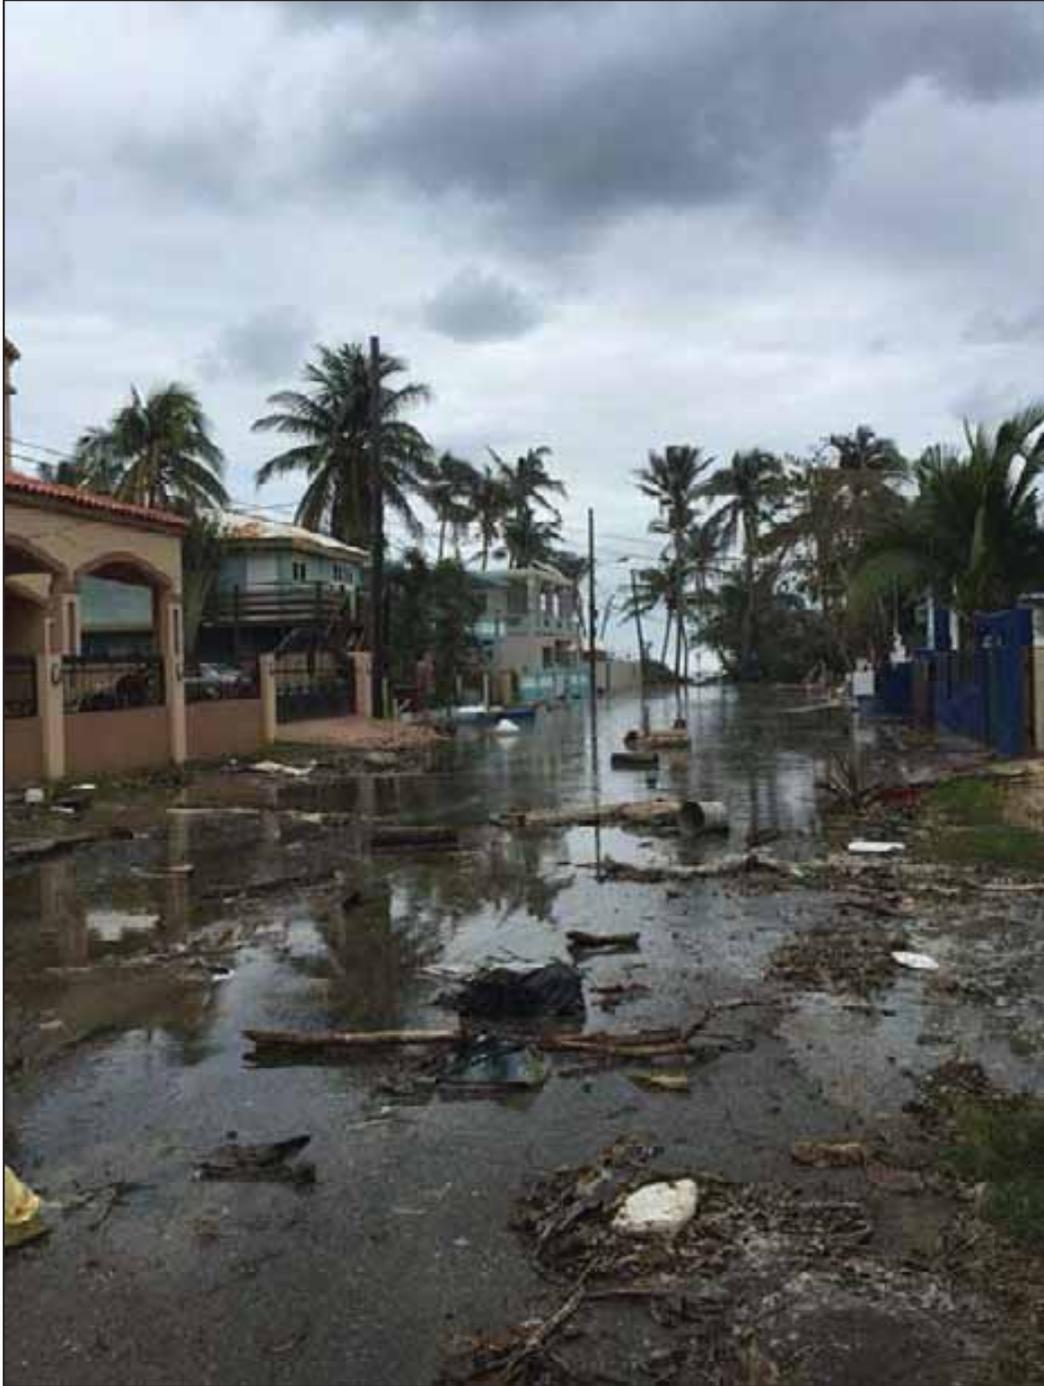
Figure 20. Accumulation of sand and sea water displaced by hurricane María at the end of Pedro Albizu Campos Street. The picture was taken on September 21, 2018.

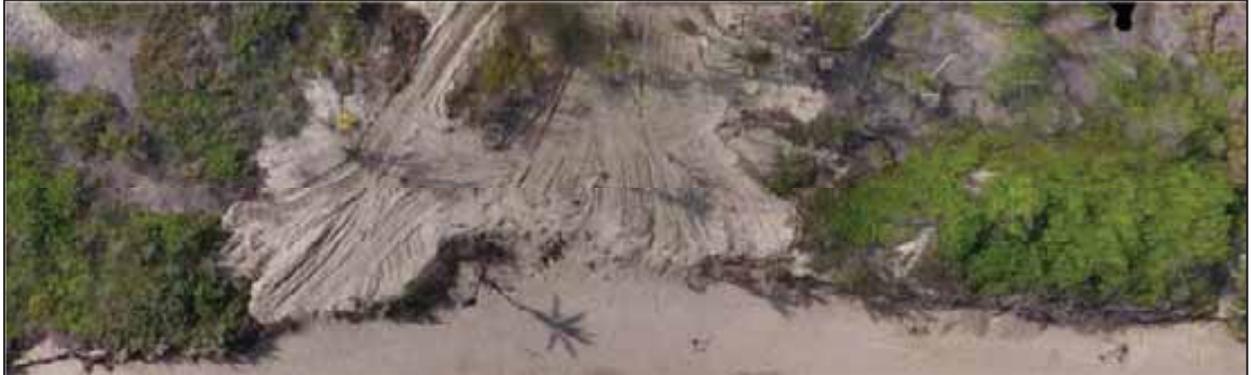
Figure 21. Area of dunes at the end of Pedro Albizu Campos Street where the ecological restoration of this location will take place.

Vegetation covers 35.6% of the area at the end of Pedro Albizu Campos Street in Barrio Bajuras, Isabela on March 14, 2018. This area will be assessed every month after the ecological restoration activities have been started. This will allow us to monitor the progress of the re-vegetation efforts in this area.

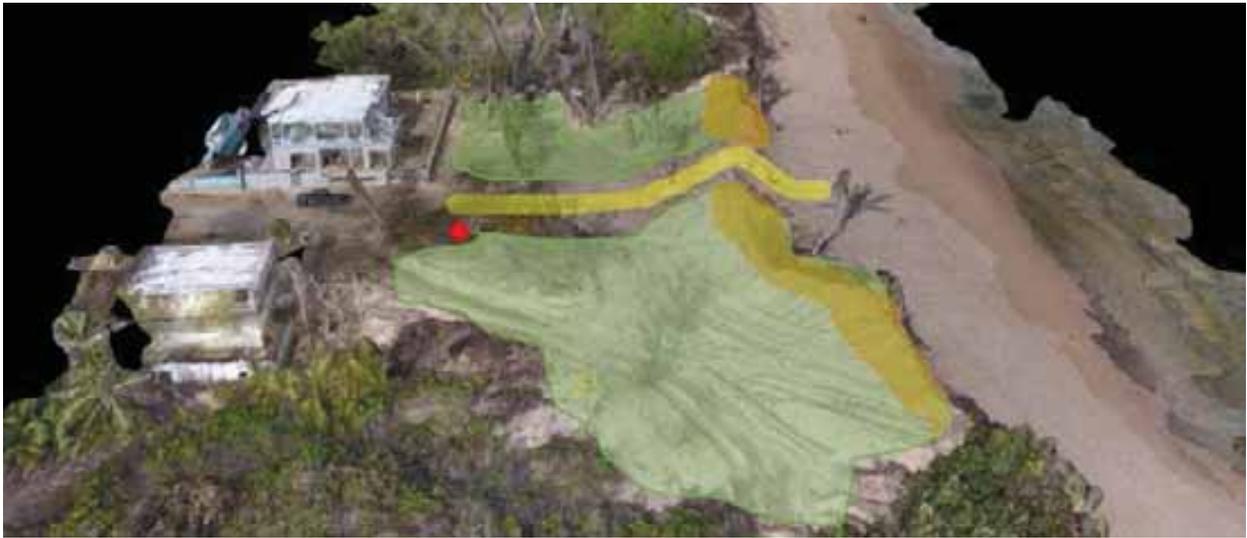
Figure 23. Area to be ecologically restored at the end of Pedro Albizu Campos St. in Barrio Bajuras, Isabela. Highlighted areas correspond to each technique that will be used in this area. Yellow represents the location of a wooden boardwalk, the red dot marks the location of an information sign, tan represents the area of the dune crest that where biomimicry matrices will be installed to promote the accumulation of sand. The areas shaded in light green represent locations for the planting of vegetation.

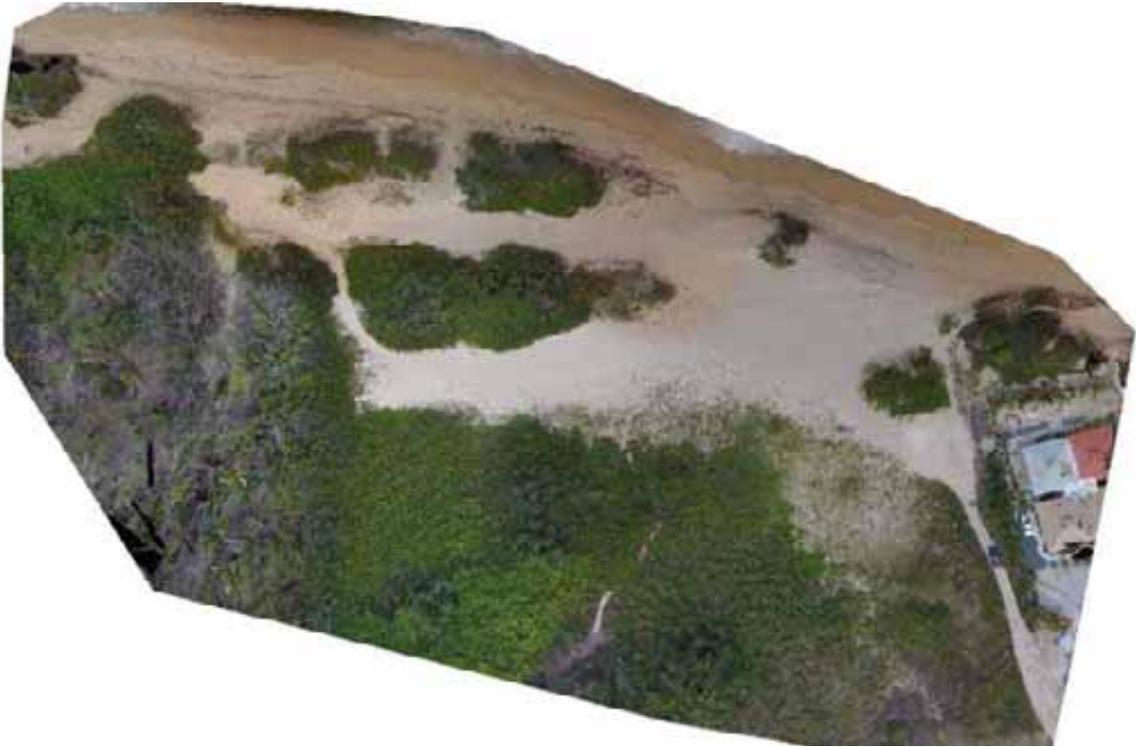
Figure 23. Aerial 3D image of the area at the end of Calle Monte de Oca, Barrio Bajuras, Isabela Puerto Rico

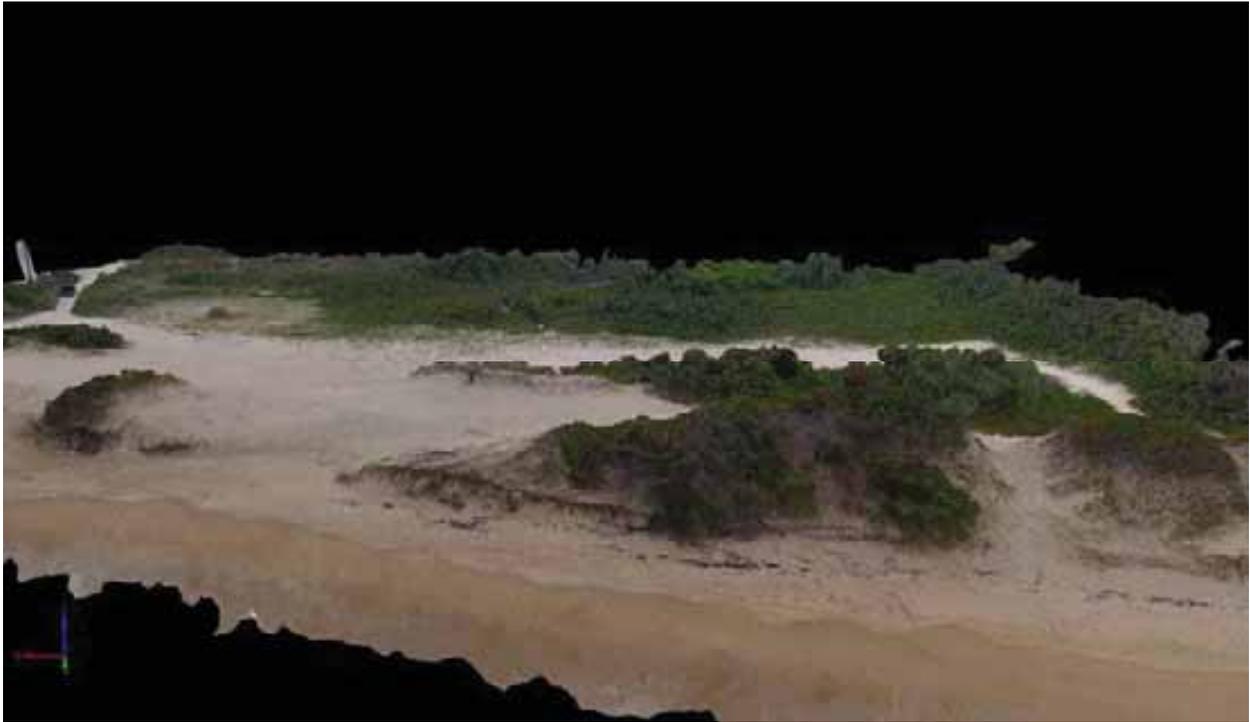
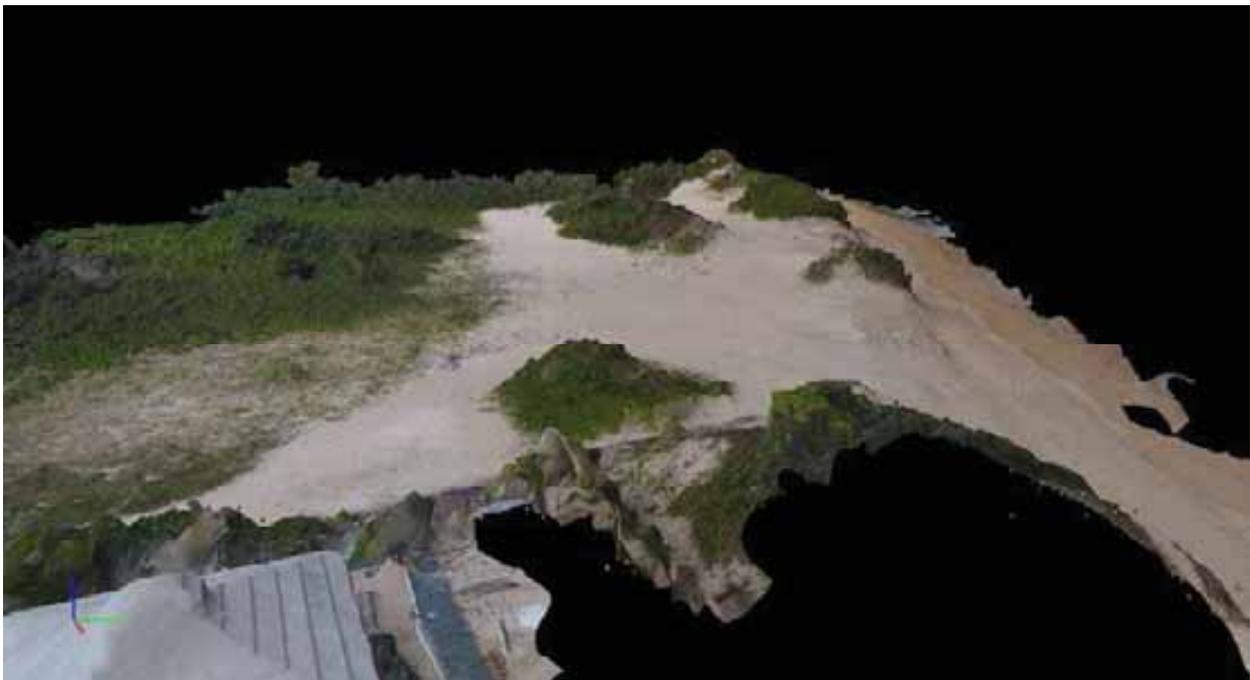
Figure 28. Three dimensional RGB images of the dune located at the end of Calle Monte de Oca, Barrio Bajuras, Isabela. The top image is a view from the north and the bottom is a view from the east.

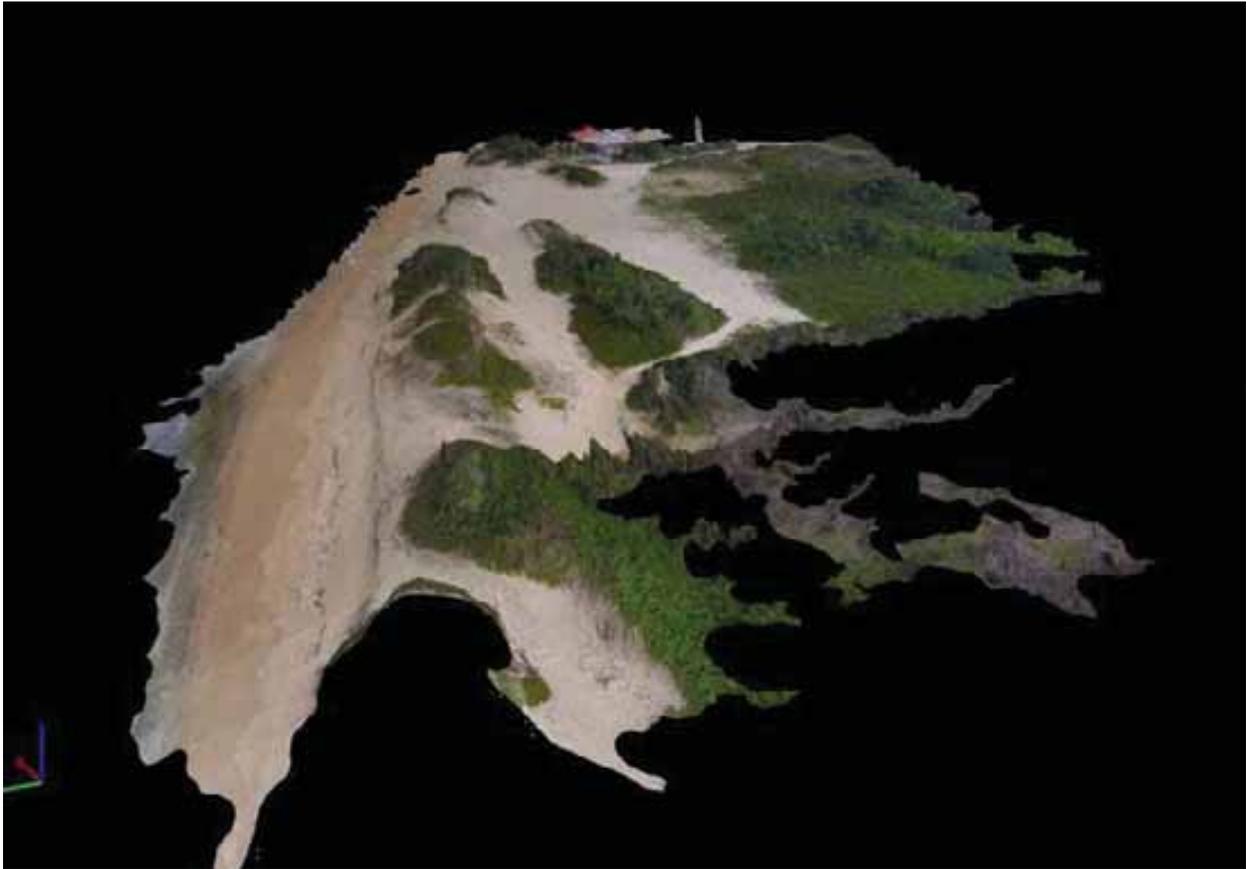
Figure 29. Three dimensional RGB image of a view from the west of the dune located at the end of Calle Monte de Oca, Barrio Bajuras, Isabela.

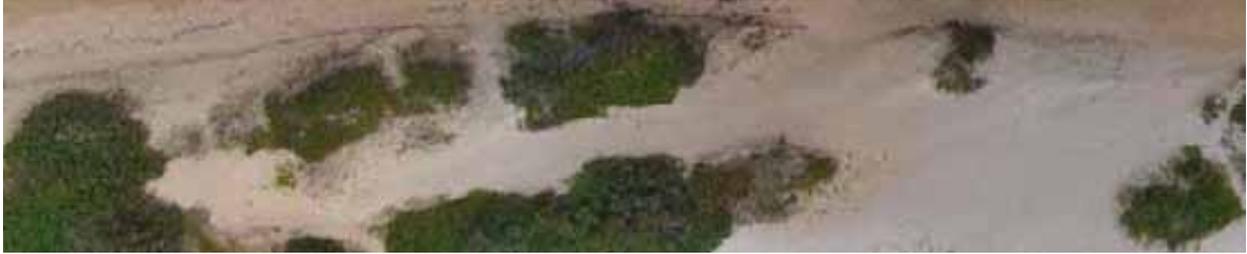
Figure 31. Area in which the percent vegetation cover is being calculated in Calle Monte de Oca, Barrio Bajuras, Isabela, Puerto Rico. The vegetation cover in this area was calculated to be 31.1% on January 22, 2018.

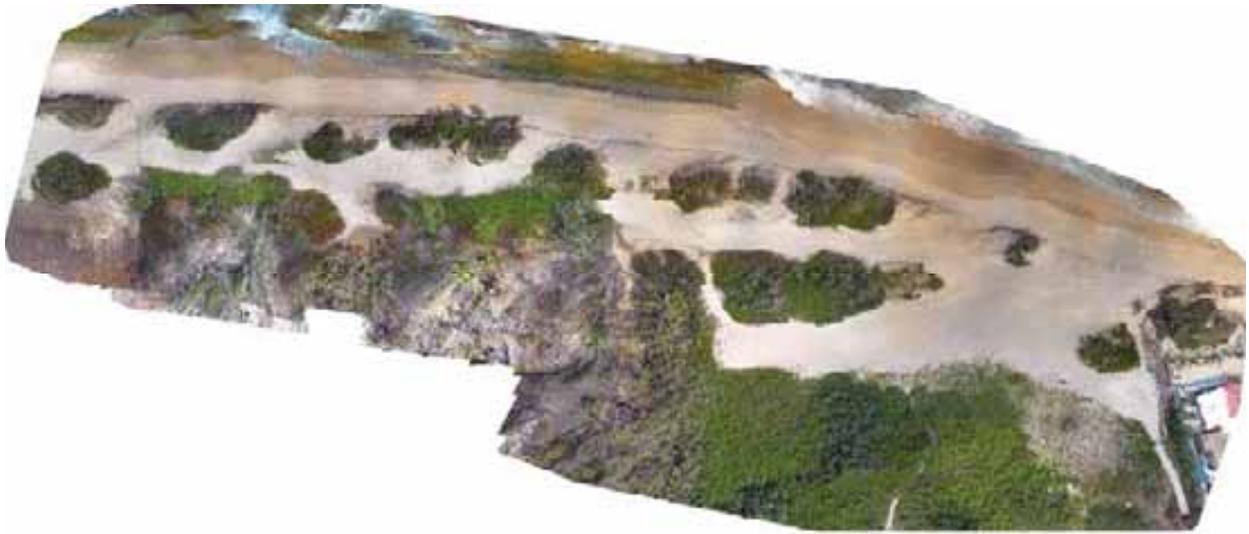
Figure 34. Orthomosaic image of the end of Calle Monte de Oca, Barrio Bajuras, Isabela Puerto Rico

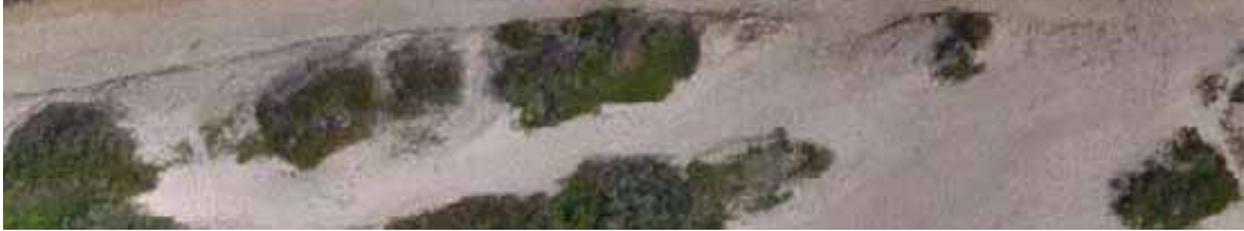
Figure 42. Area for which percent vegetation cover is being monitored in Calle Monte de Oca, Barrio Bajuras, Isabela, Puerto Rico after northeasterly event in March 14, 2018. The vegetation cover in this area was calculated to be 29.3%.

The restoration techniques we recommend for this area consist of the installation of a boardwalk adjacent to the guest house on the eastern part of the site. We also recommend the installation of wooden exclusion fencing and biomimicry matrices to promote the accumulation of sand and areas of planting dune vegetation (see figure below).

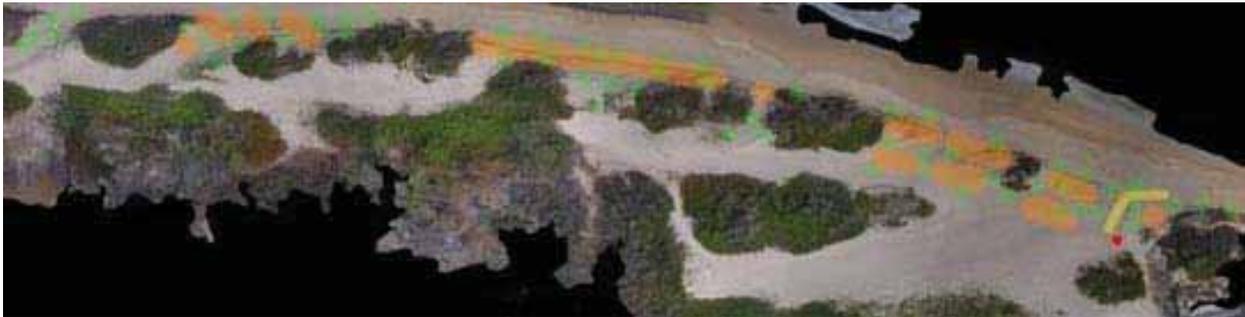
Figure 44. Area to be ecologically restored at the end of Calle Monte de Oca, Barrio Bajuras, Isabela. Highlighted areas correspond to each technique that will be used in this area. Yellow represents the location of a wooden boardwalk, the red dot marks the location of a information sign, tan represents the area of the dune crest that where biomimicry matrices will be installed to promote the accumulation of sand. The areas shaded in light green represent locations for the planting of vegetation.

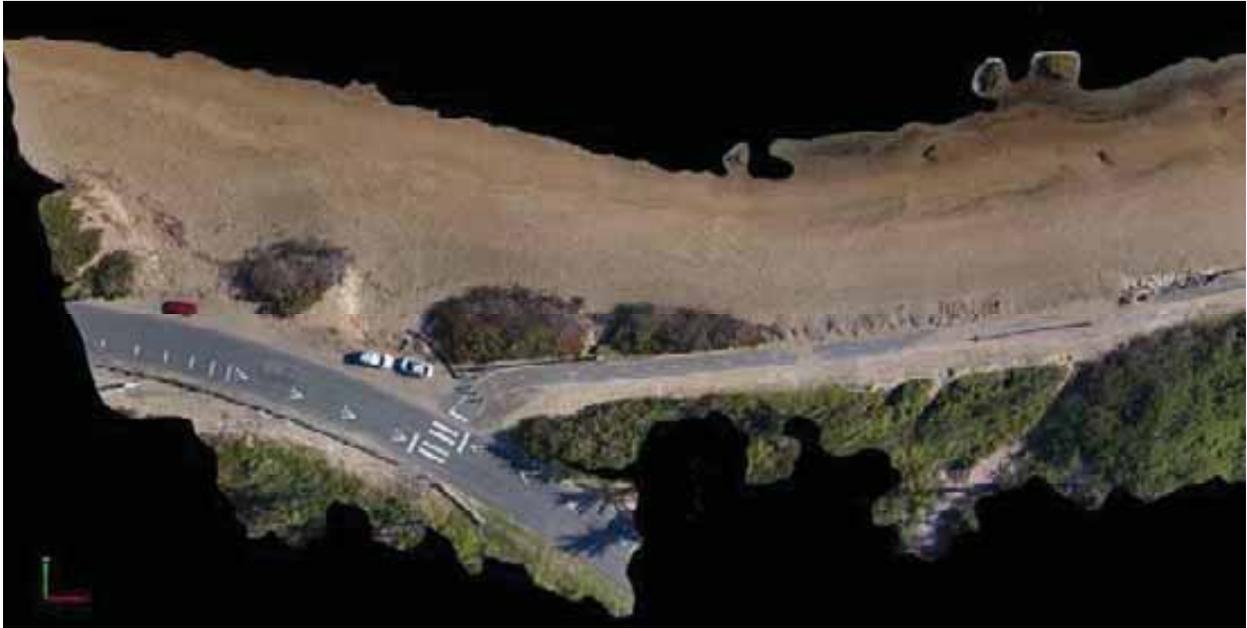
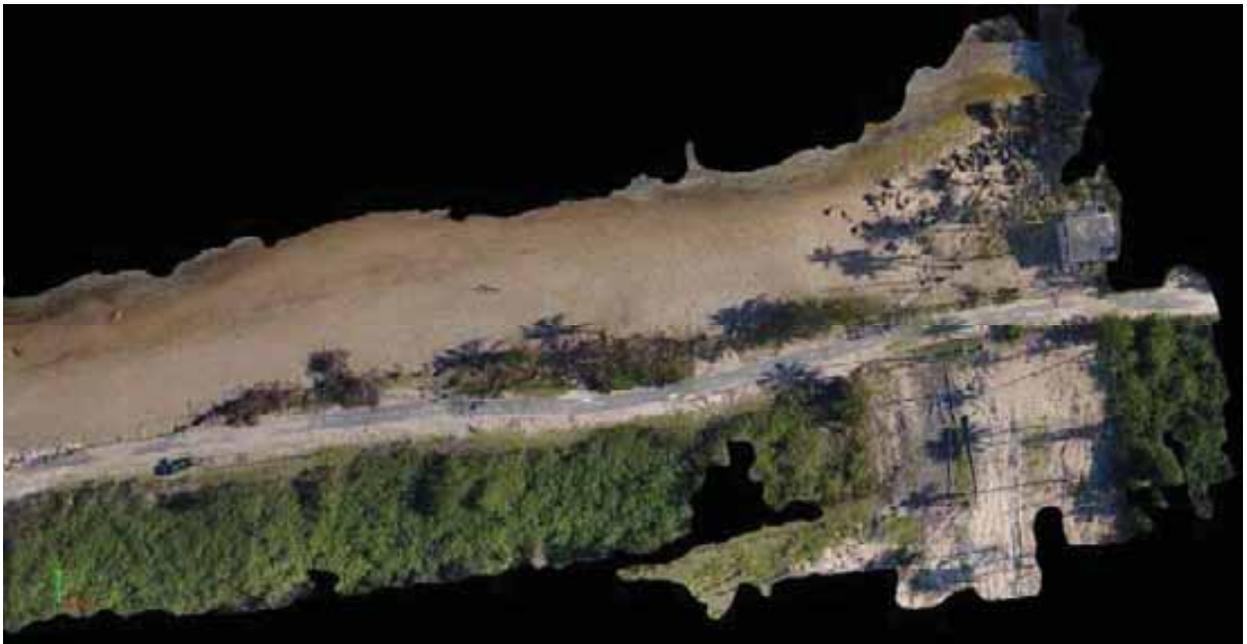
Figure 46. Aerial 3D image of Golondrinas Beach, Isabela (after the March, 2017 north-easterly swell).

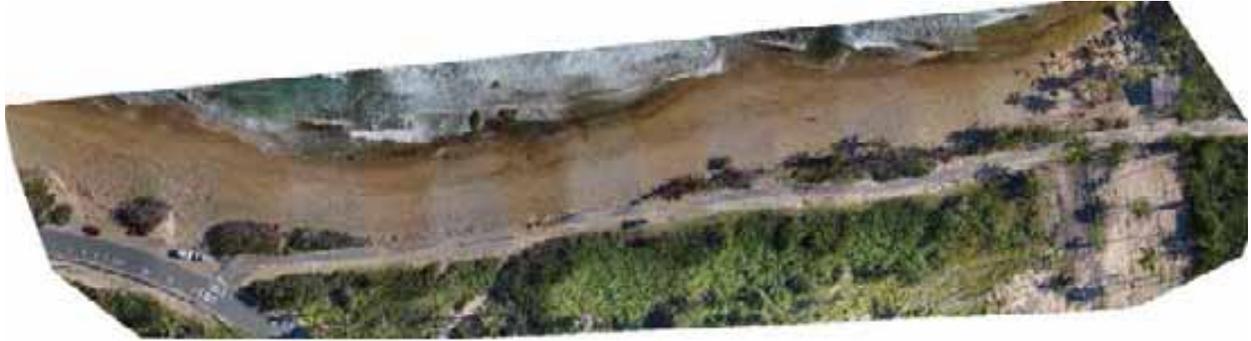
Figure 47. Orthomosaic aerial image of Golondrinas Beach, Isabela (after the March, 2017 north-easterly swell), Isabela.

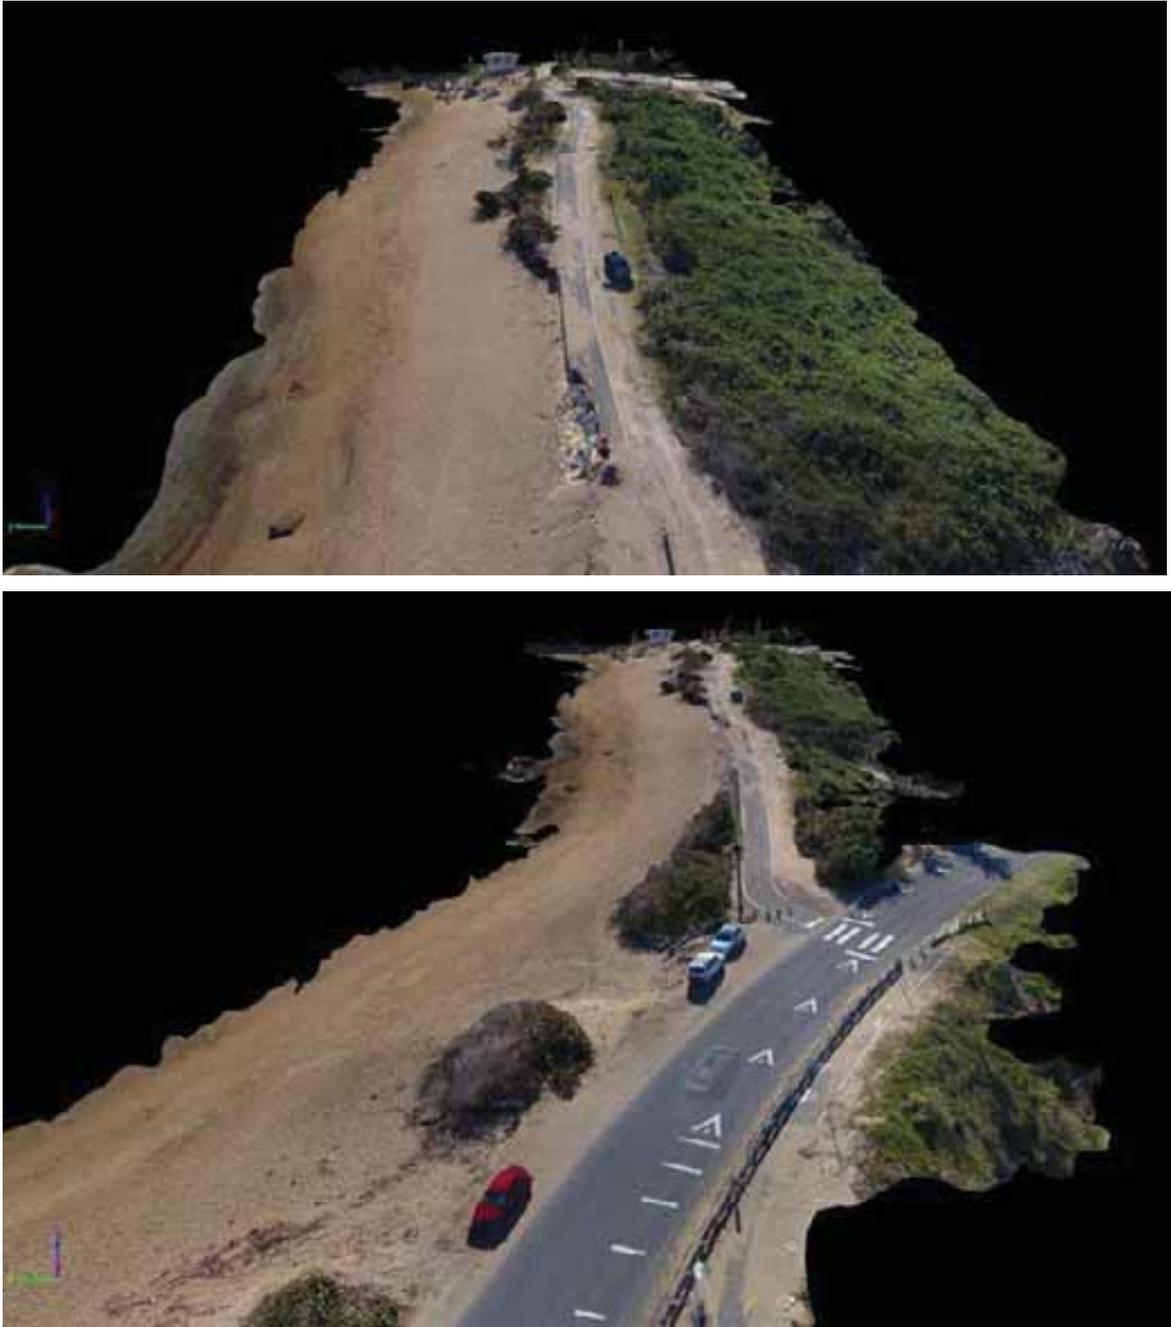
Figure 50. Aerial 3D image of Golondrinas Beach, Isabela viewed from the west (after the March, 2017 north-easterly swell).
