Coastal Dune and Erosion Assessment of the North Coast of Puerto Rico

Final Report

**DOI-FEMA Natural and Cultural Resources
Recovery Support Function (NCR RSF)**

**Universidad de Puerto Rico en Aguadilla
Vida Marina: Centro de Conservación y Restauración Ecológica Costera**

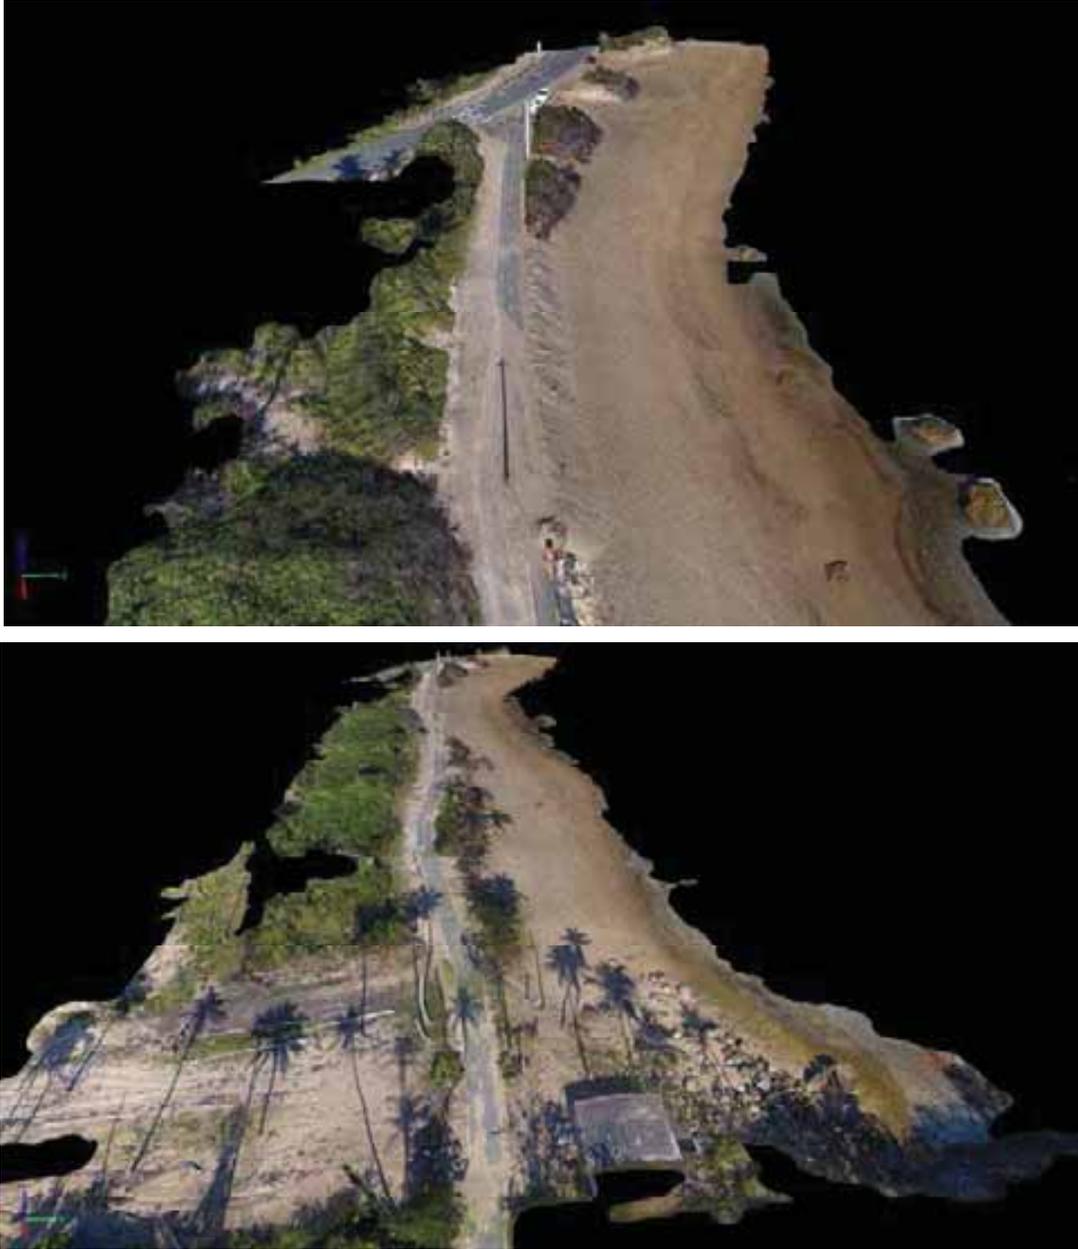
Figure 51. Three dimensional RGB images of Golondrinas beach (after the March, 2017 north-easterly swell), Isabela viewed from the east.

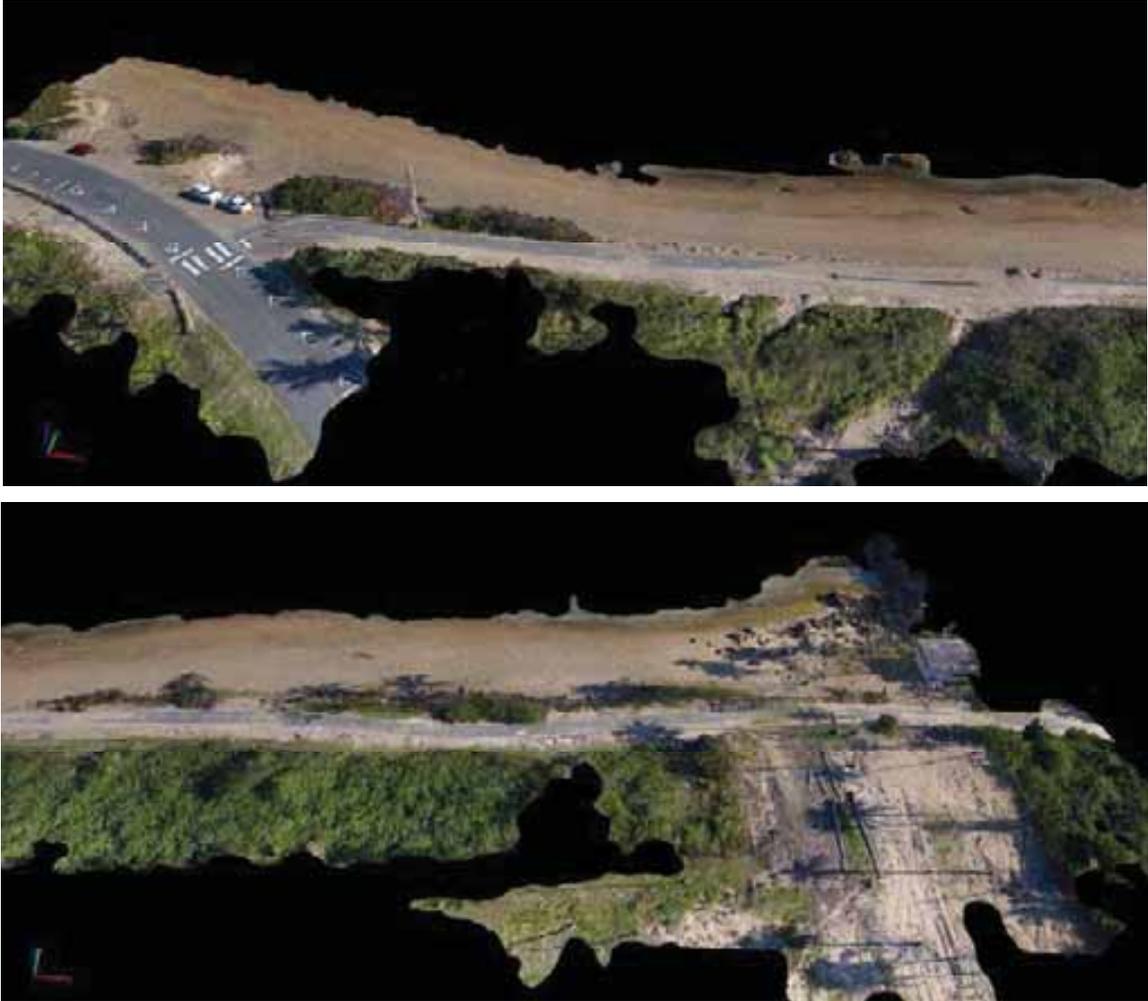
Figure 52. Three dimensional RGB images Golondrinas beach (after the March, 2017 north-easterly swell), Isabela viewed from the south.

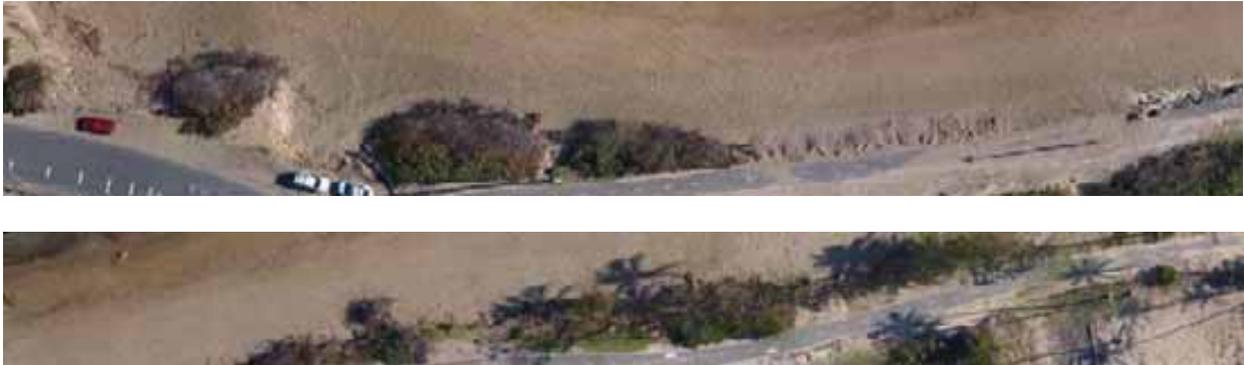
Figure 55. Vegetation cover was 47 % on Golondrinas beach, Isabela site (after the March, 2017 north-easterly swell) on April 27, 2018. The percent vegetation cover of the total area was calculated from the two pictures.

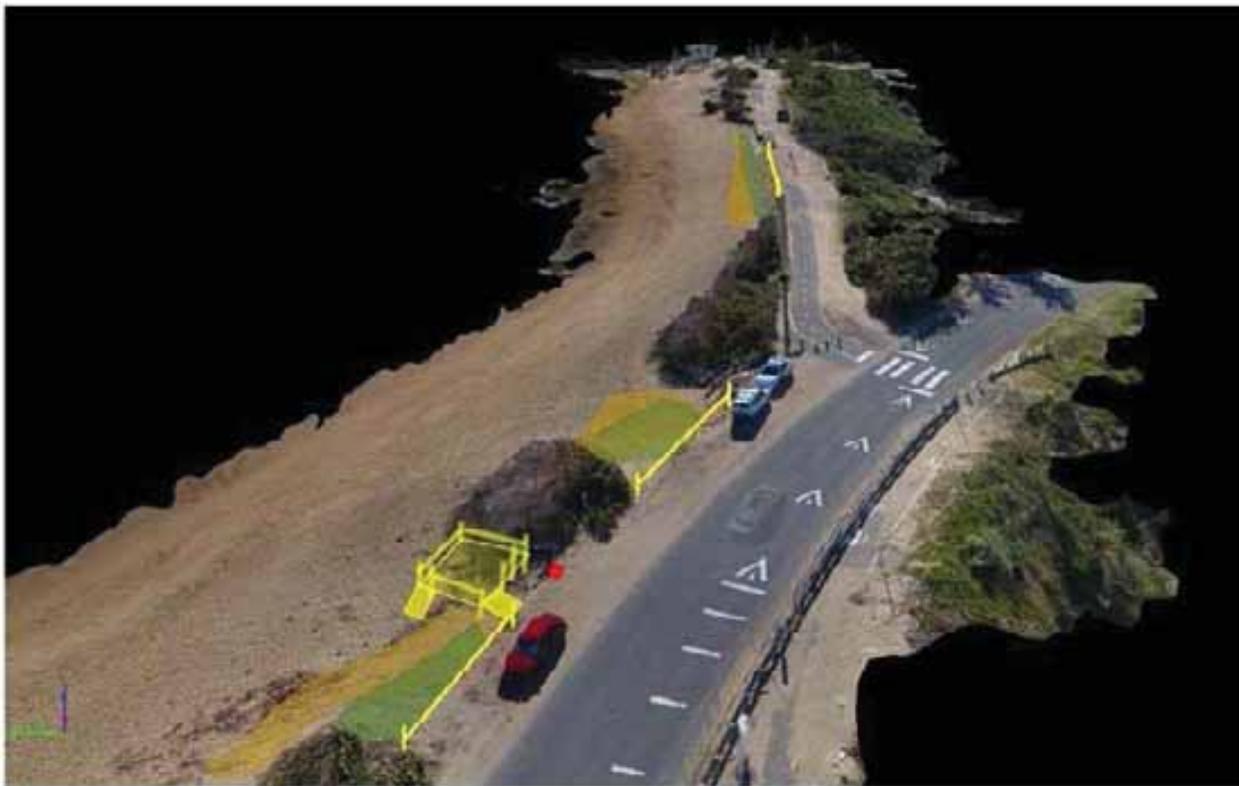
Figure 57. Area to be ecologically restored at Golondrinas Beach on PR 466 in Barrio Bajuras, Isabela. Highlighted areas correspond to each technique that will be used in this area. **Yellow** represents the location of wooden boardwalks, platform and barriers, the **red dot** marks the location of an information sign, **light green** marks the area of planting of dune vegetation, **tan** represents the area where biomimicry matrices will be installed to promote the accumulation of sand and areas shaded in light green represent locations for the planting of vegetation.

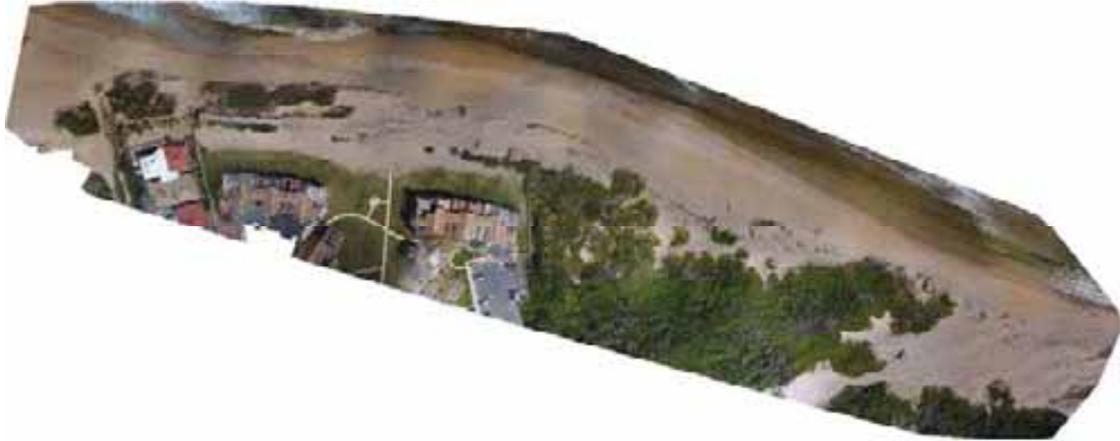
Figure 60. Orthomosaic image of Haudimar housing complex (after northeasterly swell), Isabela.

The ecological restoration measures that we recommend for this area consist of **the installation of a wooden boardwalk** to direct foot traffic away from sensitive areas where **fencing** (to promote sand accumulation) and **re-vegetation** with dune vegetation will be carried out (see figure below).

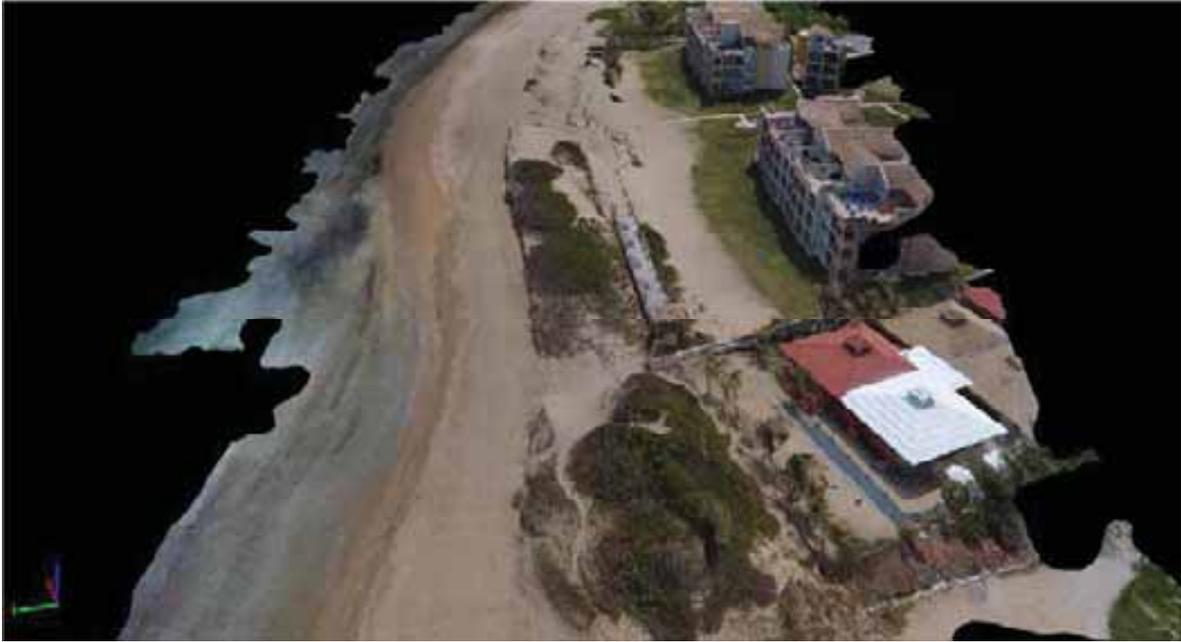
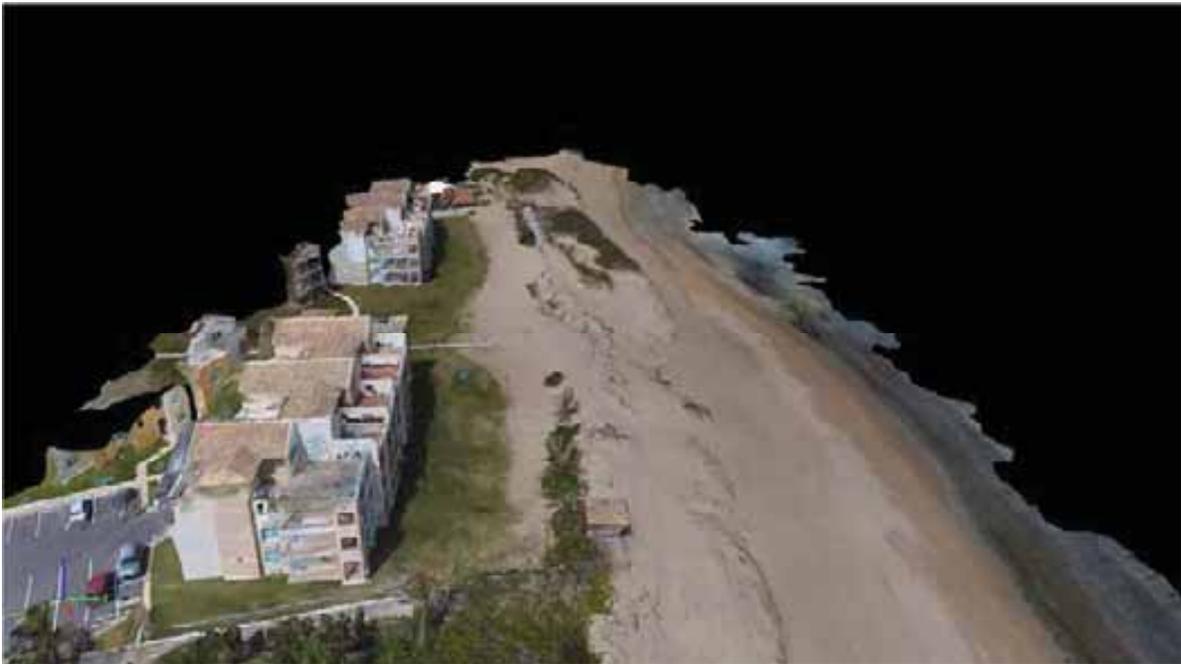
Figure 66. Three dimensional RGB images of the western part of the Haudimar housing complex (after northeasterly swell), Isabela. View from the west and from the east. Note the buried wooden boardwalk in front of the housing complex.

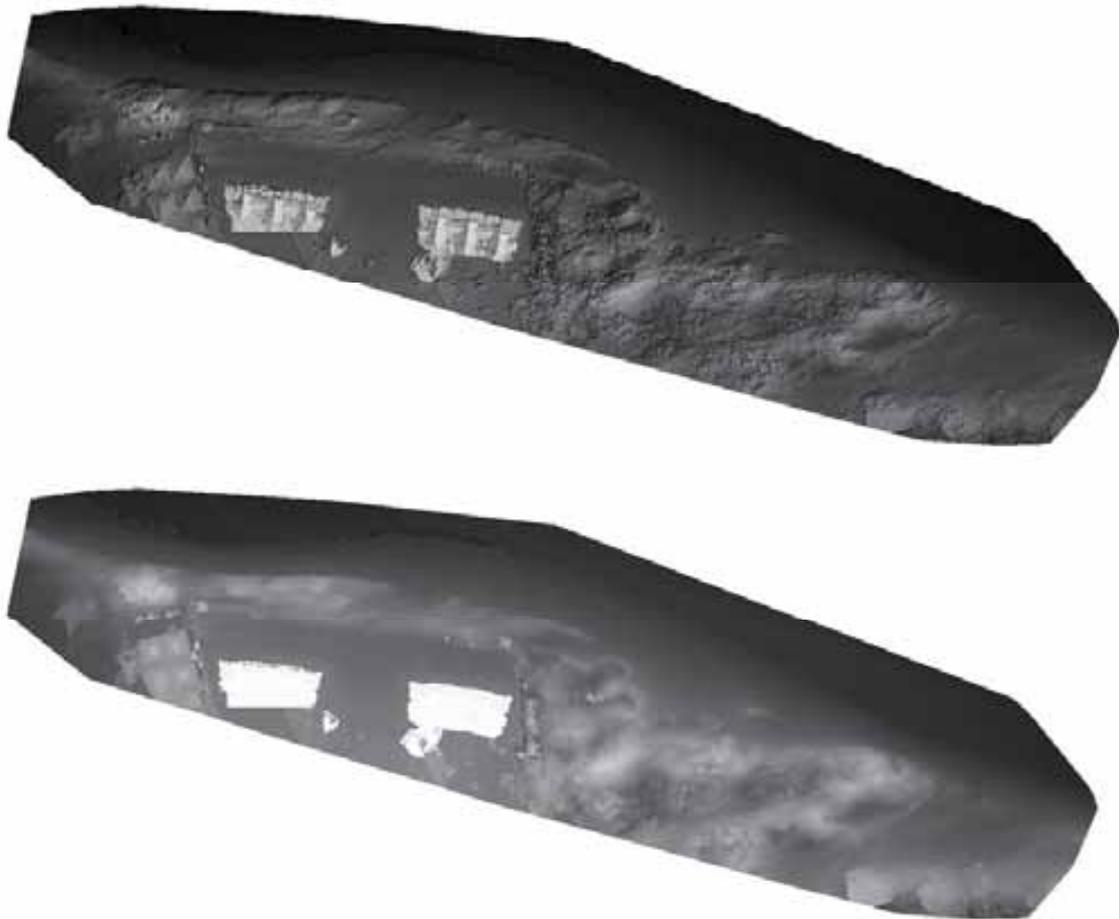
Figure 67. Grayscale DSM images of the Haudimar housing complex (after swell), Isabela. The top image shows shades and the bottom is not shaded.

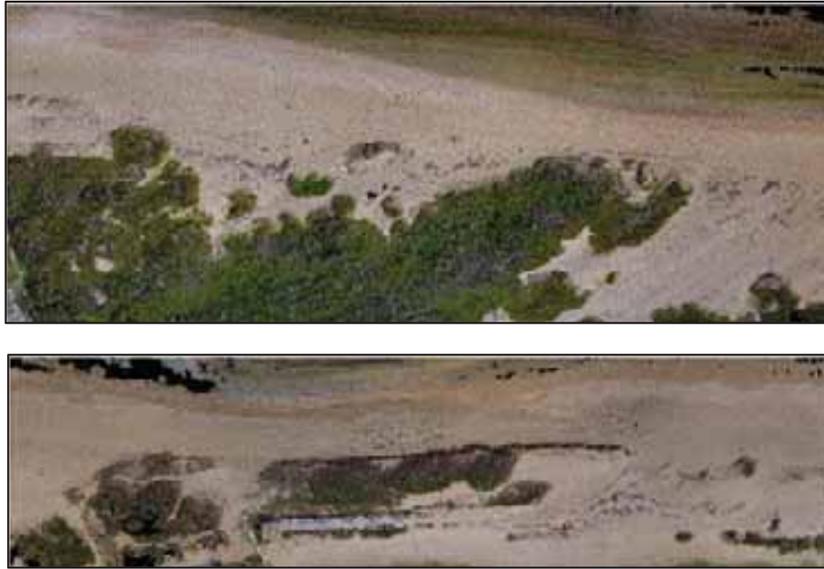
Figure 68. Images of the area for which vegetation cover is being monitored for the Haudimar housing complex in Isabela, Puerto Rico. The vegetation cover was 35.6% for the eastern part of the site (top image) and 23.6% for the western portion behind the housing complex (bottom image) on March 14, 2018.

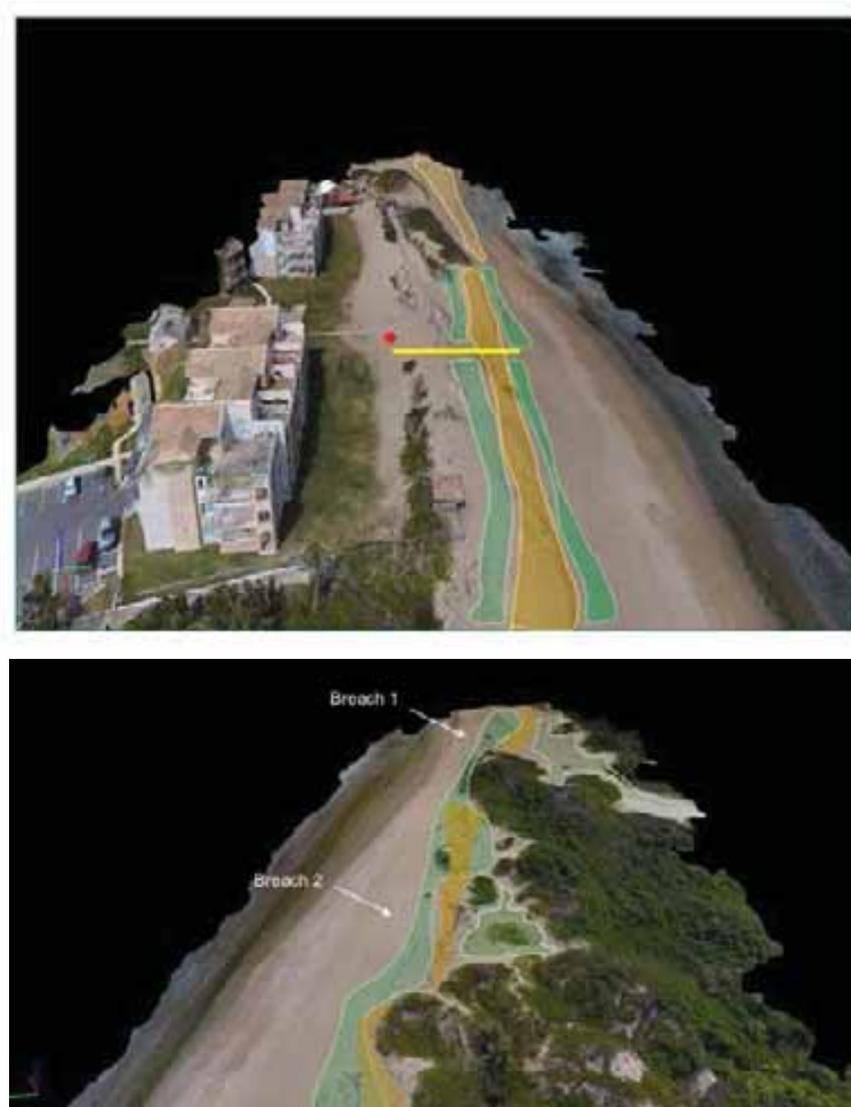
Figure 70. Area to be ecologically restored behind the Haudimar housing complex in Barrio Bajuras, Isabela. Highlighted areas correspond to each technique that will be used in this area. **Yellow** represents the location of a wooden boardwalk, **light green** marks the location of planting of dune vegetation, the **red dot** marks the location of an information sign, **tan** represents the area of the dune crest that where biomimicry matrices will be installed to promote the accumulation of sand. The areas shaded in light green represent locations for the planting of dune vegetation.

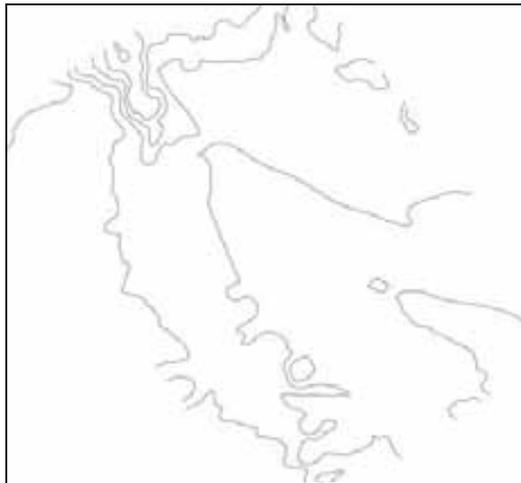
Figure 71. Contour map of the west of Secret Spot Beach, Isabela Puerto Rico with elevation intervals of 1 meter.

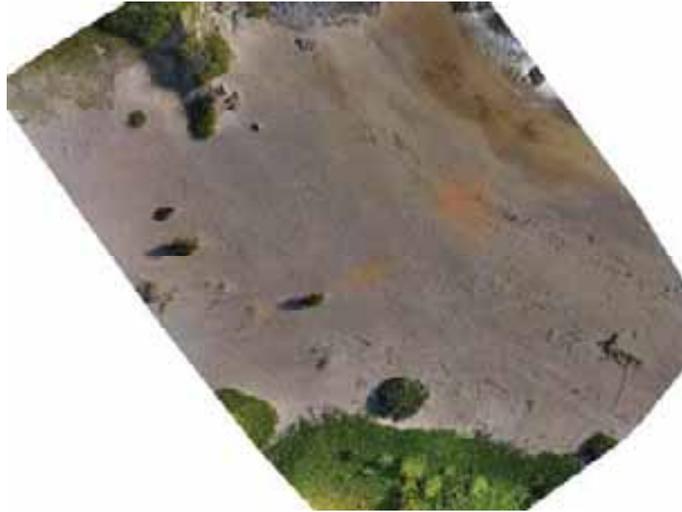
Figure 73. Orthomosaic image of the western part of Secret Spot, Isabela.

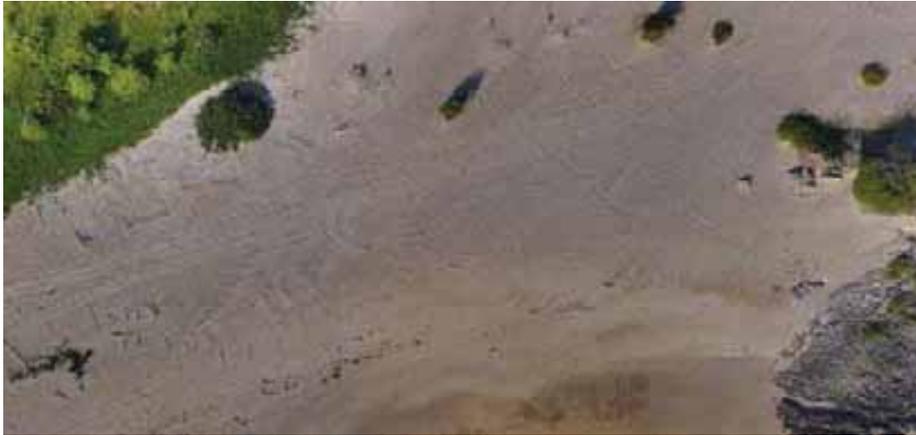
Figure 79. Area for which percent vegetation cover is being monitored in the western part of Secret Spot in Isabela, Puerto Rico. The vegetation cover in this area was calculated to be 12 % on July 29, 2017.

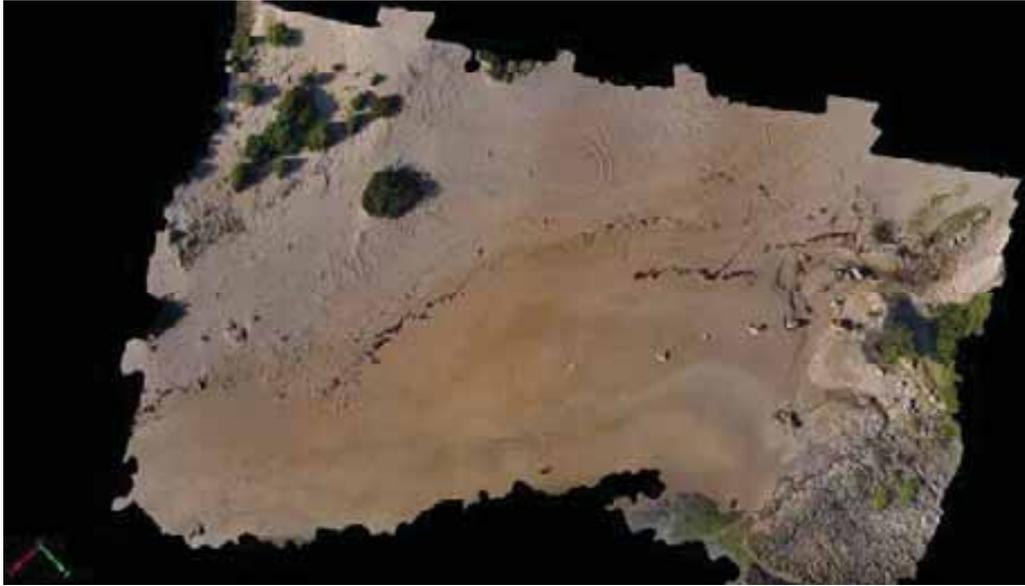
Figure 81. Aerial 3D image of the western part of Secret Spot (after Hurricane María).

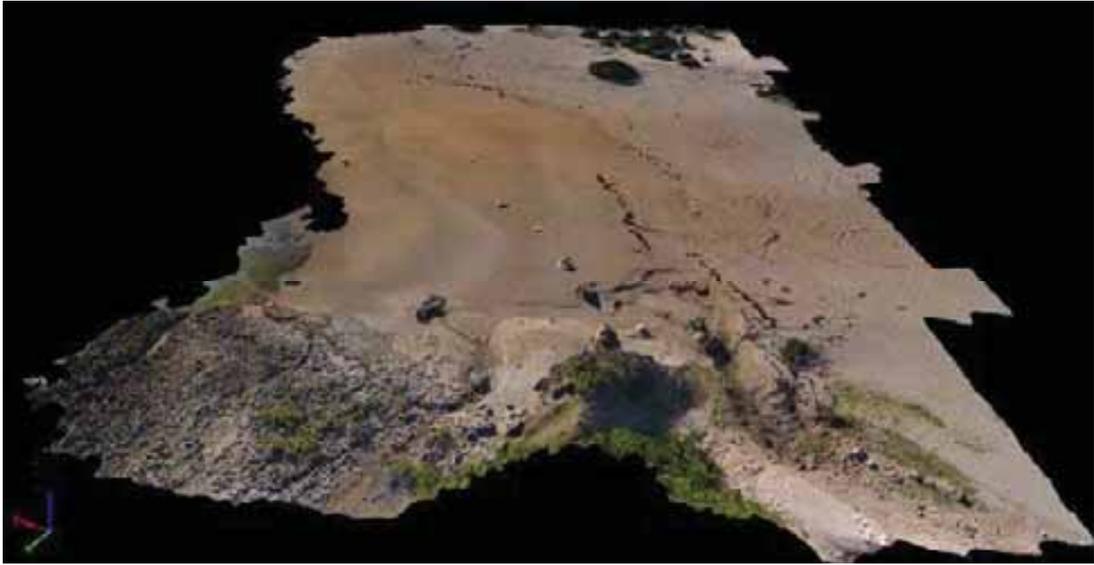
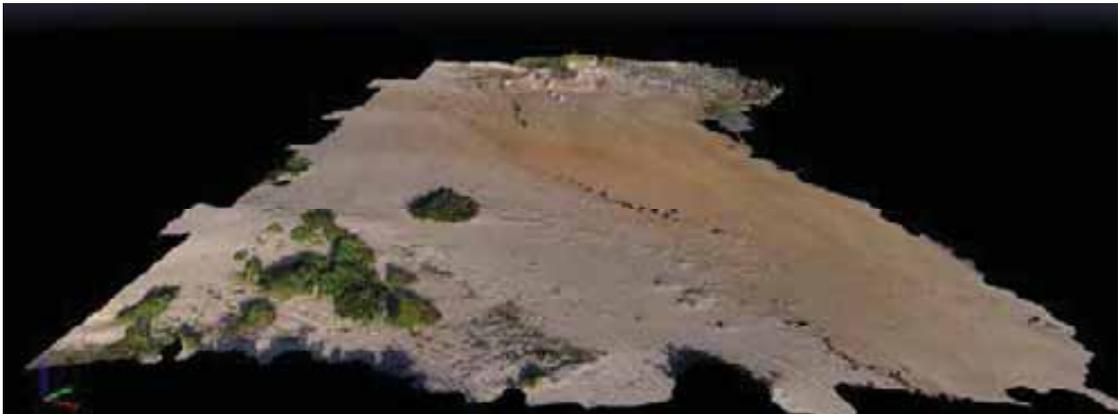
Figure 86. Three dimensional RGB images of the West of Secret Spot (after María), Isabela. View from the west (top) and from the east (bottom).

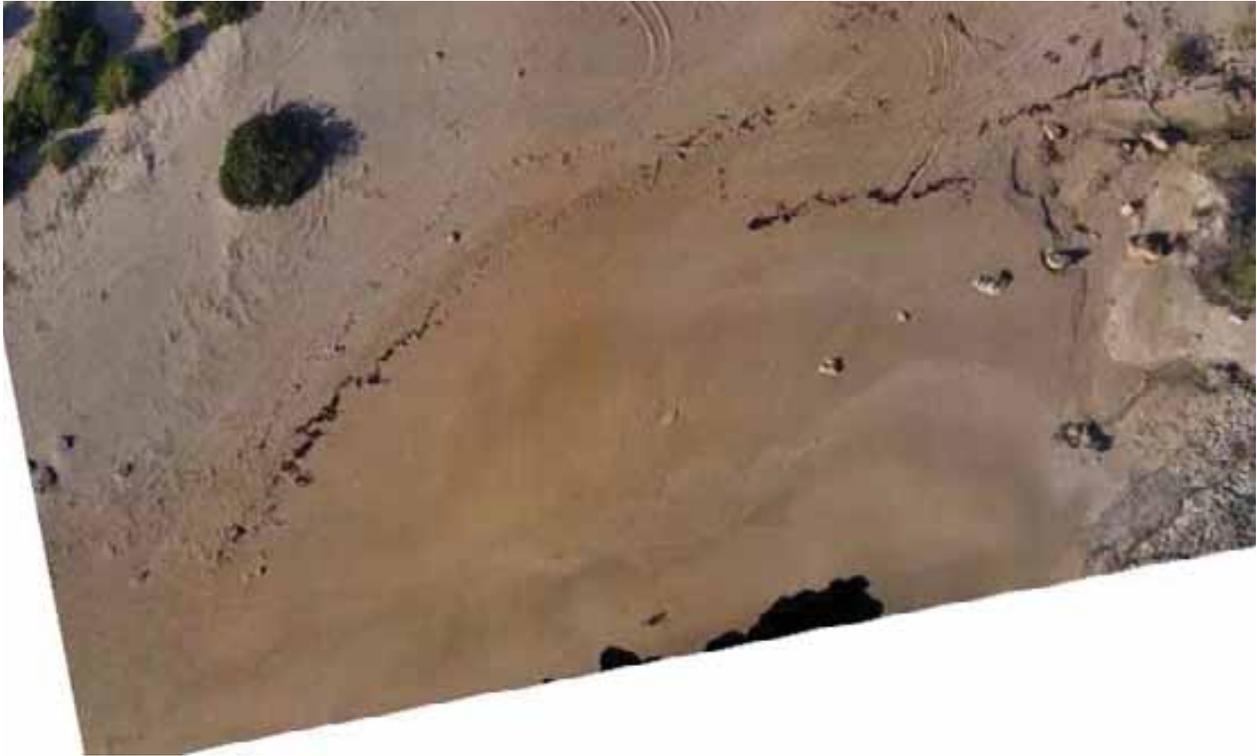
Figure 88. Image of the area for which vegetation cover is being monitored for the western part of Secret Spot Beach in Isabela, Puerto Rico. The vegetation cover was 3.6 % on January 13, 2018.

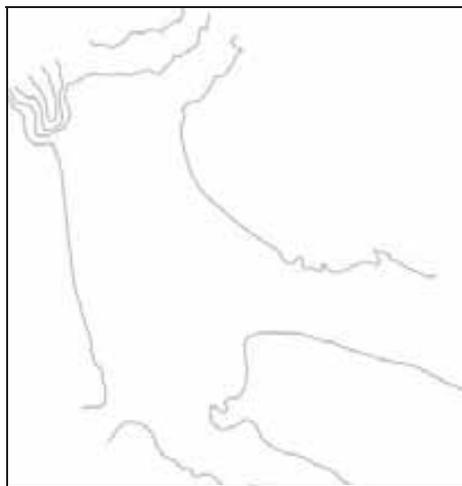
Figure . Contour map of West of Secret Spot (after swell), Isabela Puerto Rico with elevation intervals of 1 meter.

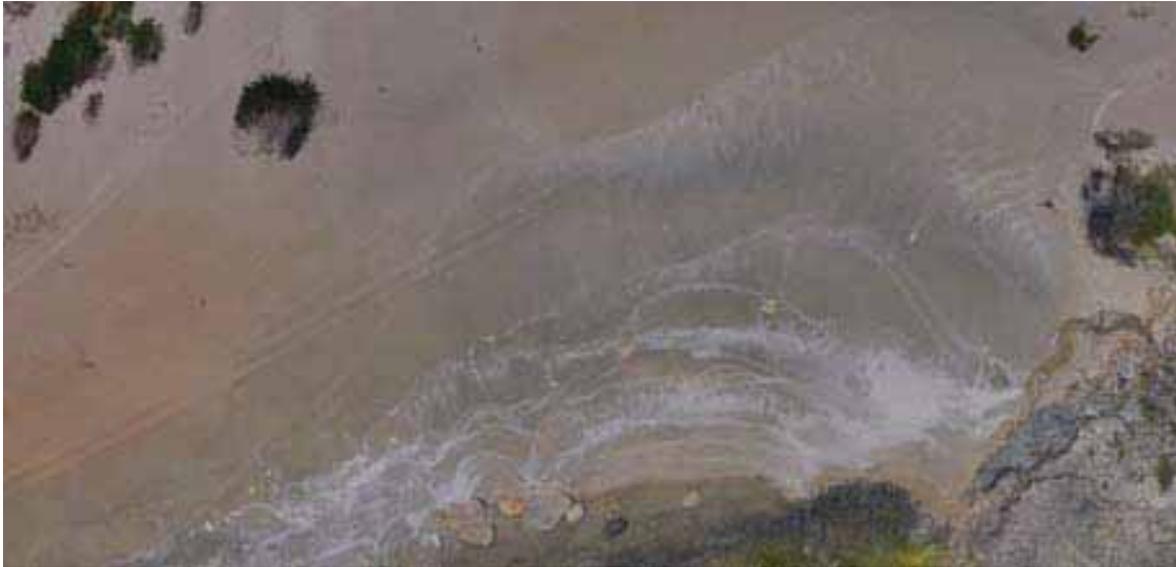
Figure. Image of the area for which vegetation cover is being monitored for the western part of Secret Spot Beach in Isabela, Puerto Rico. The vegetation cover was 3.1 % on March 19, 2018.

The recommended ecological restoration techniques for this area consist of the installation of biomimicry matrices. The area will be planted with dune vegetation in order to stabilize the accumulated sand. Two information signs will be installed in this area to advise people of the importance of dune restoration and of the importance of not interfering with any of the plants or fencing.

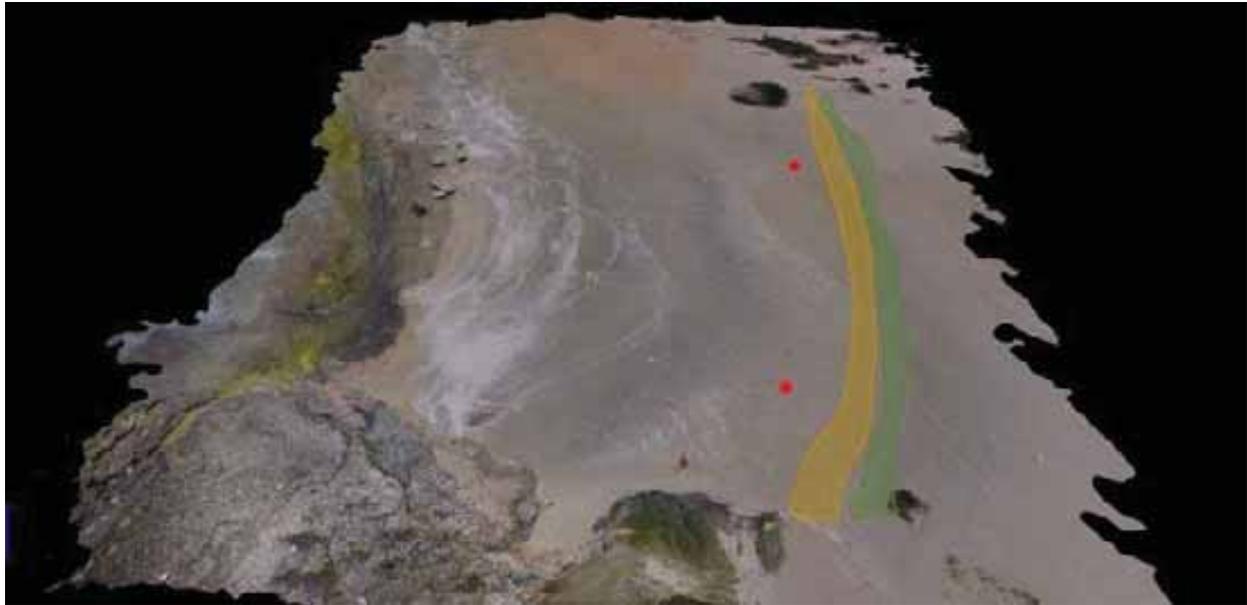
Figure. Area to be ecologically restored on the western part of Secret Spot Beach in Barrio Bajuras, Isabela, Puerto Rico. Highlighted areas correspond to each technique that will be used in this area. **Yellow** represents the location of a wooden boardwalk, the **red dot** marks the location of an information sign, **light green** marks the location of planting of dune vegetation, **tan** represents the area of the dune crest that where biomimicry matrices will be installed to promote the accumulation of sand. The areas shaded in light green represent locations for the planting of dune vegetation.

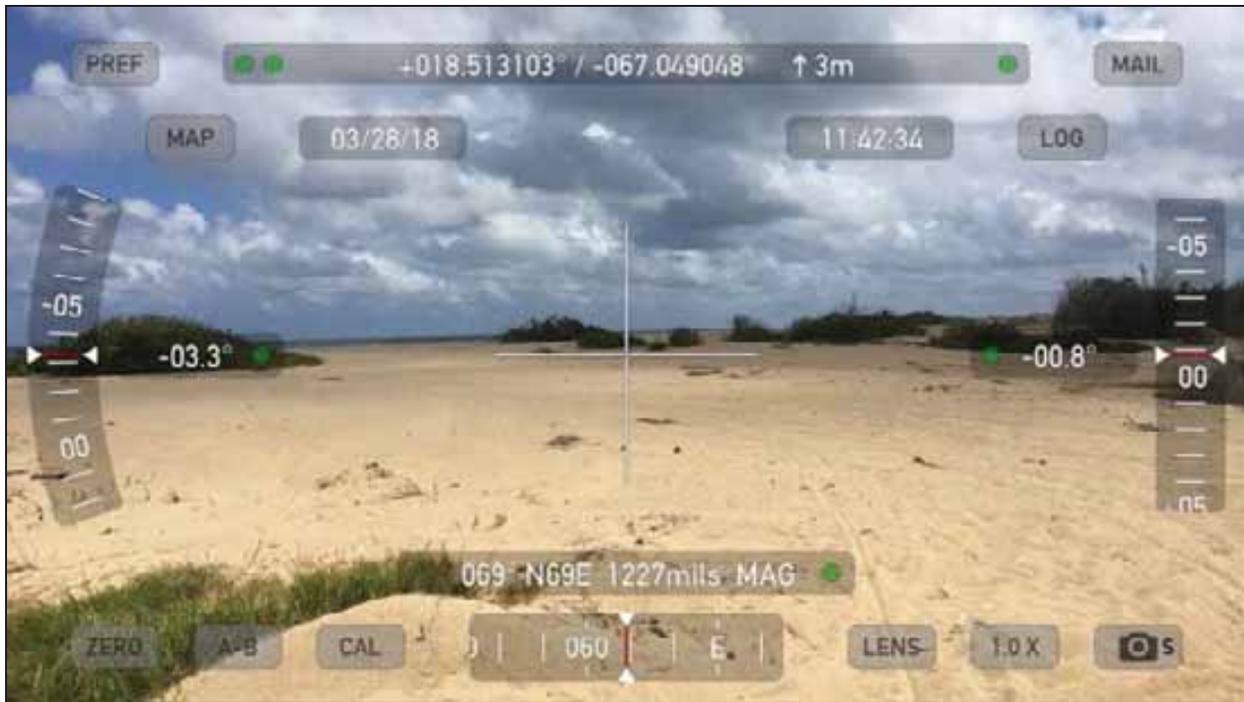
Figure. View of the breach on the west of Secret Spot beach in Isabela, Puerto Rico.

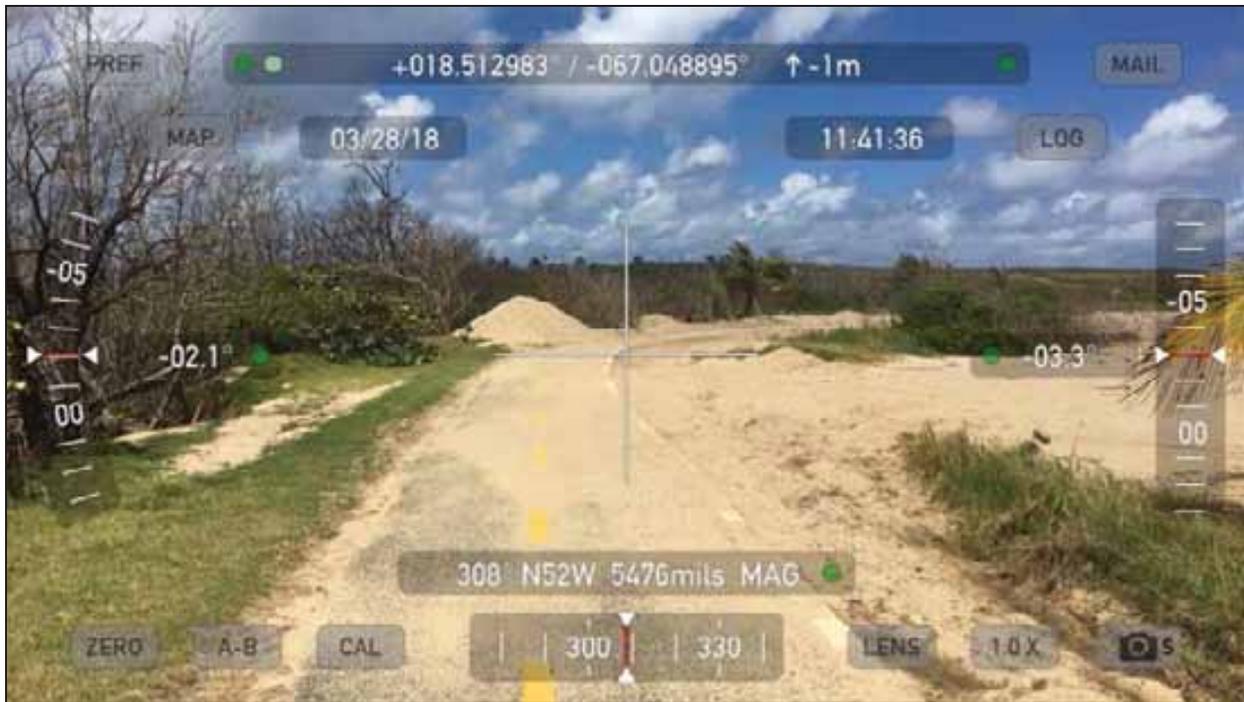
Figure. Displaced sand on the recreational path to the south of the western part of Secret Spot.

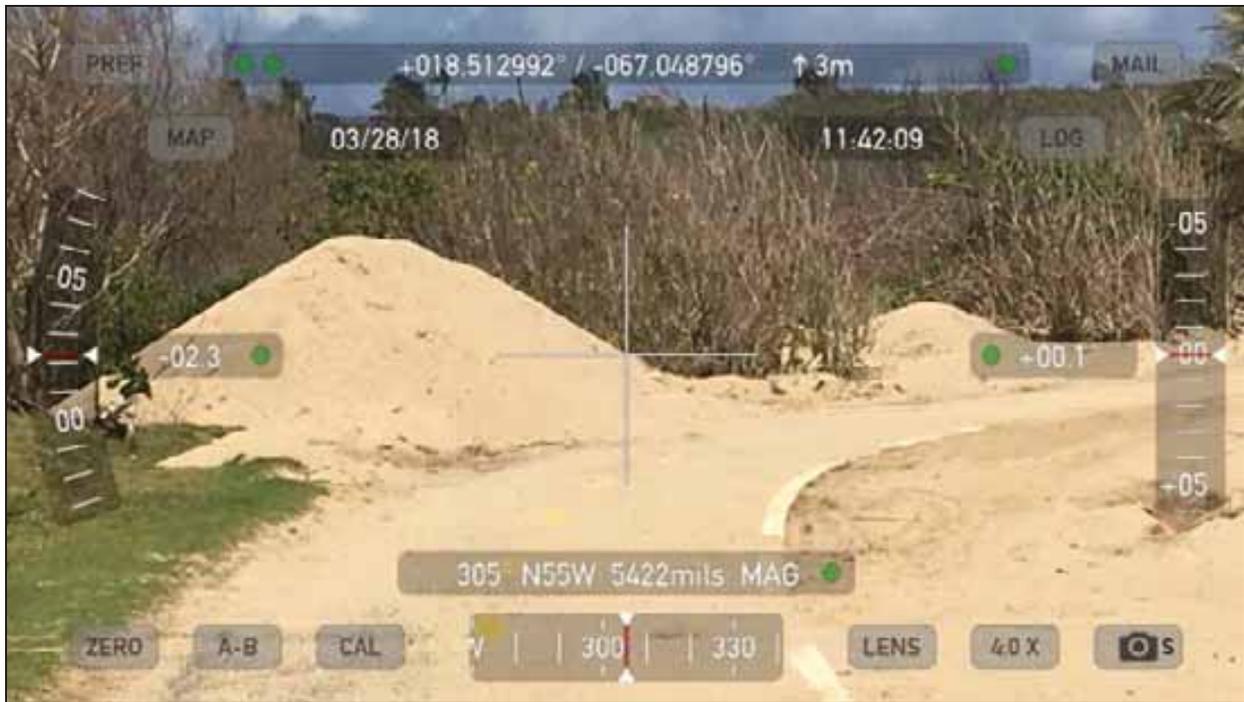
Figure. Displaced sand on the recreational path to the south of the western part of Secret Spot.

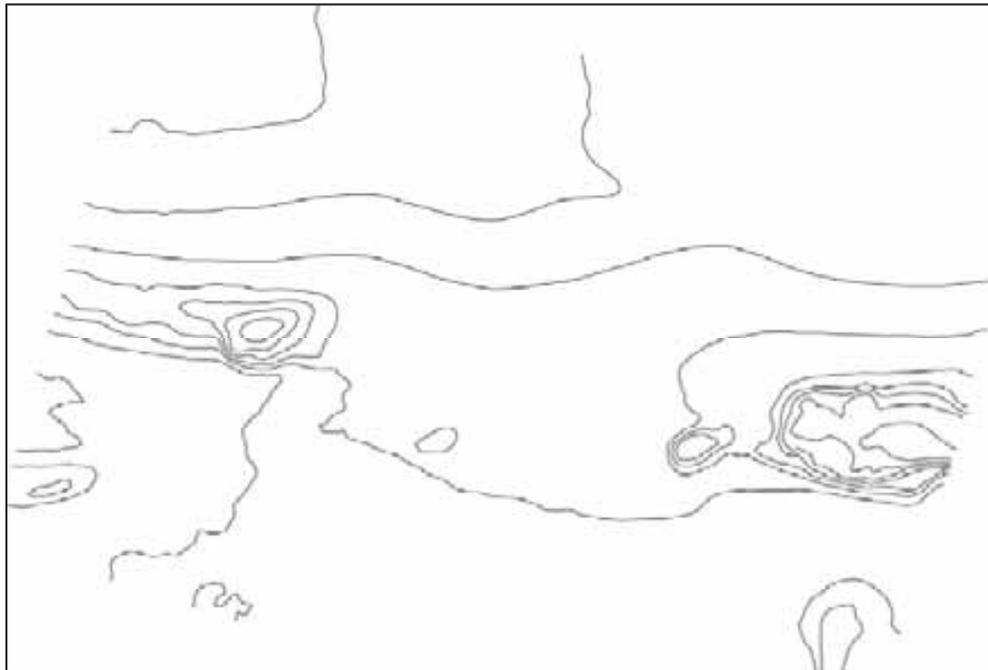
Figure 89. Contour map of the eastern part of Secret Spot Beach (before hurricane María), Isabela Puerto Rico with elevation intervals of 1 meter.

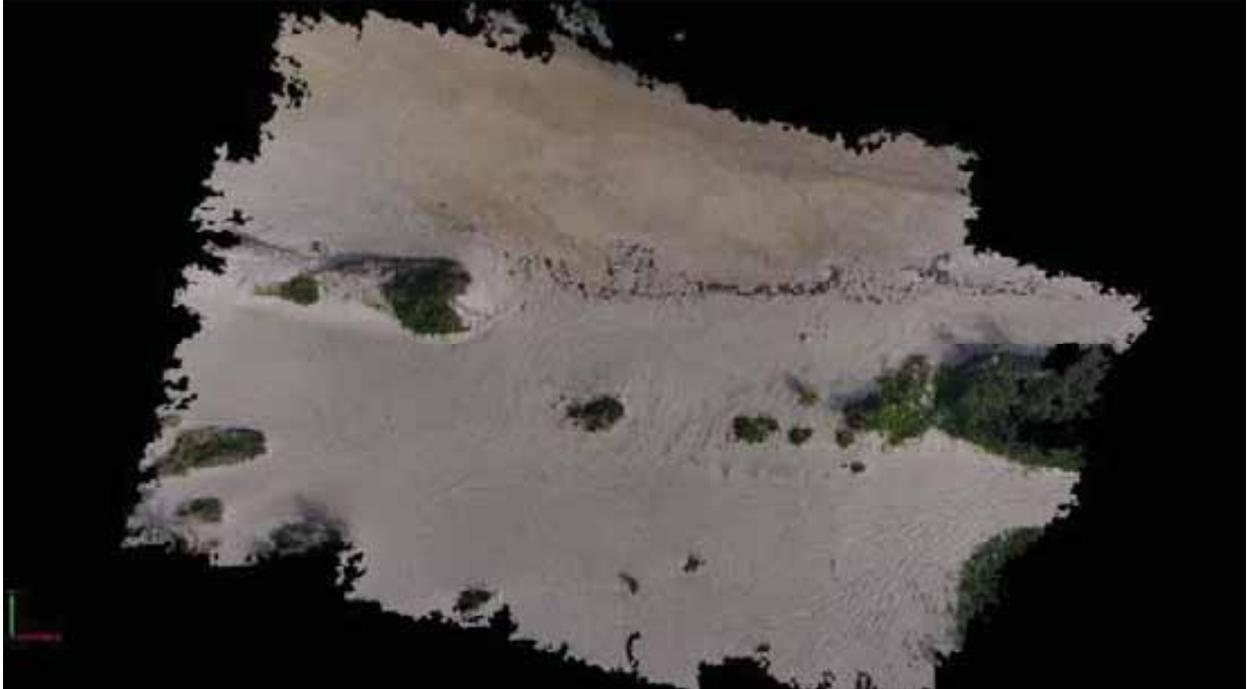
Figure 98. Aerial 3D image of the eastern part Secret Spot, Isabela (after hurricane María).

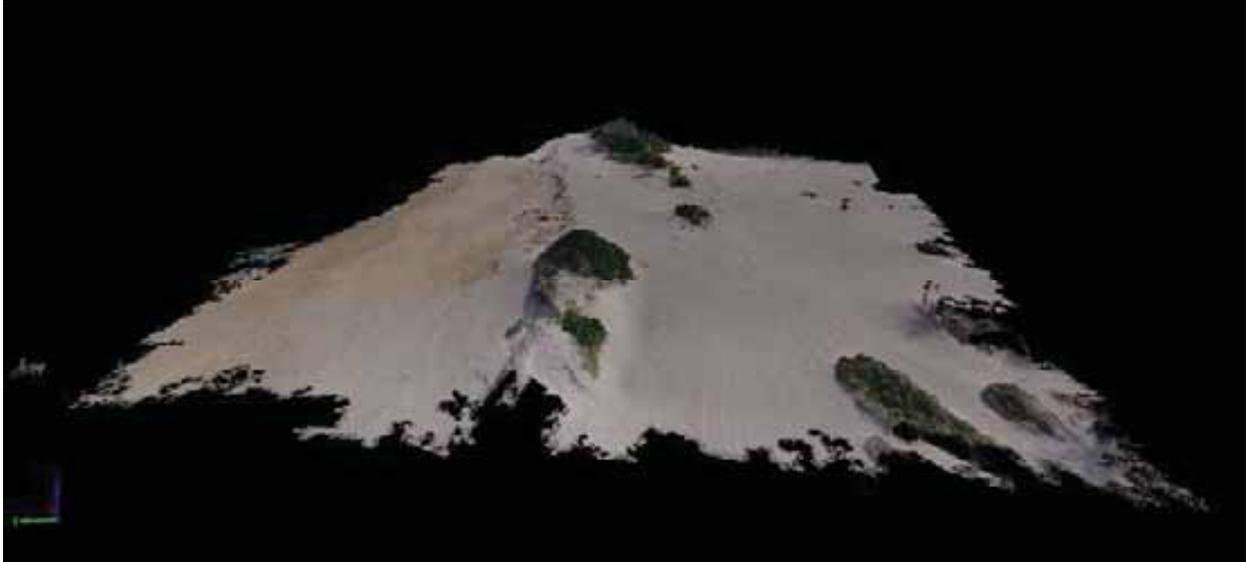
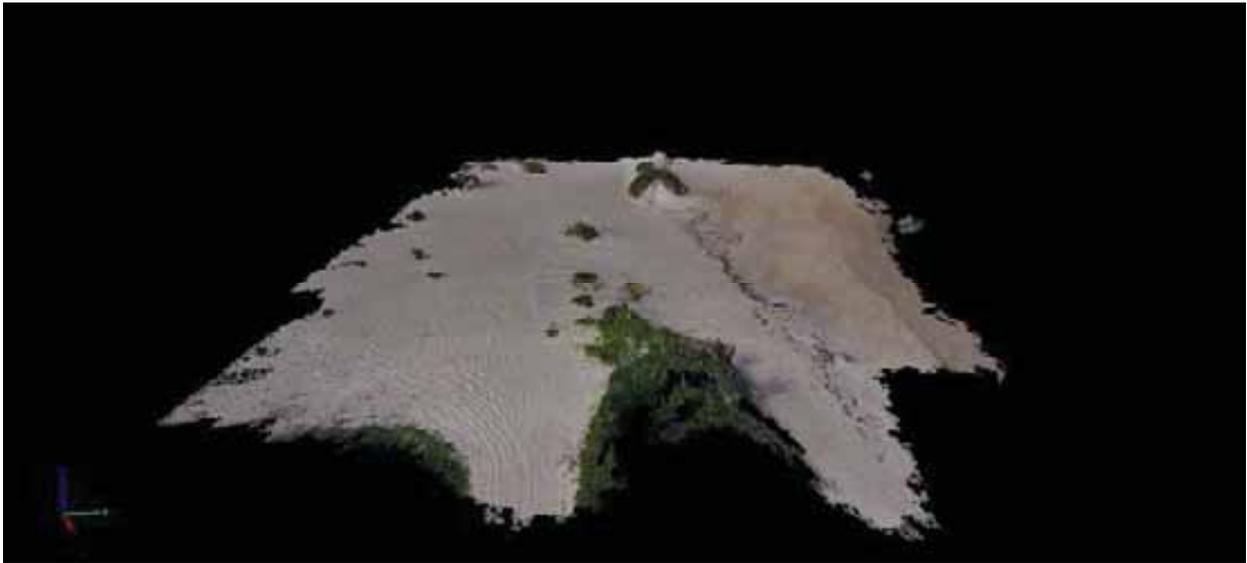
Figure 103. Three dimensional RGB images of the eastern part Secret Spot (after hurricane María), Isabela. View from the west (top) and from the east (bottom). *Note- Mayer*

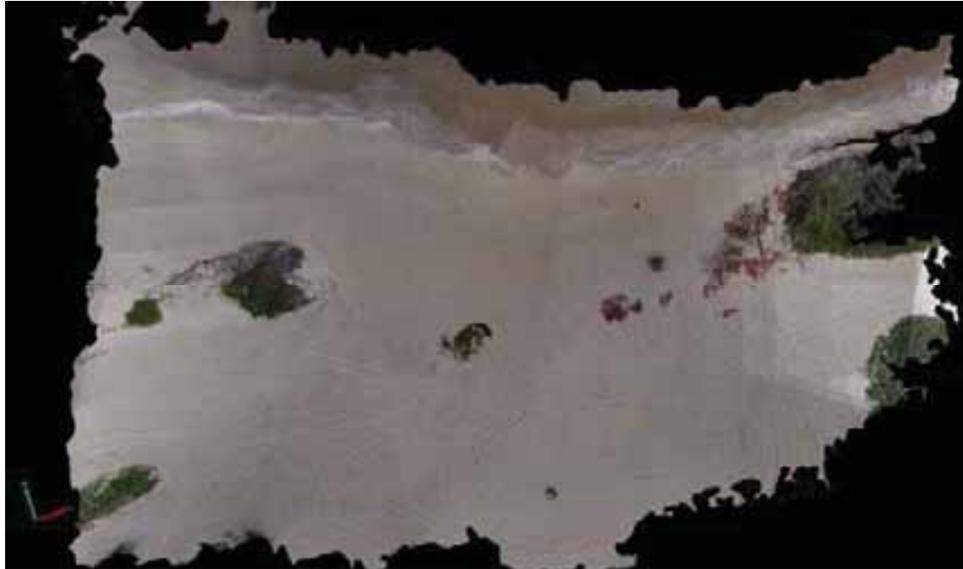
Figure 106. Aerial 3D image of the eastern part of Secret Spot Beach, Isabela (after swell).

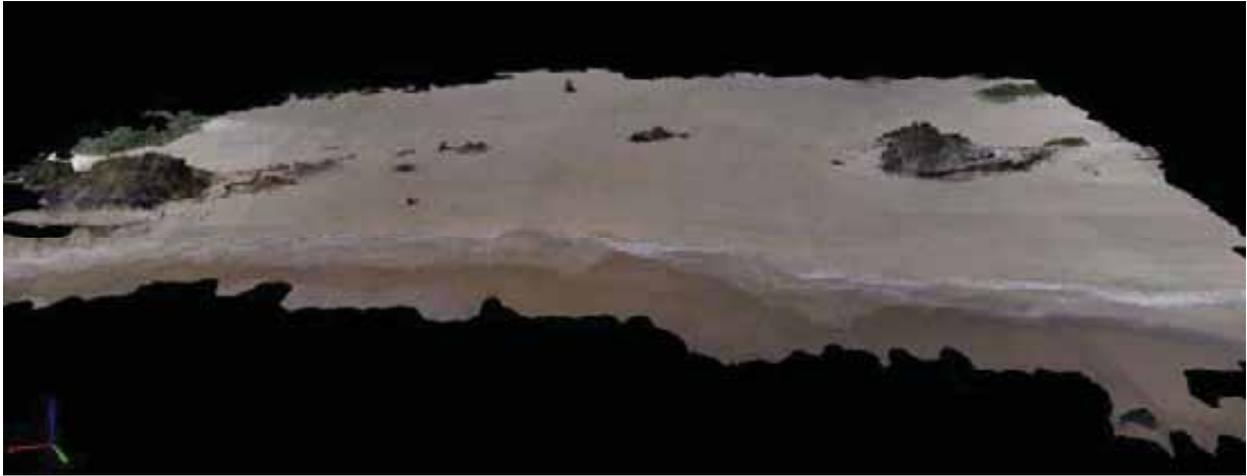
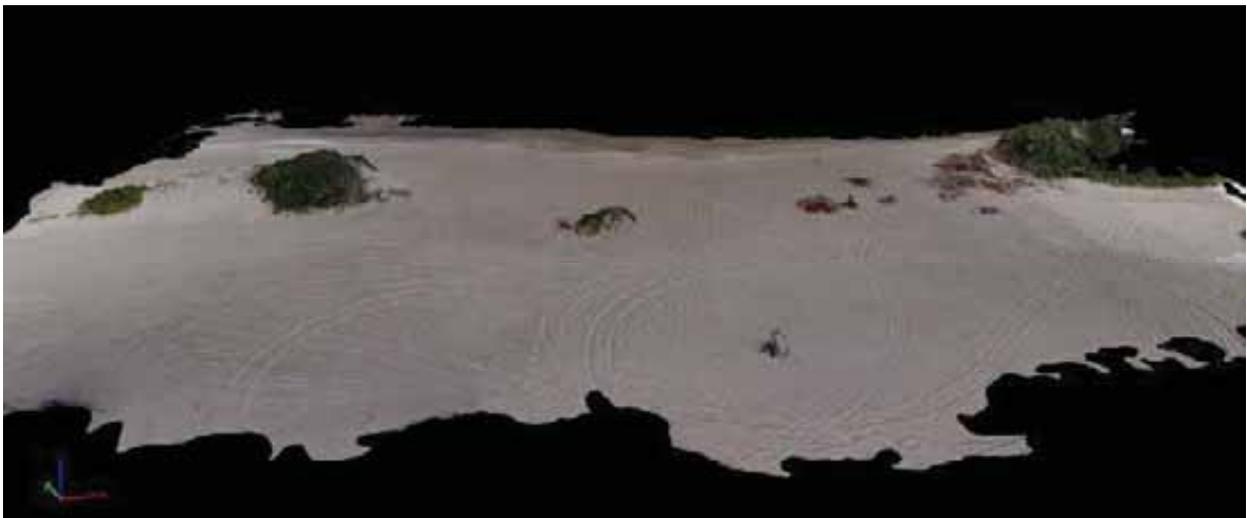
Figure 110. Three dimensional RGB images of the the eastern part of Secret Spot Beach, Isabela (after swell). View from the north (top) and from the south (bottom).
