Coastal Dune and Erosion Assessment of the North Coast of Puerto Rico

Final Report

**DOI-FEMA Natural and Cultural Resources
Recovery Support Function (NCR RSF)**

**Universidad de Puerto Rico en Aguadilla
Vida Marina: Centro de Conservación y Restauración Ecológica Costera**

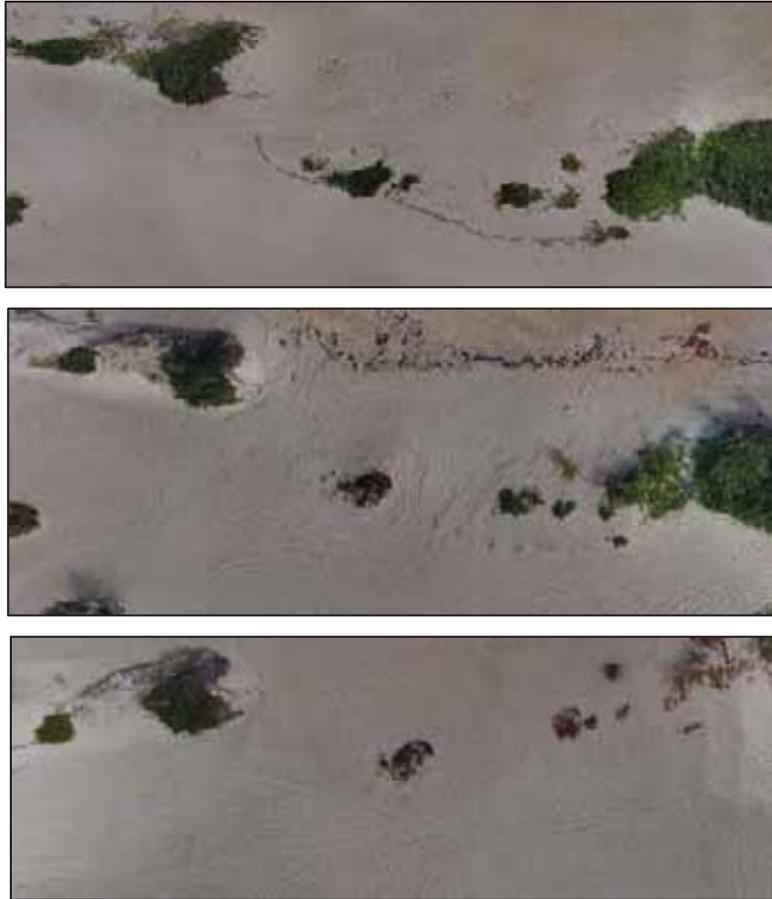
Figure 113. Vegetation covered 13.3% of the area on the breached dune on July 11, 2017 (before hurricanes Irma and María), 7.1% on January 13, 2018 (after hurricane María) and 5.8% on March 28, 2018 (after the northeasterly swell) of the area at the eastern part of Secret Spot Beach.

This area was severely affected by the 2017 hurricanes and the strong northeasterly swell of March of 2018. This area had been restored since 2007 but all these efforts were destroyed in the last 8 months. The vegetation cover and sand accumulation in the area was significantly reduced by the strong waves. The area is also subject to erosion caused by high illegal all-terrain vehicle traffic (see tire tracks on image below). This is the most significant conservation threat in the area, coupled with low sand accumulation relative to other parts of the Isabela dune system.

This area was in the process of being ecologically restored (note sand, exclusion fencing and biomimicry matrices on the aerial pictures of the area from before hurricane María). All these efforts were destroyed by the extreme weather caused by two major storms and a strong northeasterly swell. This is a large breach that needs to be restored as soon as possible by the installation of exclusion fencing to keep all terrain vehicles and foot traffic out of sensitive areas. Sand accumulation in this area is lower than in other areas of this dune system but the installation of biomimicry matrices followed by the planting of vegetation are needed to stabilize it.

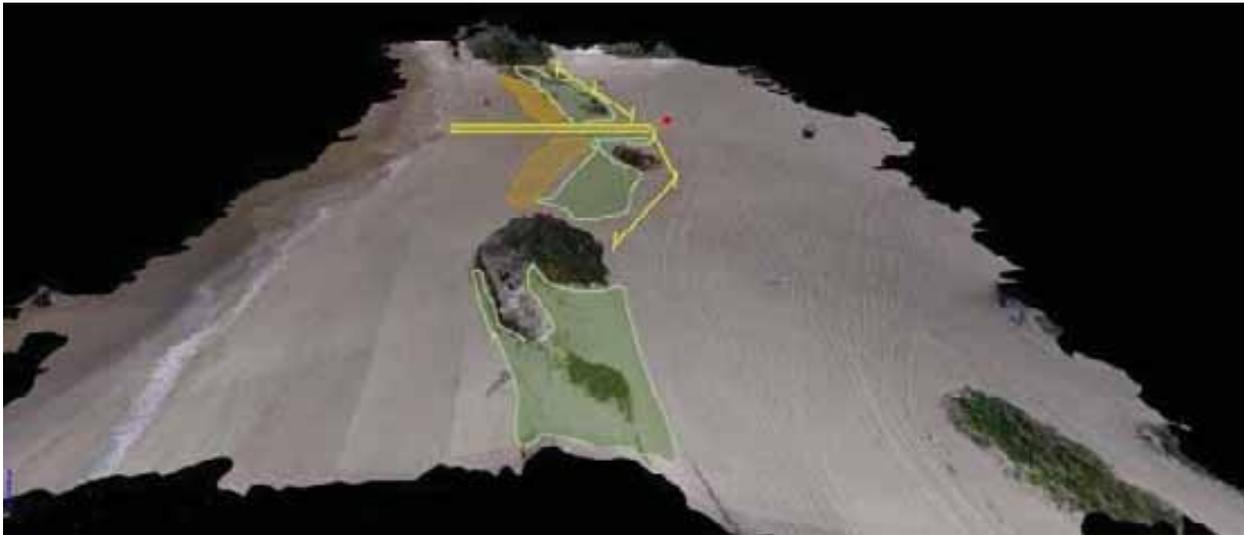
Figure 115. Area to be ecologically restored at the eastern part of Secret Spot Beach on PR 466 in Barrio Bajuras, Isabela. Highlighted areas correspond to each technique that will be used in this area. **Yellow** represents the location of wooden boardwalks, platform and barriers, the **red dot** marks the location of an information sign, **light green** marks the location of planting of dune vegetation, **tan** represents the area where biomimicry matrices will be installed to promote the accumulation of sand and areas shaded in light green represent locations for the planting of vegetation. Note the tire tracks on the back dune area. All the sand in this area is from a wash-over fan from the creation of this breach during a northeasterly event in 2008.

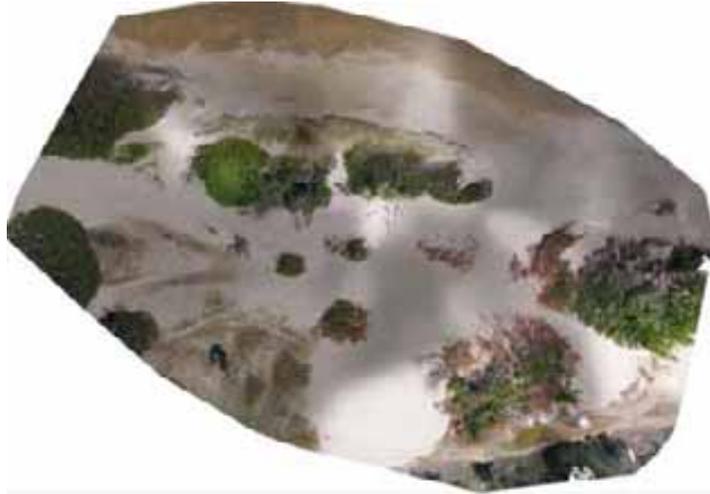
Figure 120. Orthomosaic image of Breach between Middles and Secret Spot (after swell)Isabela

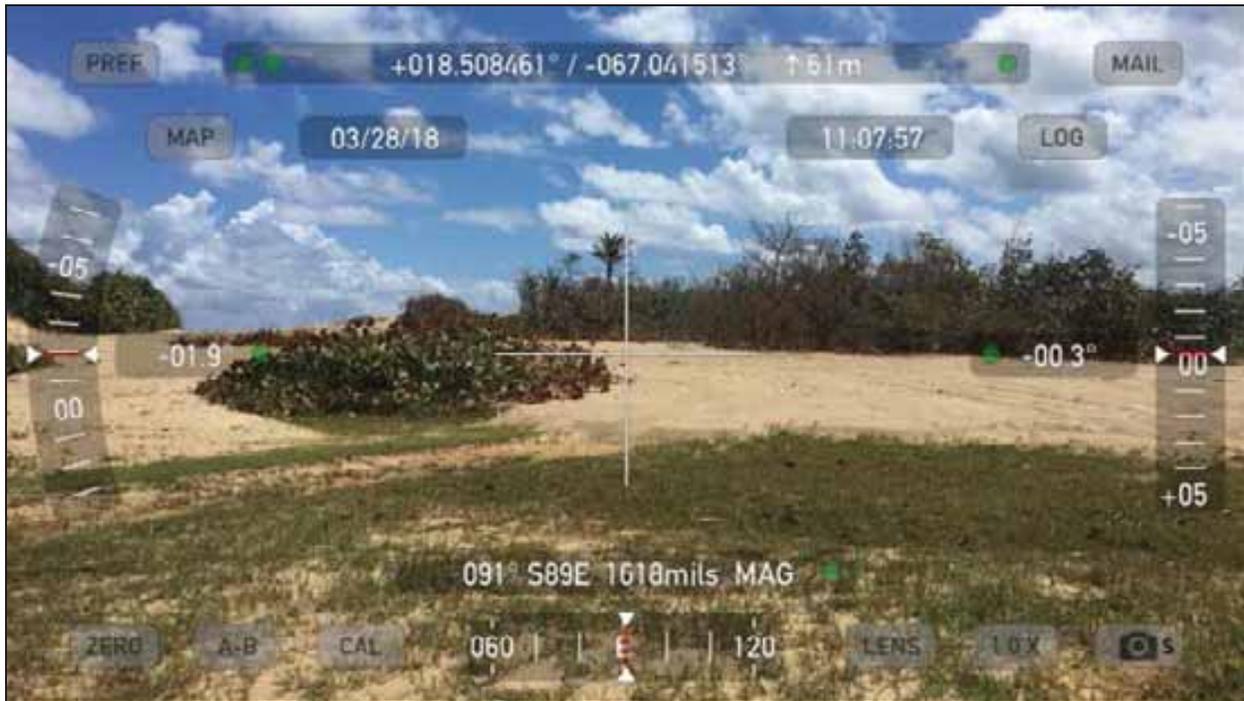
Figure 126. View from the ground of the breach between Middles and Secret Spot beaches in Isabela. This was created during the March 2018 northeasterly swell.

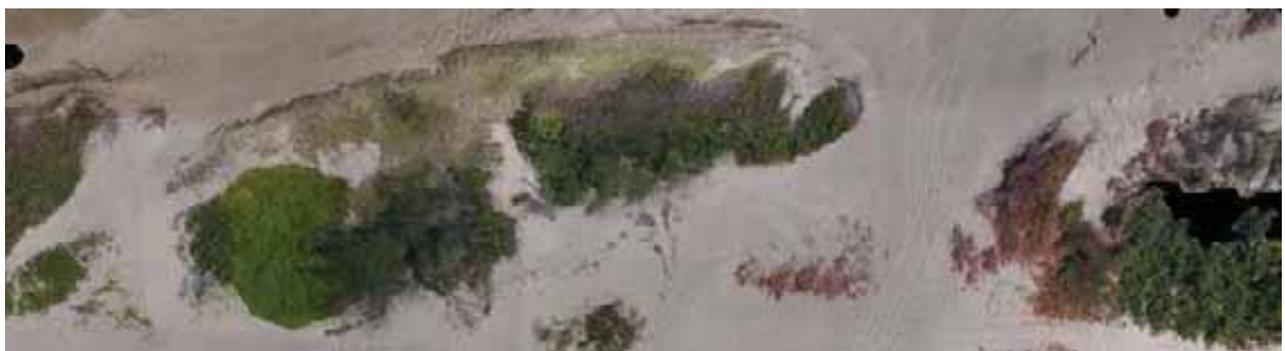
Figure 127 Vegetation covers 40 % of the area of the breach between Middles and Secret Spot (after swell), Isabela on March 28, 2018.

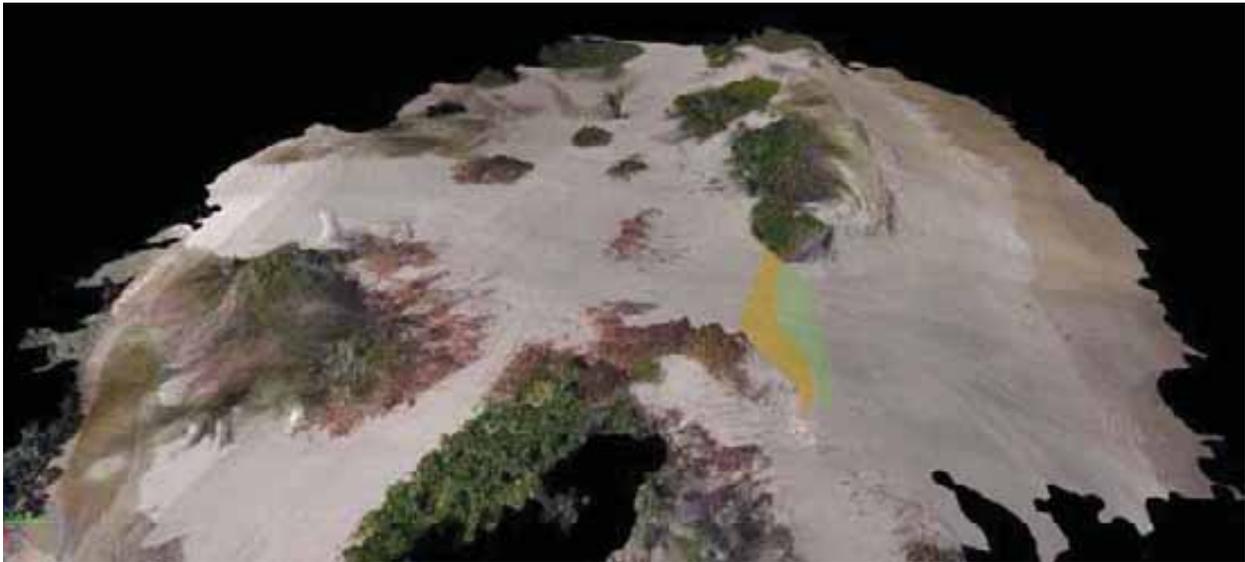
Figure 129. Area to be ecologically restored on the breach between Middles and Secret Spot in Barrio Bajuras, Isabela. Highlighted areas correspond to each technique that will be used in this area. Areas shaded in tan color represent the area of the dune crest that where biomimicry matrices will be installed to promote the accumulation of sand. The areas shaded in light green represent locations for the planting of dune vegetation.

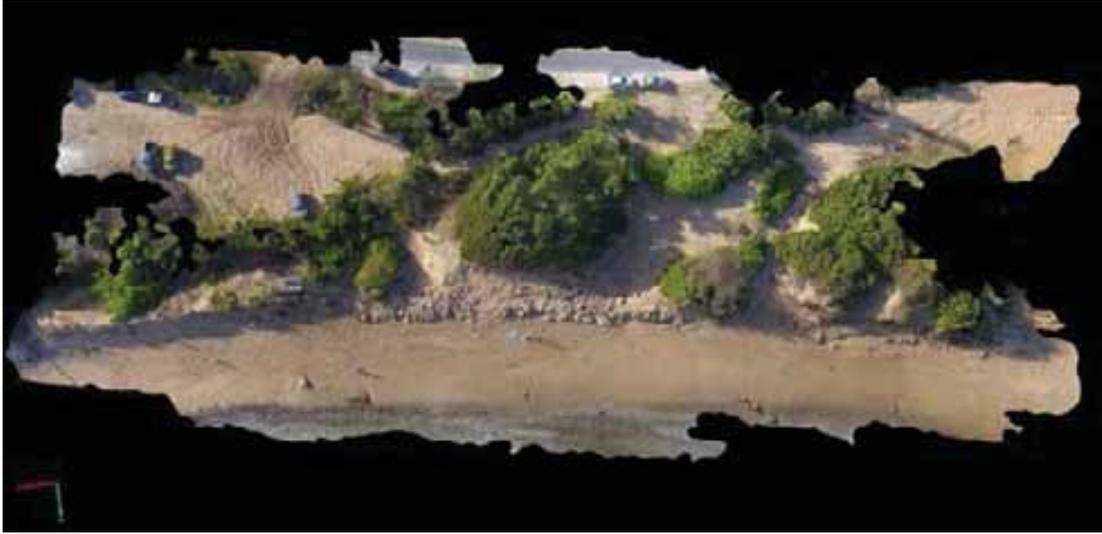
Figure 131. Aerial 3D image of Middles Beach (After hurricane María), Isabela, Puerto Rico. View from north.

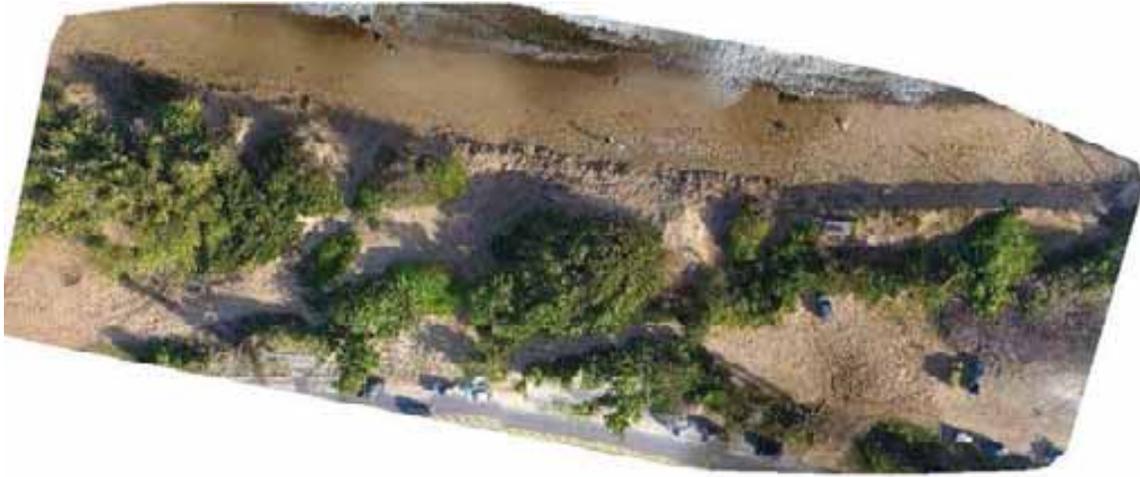
Figure 132. Orthomosaic image of Middles Beach (after hurricane María), Isabela, Puerto Rico.

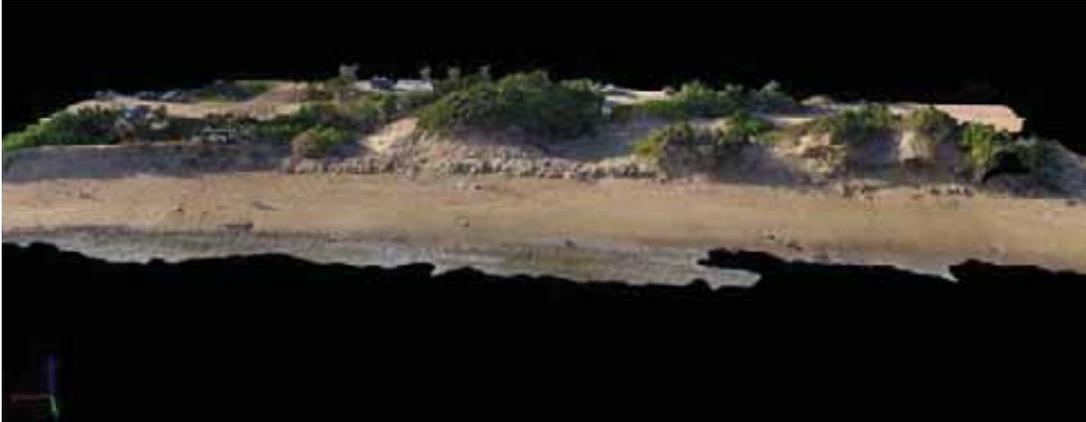
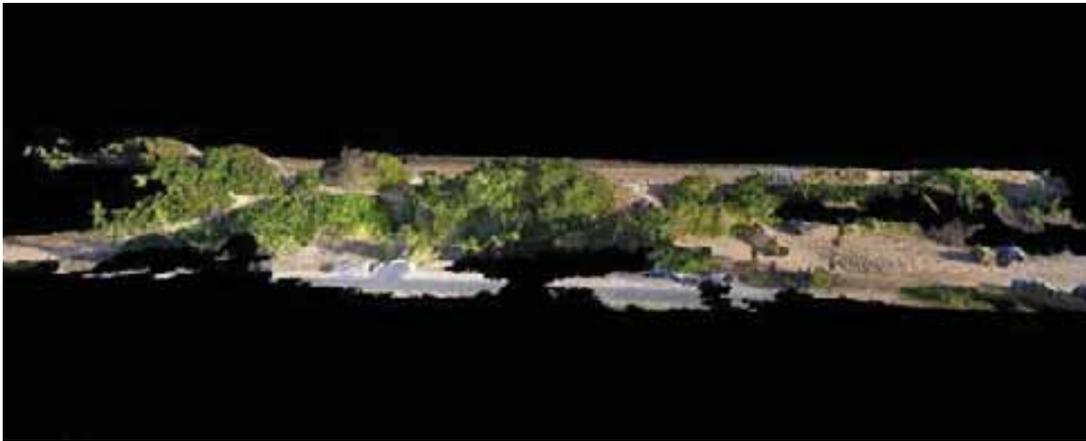
Figure 135. Three dimensional RGB images of Middles Beach (After hurricane María), Isabela, Puerto Rico. View from the north (top) and from the south (bottom).

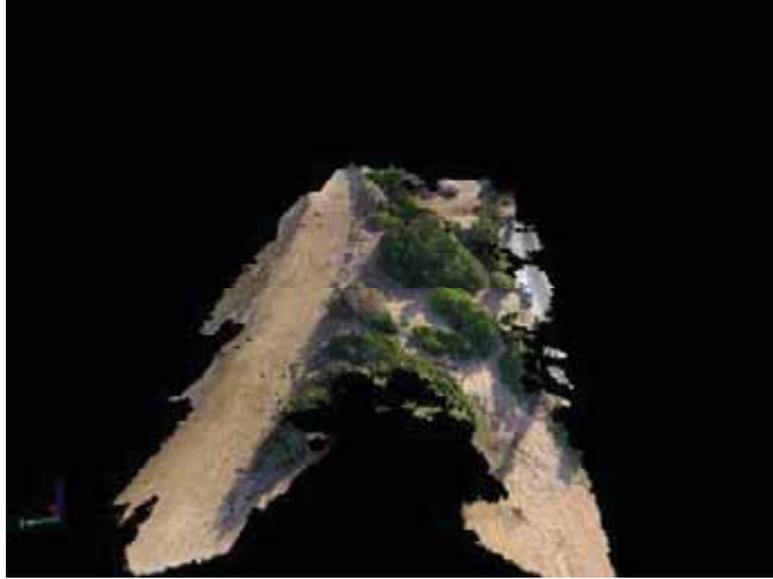
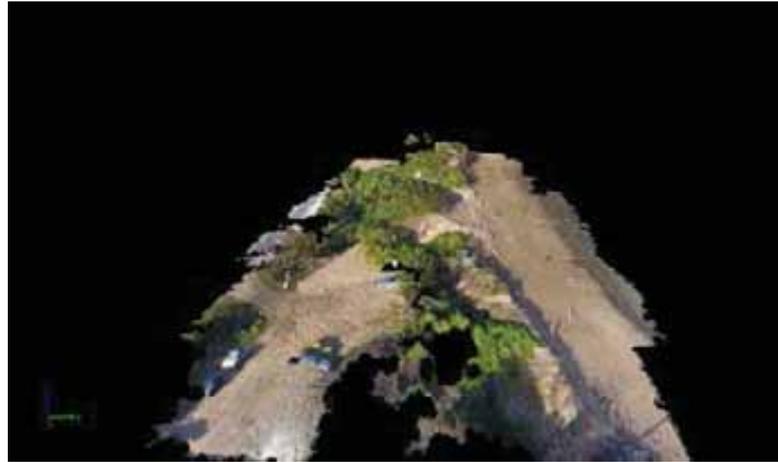
Figure 136. Three dimensional RGB images of Middles Beach (after María), Isabela. View from the west (top) and from the east (bottom).

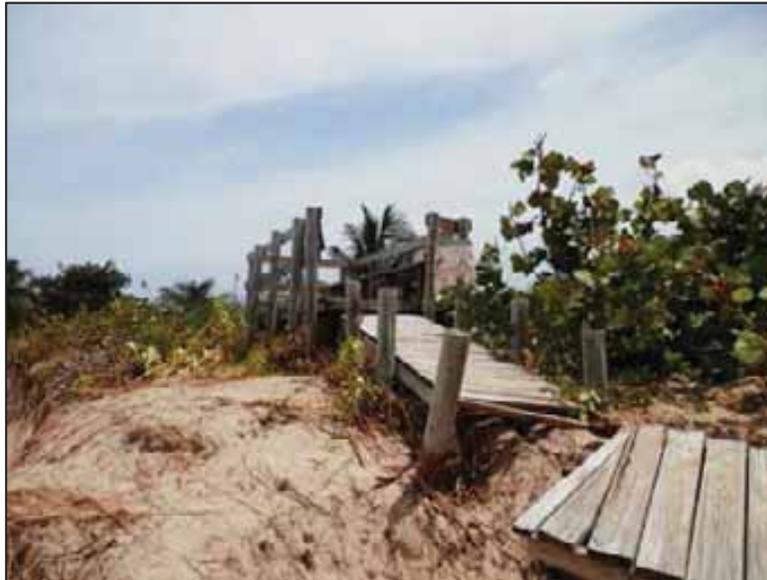
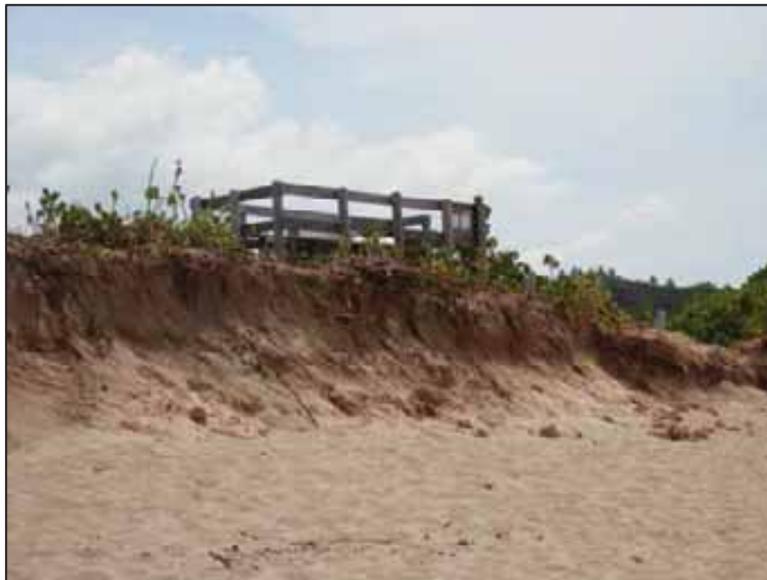
Figure 138. Severely eroded part of the dune crest in Middles beach. Note the condition of the boardwalk on the middles beach platform after the 2017 hurricane season.

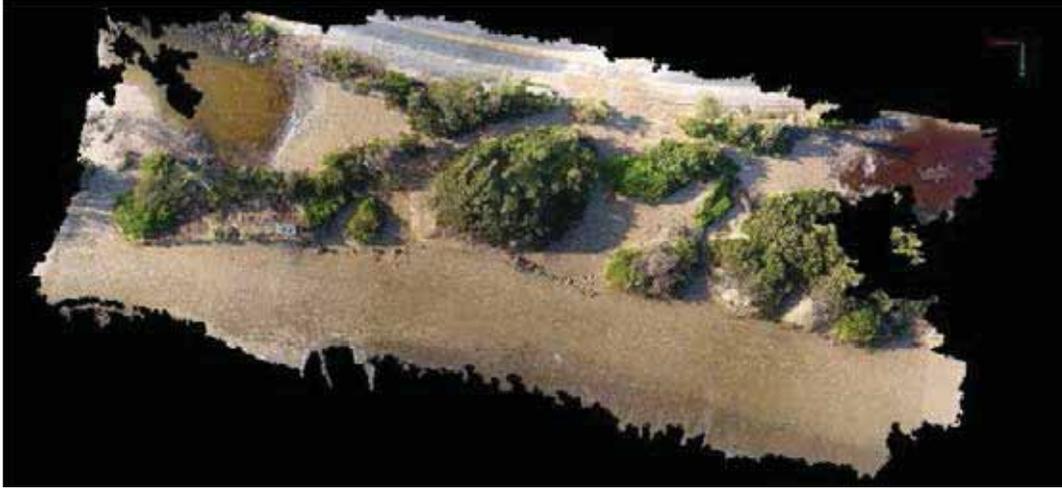
Figure 139. Aerial 3D image of Middles Beach, Isabela (after northeasterly swell).

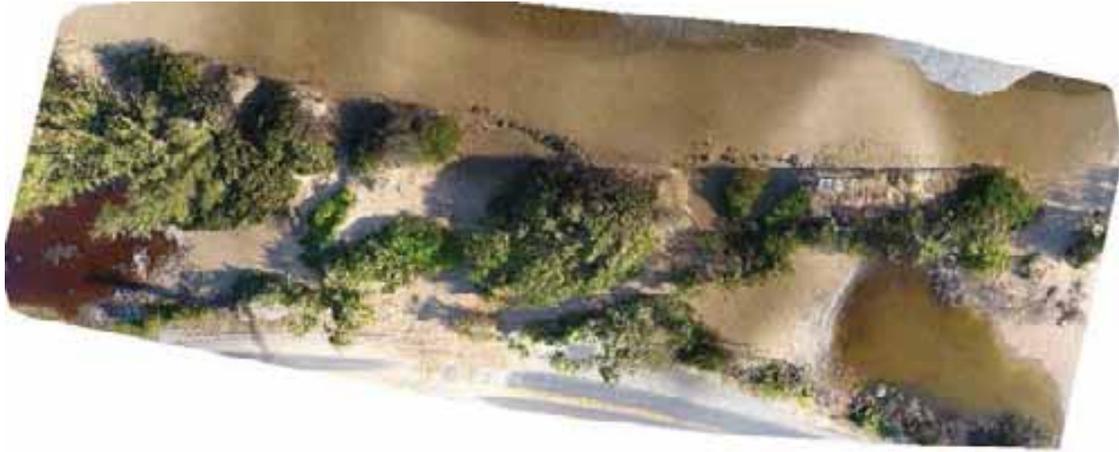
Figure 140. Orthomosaic image of Middles Beach, Isabela (after northeasterly swell).

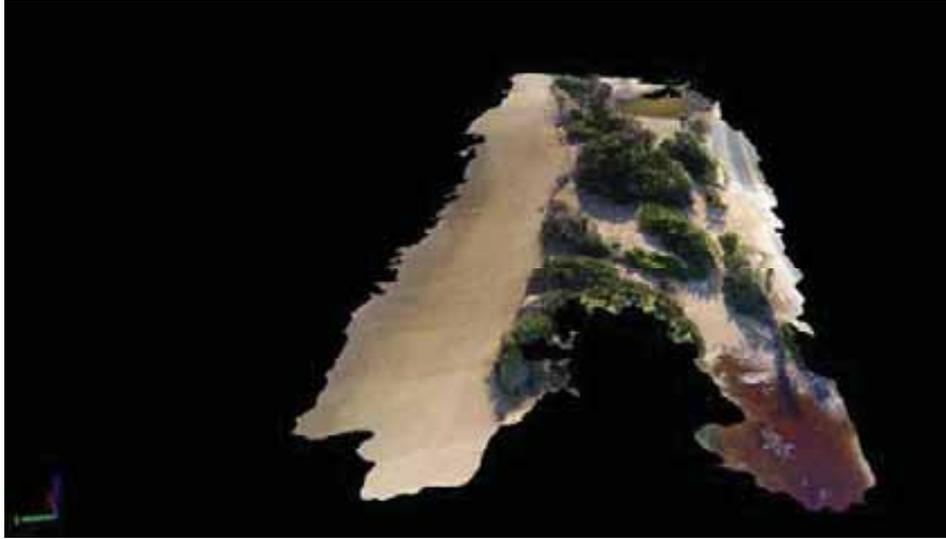
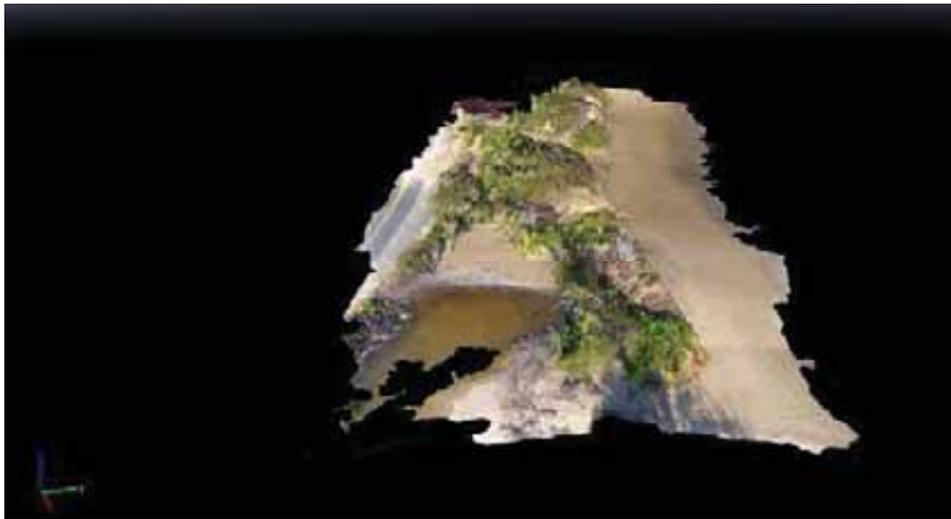
Figure 144. Three dimensional RGB images of Middles Beach, Isabela (after northeasterly swell). View from the west (top) and from the east (bottom).

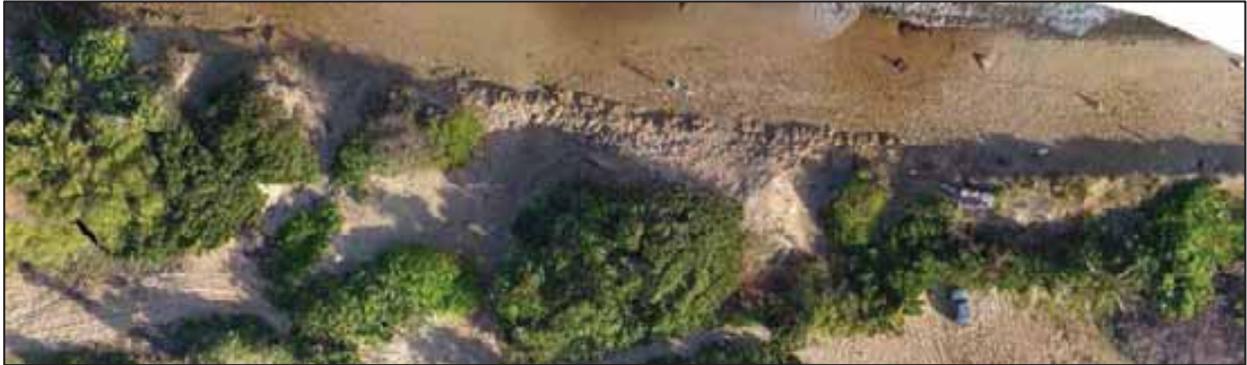
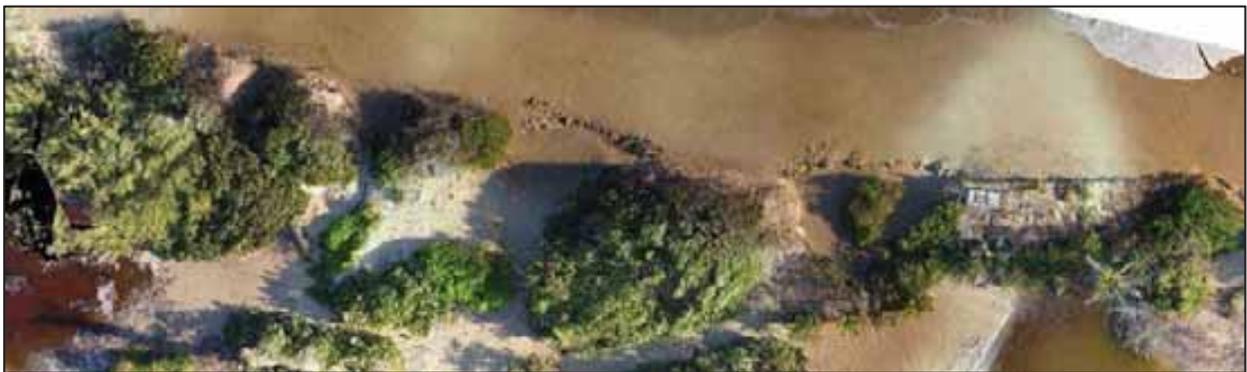
Figure 146. Images of the area for which vegetation cover is being monitored for the Middles Beach site in Isabela, Puerto Rico. The vegetation cover is 47.1% on January 16, 2018 (top) and 41.3% on March 7, 2018 (bottom).

Middles beach is a very popular surfing location that is subject to constant heavy foot traffic. The access trails are areas where no vegetation grows and were breached during the extreme weather events of 2017 and early 2018. This site is where several surfing contests are held every year. Even though we try to collaborate with the contest sponsors and request that their security officers help us protect the vegetated areas of this system there is always some damage to the system during one of these events. Heavy foot traffic is the main threat in this area.

We recommend the installation of exclusion fencing, two wooden boardwalks (one on the main entrance and replacement of the broken boardwalk leading to the observation platform), two information signs. Biomimicry matrices will also be installed to promote the accumulation of sand and the accumulated sand will be stabilized with the planting of dune vegetation.

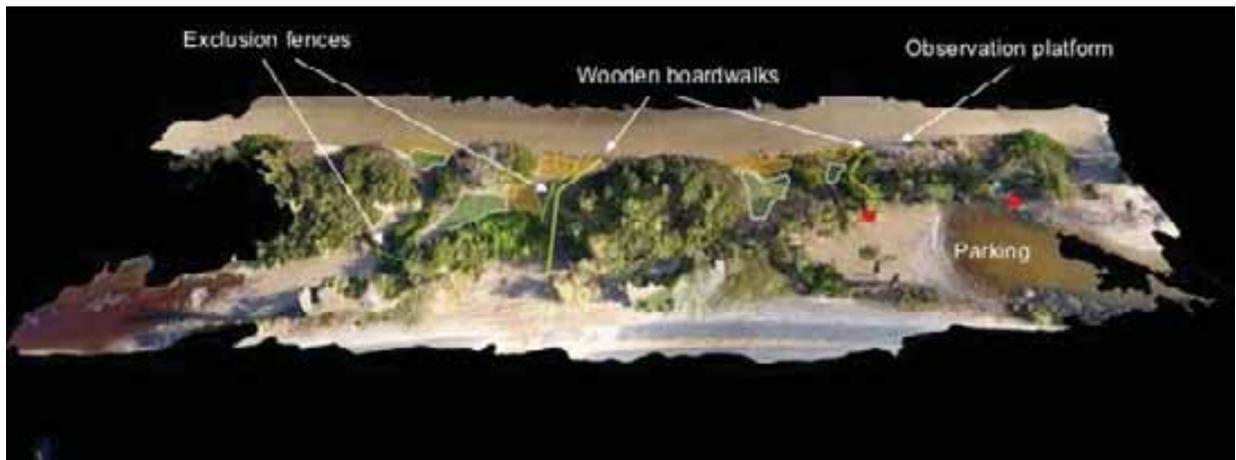
Figure 148. Area to be ecologically restored at Middles Beach on PR 466 in Barrio Bajuras, Isabela. **Highlighted areas correspond to each technique that will be used in this area.** Yellow represents the location of wooden boardwalks, platform and barriers, the red dot marks the location of an information sign, tan represents the area where biomimicry matrices will be installed to promote the accumulation of sand and areas shaded in light green represent locations for the planting of vegetation.

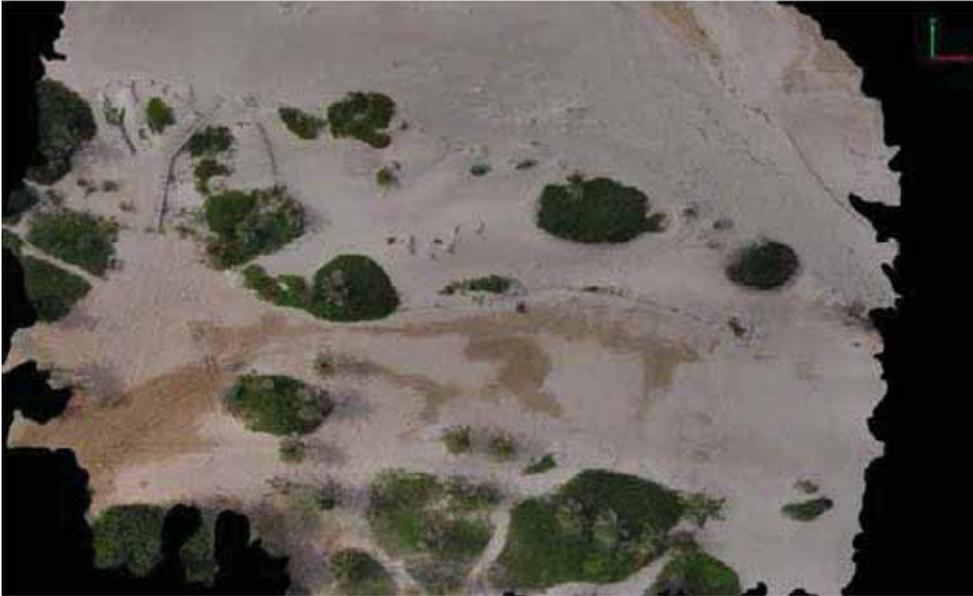
Figure 162. Aerial 3D image of Poza Teodoro (before María), Isabela, Puerto Rico, Puerto Rico.

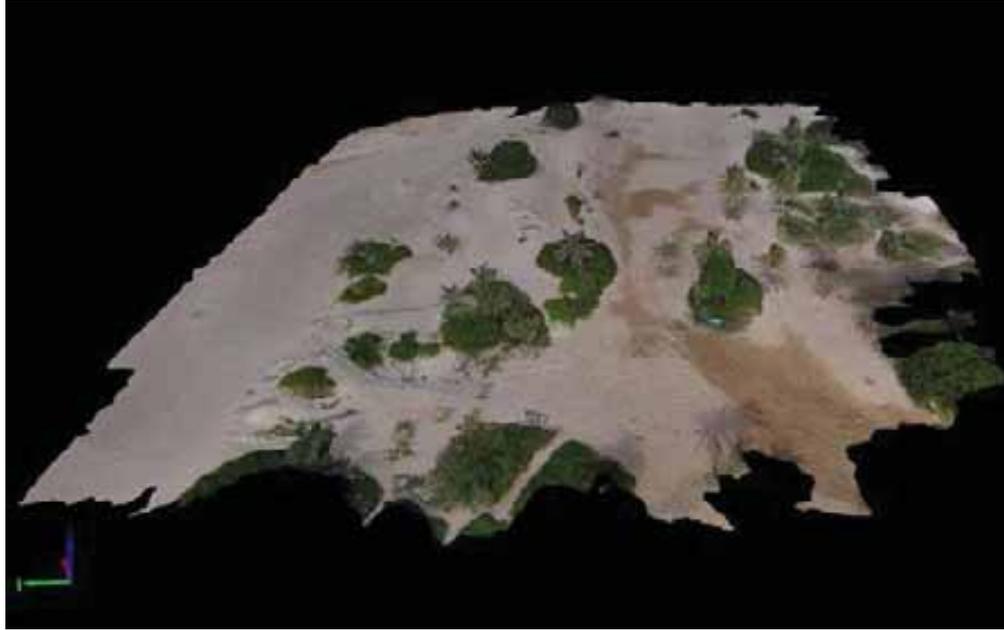
Figure 167. Three dimensional RGB images of the Poza Teodoro (before María), Isabela, Puerto Rico. View from the west (top) and from the east (bottom).

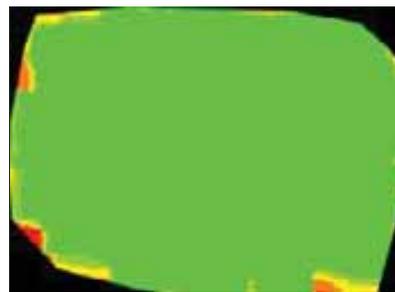
Figure 4: Number of overlapping images computed for each pixel of the orthomosaic. Red and yellow areas indicate low overlap for which poor results may be generated. Green areas indicate an overlap of over 5 images for every pixel. Good quality results will be generated as long as the number of keypoint matches is also sufficient for these areas (see Figure 5 for keypoint matches).

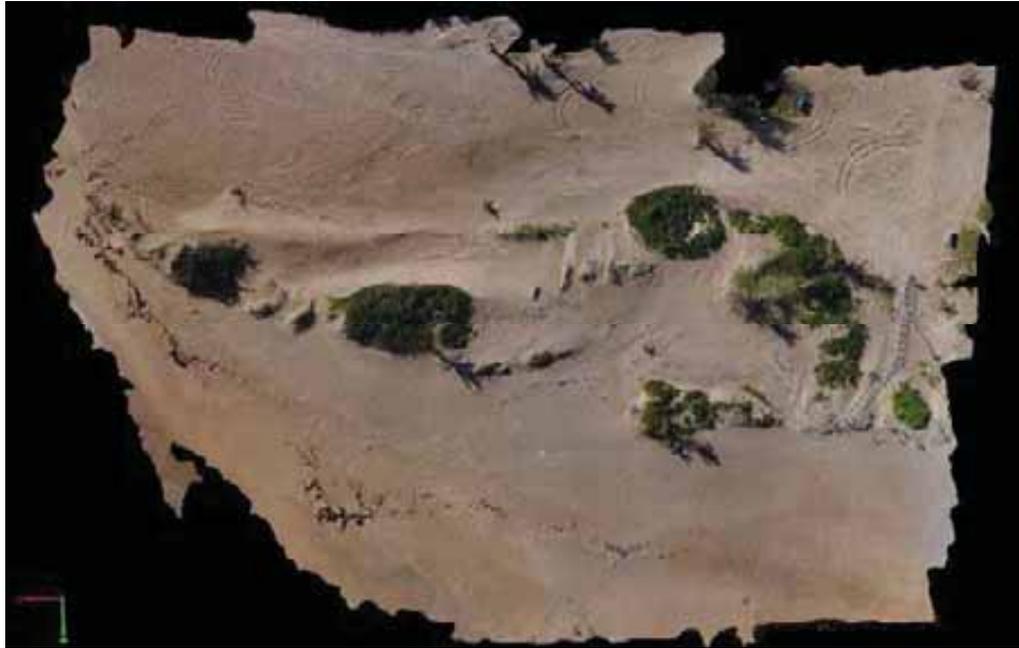
Figure 170. Aerial 3D image of Poza Teodoro (after hurricane María), Isabela, Puerto Rico.

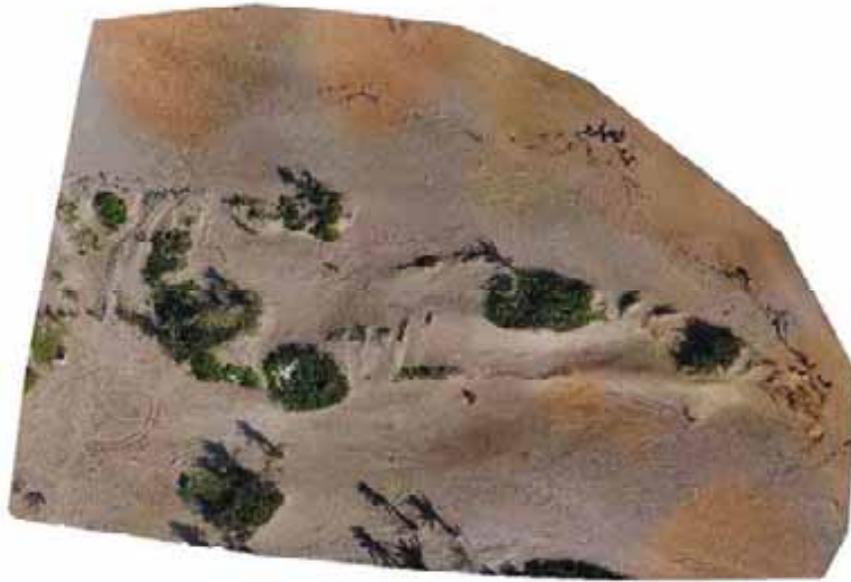
Figure 171. Orthomosaic image of Poza Teodoro (after hurricane María), Isabela, Puerto Rico.

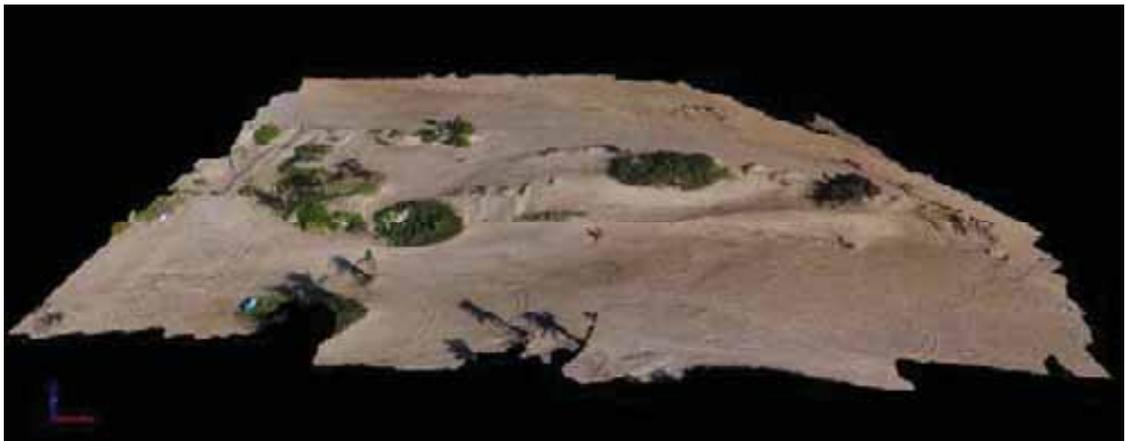
Figure 174. Three dimensional RGB images of the Poza Teodoro (after María), Isabela, Puerto Rico. View from the north (top) and from the south (bottom).

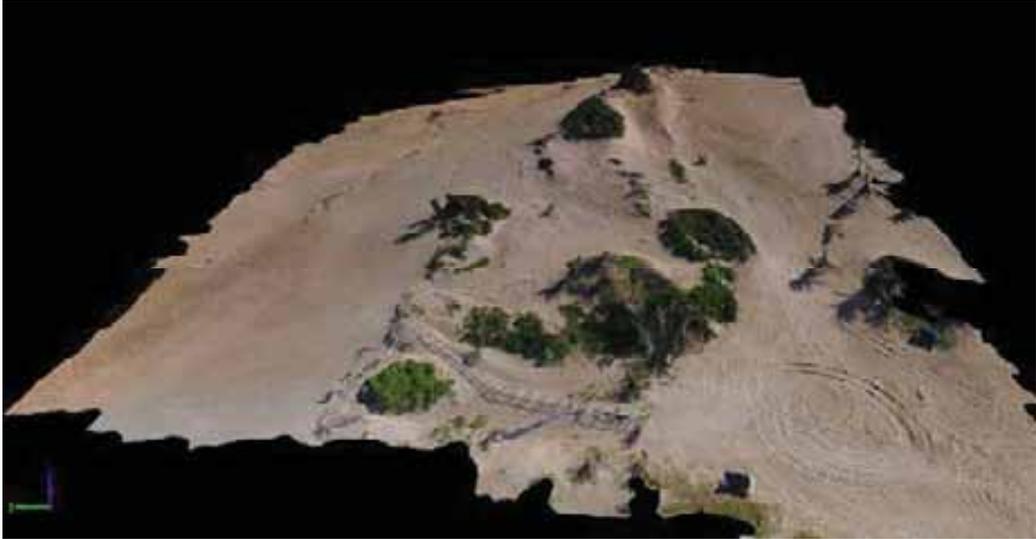
Figure 175. Three dimensional RGB images of the Poza Teodoro (after María), Isabela, Puerto Rico. View from the west (top) and from the east (bottom).

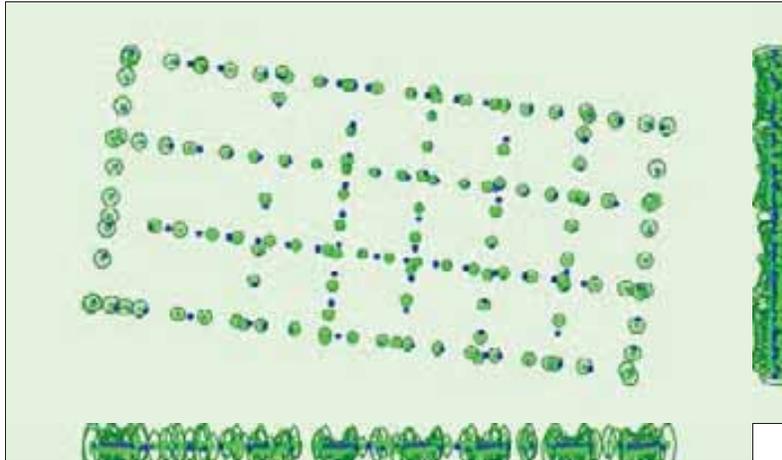
Figure 3: Offset between initial (blue dots) and computed (green dots) image positions as well as the offset between the GCPs initial positions (blue crosses) and their computed positions (green crosses) in the top-view (XY plane), front-view (XZ plane), and side-view (YZ plane). Dark green ellipses indicate the absolute position uncertainty of the bundle block adjustment result.

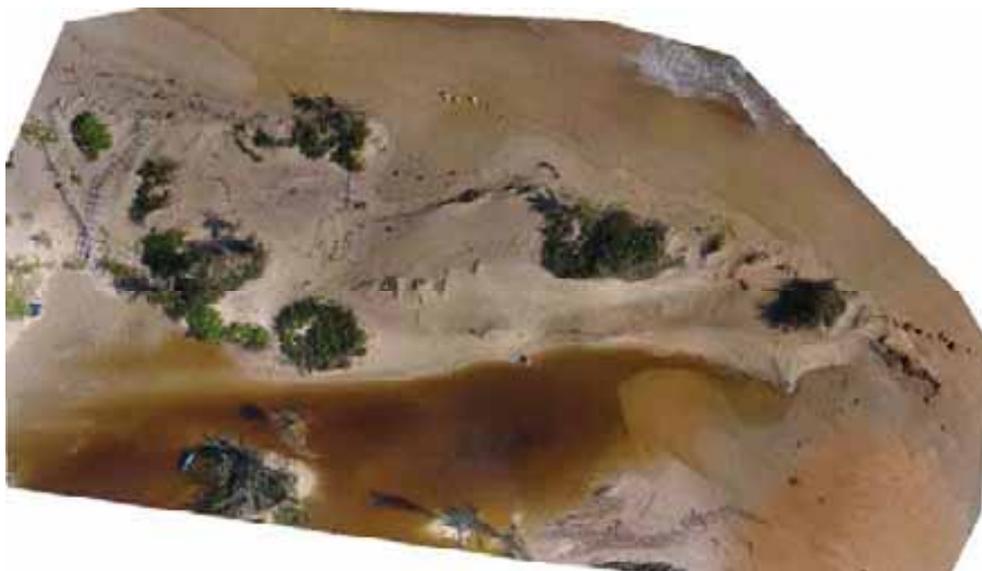
Figure 178. Orthomosaic image of Poza Teodoro (after swell), Isabela, Puerto Rico.

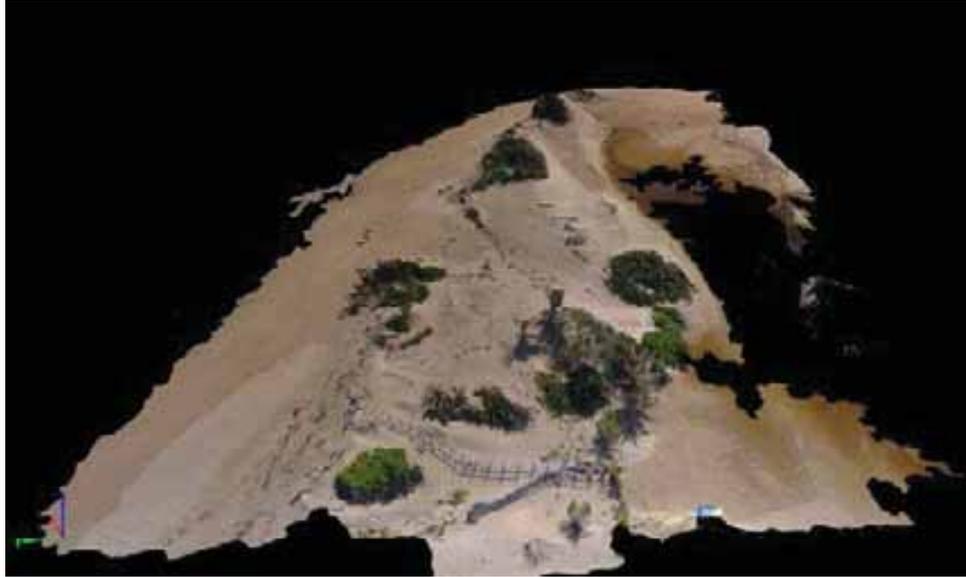
Figure 182. Three dimensional RGB images of the Poza Teodoro (after swell), Isabela. View from the west (top) and from the east (bottom).

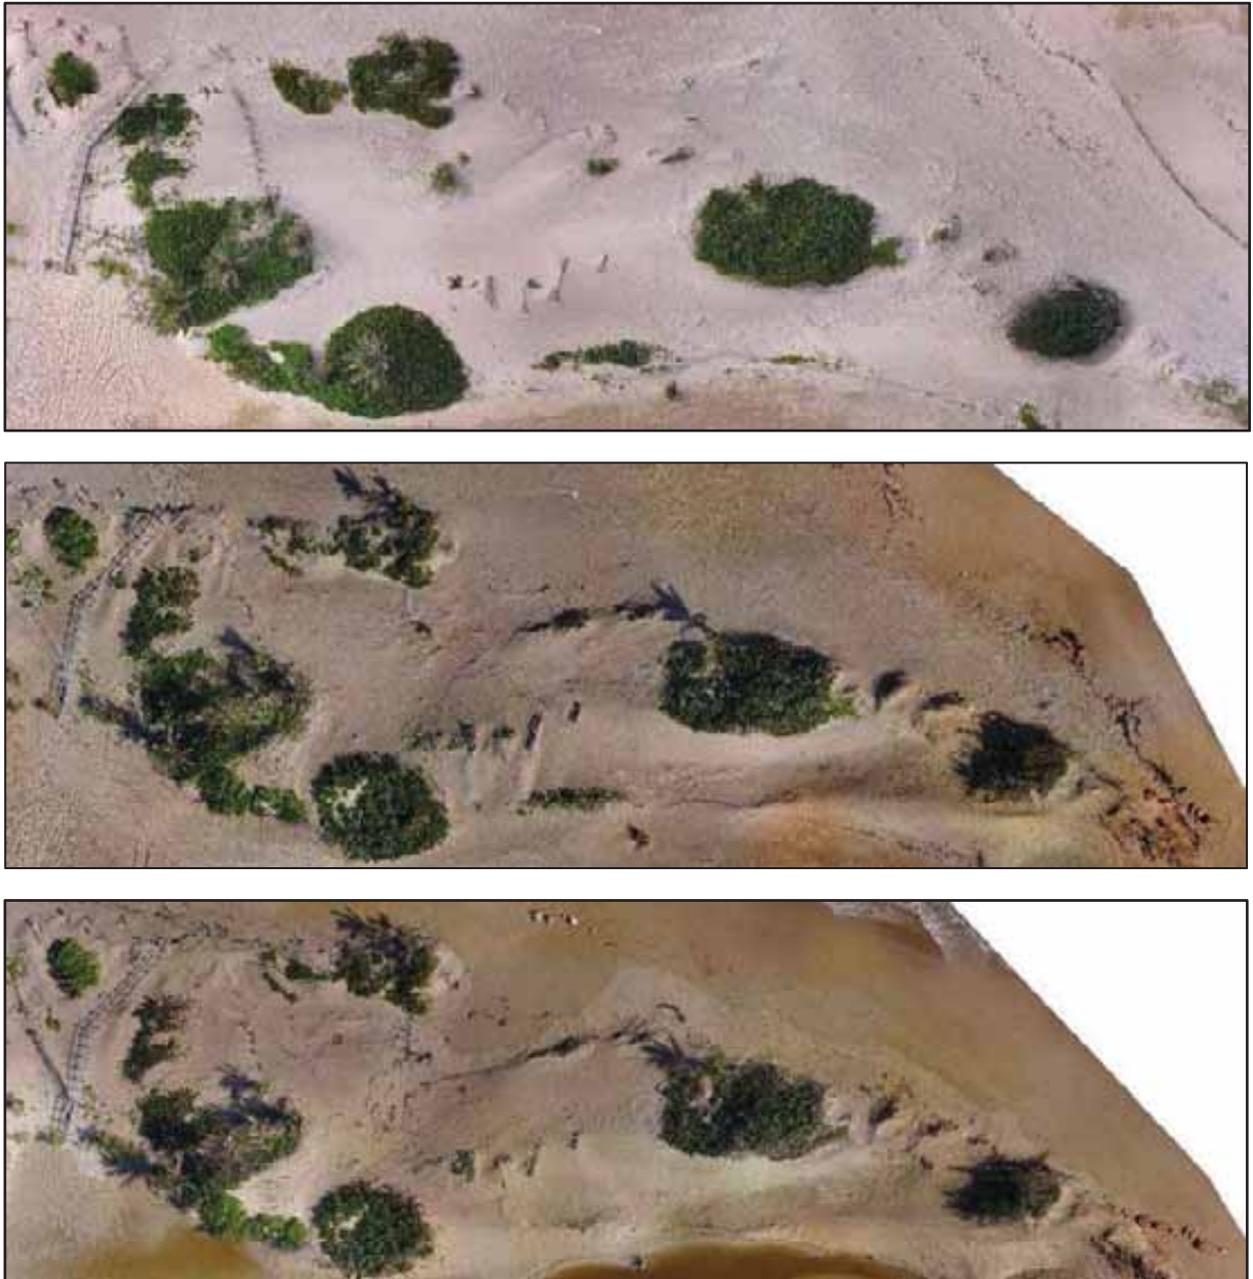
Figure 184. Vegetation cover was 22.7 % on Poza de Teodoro before hurricane María (May 22, 2018) (top), 19.6 % after hurricane María and before the northeasterly swell (January 16, 2018) (middle) and 17.8 % after the northeasterly swell (March 7, 2018) (bottom).

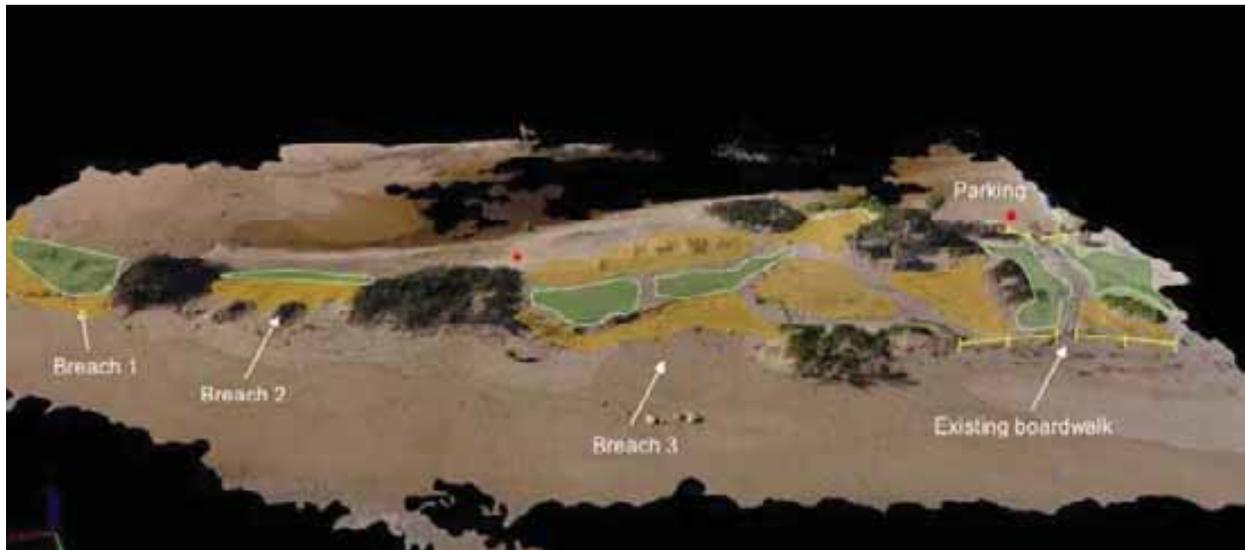
Figure 186. Area to be ecologically restored at Poza de Teodoro in Barrio Bajuras, Isabela. Highlighted areas correspond to each technique that will be used in this area. **Yellow** represents the location of wooden boardwalks, platform and barriers, the **red dot** marks the location of an information sign, light green marks the location of planting of dune vegetation, tan represents the area where biomimicry matrices will be installed to promote the accumulation of sand and areas shaded in light green represent locations for the planting of vegetation.

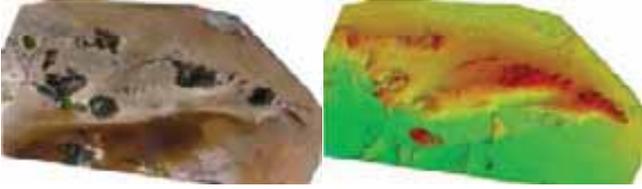
Figure 1: Orthomosaic and the corresponding sparse Digital Surface Model (DSM) before densification.

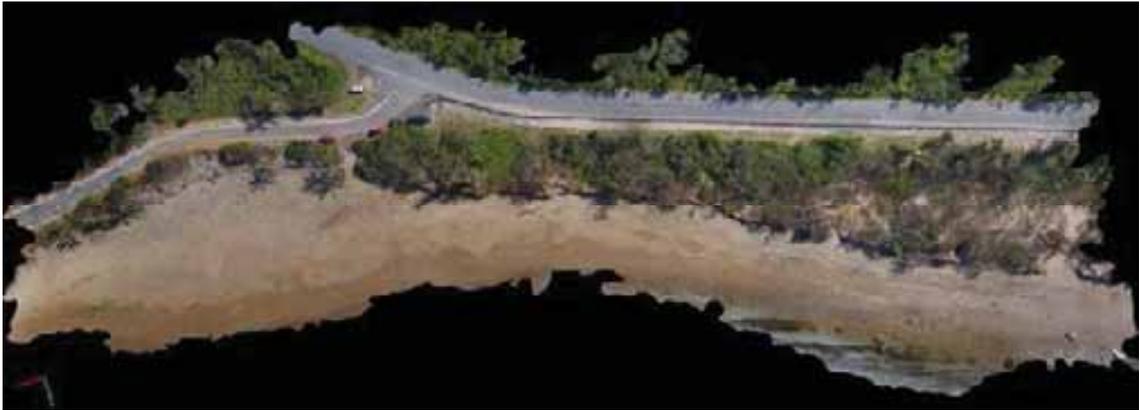
Figure 188. Aerial 3D image of Shore Island (after swell) Isabela

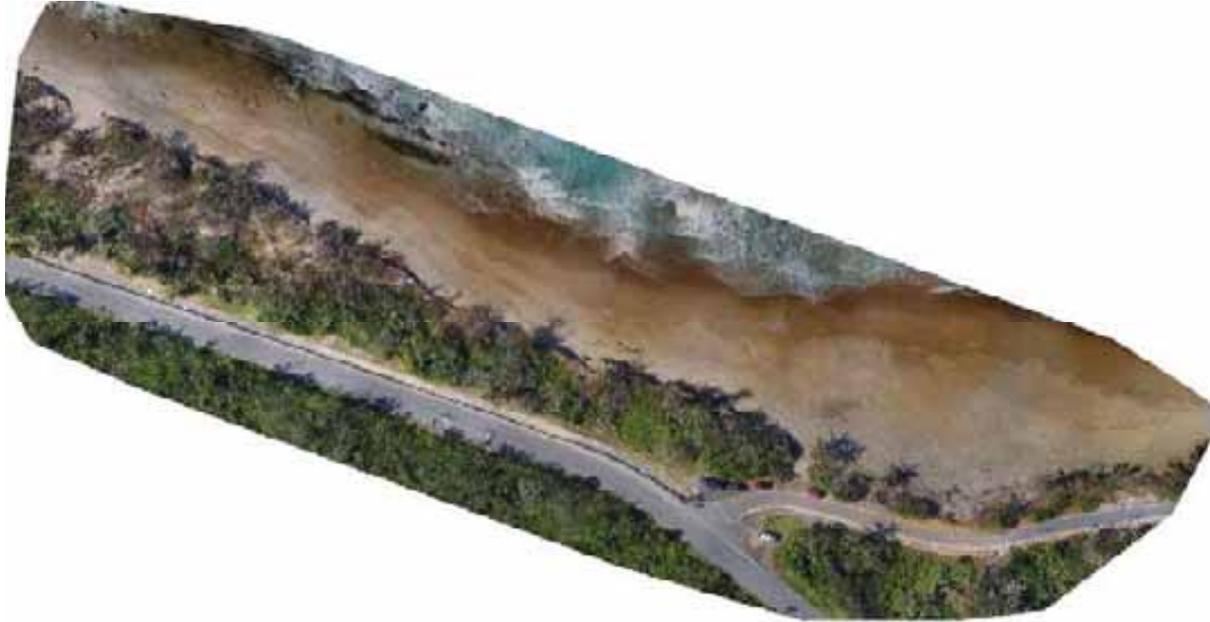
Figure 189. Orthomosaic image of East Middles (after swell) Isabela.

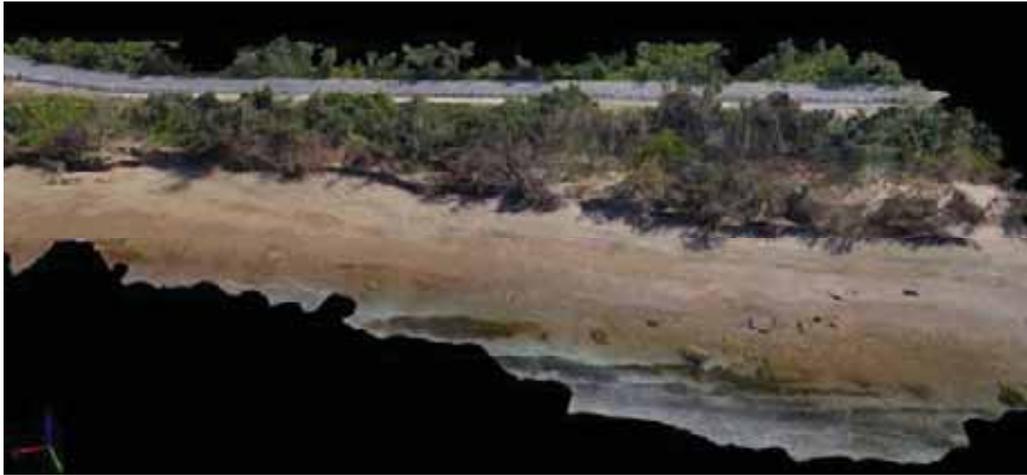
Western section - Shore Island

Figure 193. Three dimensional RGB images of the Shore Island (after swell), Isabela. View from the north (top) and from the south (bottom).
