Coastal Dune and Erosion Assessment of the North Coast of Puerto Rico

Final Report

**DOI-FEMA Natural and Cultural Resources
Recovery Support Function (NCR RSF)**

**Universidad de Puerto Rico en Aguadilla
Vida Marina: Centro de Conservación y Restauración Ecológica Costera**

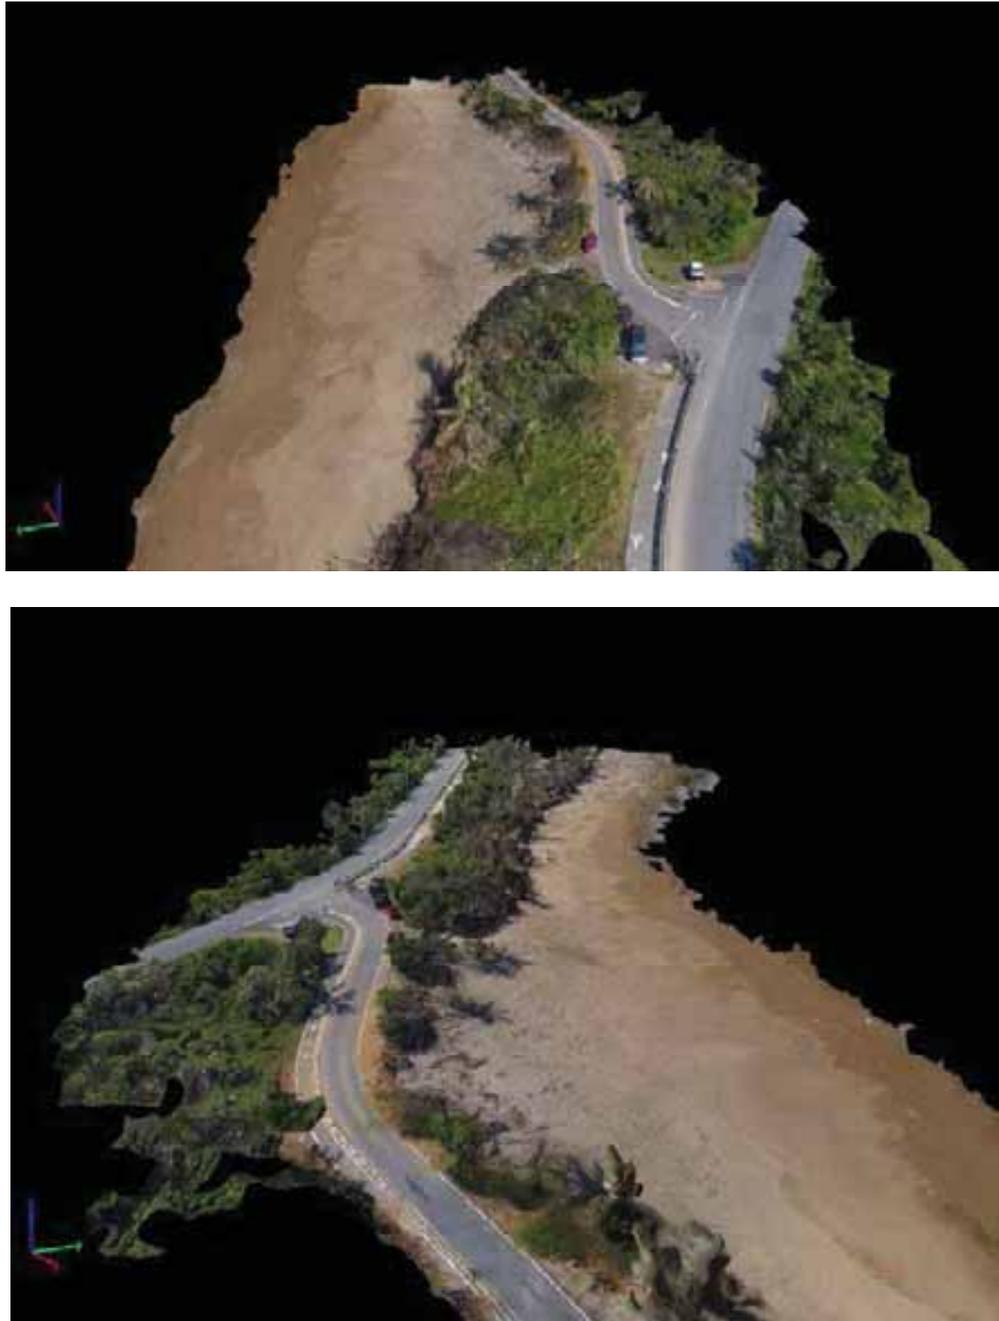
Eastern section - Shore Island

Figure 194. Three dimensional RGB images of the Shore Island (after swell), Isabela. View from the west (top) and from the east (bottom).

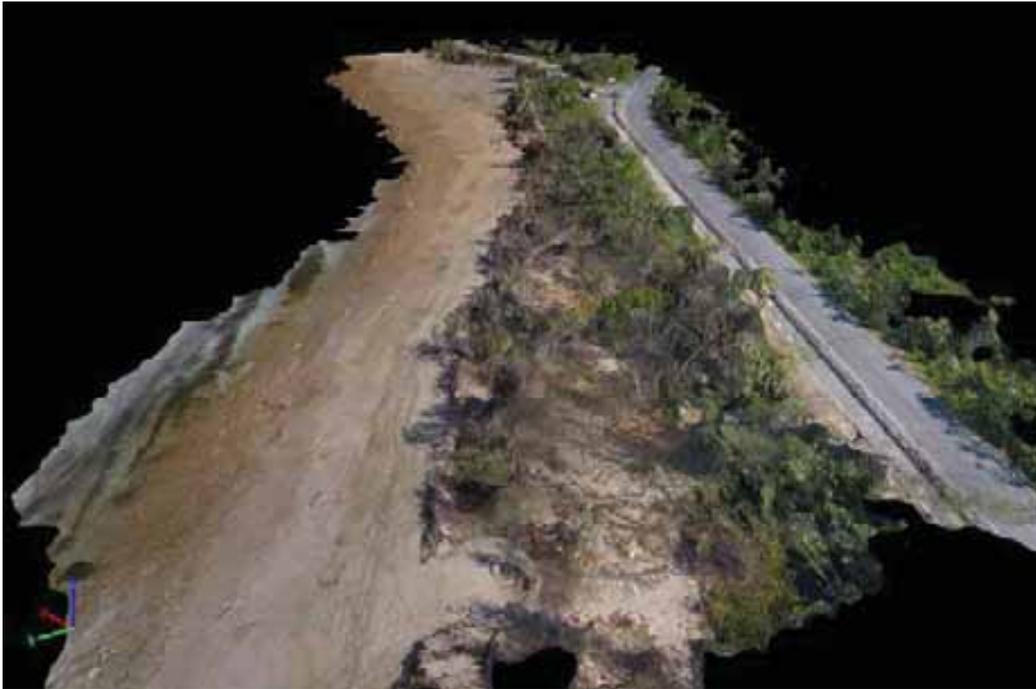
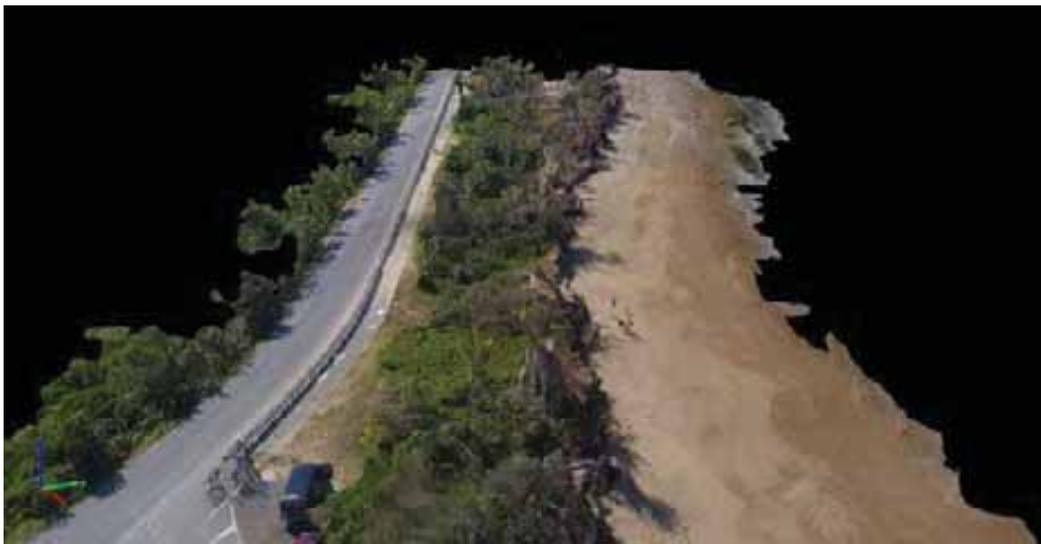
Western section - Shore Island

Figure 195. Three dimensional RGB images of the Shore Island (after swell), Isabela. View from the west (top) and from the east (bottom).

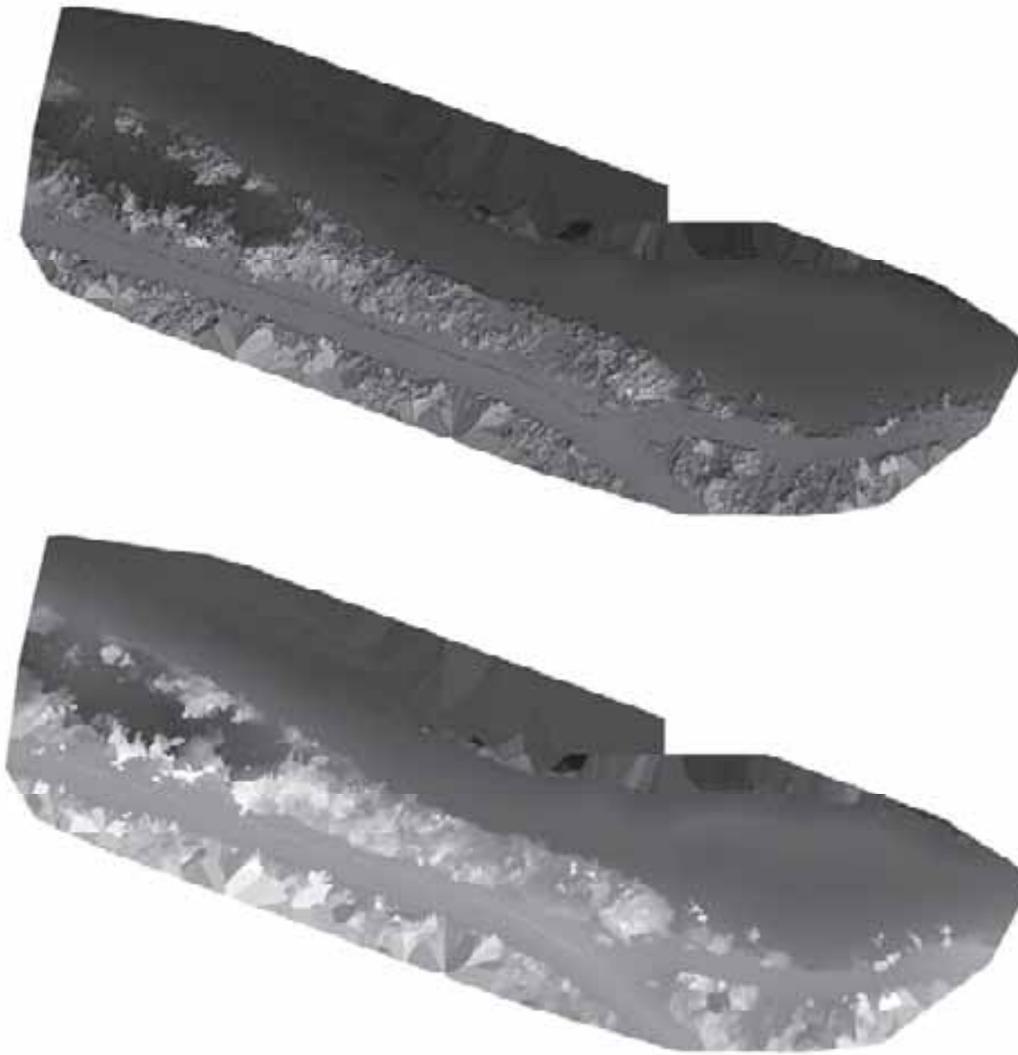
Figure 196. Grayscale DSM images of the dune to the Shore Island (after swell), Isabela. The top image shows shades and the bottom is not shaded.

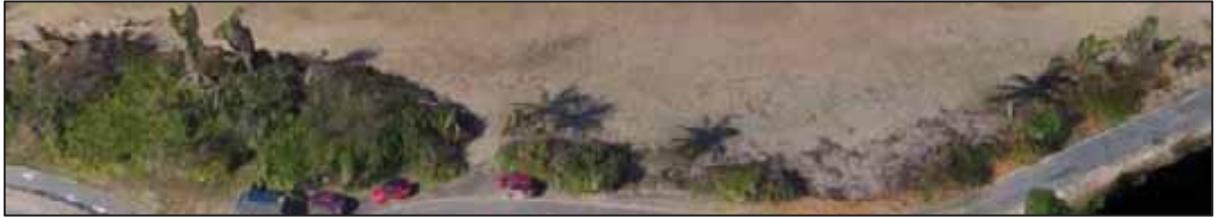
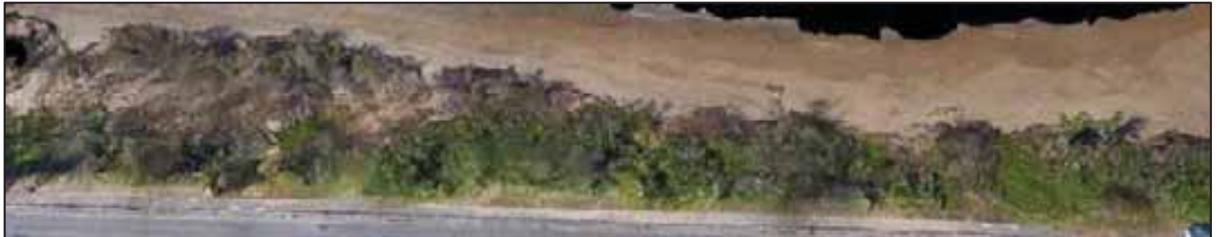
Figure 197. Vegetation covered 40.4% of the area on the western section of Shore Island (top) and 49.8 % on the eastern section of Shore Island in Isabela on March 19, 2018

We recommend the installation of a boardwalk on the beach entrance as well as the installation of biomimicry matrices and planting dune vegetation on that segment of primary dune.

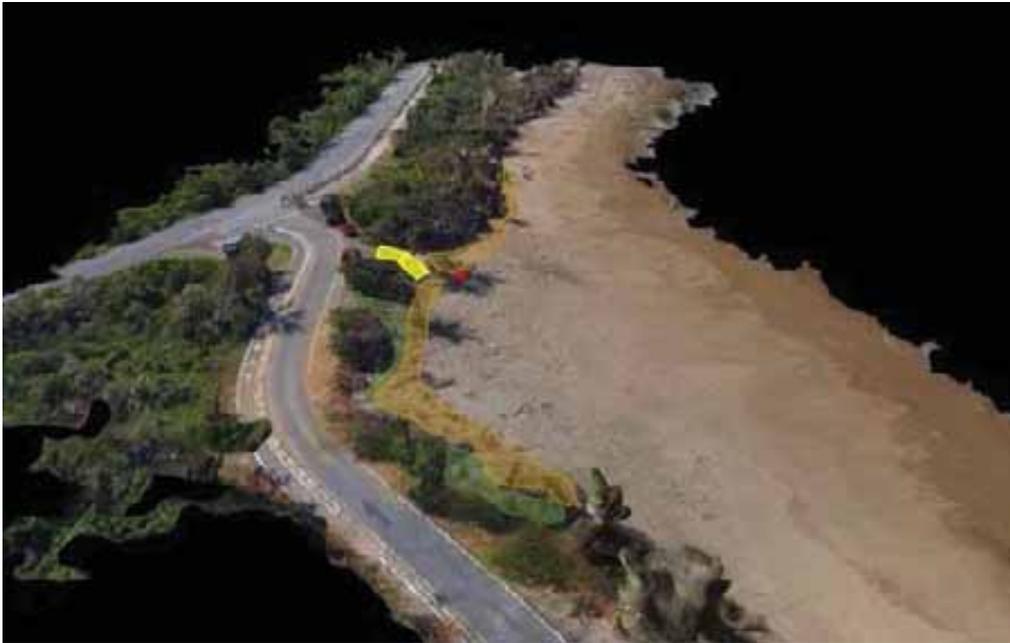
Figure 199. Area to be ecologically restored in Shore Island Beach in Isabela, Puerto Rico. Highlighted areas correspond to each technique that will be used in this area. Yellow represents the location of a wooden boardwalk, the red dot marks the location of an information sign, light green marks the location of planting of dune vegetation, tan represents the area of the dune crest that where biomimicry matrices will be installed to promote the accumulation of sand. The areas shaded in light green represent locations for the planting of dune vegetation.

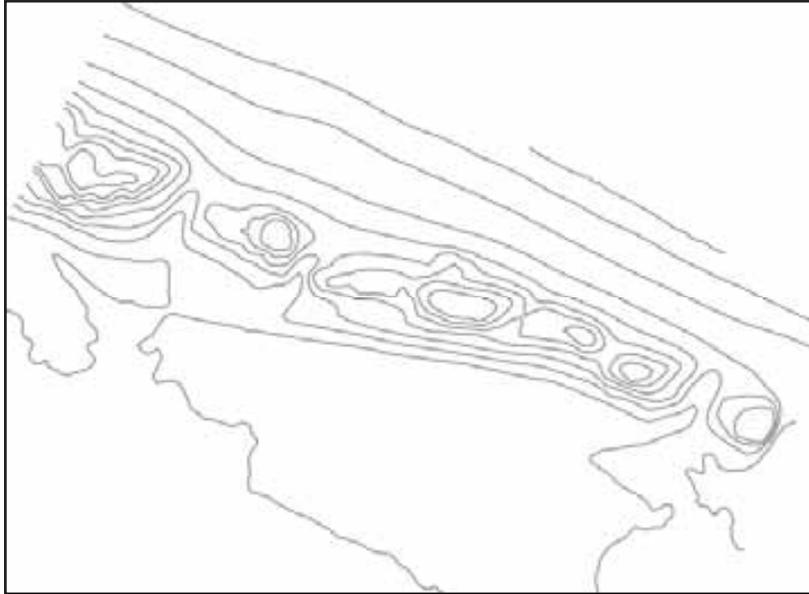
Figure 200. Contour map of Pozo Brujo (after Maria), Isabela Puerto Rico with elevation intervals of 1 meter.

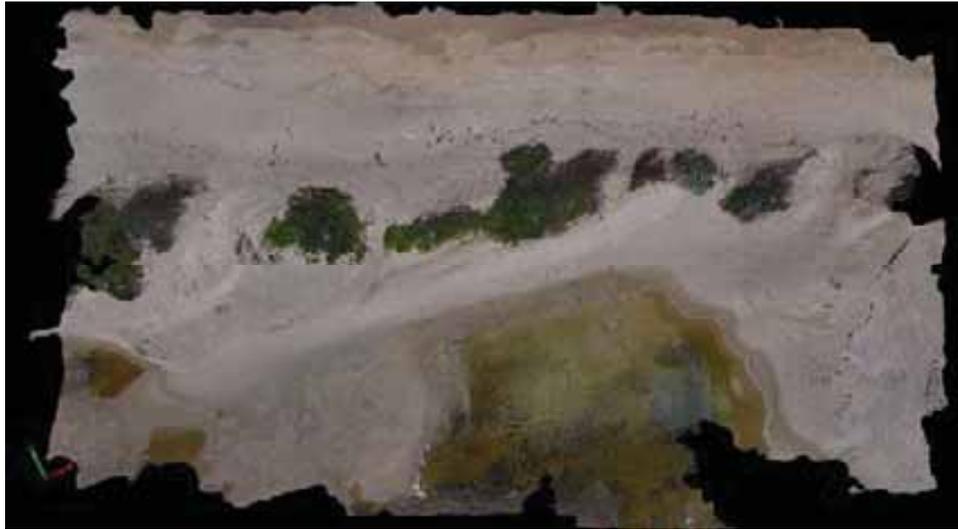
Figure 201. Aerial 3D image of Pozo Brujo (after María),

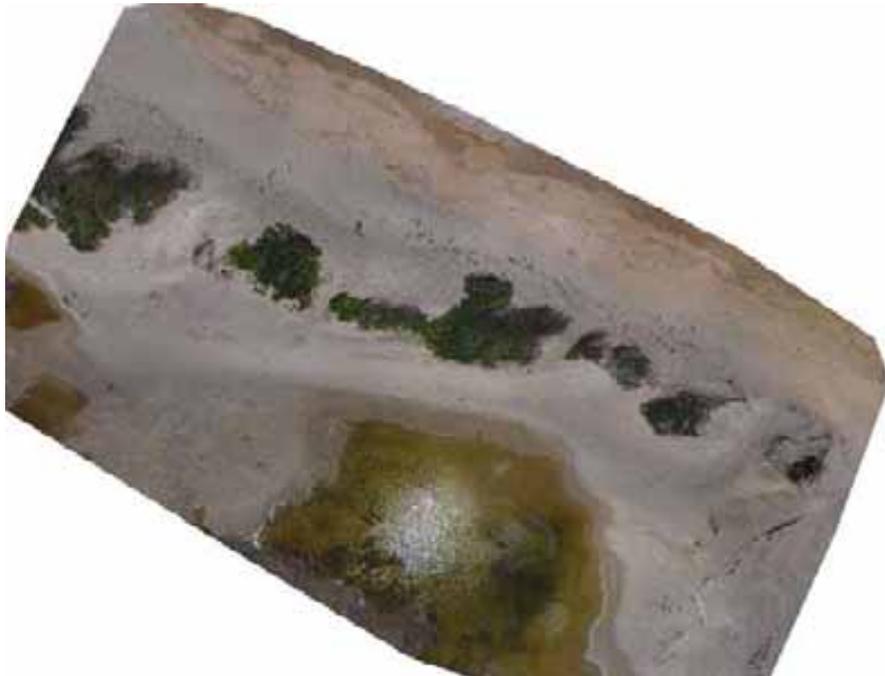
Figure 202. Orthomosaic image of Pozo Brujo (after María), Isabela

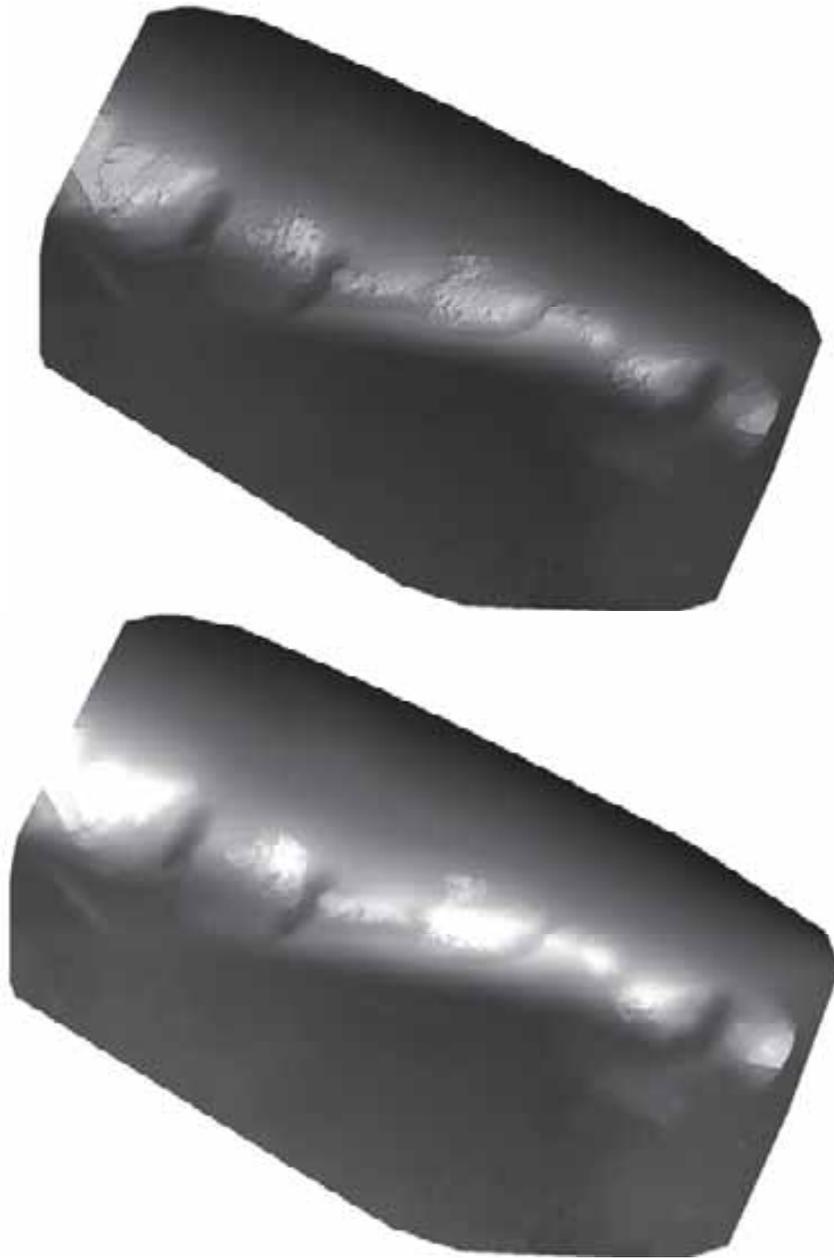
Figure 207. Grayscale DSM images of the dune to the Pozo Brujo (after María), Isabela. The top image shows shades and the bottom is not shaded.

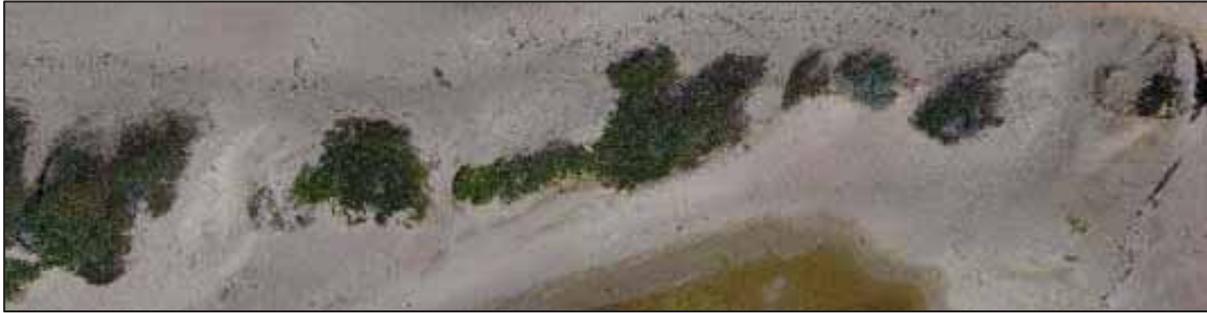
Figure 208. Vegetation covered 18.7 % of the area at Pozo Brujo (after María), Isabela on February 28, 2018.

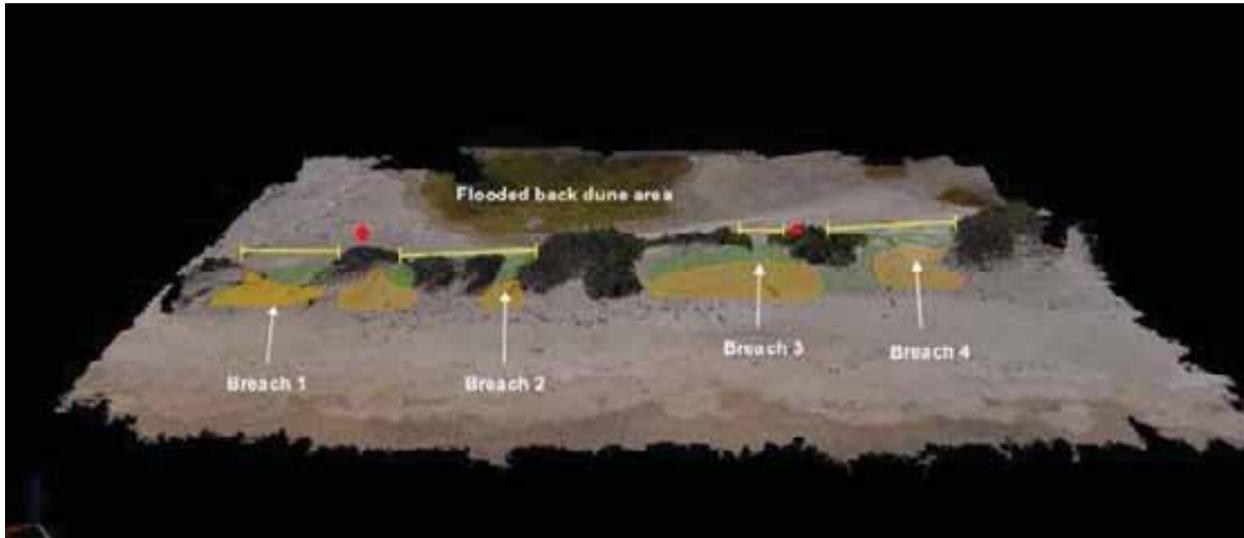
Figure 210. Area to be ecologically restored in Pozo Brujo Isabela, Puerto Rico. Highlighted areas correspond to each technique that will be used in this area. Yellow represents the location of a wooden boardwalk, light green marks the location of planting of dune vegetation, the red dot marks the location of an information sign, tan represents the area of the dune crest that where biomimicry matrices will be installed to promote the accumulation of sand. The areas shaded in light green represent locations for the planting of dune vegetation.

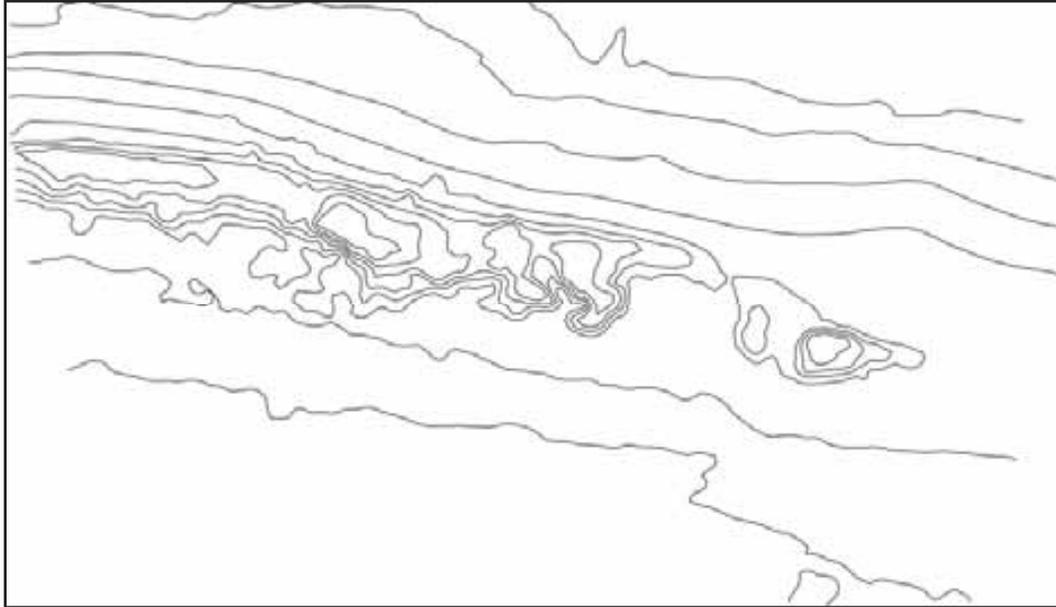
Figure 211. Contour map of Villa Pesquera, Camuy Puerto Rico with elevation intervals of 1 meter.

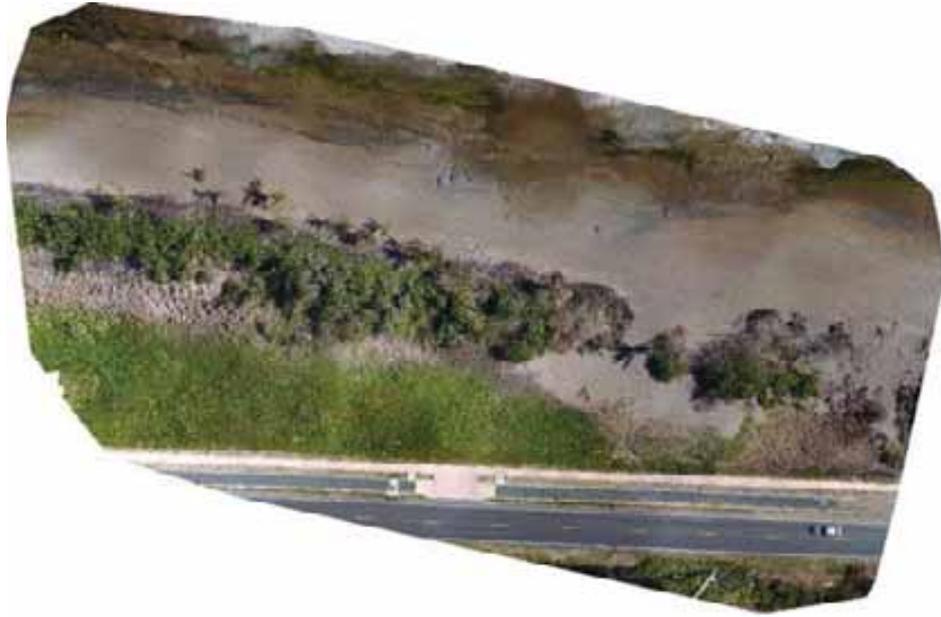
Figure 213. Orthomosaic image of the Villa Pesquera area, Camuy.

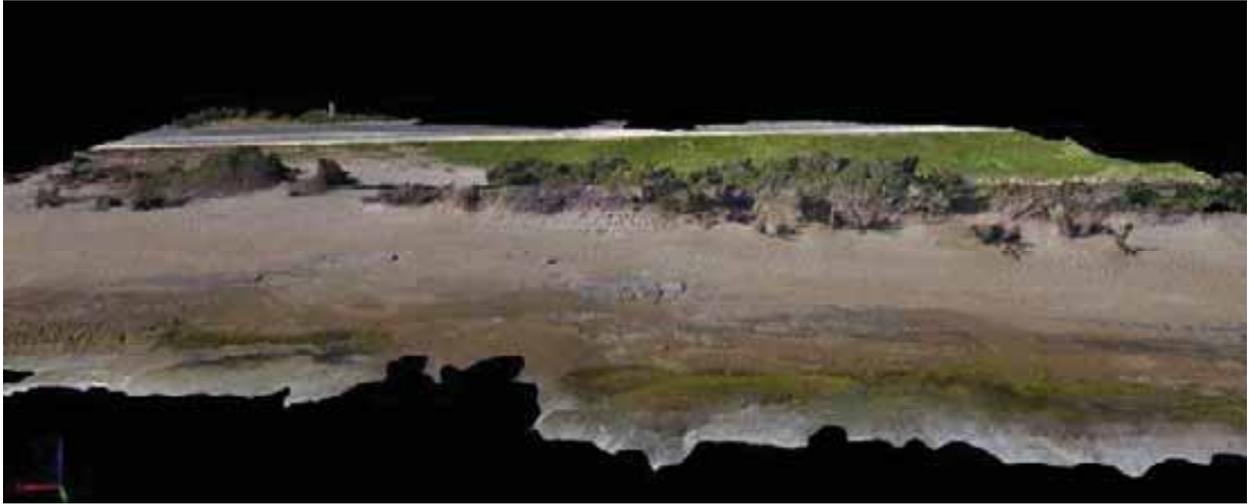
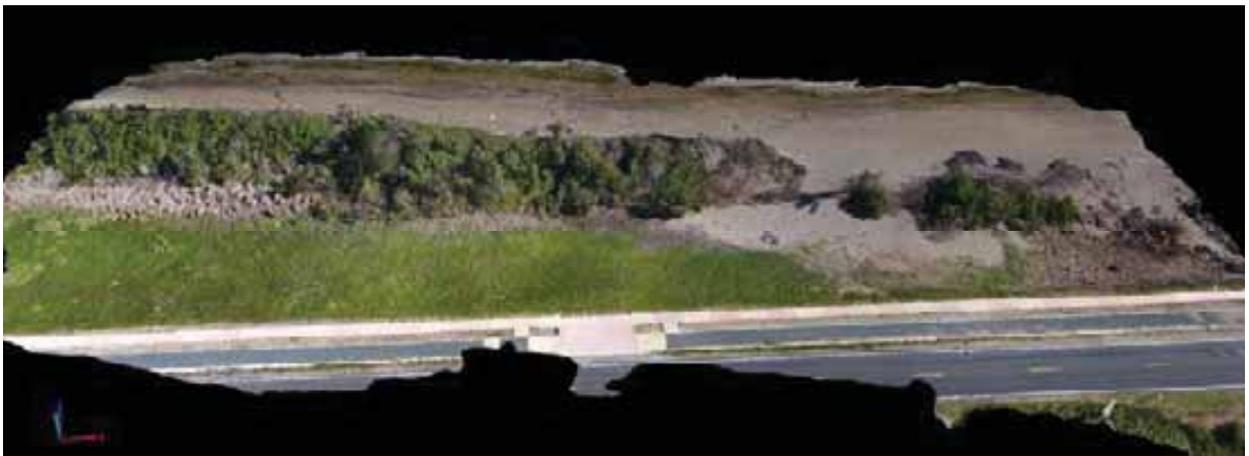
Figure 216. Three dimensional RGB images of Villa Pesquera, Camuy. View from the north (top) and from the south (bottom).

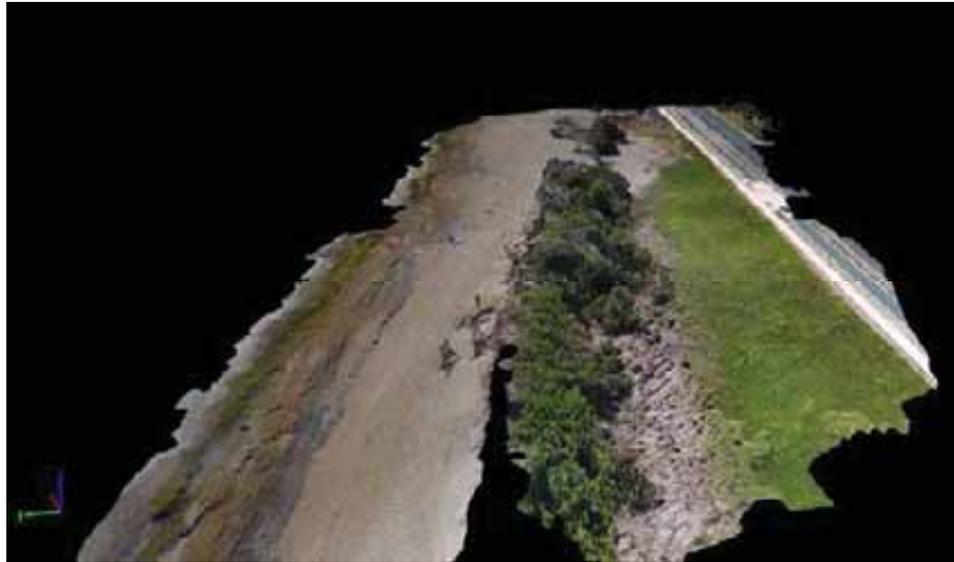
Figure 217. Three dimensional RGB images of Villa Pesquera, Camuy. View from the west (top) and from the east (bottom).

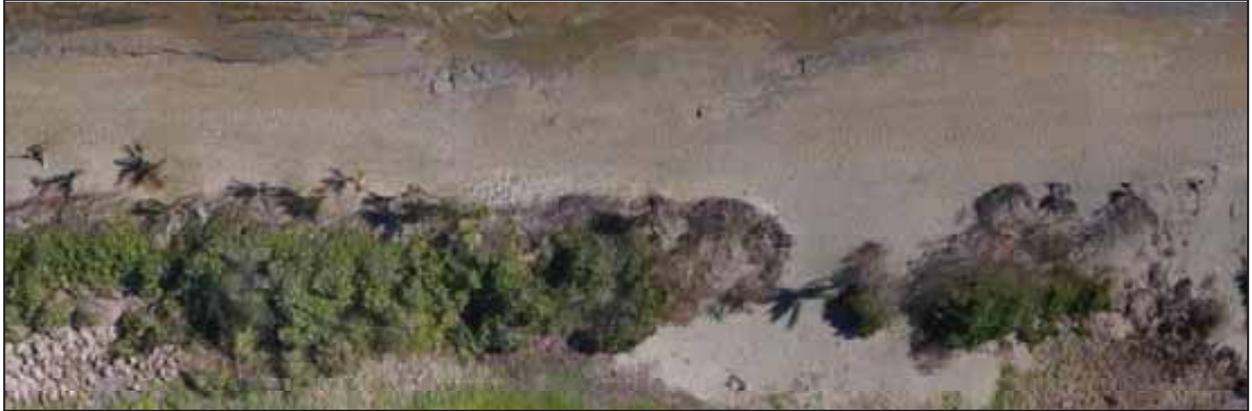
Figure 219. Vegetation covered 32.9% of the Villa Pesquera area in Camuy on April 27, 2018 (after the northeasterly swell).

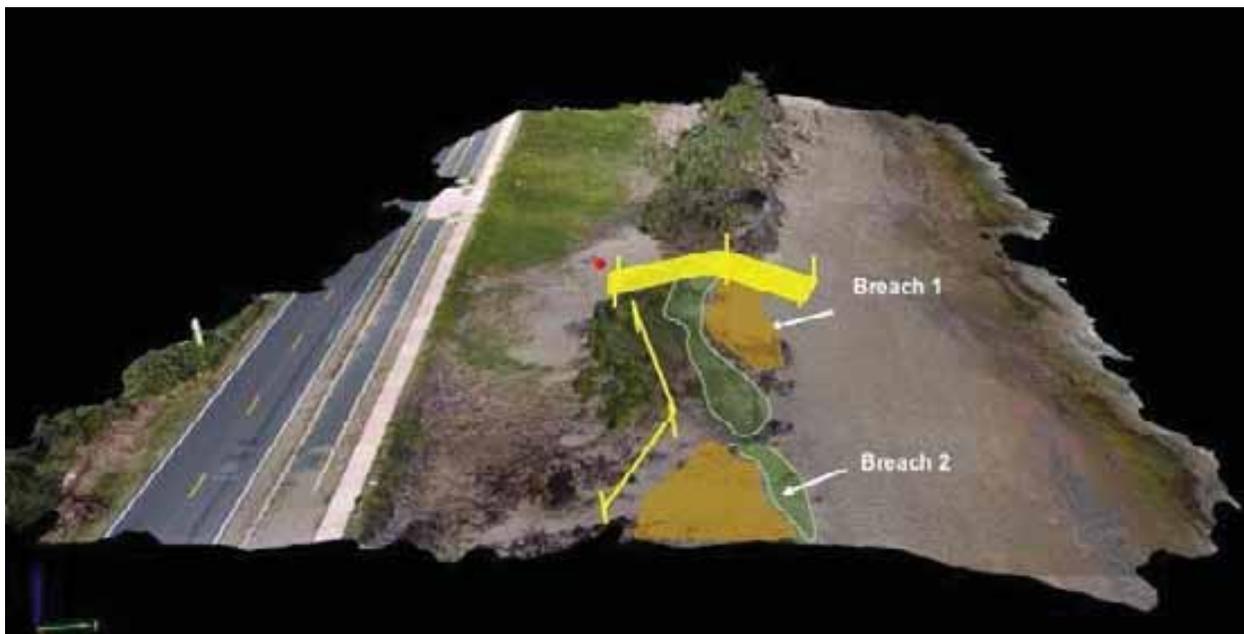
Figure 221. Area to be ecologically restored in the Villa Pesquera area in Camuy, Puerto Rico. Highlighted areas correspond to each technique that will be used in this area. **Yellow** represents the location of a wooden boardwalk, the **red dot** marks the location of an information sign, **tan** represents the area of the dune crest that where biomimicry matrices will be installed to promote the accumulation of sand. The areas shaded in **light green** represent locations for the planting of dune vegetation.

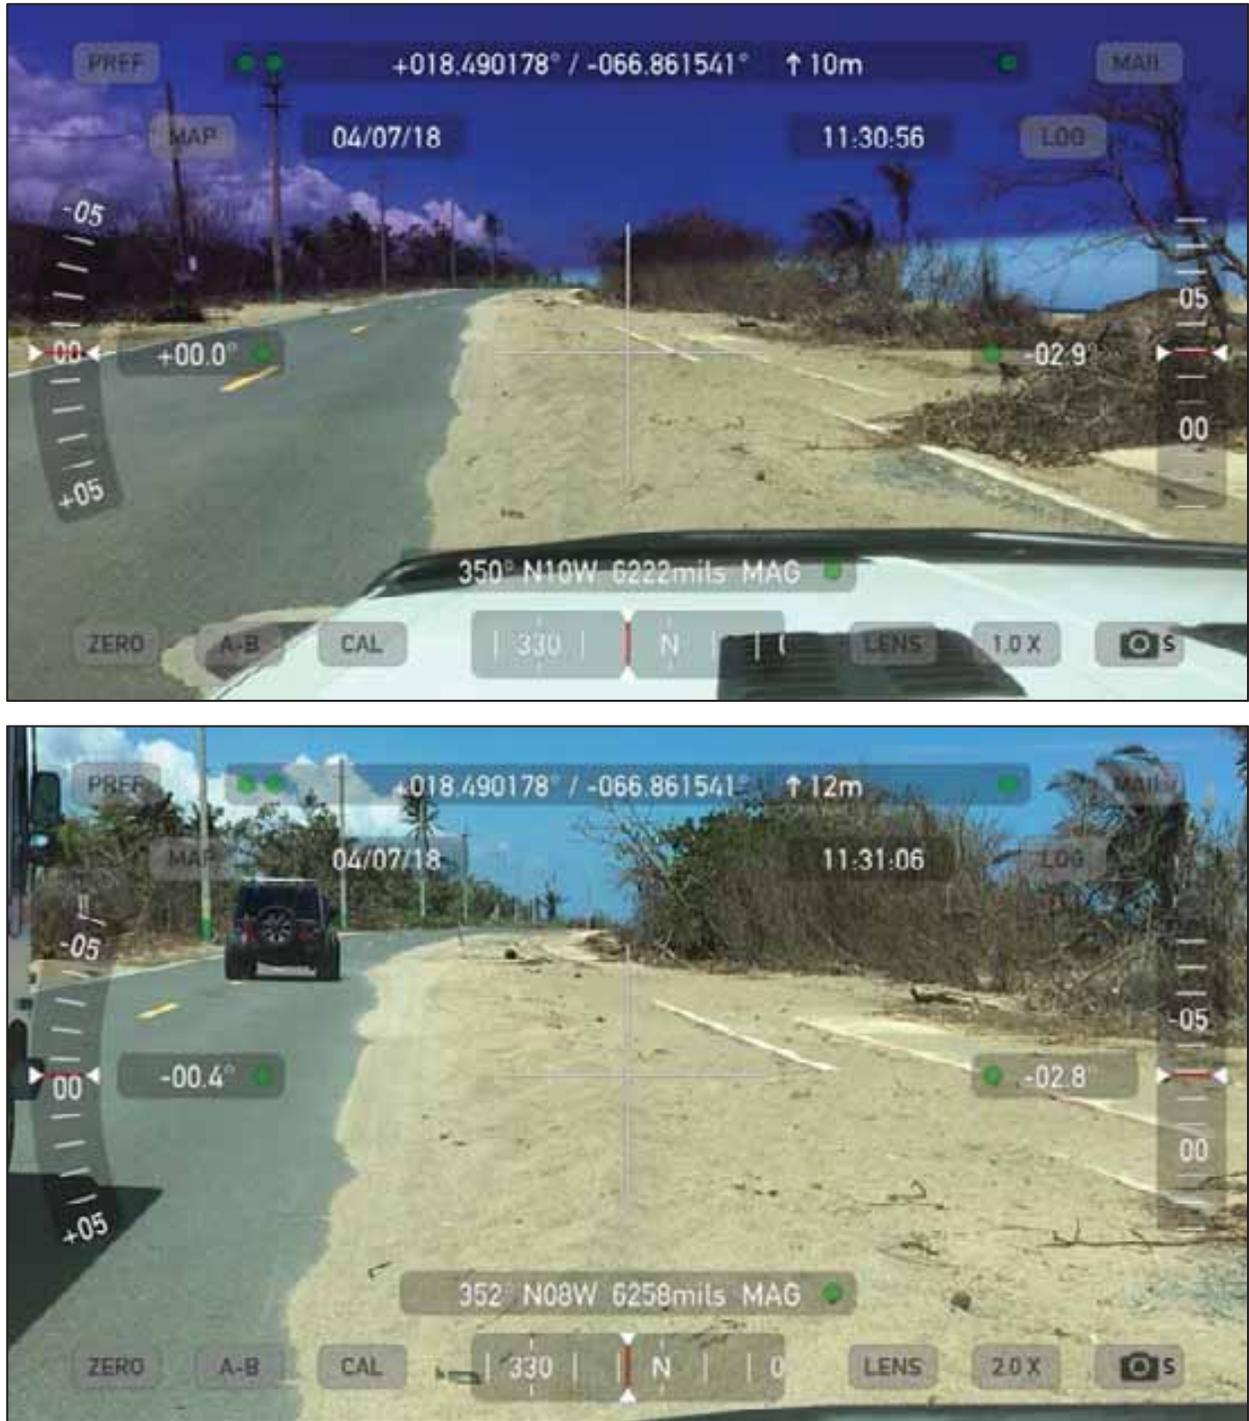
Figure 222. Displaced sand along PR-485 in front of the Villa Pesquera area site in Camuy, Puerto Rico.

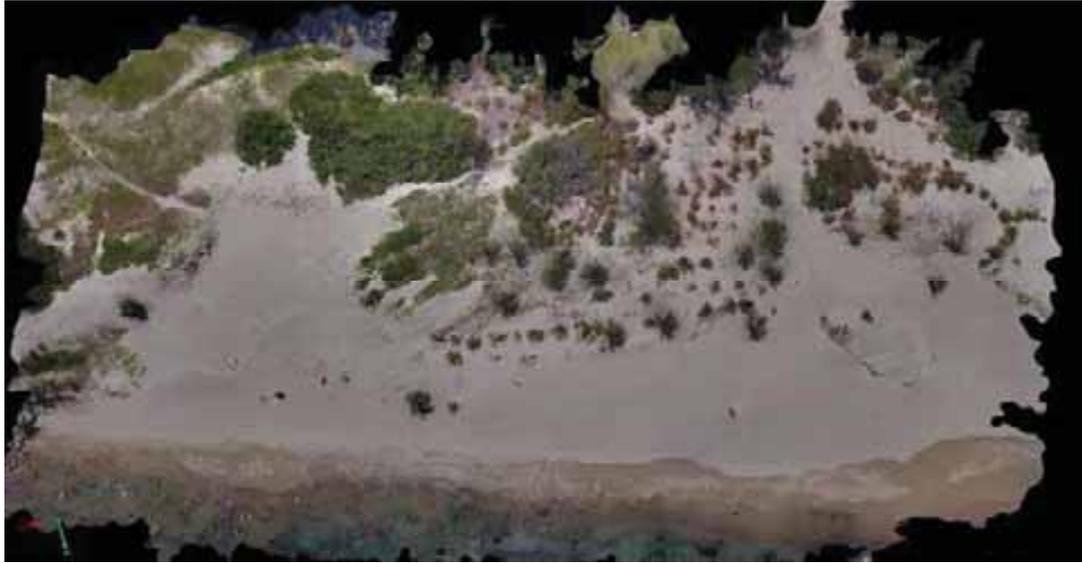
Figure 224. Aerial 3D image of the east of the FNNR, Camuy.

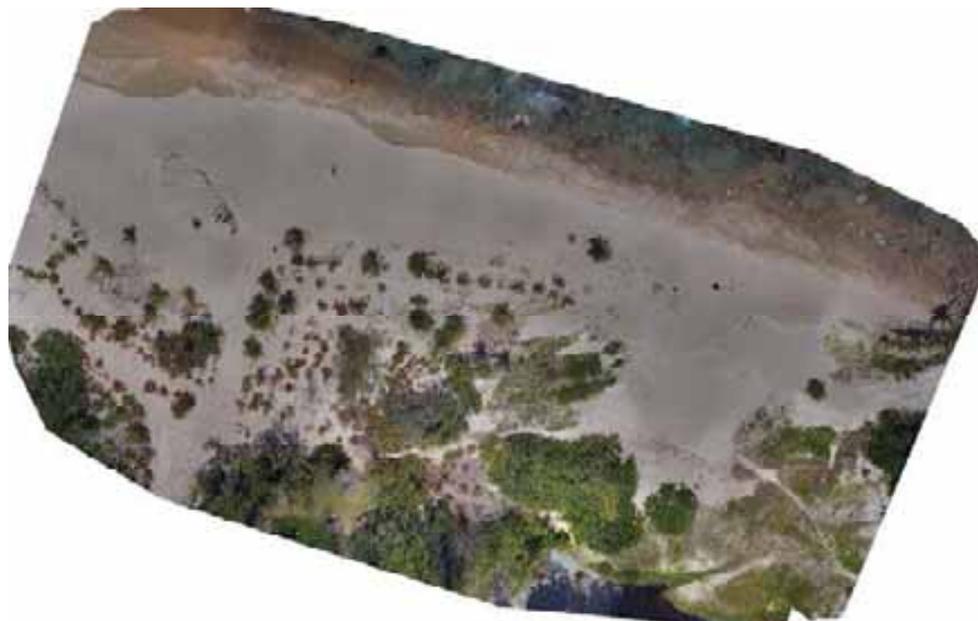
Figure 225. Orthomosaic image of Dune east of the FNNR, Camuy.

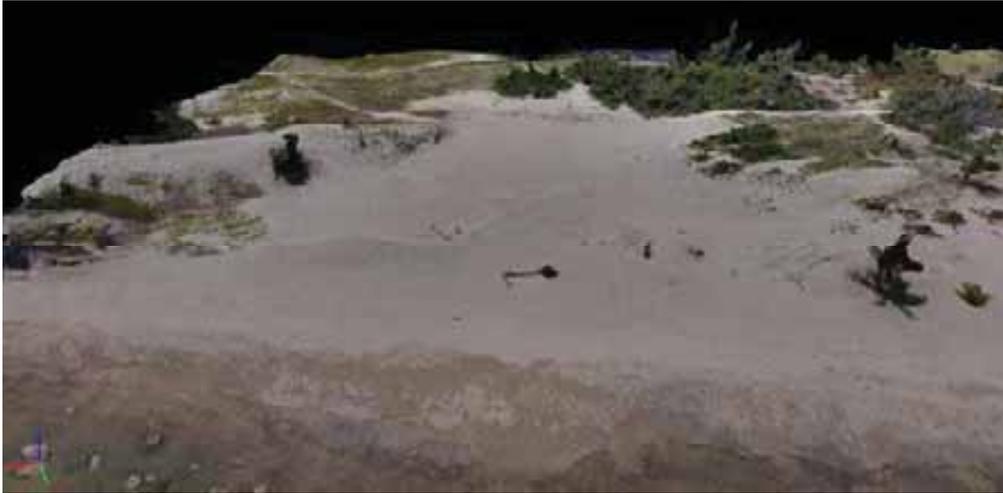
Figure 228. Three dimensional RGB images of the easternmost part of the study site on the east of the FNNR in Camuy, Puerto Rico. The top image is a view from the north and the bottom is a view from the south.

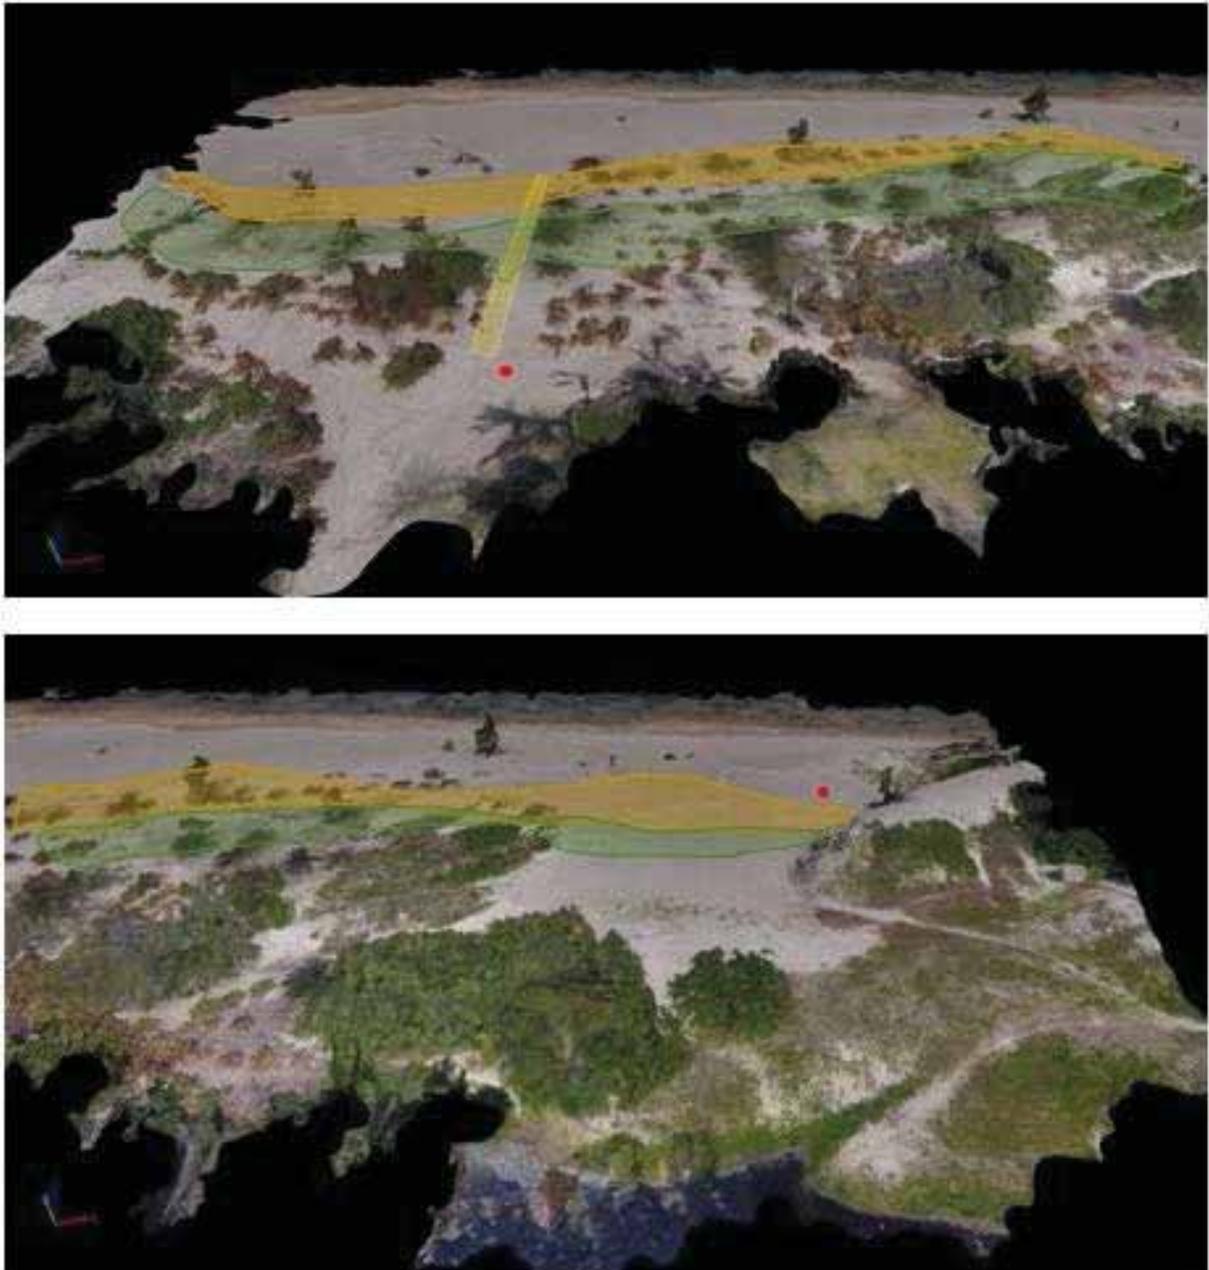
Figure 235. Area to be ecologically restored in the eastern most part of the Finca Nolla Nature Reserve in Camuy, Puerto Rico. Highlighted areas correspond to each technique that will be used in this area. **Yellow** represents the location of a wooden boardwalk, the **red dot** marks the location of an information sign, **tan** represents the area of the dune crest that where biomimicry matrices will be installed to promote the accumulation of sand. The areas shaded in light green represent locations for the planting of dune vegetation.

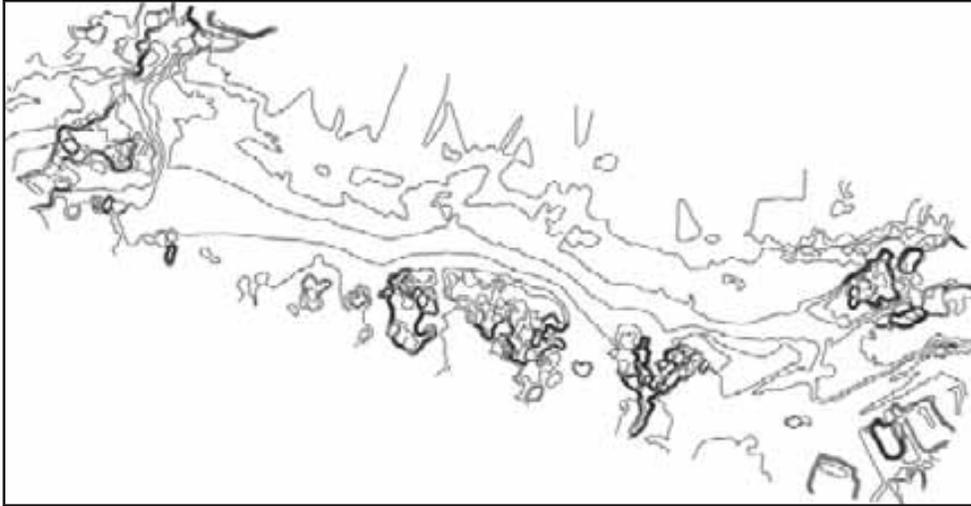
Figure 236. Contour map of the area behind the Costa Norte housing complex, in Hatillo Puerto Rico with elevation intervals of 1 meter.

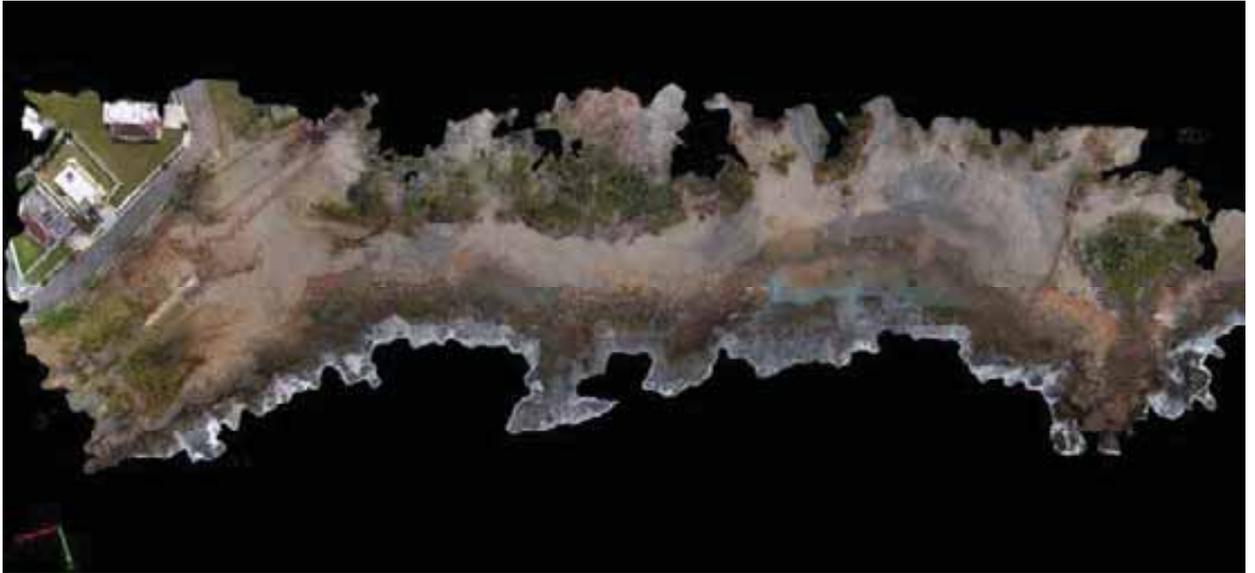
Figure 237. Aerial 3D image of the Costa Norte housing complex, Hatillo.

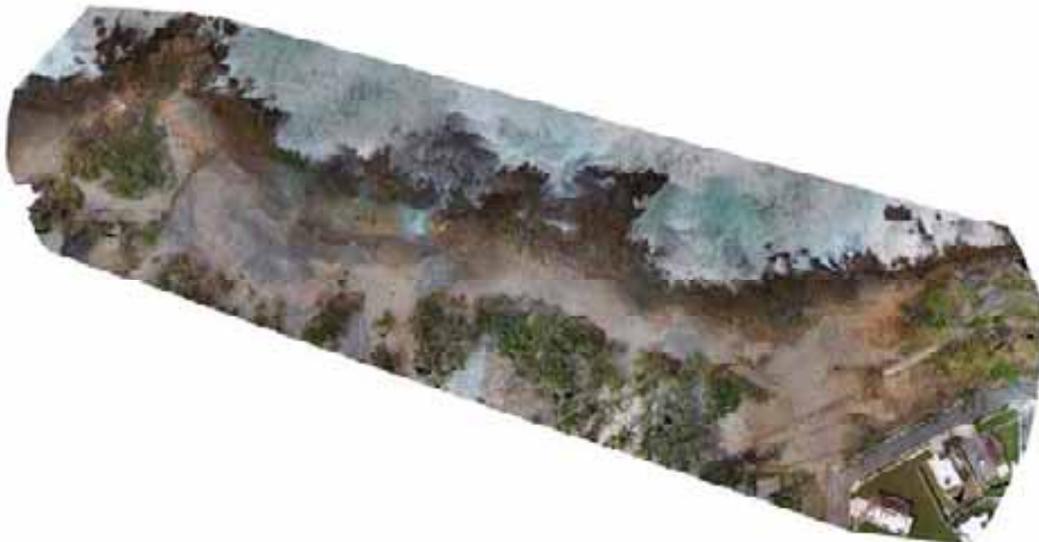
Figure 238. Orthomosaic image of Costa Norte housing complex, Hatillo.

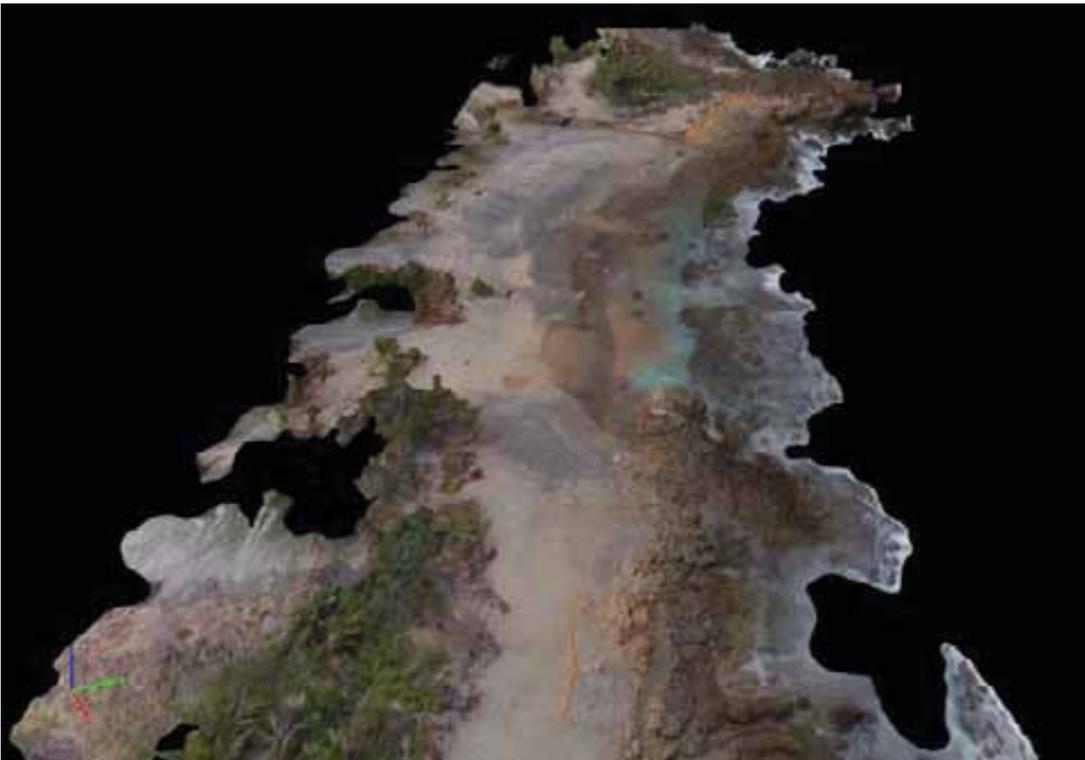
Figure 244. Three dimensional RGB images of the Costa Norte housing complex, Hatillo. View from the east (top) and from the west of the same area (bottom).

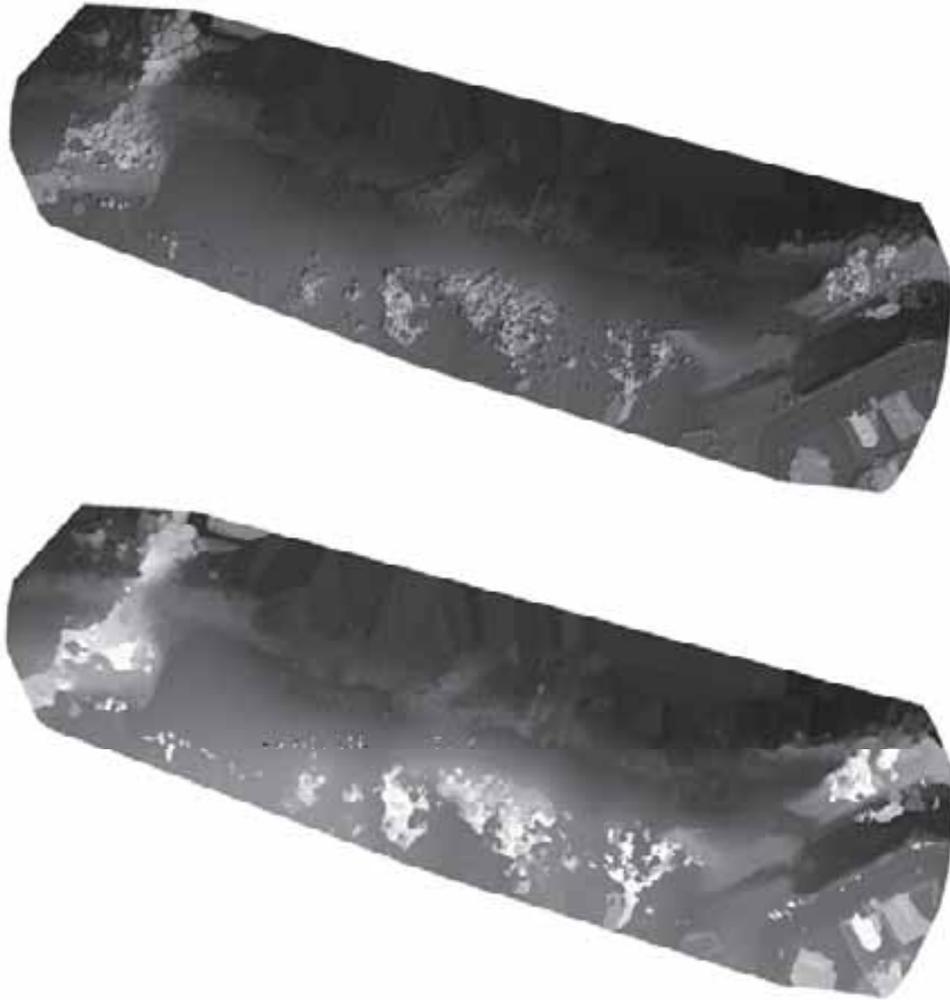
Figure 245. Grayscale DSM images of Costa Norte housing complex. The top image shows shades and the bottom is not shaded.

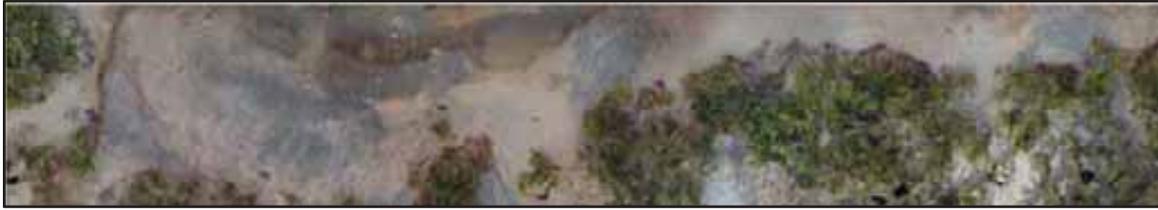
Figure 246. Vegetation covered 27.6% of the area of the Costa Norte housing complex on March 15, 2018 (after northeasterly swell).
