Coastal Dune and Erosion Assessment of the North Coast of Puerto Rico

Final Report

**DOI-FEMA Natural and Cultural Resources
Recovery Support Function (NCR RSF)**

**Universidad de Puerto Rico en Aguadilla
Vida Marina: Centro de Conservación y Restauración Ecológica Costera**

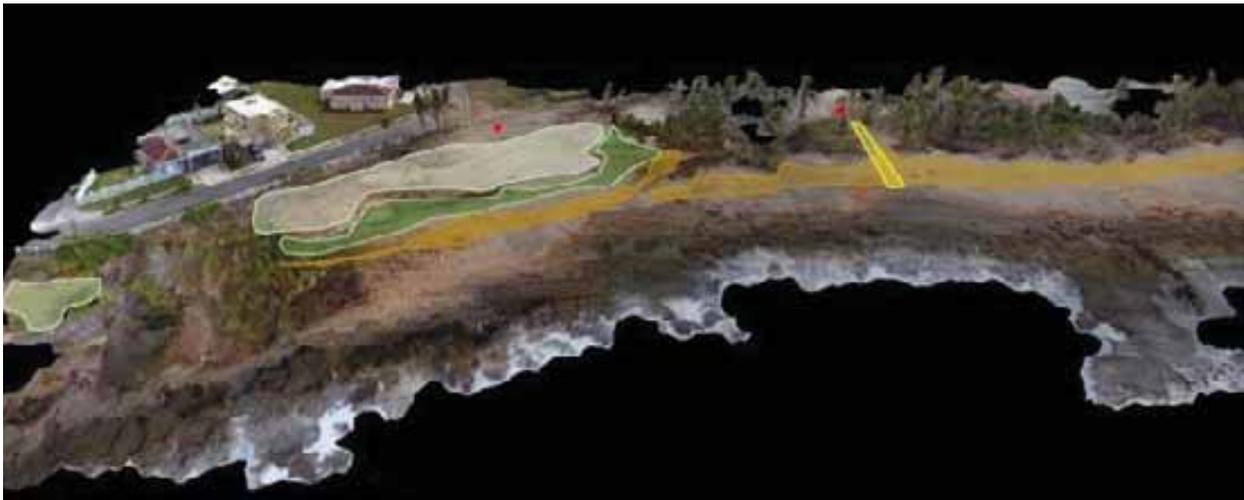
Figure 248. Area to be ecologically restored behind the Costa Norte housing complex in Hatillo, Puerto Rico. Highlighted areas correspond to each technique that will be used in this area. Yellow represents the location of a wooden boardwalk, the red dot marks the location of an information sign, dark green marks the location of dune vegetation, light green marks the location of vetiver grass, tan represents the area of the dune crest that where biomimicry matrices will be installed to promote the accumulation of sand. The areas shaded in light green represent locations for the planting of dune vegetation.

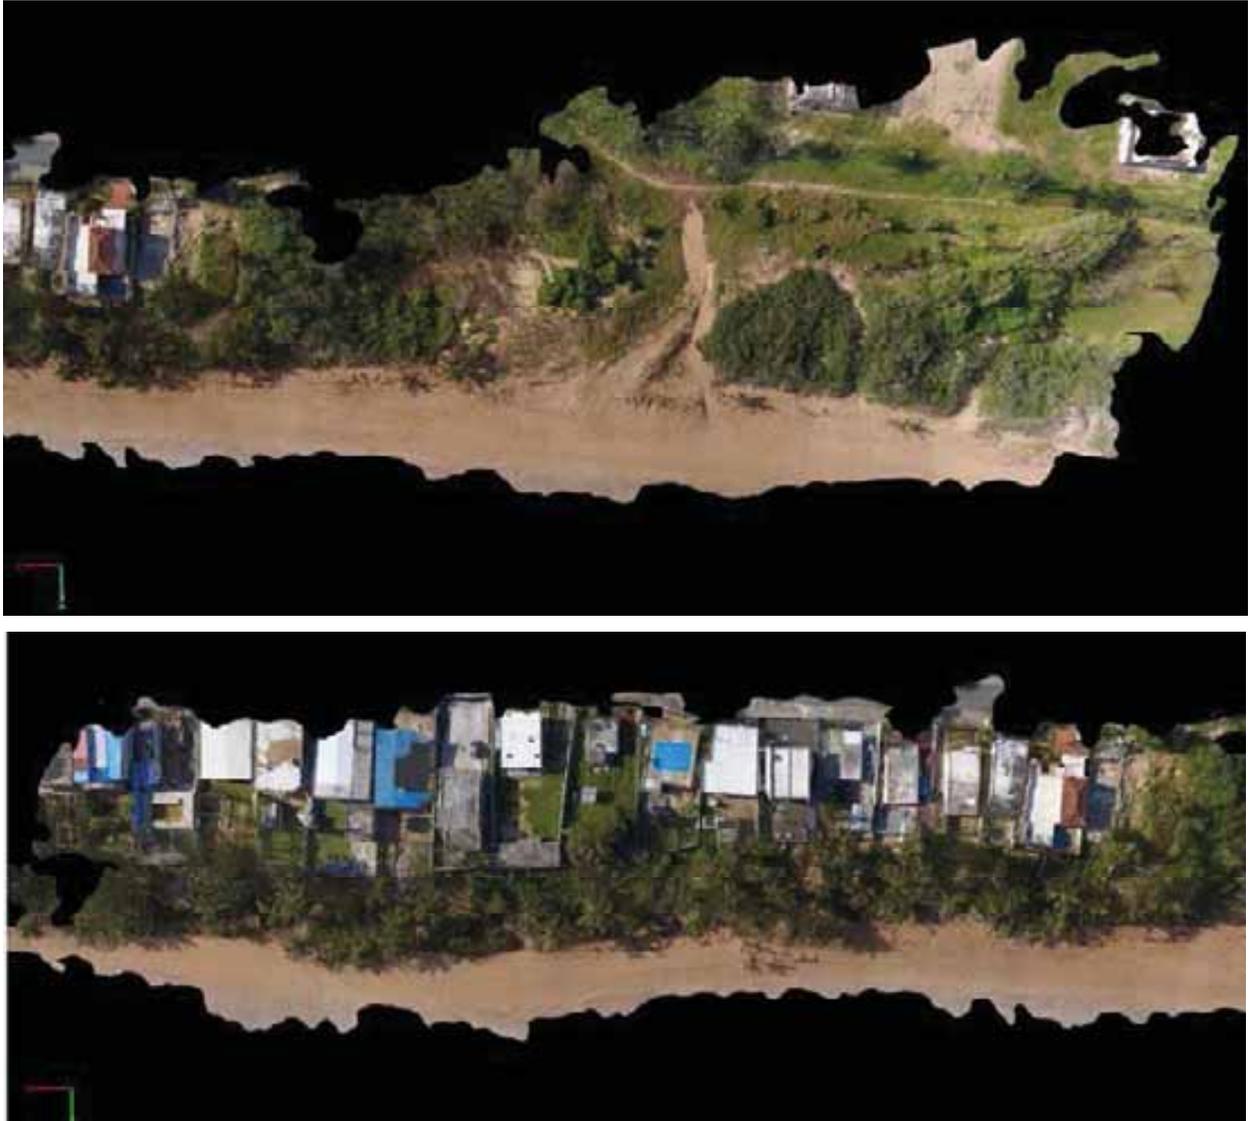
Figure 238. Aerial 3D image of Jarealito Sector, Arecibo.

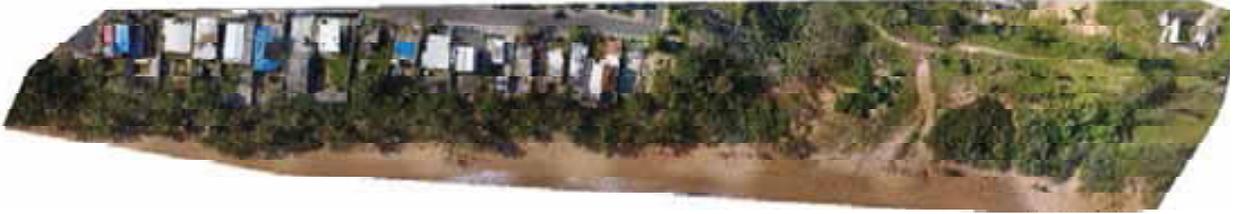
Figure 239. Orthomosaic image of Jarealito Sector, Arecibo.

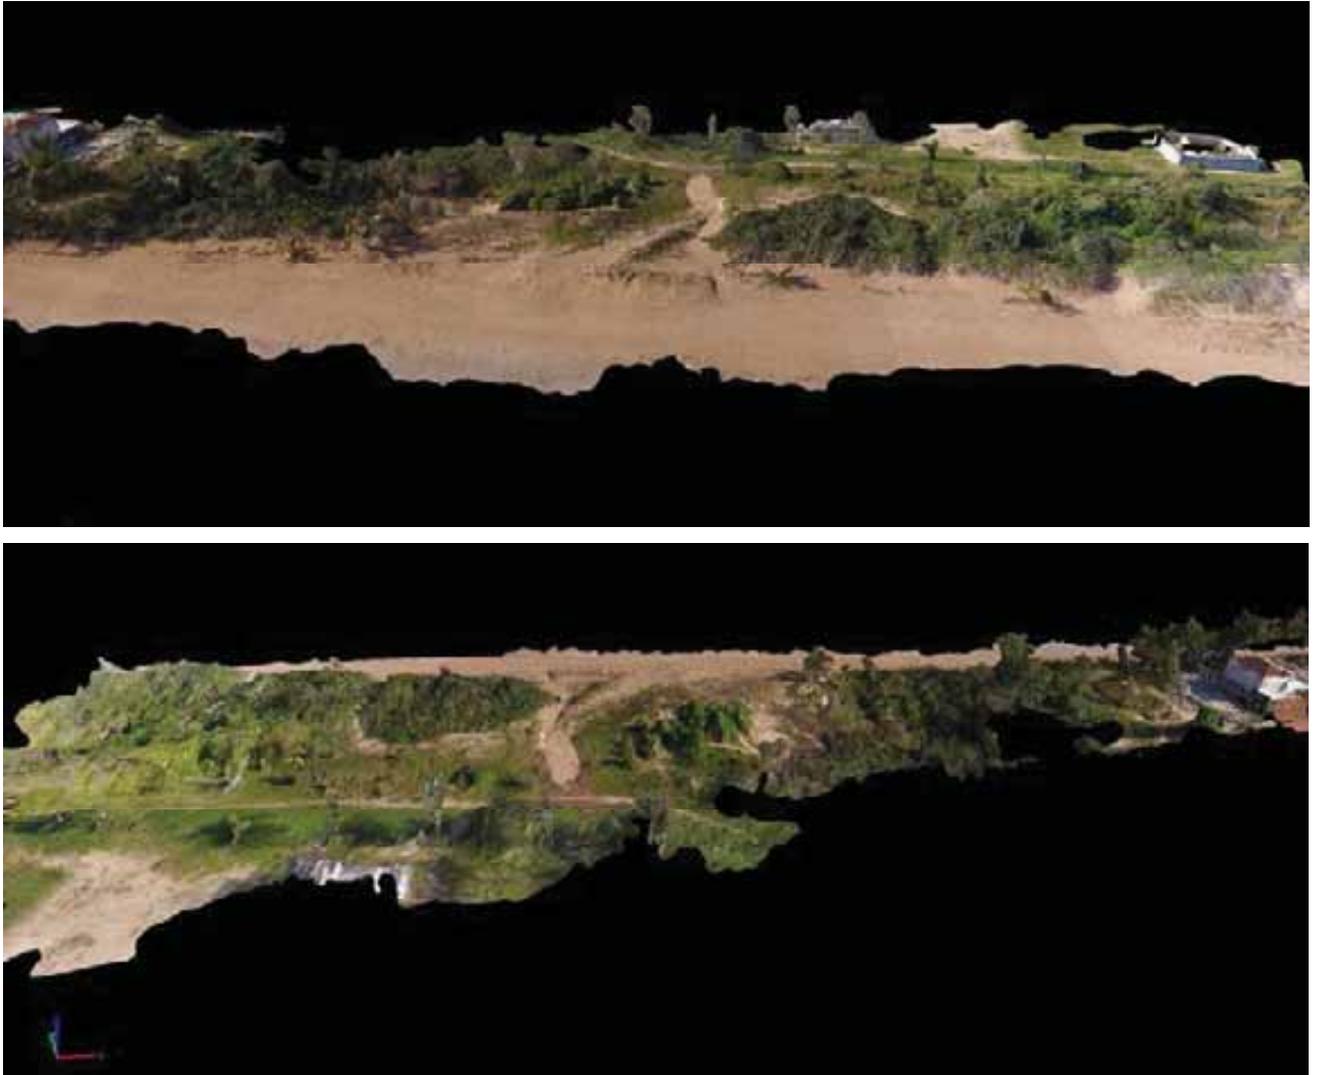
Figure 242. Three dimensional RGB images of Jarealito Sector, Arecibo. View from the north (top) and from the south (bottom).

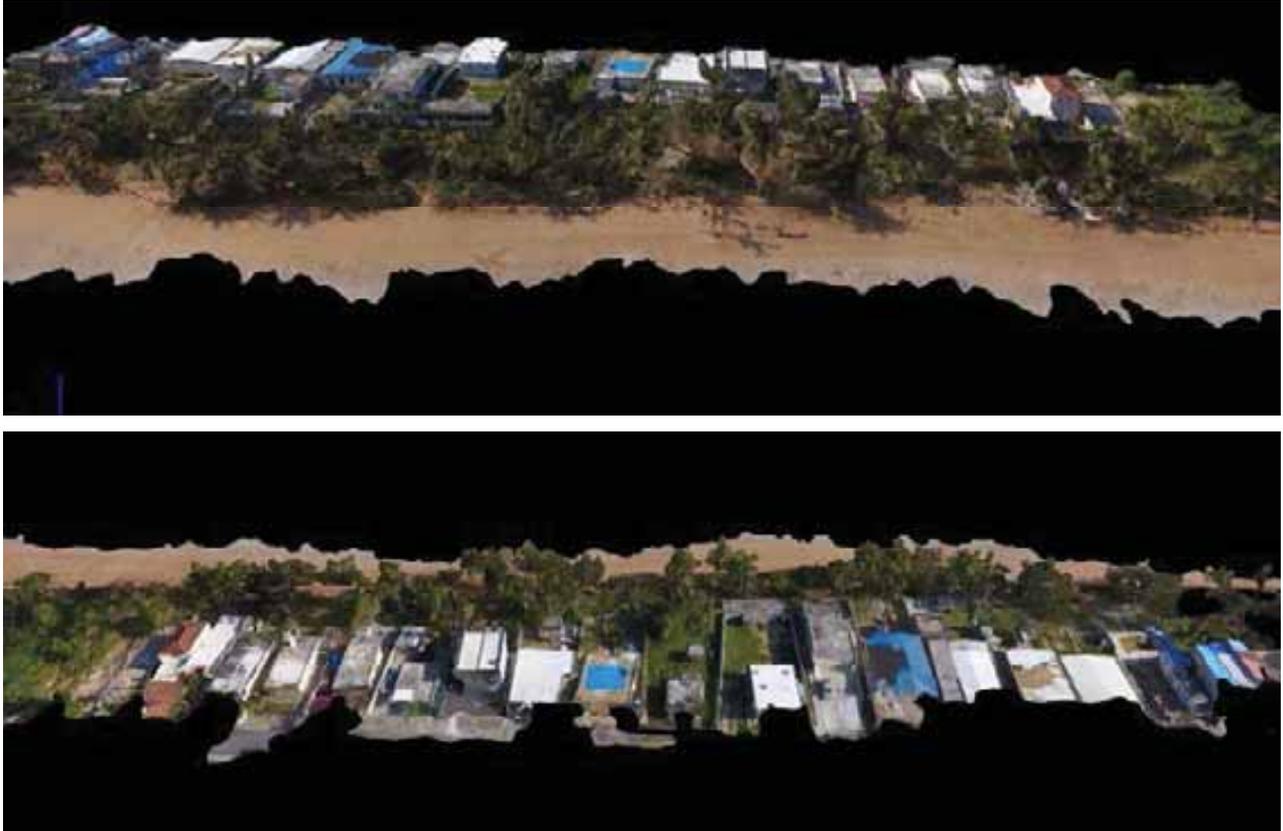
Figure 243. Three dimensional RGB images of the eastern portion of the Jarealito Sector, Arecibo. View from the north (top) and from the south (bottom).

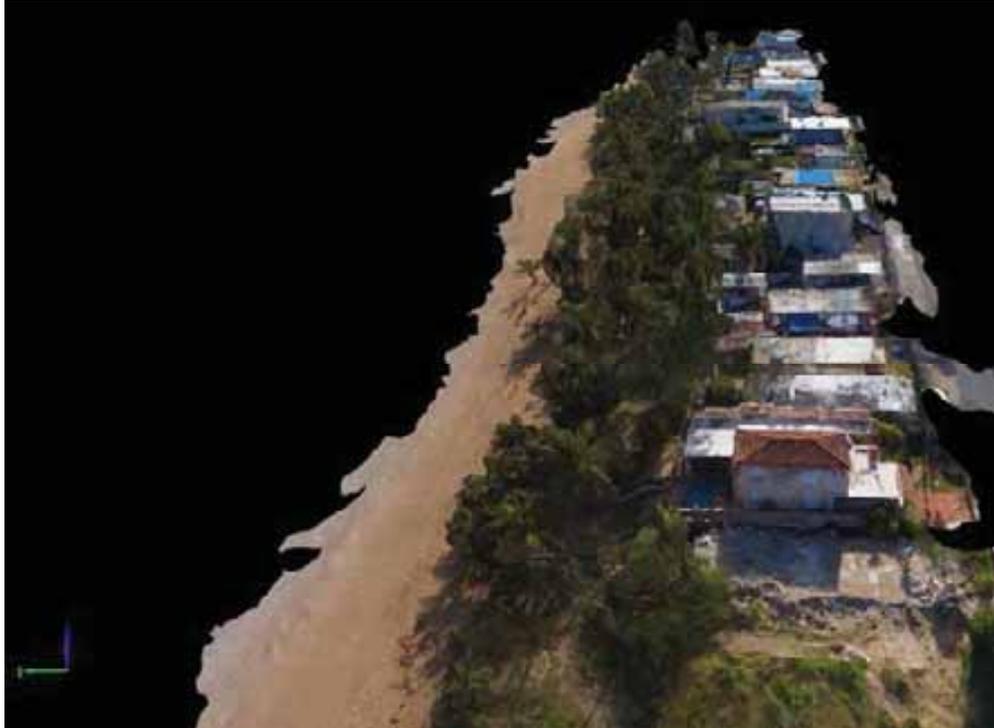
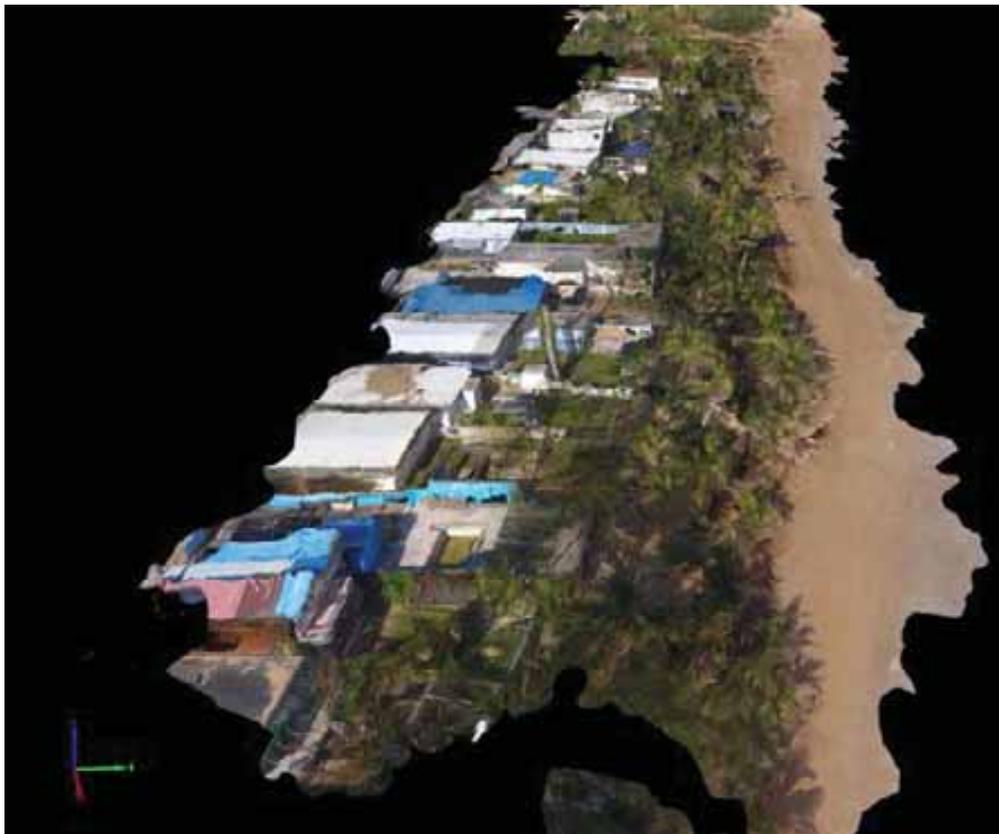
Figure 245. Three dimensional RGB images of Jarealito sector, Arcibo. View from the west (top) and from the east (bottom).

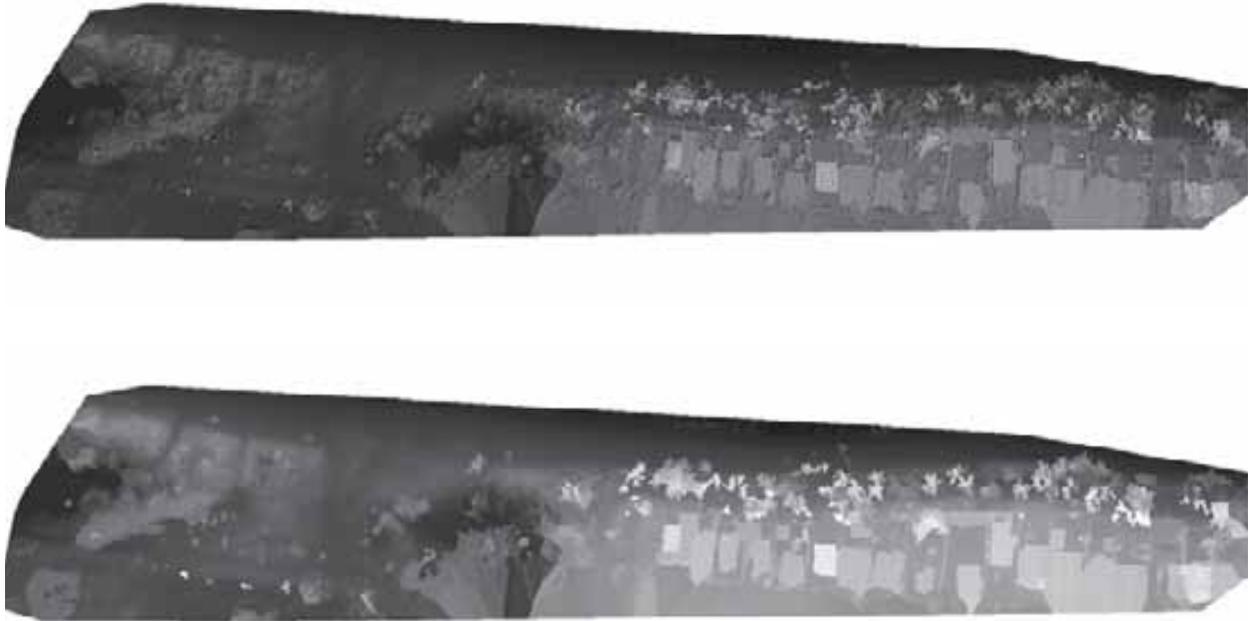
Figure 246. Grayscale DSM images of the dune at Jarealito sector, Arecibo. The top image shows shades and the bottom is not shaded.

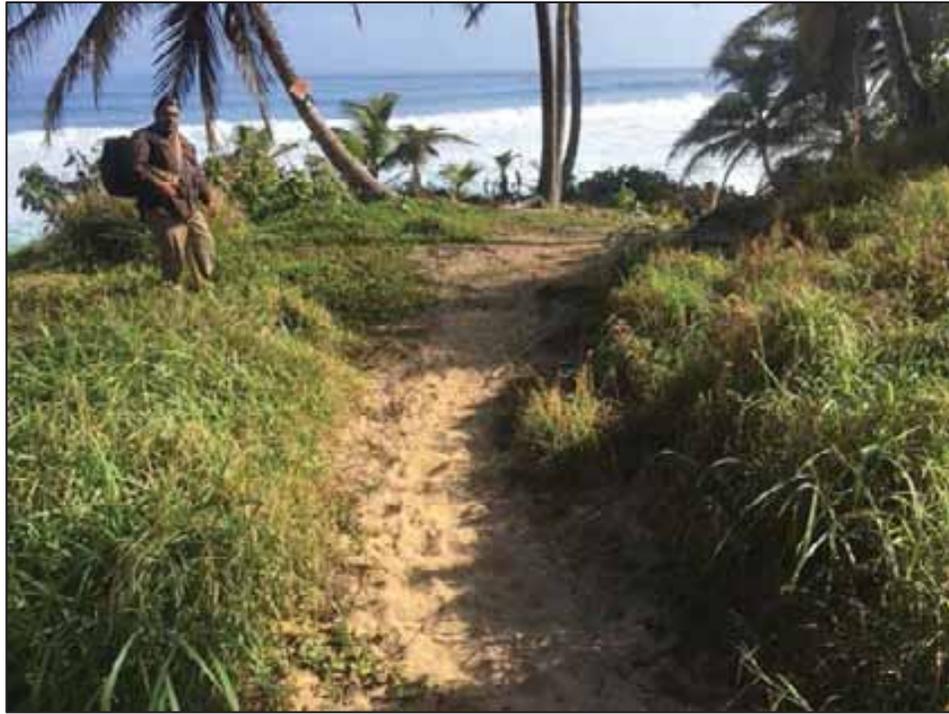
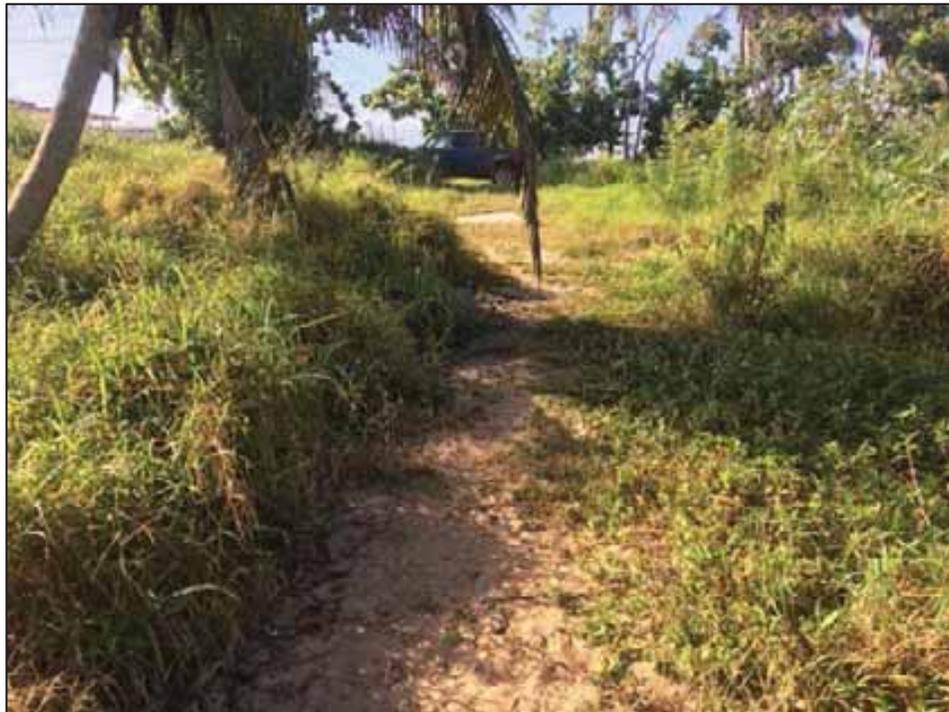
Figure 247. Trail from populated area to the beach. This is located on the western part of the site.

We recommend the planting of vetiver grass on the back dune area of the main path (see image below) to stabilize the area and protect it from rain runoff. We also recommend to install a wooden boardwalk on this path to re-direct people away from the sensitive areas. Dune vegetation will be planted on both sides of the boardwalk and biomimicry matrices will be installed on the fore dune area on both sides of the boardwalk. We also recommend re-vegetating the foredune area to the east of the future boardwalk with dune vegetation.

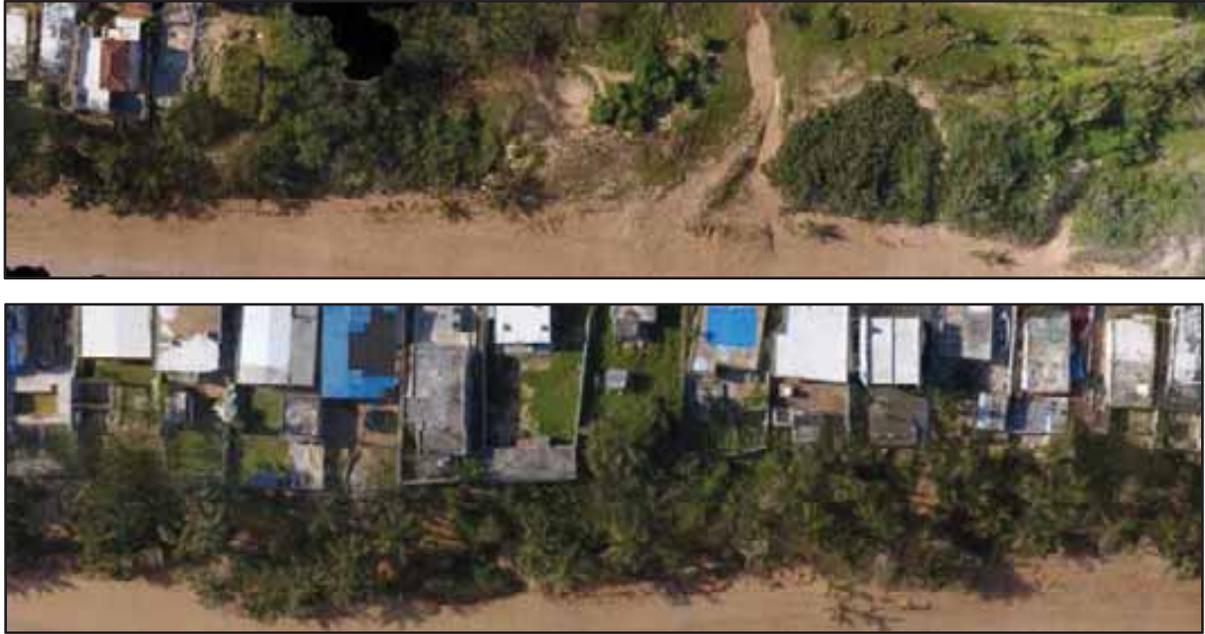
Figure 248. Vegetation covered 68.4% of the area to the west of the Jarealito Sector on the picture on top and 38.7% of the east of the area of Jarealito Sector in Arecibo, Puerto Rico on March 15, 2018 (after northeasterly swell).

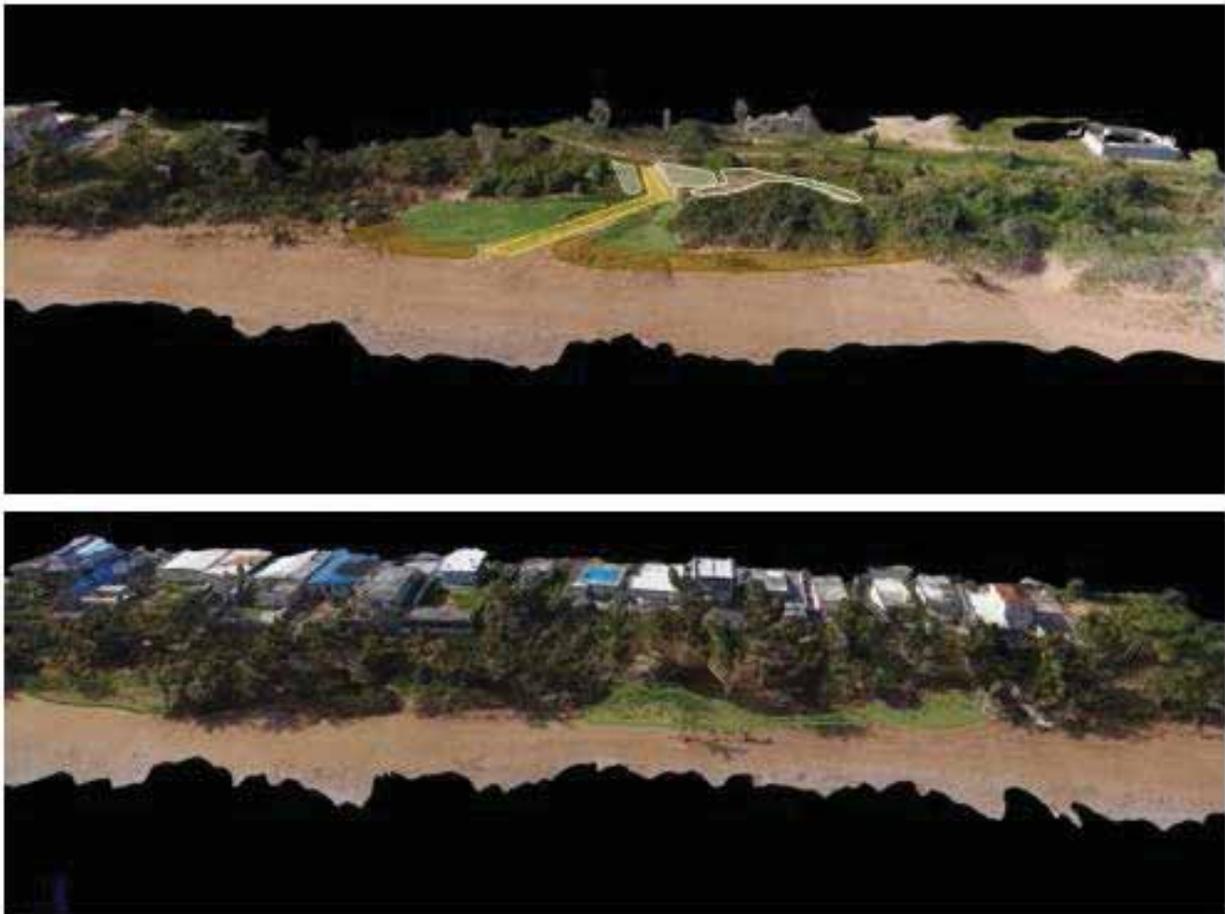
Figure 249. Area to be ecologically restored behind the Costa Norte housing complex in Hatillo, Puerto Rico. Highlighted areas correspond to each technique that will be used in this area. **Yellow** represents the location of a wooden boardwalk, the **red dot** marks the location of an information sign, **dark green** marks the location of dune vegetation, **light green** marks the location of vetiver grass, tan represents the area of the dune crest that where biomimicry matrices will be installed to promote the accumulation of sand. The areas shaded in light green represent locations for the planting of dune vegetation.

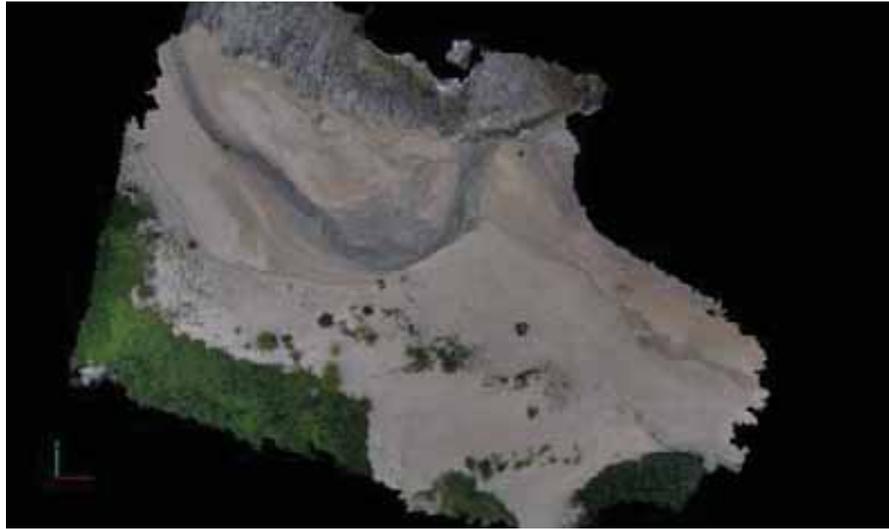
Figure 251. Aerial 3D image of Maranto Beach, Arcibo.

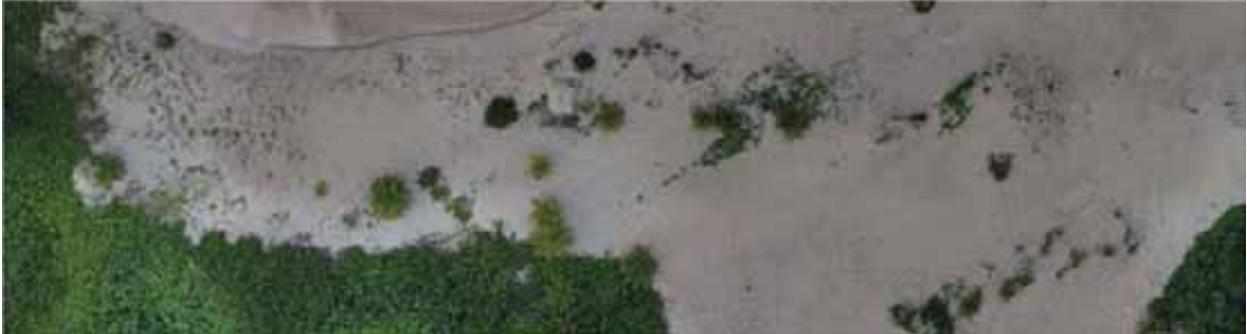
Figure 257. Images of the area for which vegetation cover is being monitored for Maranto Beach in Arecibo, Puerto Rico. The vegetation cover was 20.40% for the eastern part of the site on October 20, 2016.

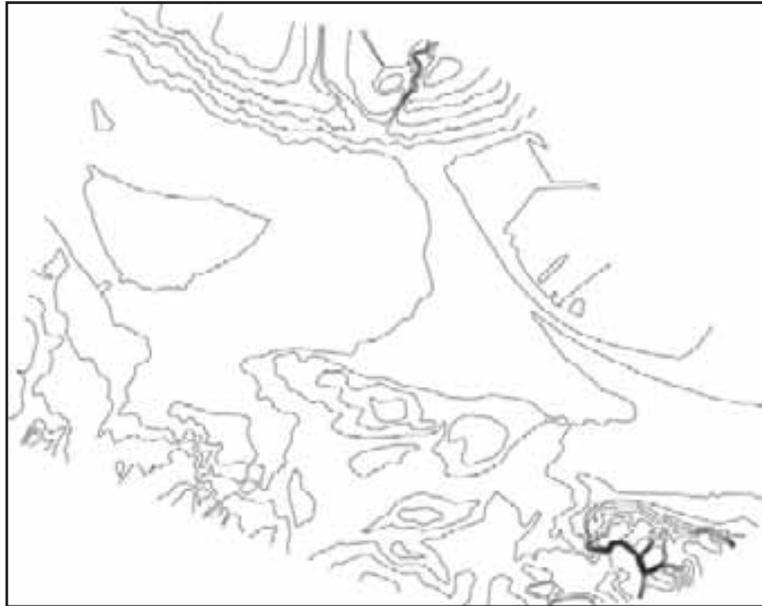
Figure 258. Contour map of the area behind Maranto Beach, Arecibo Puerto Rico with elevation intervals of 1 meter.

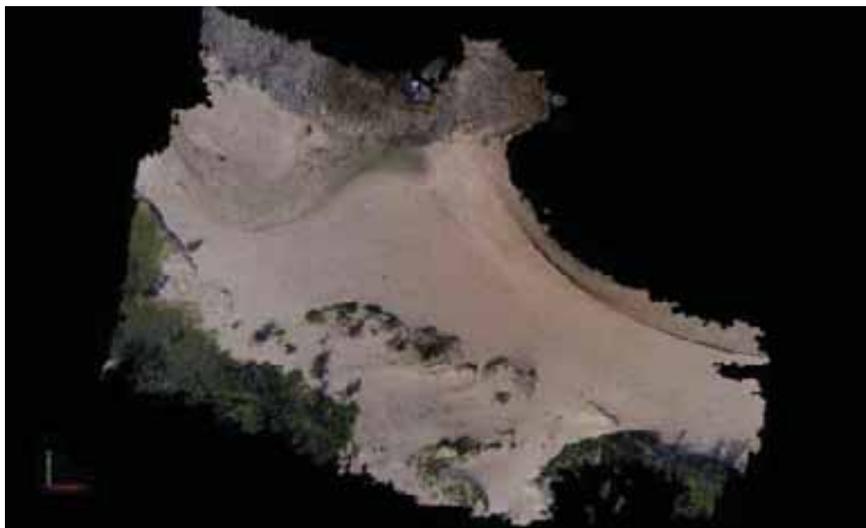
Figure 259. Aerial 3D image of Maranto Beach, Arecibo.

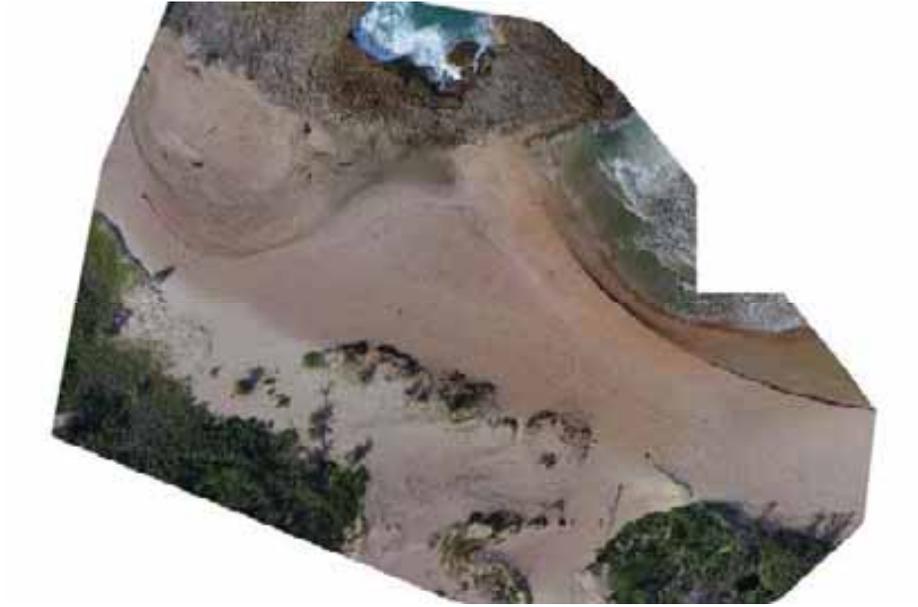
Figure 260. Orthomosaic image of Maranto Beach, Arcibo.

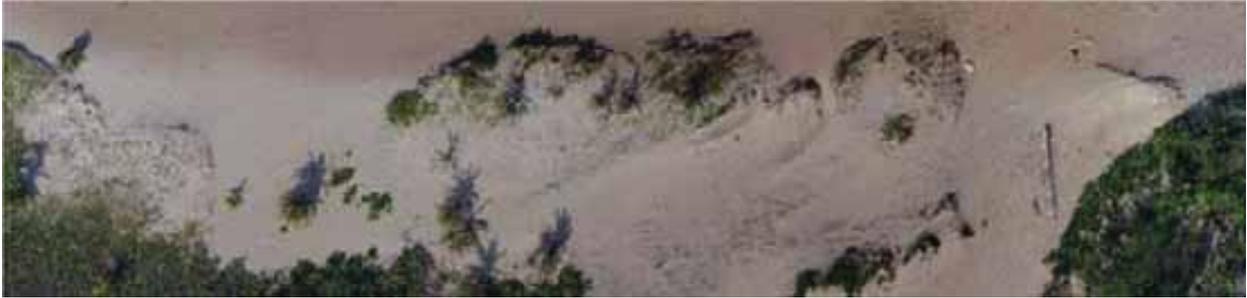
Figure 266. Images of the area for which vegetation cover is being monitored for the Maranto Beach in Arecibo, Puerto Rico. The vegetation cover was 16.90% for the eastern part of the site on January 17, 2018.

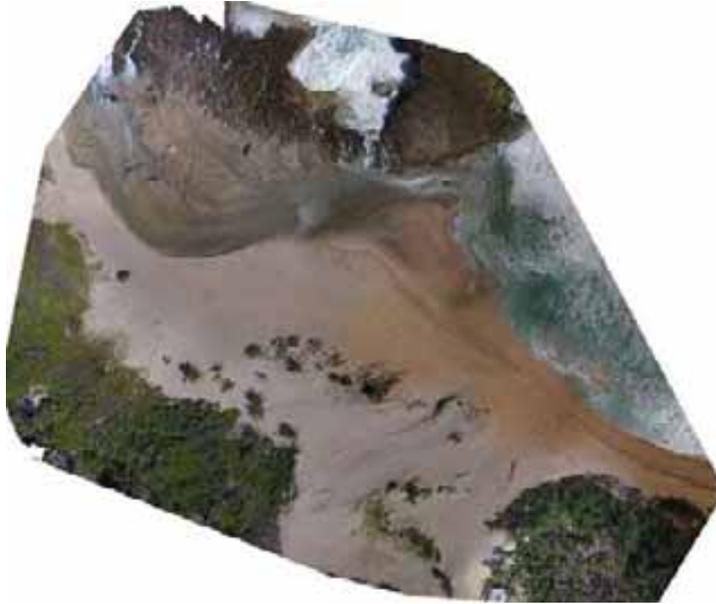
Figure 269. Orthomosaic image of Maranto Beach, Arcibo.

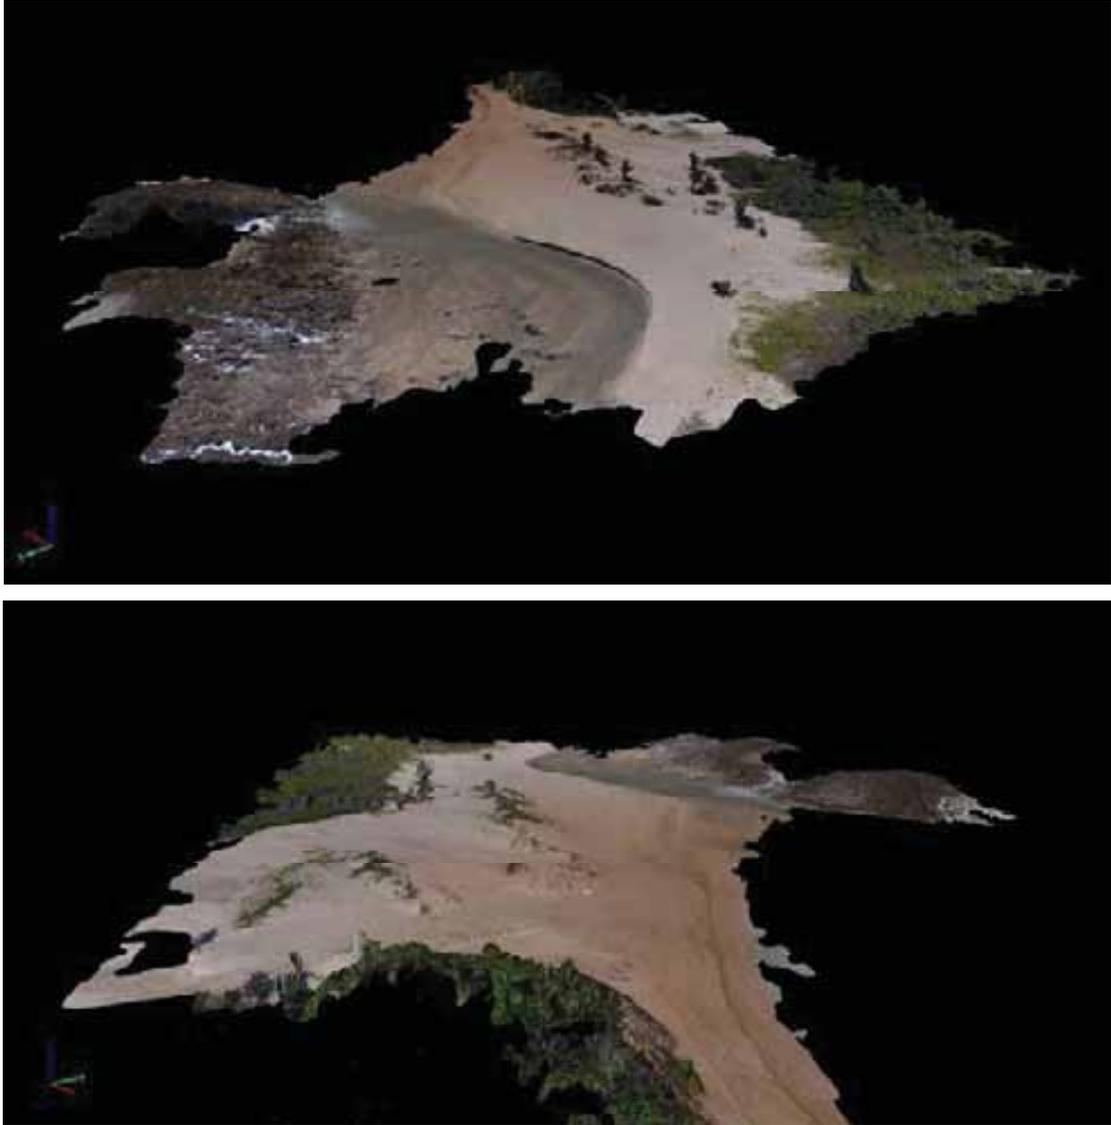
Figure 273. Three dimensional RGB images of the eastern part of the Maranto Beach, Arcibo. View from the west (top) and from the east (bottom).

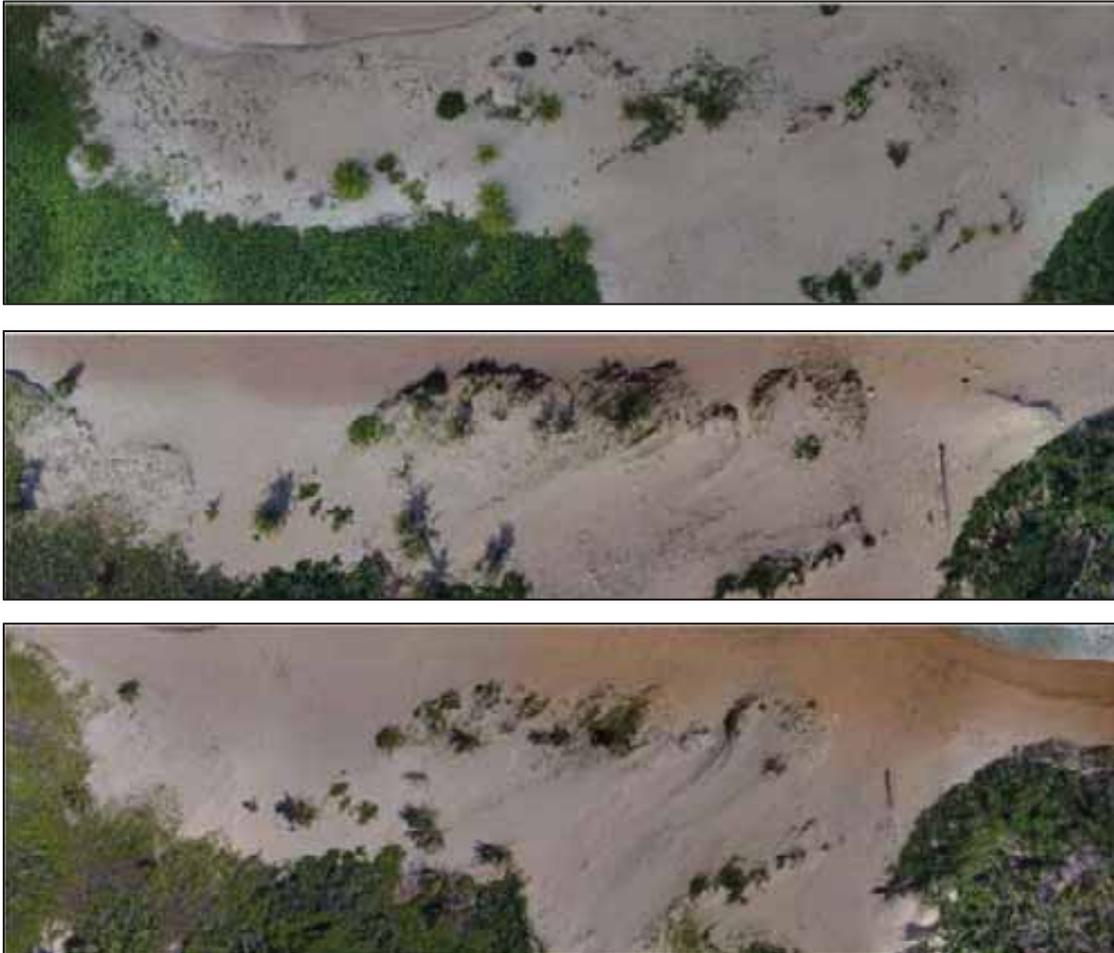
Figure 275. Images of the area for which vegetation cover is being monitored for Maranto Beach in Arecibo, Puerto Rico. The vegetation cover was 20.40% for the eastern part of the site on October 20, 2016.

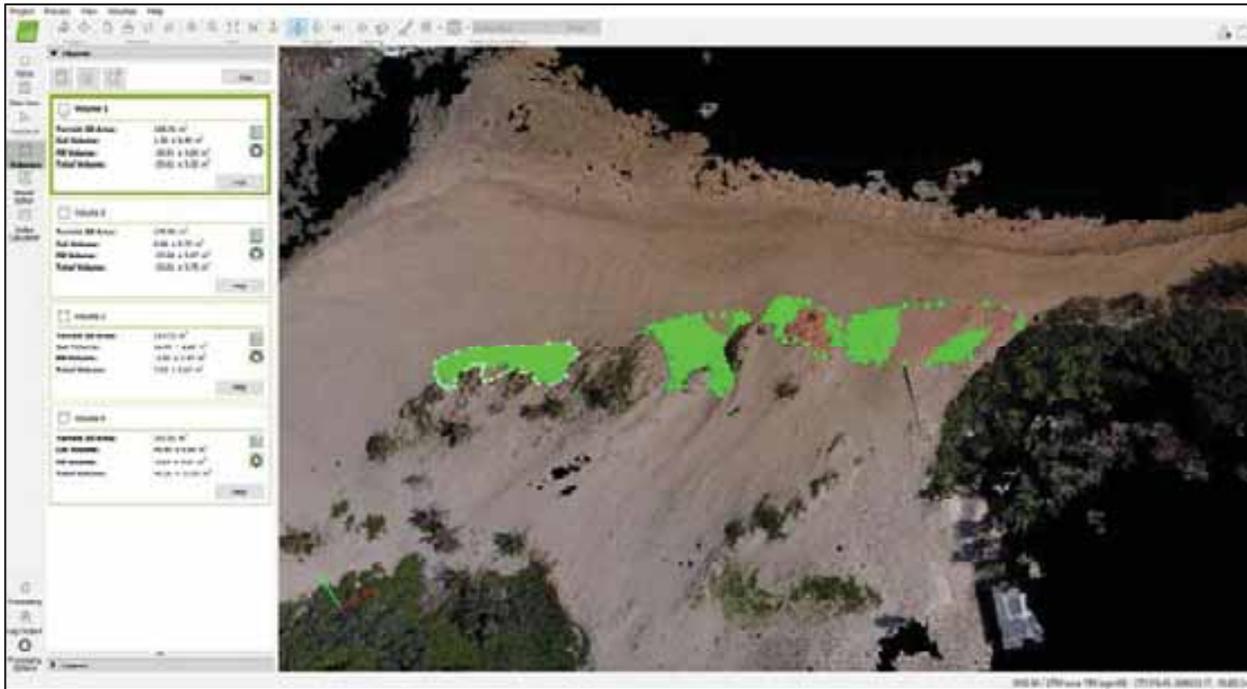
Figure 276. Three dimensional aerial picture of Maranto Beach, Arecibo with four areas marked by polygons for which three dimensional area, cut volume, fill volume and total volume were calculated using the Pix4D software. Refer to image above for the data. The order of the data is from left to right on the image.

The ecological restoration measures that we recommend for this area consist of the installation of an extra segment of wooden boardwalk to existing one (see figure 276) in order to re-direct foot traffic away from sensitive areas that are being restored. We recommend installation of biomimicry matrices to promote the accumulation of sand followed by stabilization of these areas with dune vegetation.

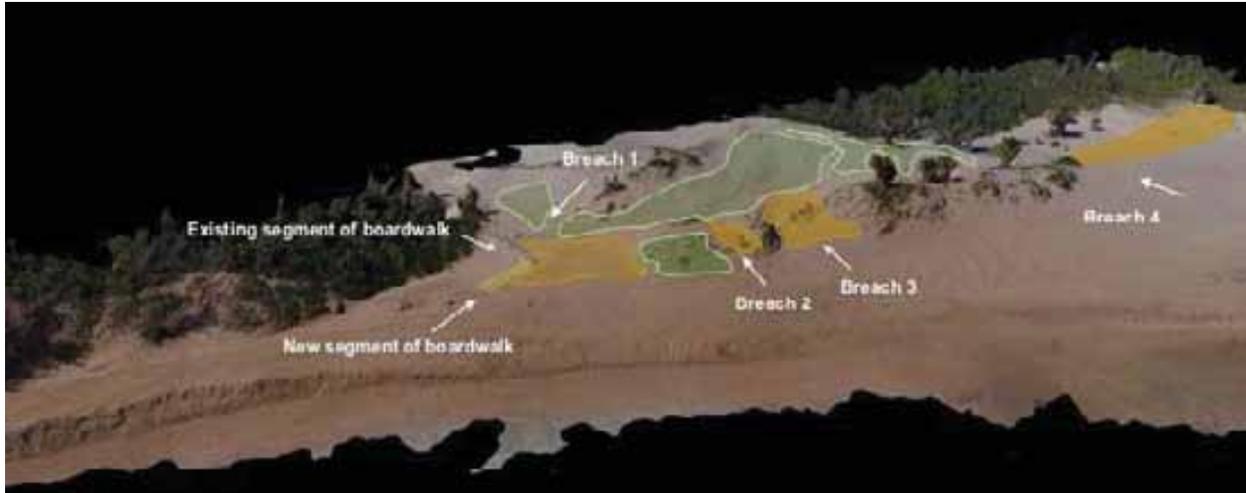
Figure 277. Area to be ecologically restored in Maranto Beach in Arecibo. Highlighted areas correspond to each technique that will be used in this area. **Yellow** represents the location of a wooden boardwalk, the **red dot** marks the location of an information sign, **tan** represents the area of the dune crest that where biomimicry matrices will be installed to promote the accumulation of sand. The areas shaded in **light green** represent locations for the planting of dune vegetation.

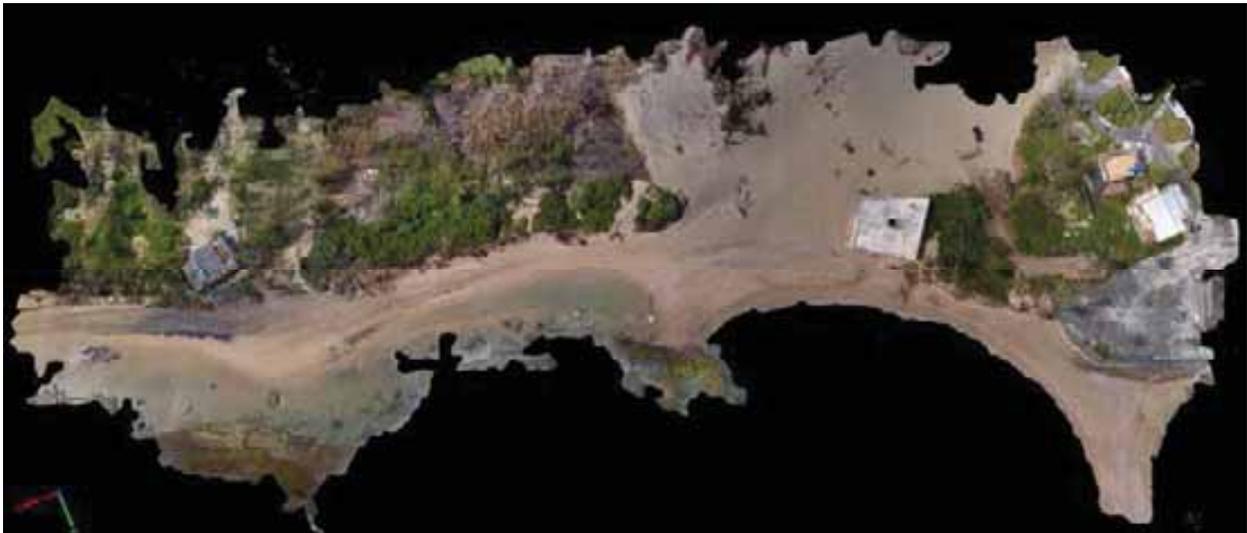
Figure 279. Aerial 3D image of the Poza de las Mujeres area (after northeasterly swell), Manatí.

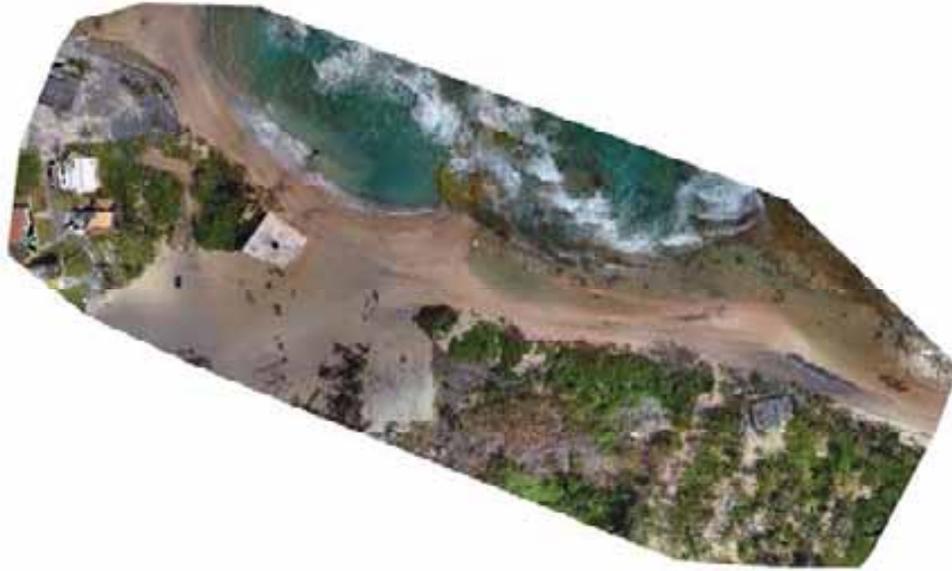
Figure 280. Orthomosaic image of Poza de las Mujeres area (after northeasterly swell), Manatí.

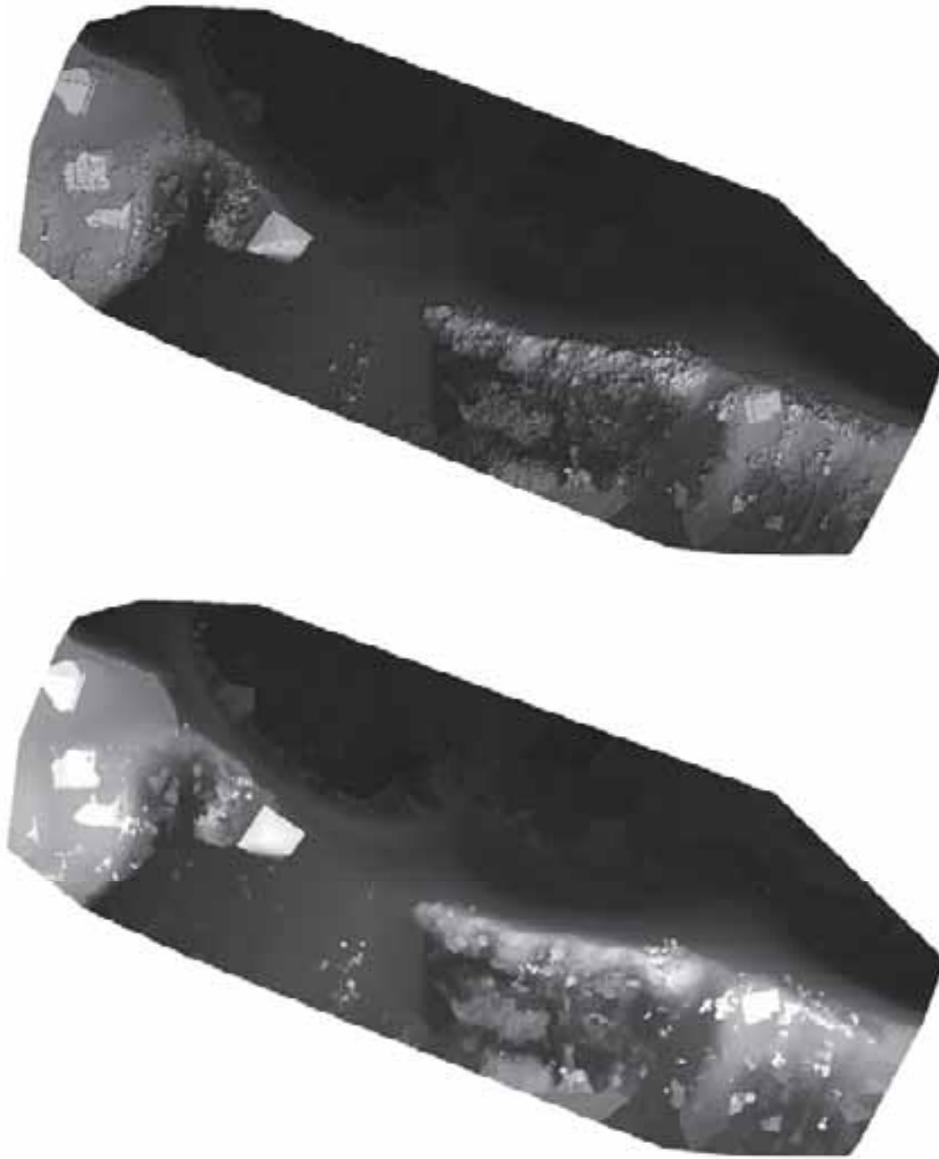
Figure 287. Grayscale DSM images of the Poza de las Mujeres (after swell), Manatí. The top image shows shades and the bottom is not shaded.

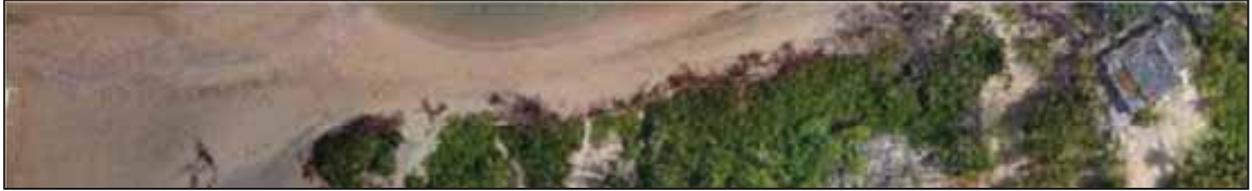
Figure 288. Images of the area for which vegetation cover is being monitored for the Poza de las Mujeres in Manatí, Puerto Rico. The vegetation cover was 37.3% for the eastern part of the site on March 22, 2018.

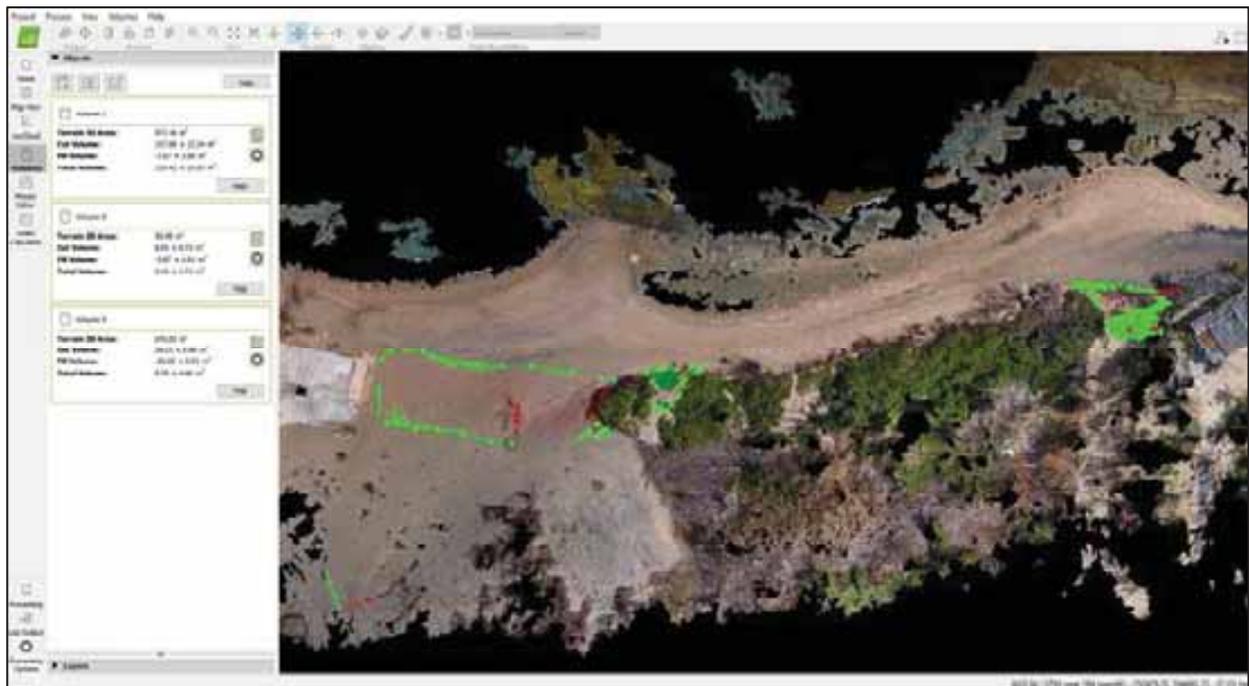
Figure 289. Three dimensional aerial picture of Poza de las Mujeres in Manatí with three areas marked by polygons for which three dimensional area, cut volume, fill volume and total volume were calculated using the Pix4D software. Refer to image above for the data. The order of the data is from left to right on the image.

We recommend the installation of a wooden walkover to re-direct foot traffic out of sensitive areas and two biomimicry matrices to promote the accumulation of sand. We also propose the planting of dune vegetation to stabilize the sand that accumulates. Planting of vetiver grass could also contribute to the stabilization of the backdune area.
