Coastal Dune and Erosion Assessment of the North Coast of Puerto Rico

Final Report

**DOI-FEMA Natural and Cultural Resources
Recovery Support Function (NCR RSF)**

**Universidad de Puerto Rico en Aguadilla
Vida Marina: Centro de Conservación y Restauración Ecológica Costera**

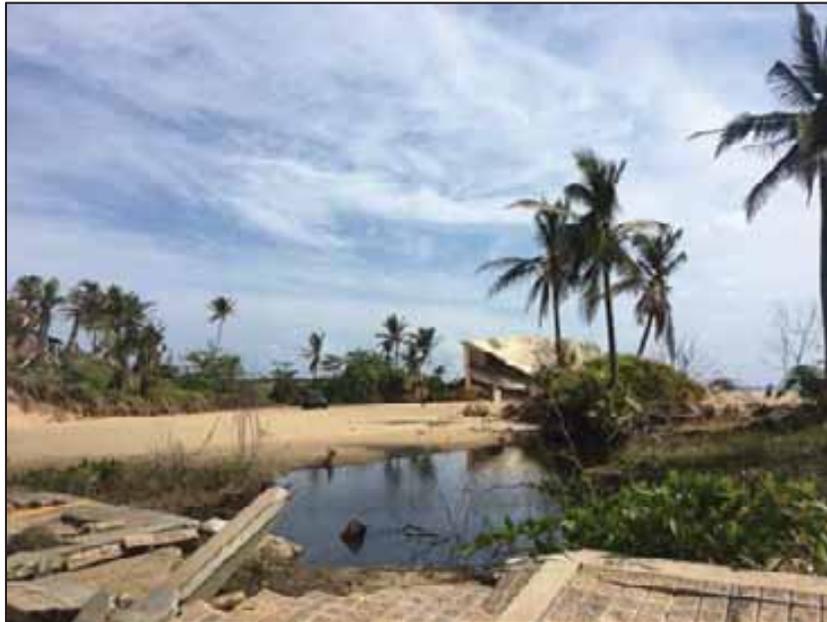
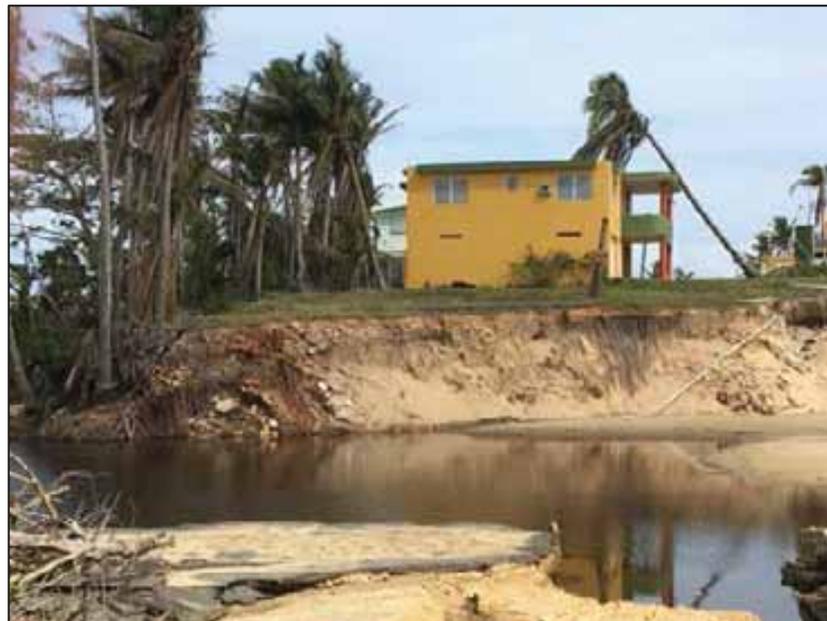
Figure 290. Area of severe erosion in Poza de las Mujeres in Manatí.

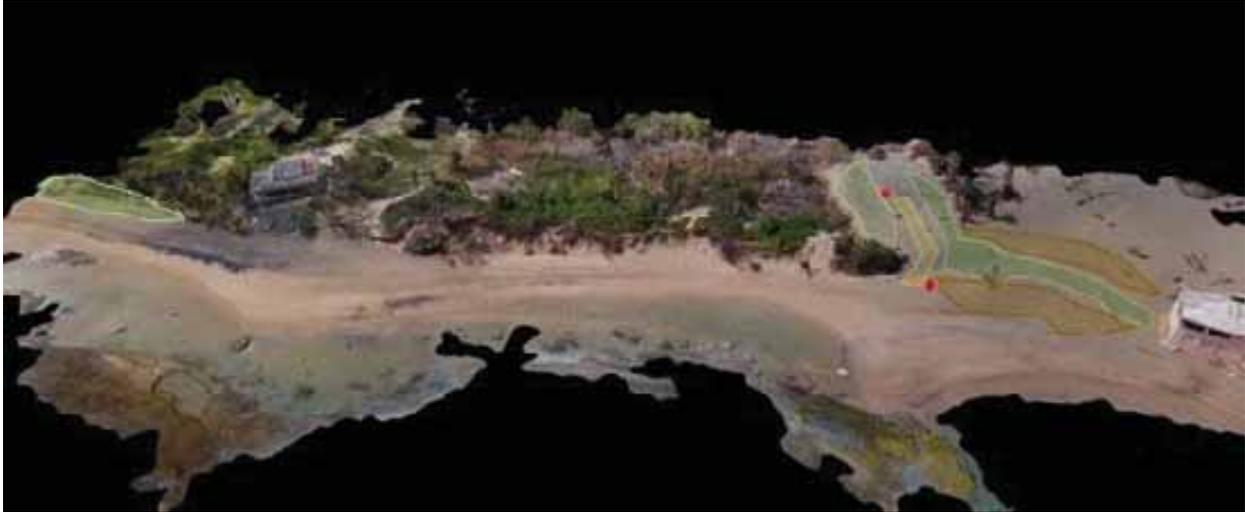
Figure 291. Area to be ecologically restored behind the Poza de las Mujeres, Manatí. Highlighted areas correspond to each technique that will be used in this area. Yellow represents the location of a wooden boardwalk, the red dot marks the location of an information sign, tan represents the area of the dune crest that where biomimicry matrices will be installed to promote the accumulation of sand. The areas shaded in light green represent locations for the planting of dune vegetation.

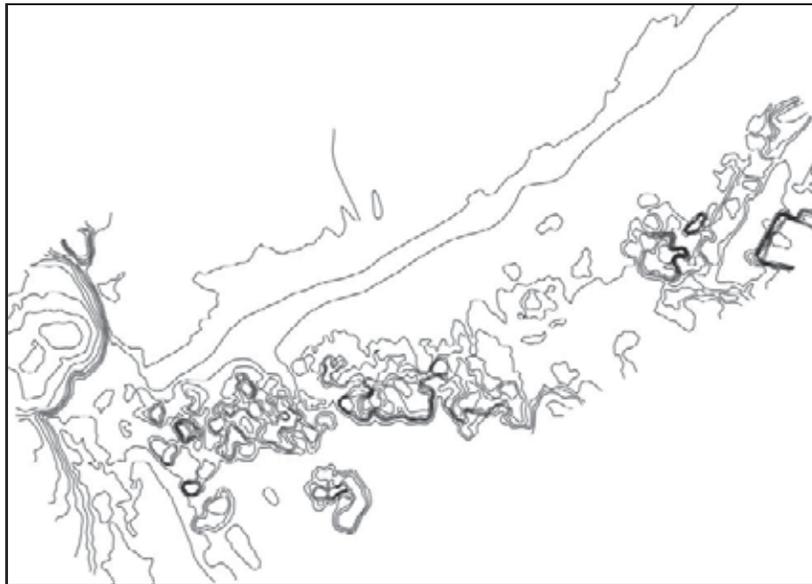
Figure 292. Contour map of the area behind the Mar Chiquita area (after northeasterly swell), in Manatí Puerto Rico with elevation intervals of 1 meter.

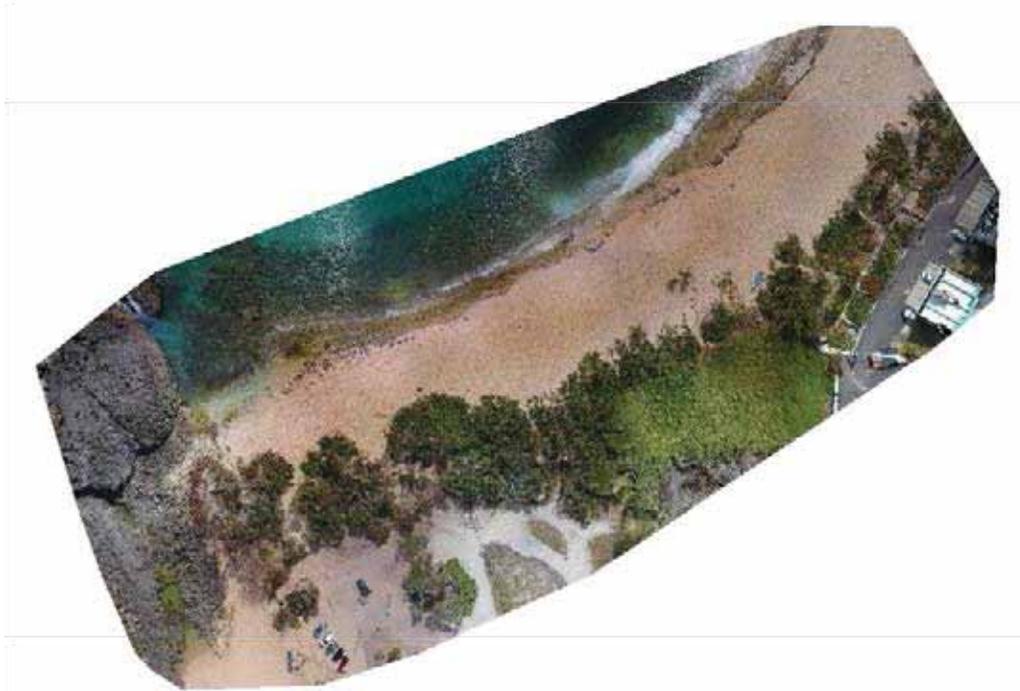
Figure 294. Orthomosaic image of Mar Chiquita area (after northeasterly swell), Manatí.

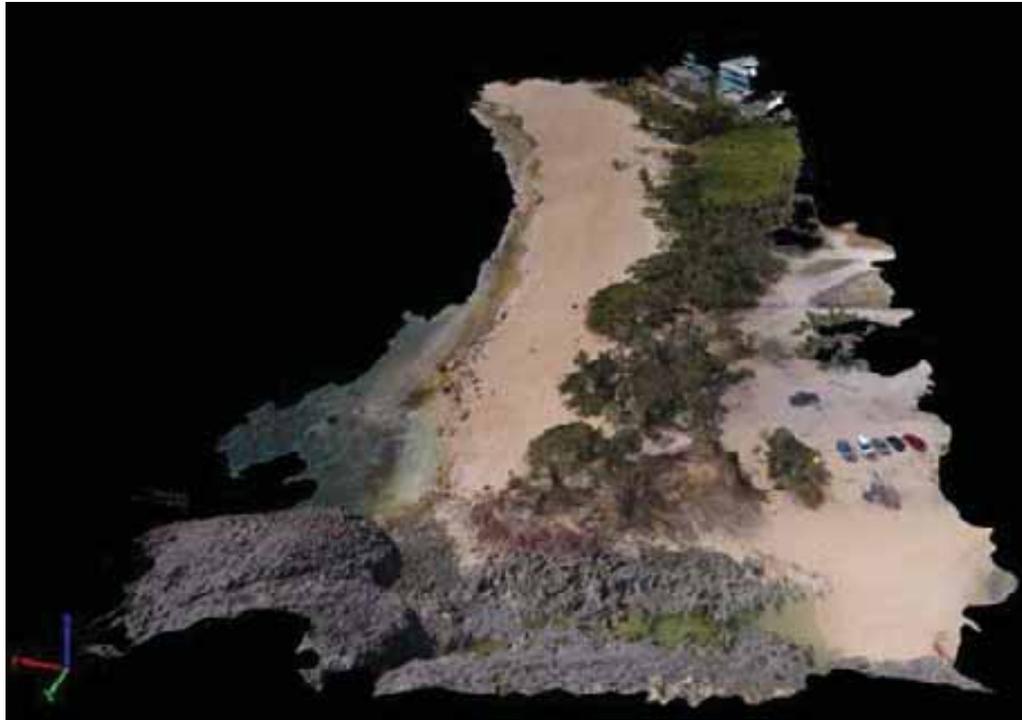
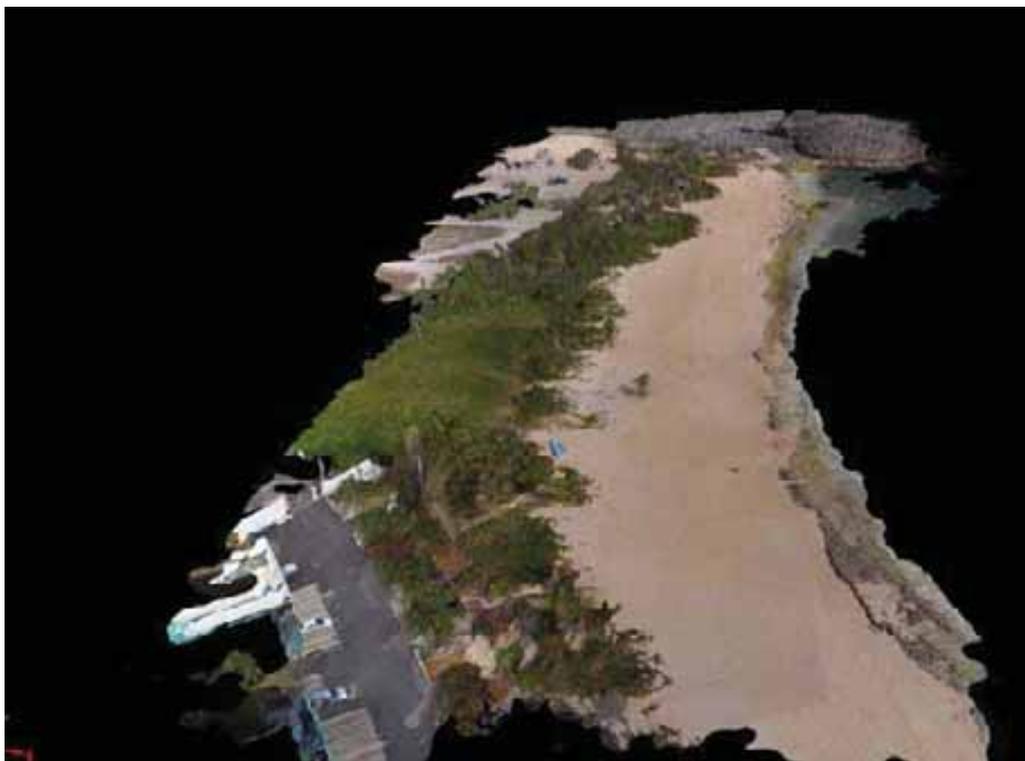
Figure 298. Three dimensional RGB images of the eastern part of the Mar Chiquita area, Manatí. View from the west (top) and from the east (bottom).

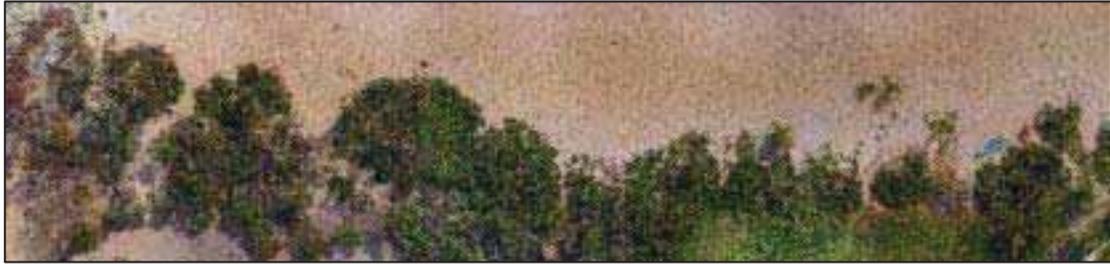
Figure 300. Vegetation covered 52% of the area of Mar Chiquita in Manatí area, Puerto Rico on March 22, 2018 (after northeasterly swell).

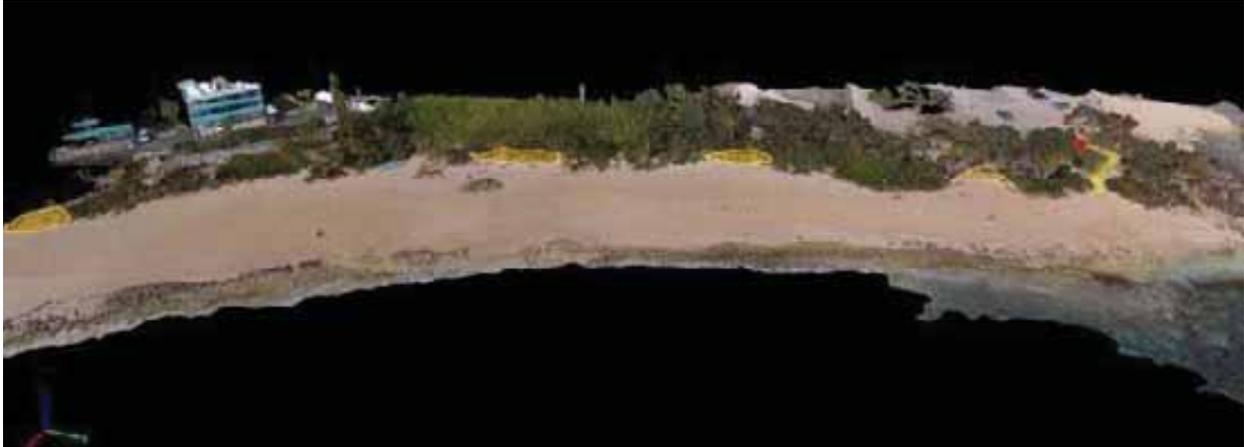
Figure 302. Area to be ecologically restored in Mar Chiquita, Manatí. Highlighted areas correspond to each technique that will be used in this area. Yellow represents the location of a wooden boardwalk, the red dot marks the location of an information sign, tan represents the area of the dune crest that where biomimicry matrices will be installed to promote the accumulation of sand.

We suggest the installation of a wooden boardwalk in front of the area used as parking as well as several biomimicry matrices on the foredune area. This areas will be stabilized with dune vegetation when sand accumulates.

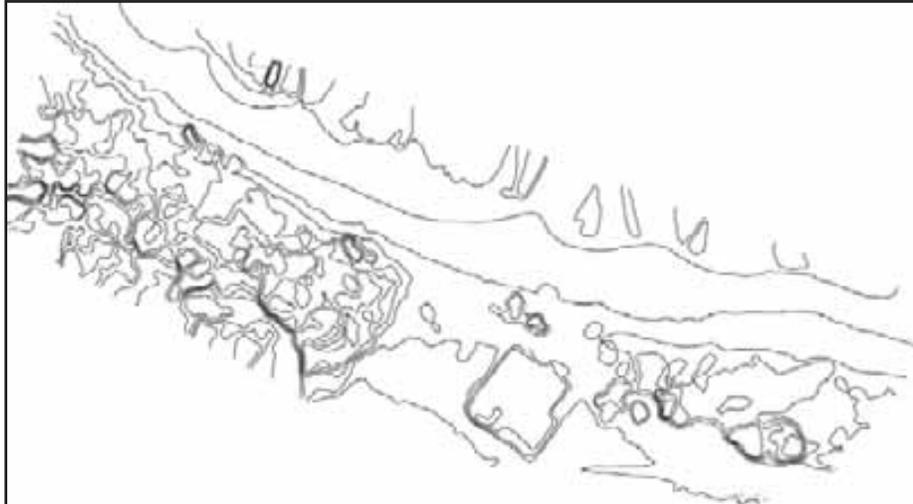
Figure 303. Contour map of the area behind the El Caracol (after northeasterly swell), in Dorado Puerto Rico with elevation intervals of 1 meter.

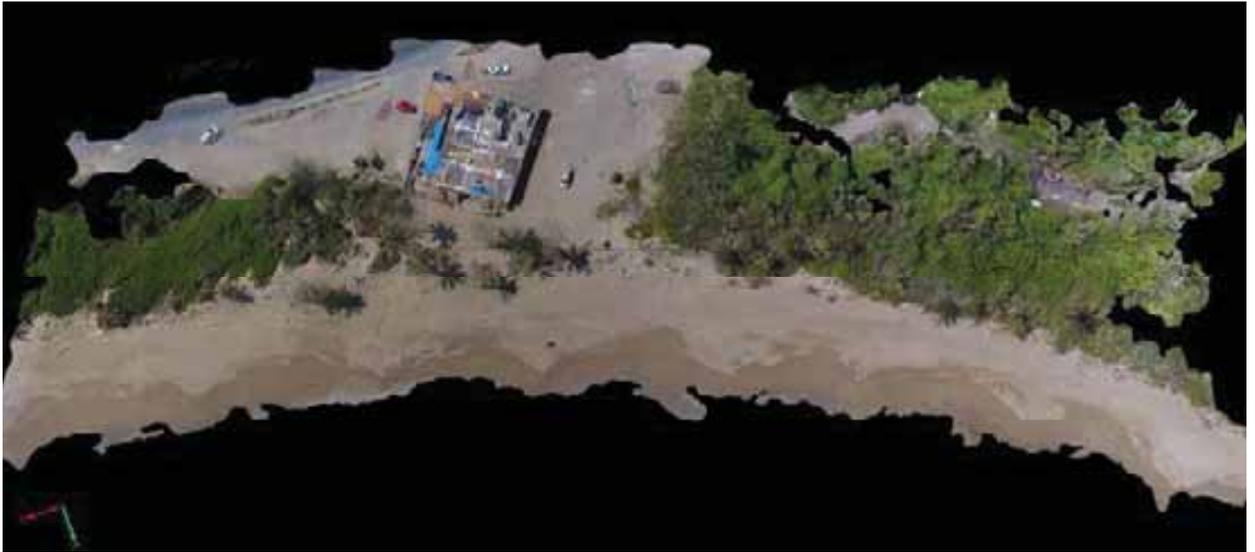
Figure 304. Aerial 3D image of the El Caracol (after northeasterly swell), Dorado.

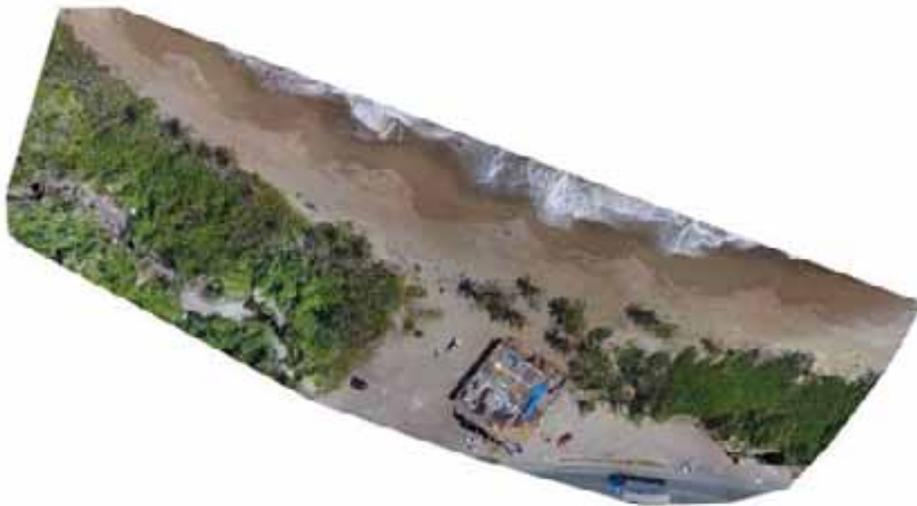
Figure 305. Orthomosaic image of El Caracol (after northeasterly swell), Dorado.

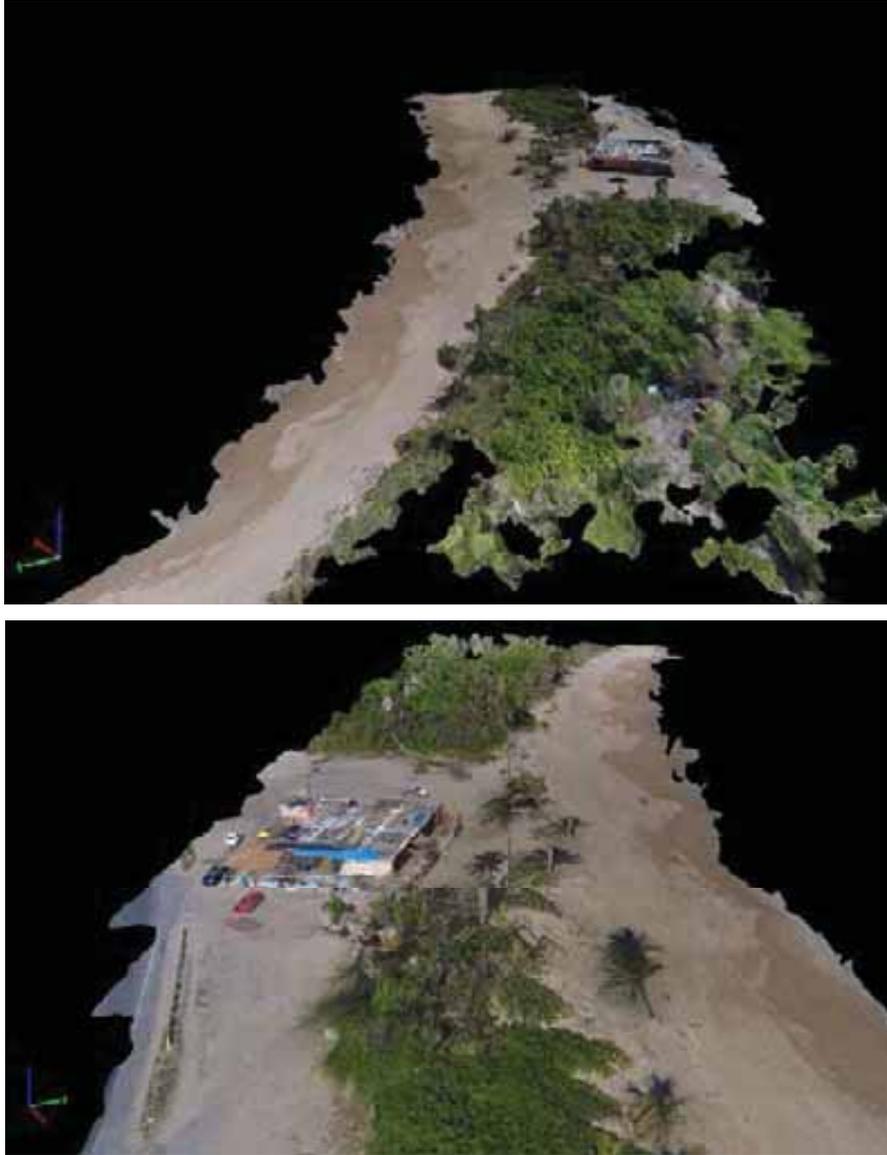
Figure 309. Three dimensional RGB images of the eastern part of the El Caracol, Dorado. View from the west (top) and from the east (bottom).

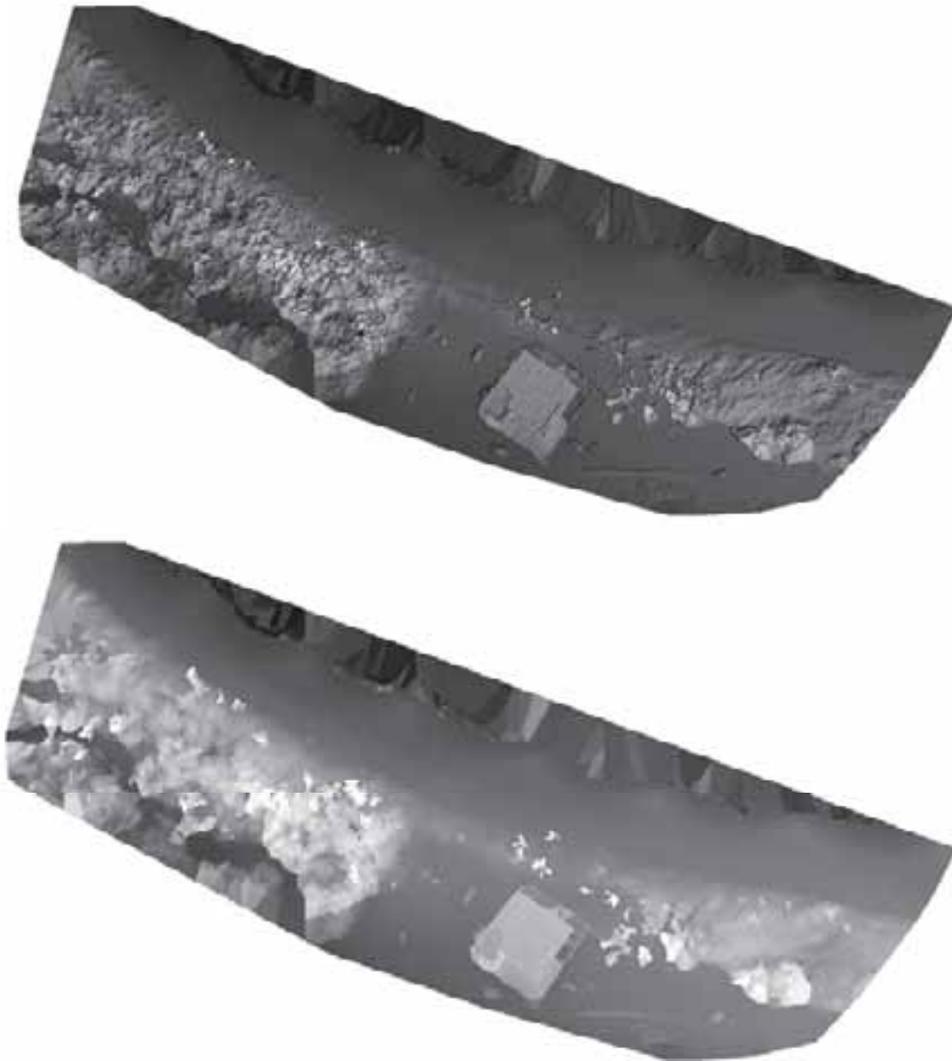
Figure 310. Grayscale DSM images of the El Caracol (after swell), Dorado. The top image shows shades and the bottom is not shaded.

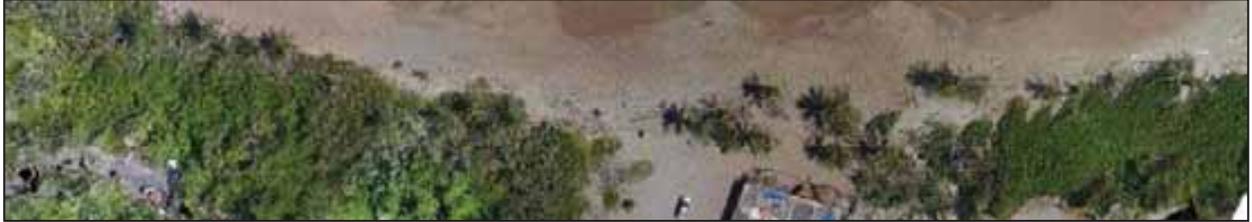
Figure 311. Images of the area for which vegetation cover is being monitored for the El Caracol in Dorado, Puerto Rico. The vegetation cover was 53.3% for the eastern part of the site March 20, 2018.

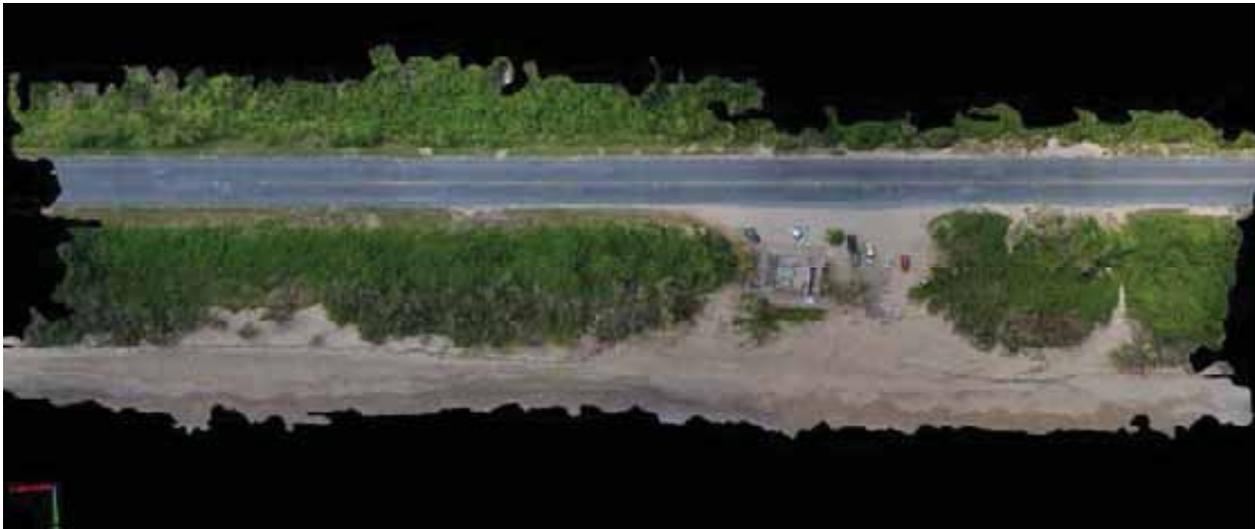
Figure 315. Aerial 3D image of the El Único (after northeasterly swell), Dorado.

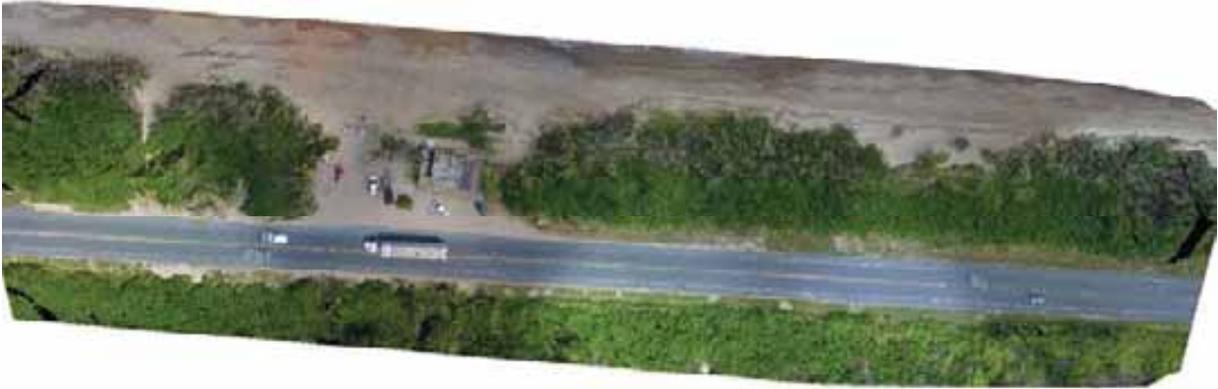
Figure 316. Orthomosaic image of El Único (after northeasterly swell), Dorado.

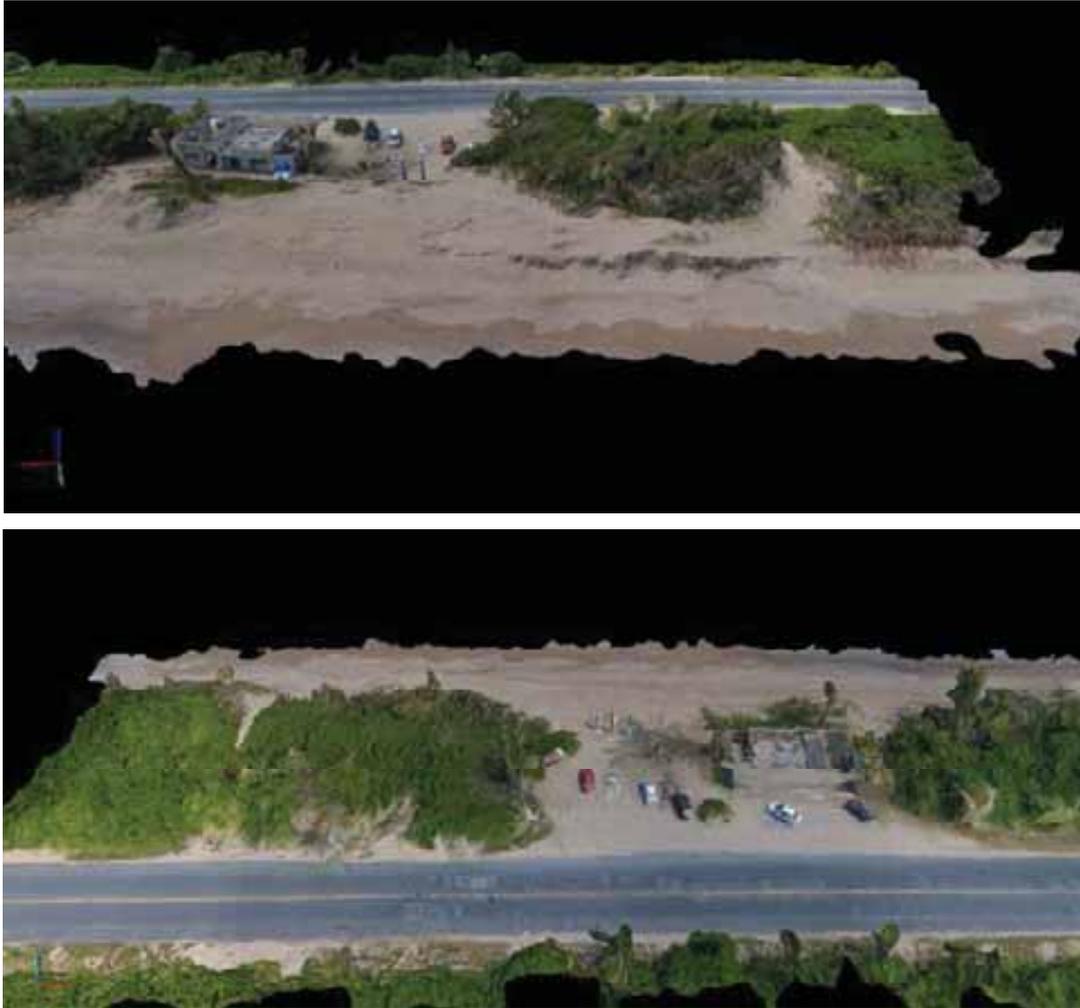
Figure 319. Three dimensional RGB images of the El Único, Dorado. View from the north of the western part of the site (top) and from the south of the same area (bottom).

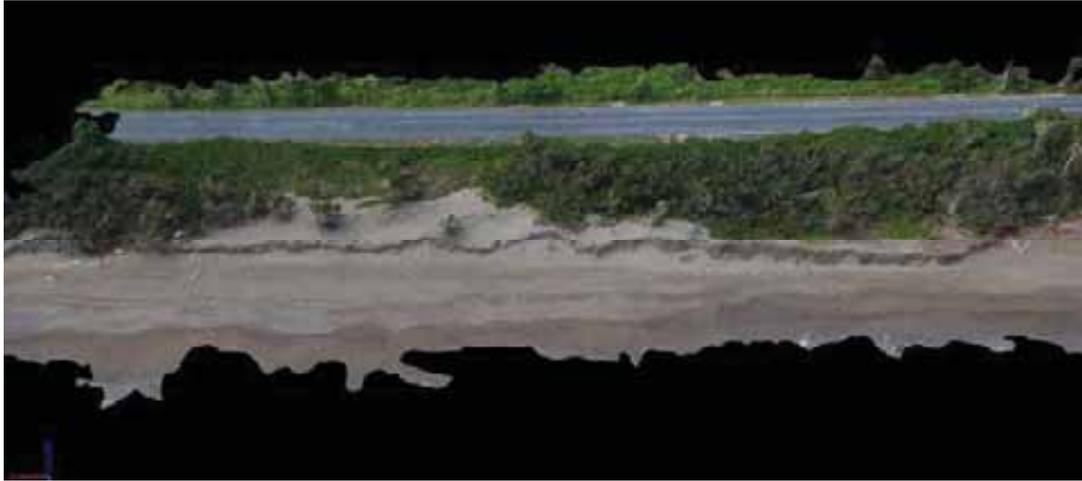
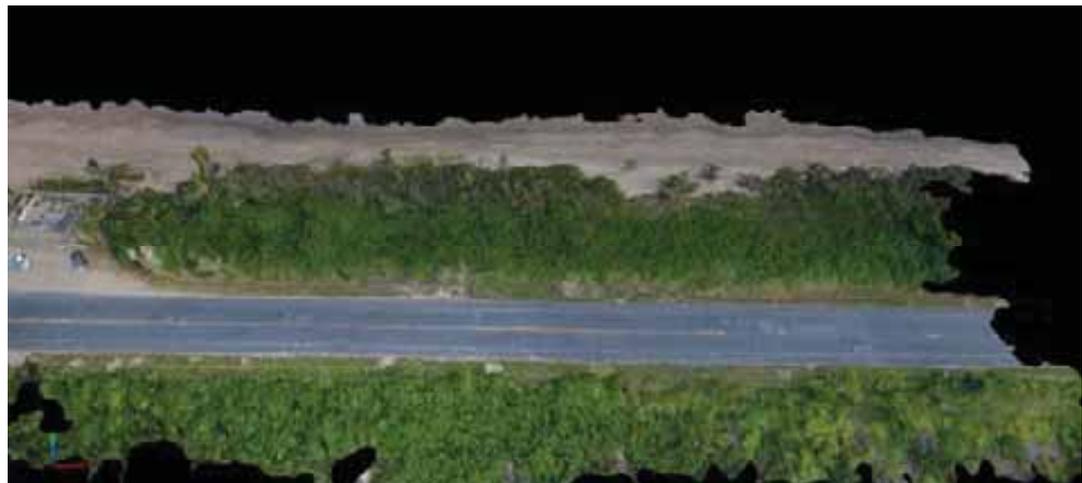
Figure 320. Three dimensional RGB images of the El Único, Dorado. View from the north of the eastern part of the site (top) and from the south of the same area (bottom).

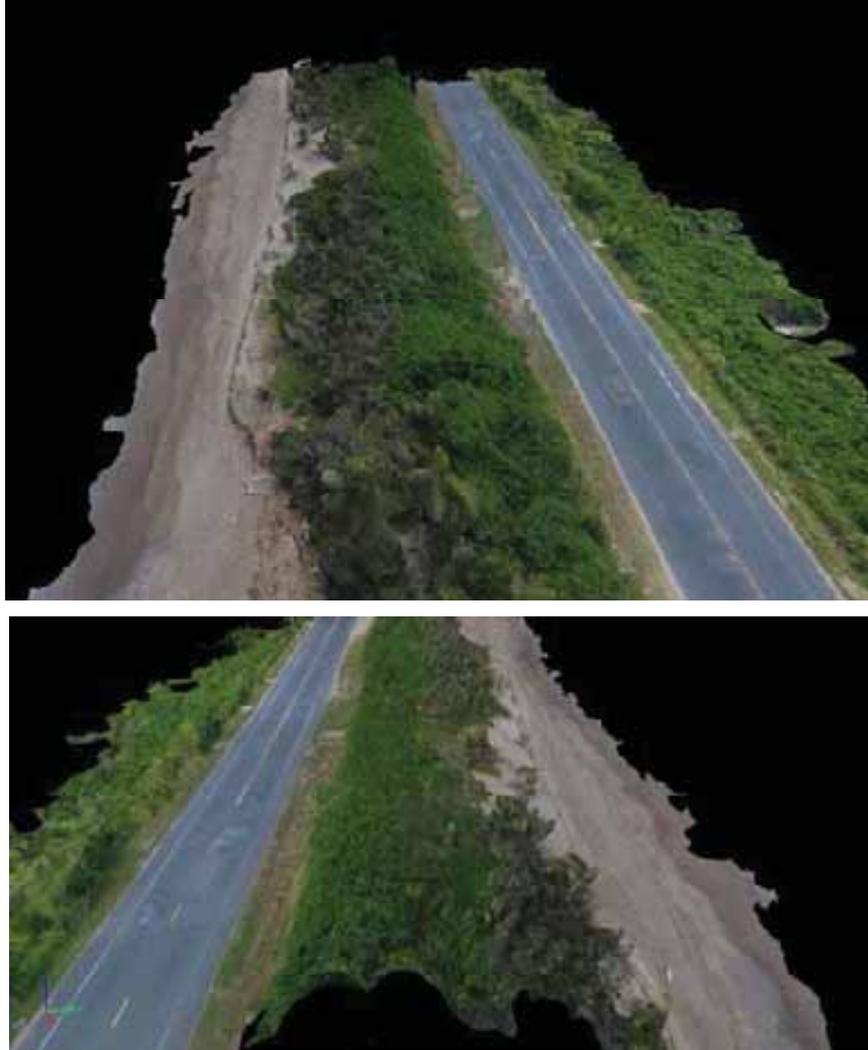
Figure 322. Three dimensional RGB images of the western part of the El Unico, Dorado. View from the west (top) and from the east (bottom).

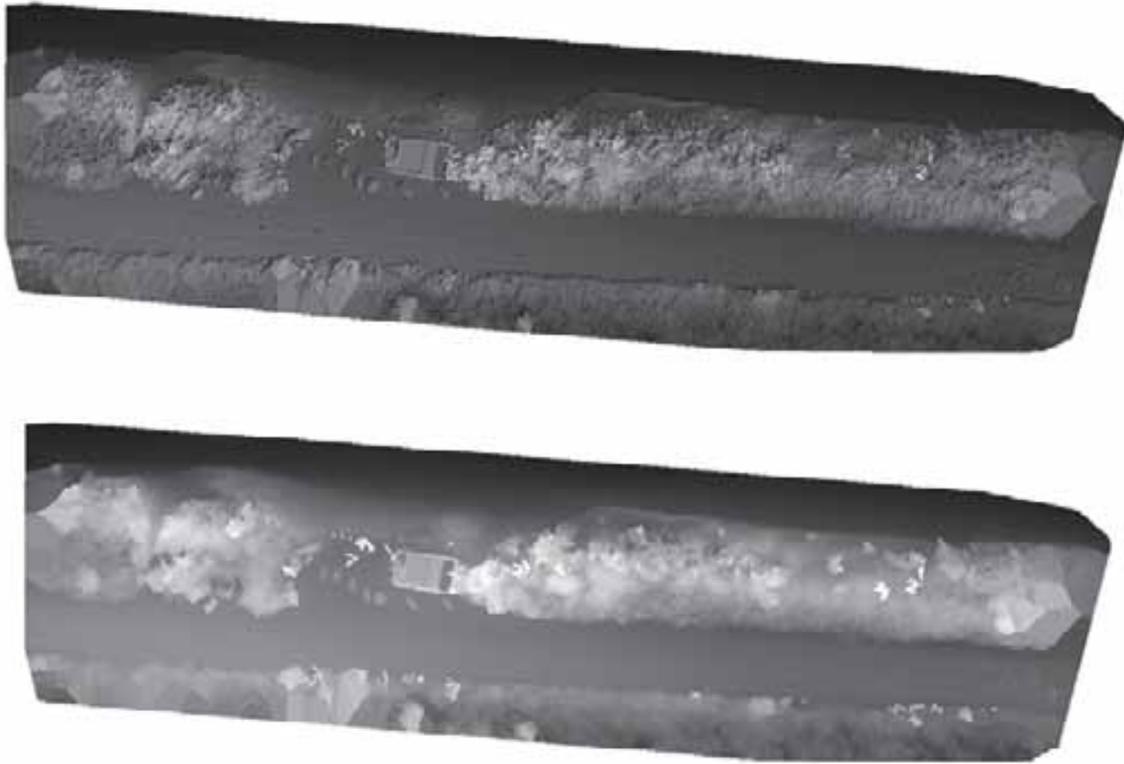
Figure 323. Grayscale DSM images of the El Único (after swell), Dorado. The top image shows shades and the bottom is not shaded.

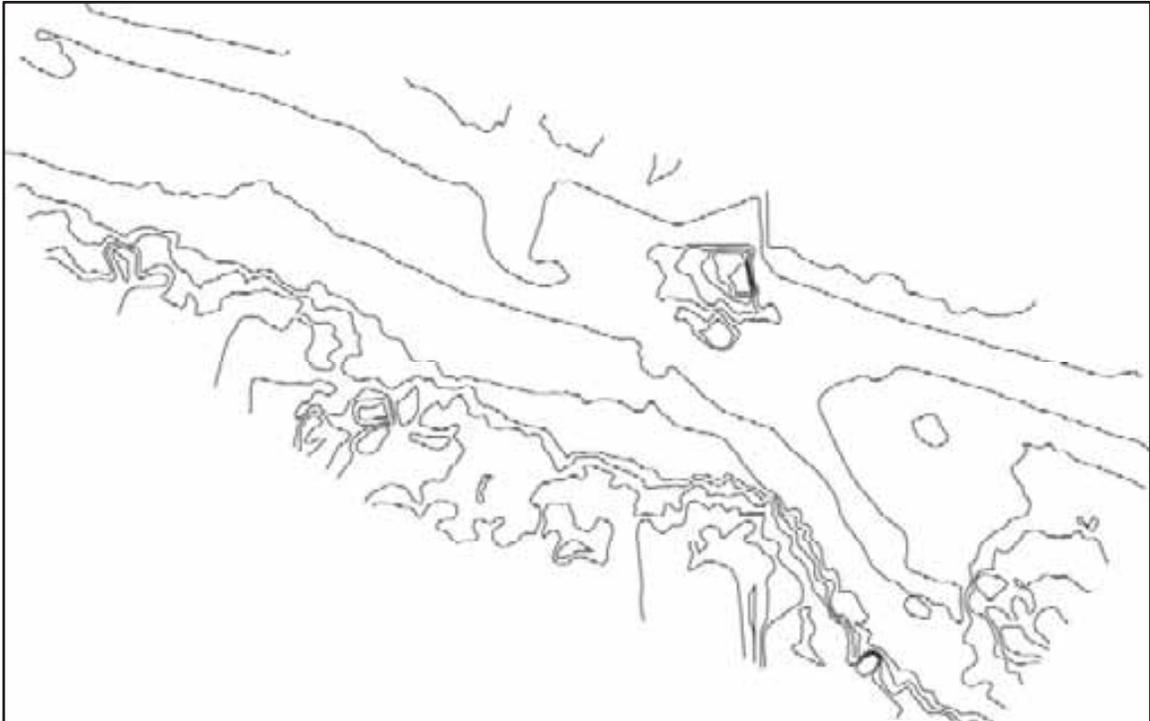
Figure 327. Contour map of Northeastern Ecological Corridor, Luquillo, Puerto Rico with elevation intervals of 1 meter.

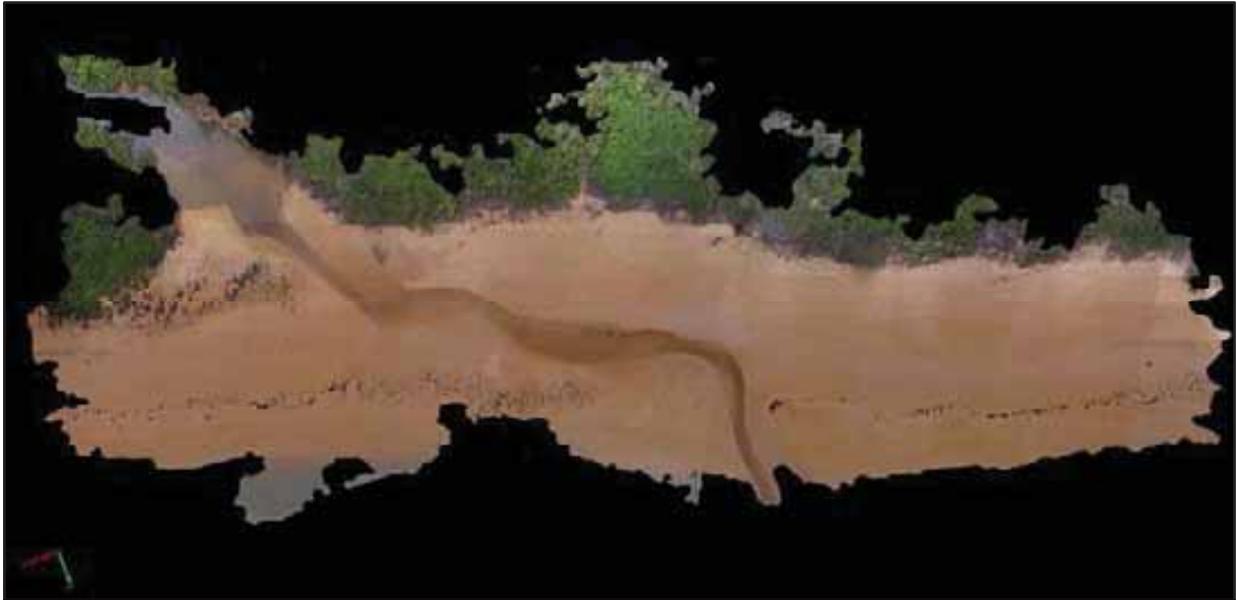
Figure 328. Aerial 3D image of Northeastern Ecological Corridor, Luquillo.

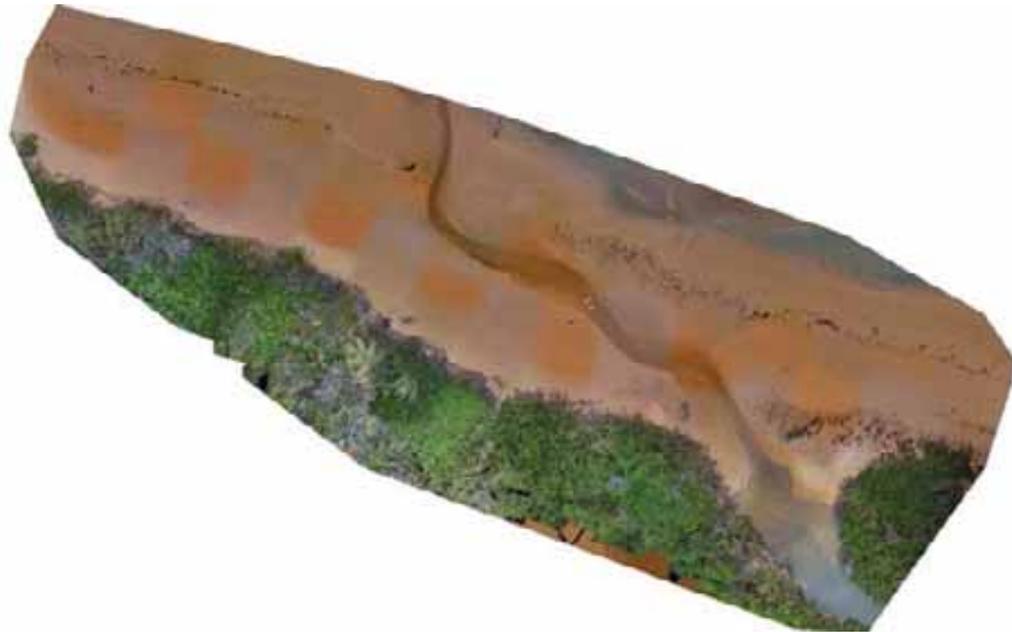
Figure 329. Orthomosaic image of Northeastern Ecological Corridor, Luquillo.

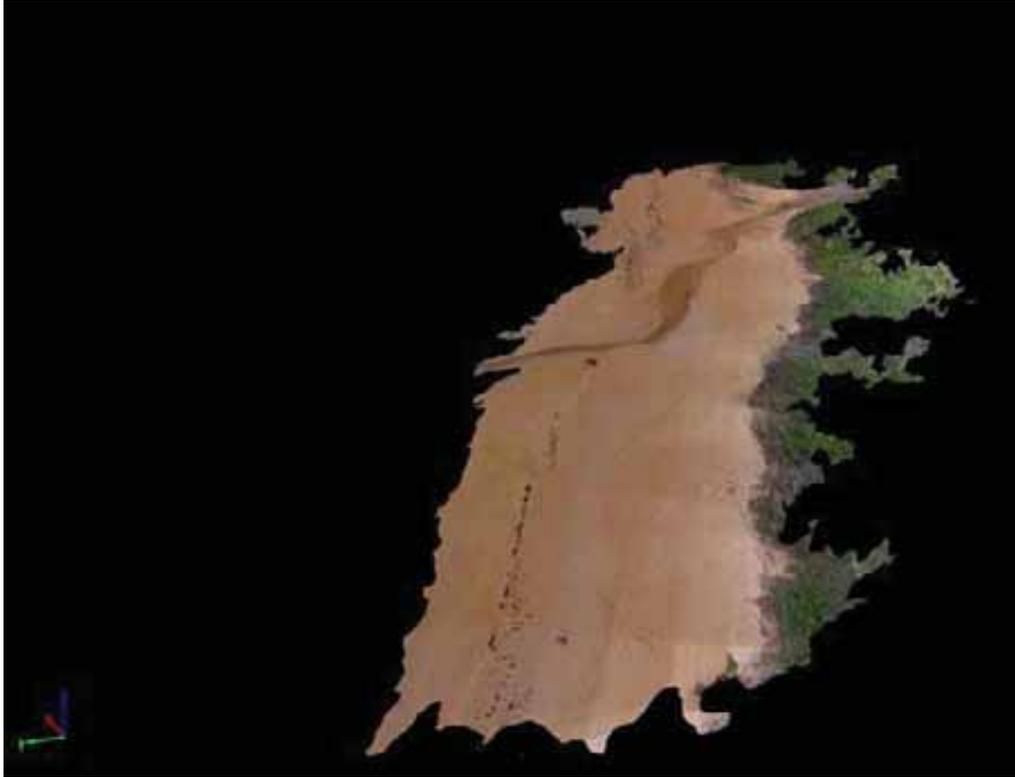
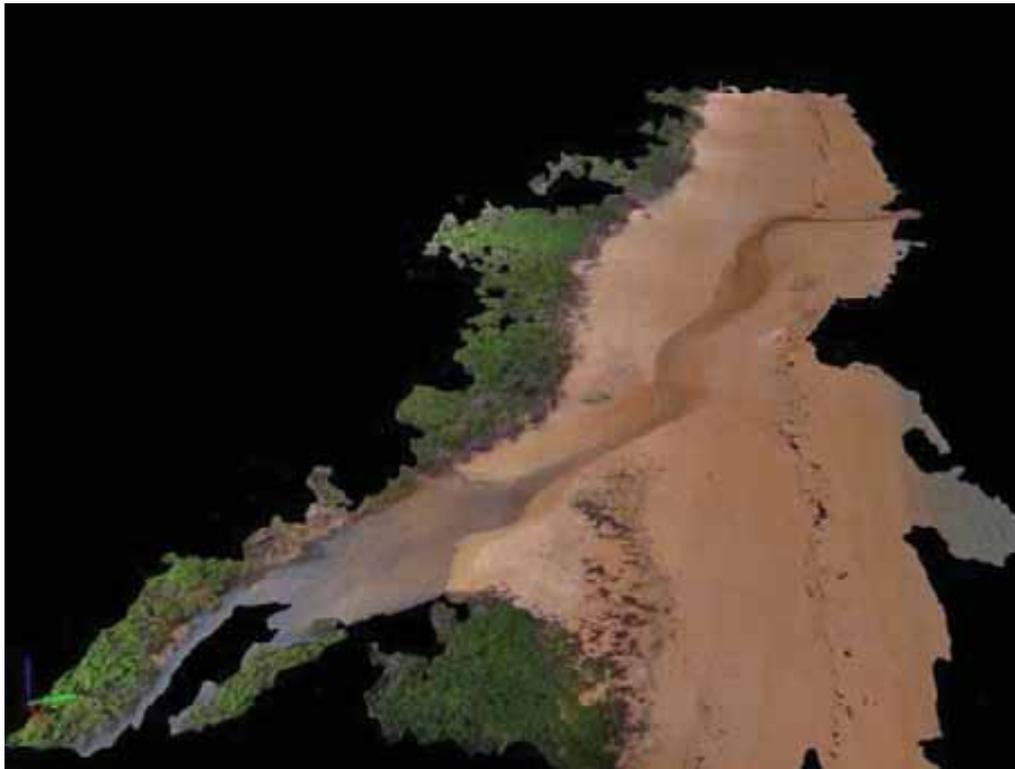
Figure 333. Three dimensional RGB images of Northeastern Ecological Corridor, Luquillo. View from the west (top) and from the east (bottom).

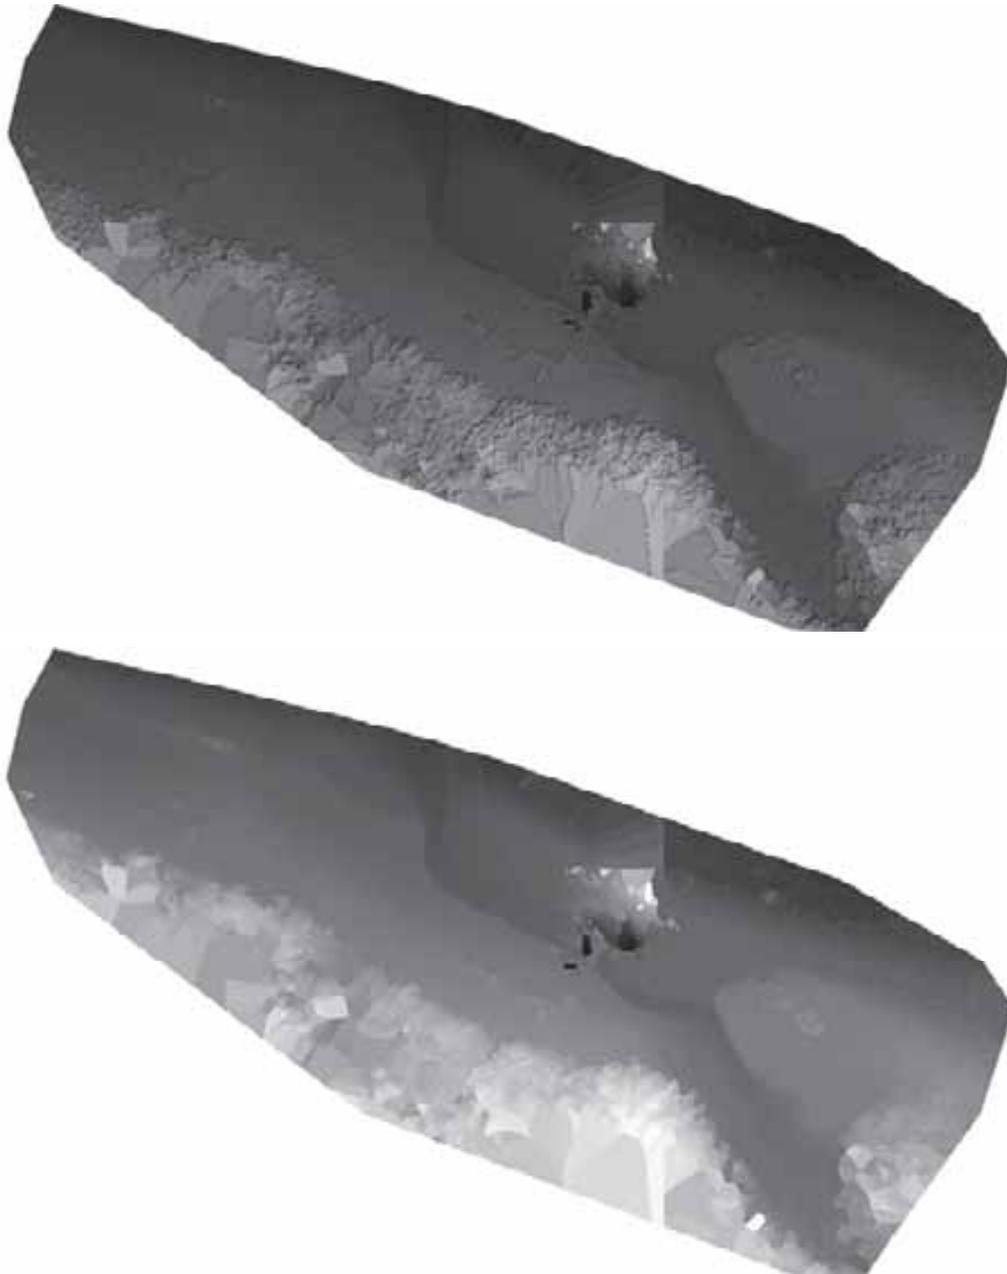
Figure 334. Grayscale DSM images of the dune at Northeastern Ecological Corridor, Luquillo. The top image shows shades and the bottom is not shaded.

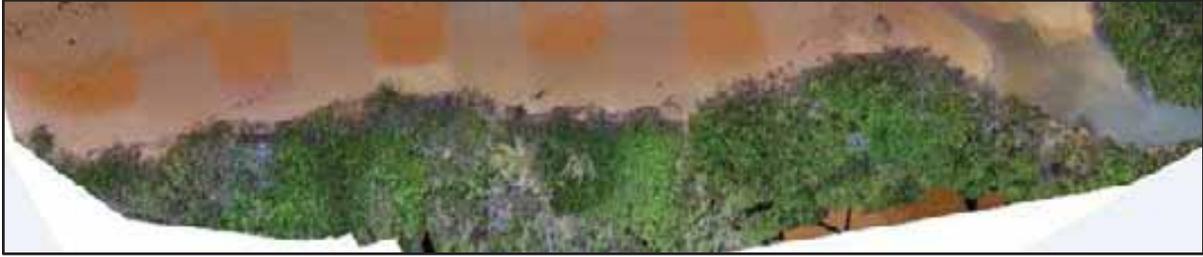
Figure 335. Vegetation covered 56.4% of the area of the Northeastern Ecological Corridor in Luquillo, Puerto Rico on April 18, 2018 (after northeasterly swell).
