El papel de viveros en restauración después de encallamientos en Guayanilla, Puerto Rico

May 16, 2013

NOAA
Restoration
Center

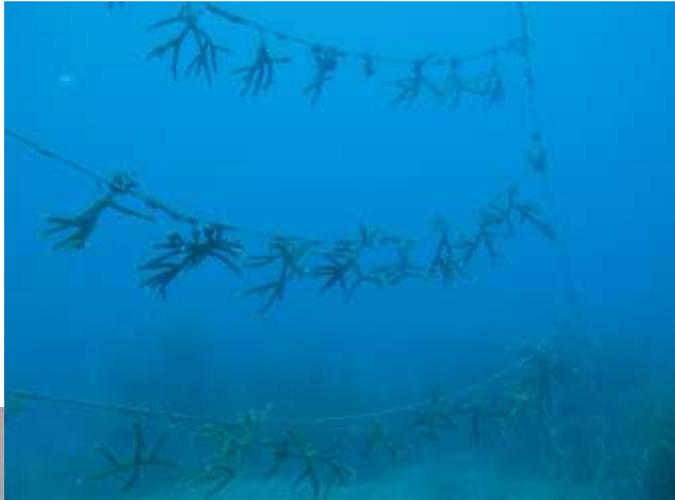
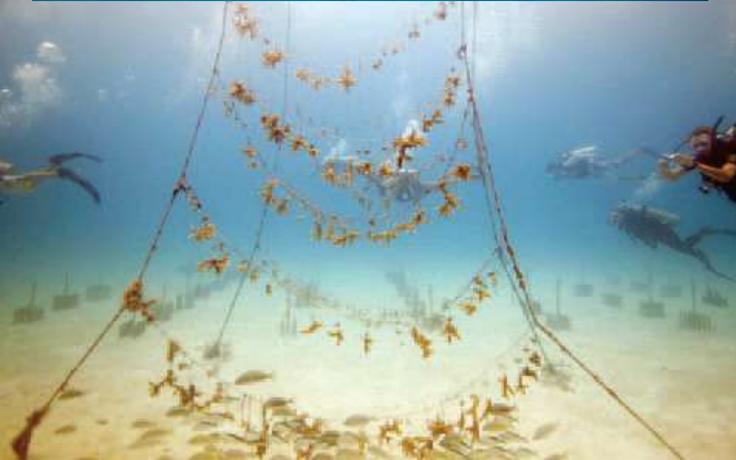
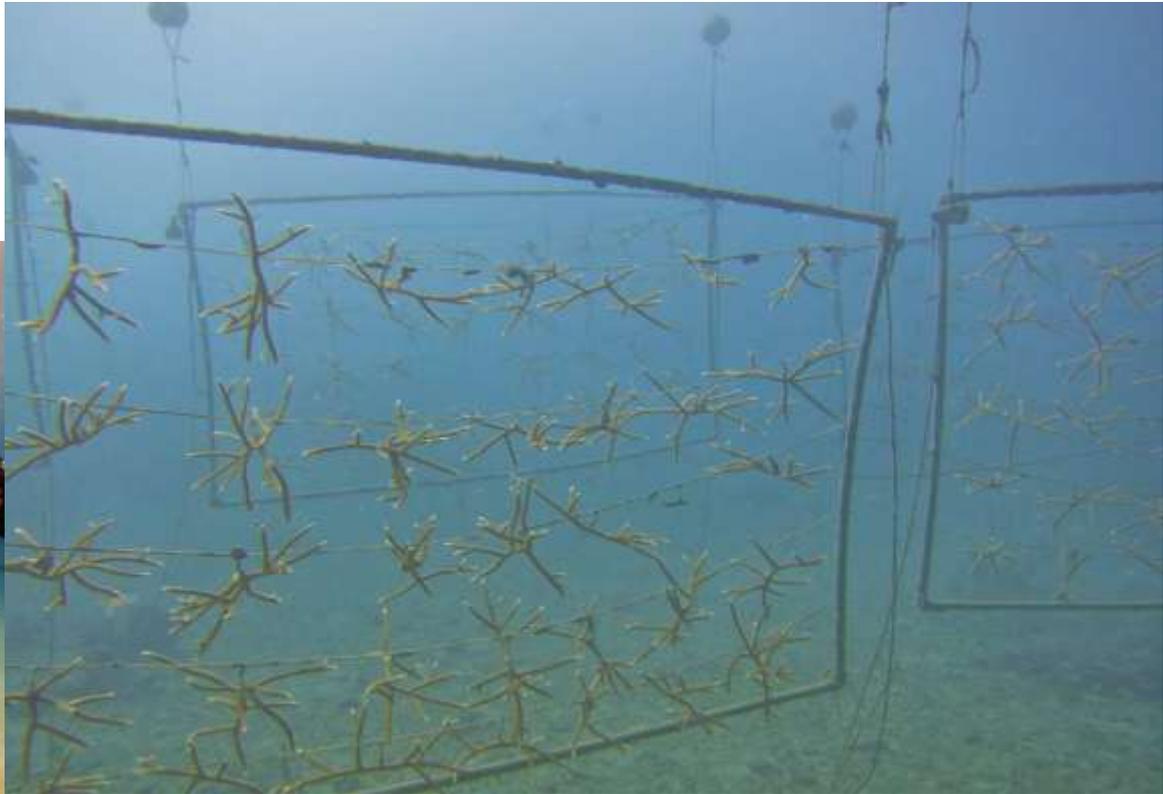
FUCAs

- PVC frame prevents sagging in middle as corals grow
- No Maintenance
- High Growth Rates/ Low Mortality
- Storm Resistant
- Dimensions: 1.5m x 3m

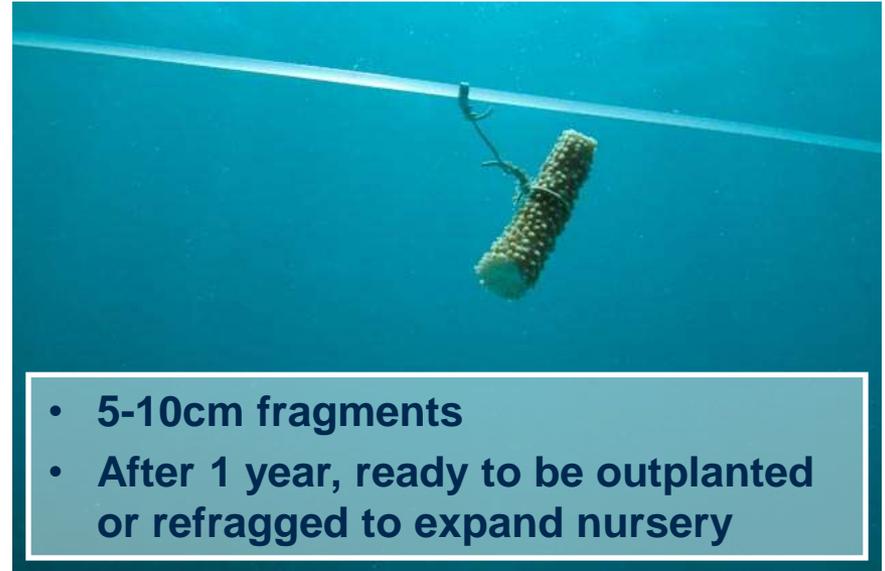
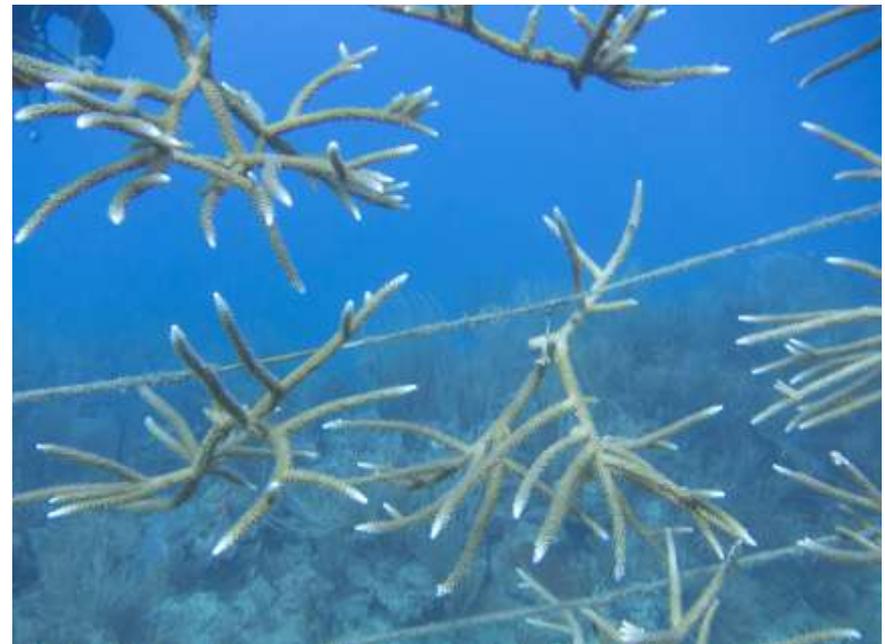
Survival and Growth

Time Period	One Year
Mean Linear Growth	52.5 ± 1.1 cm
Mean Linear Growth Rate	4.4 cm/month
Maximum Diameter	21.7 ± 0.3 cm
Change in Diameter	1.4 cm/month
Mortality	4.5%

- Currently 1,600 colonies in the nursery
- Outplant 1,200 each year
- Remaining 400 colonies used to restock the nursery

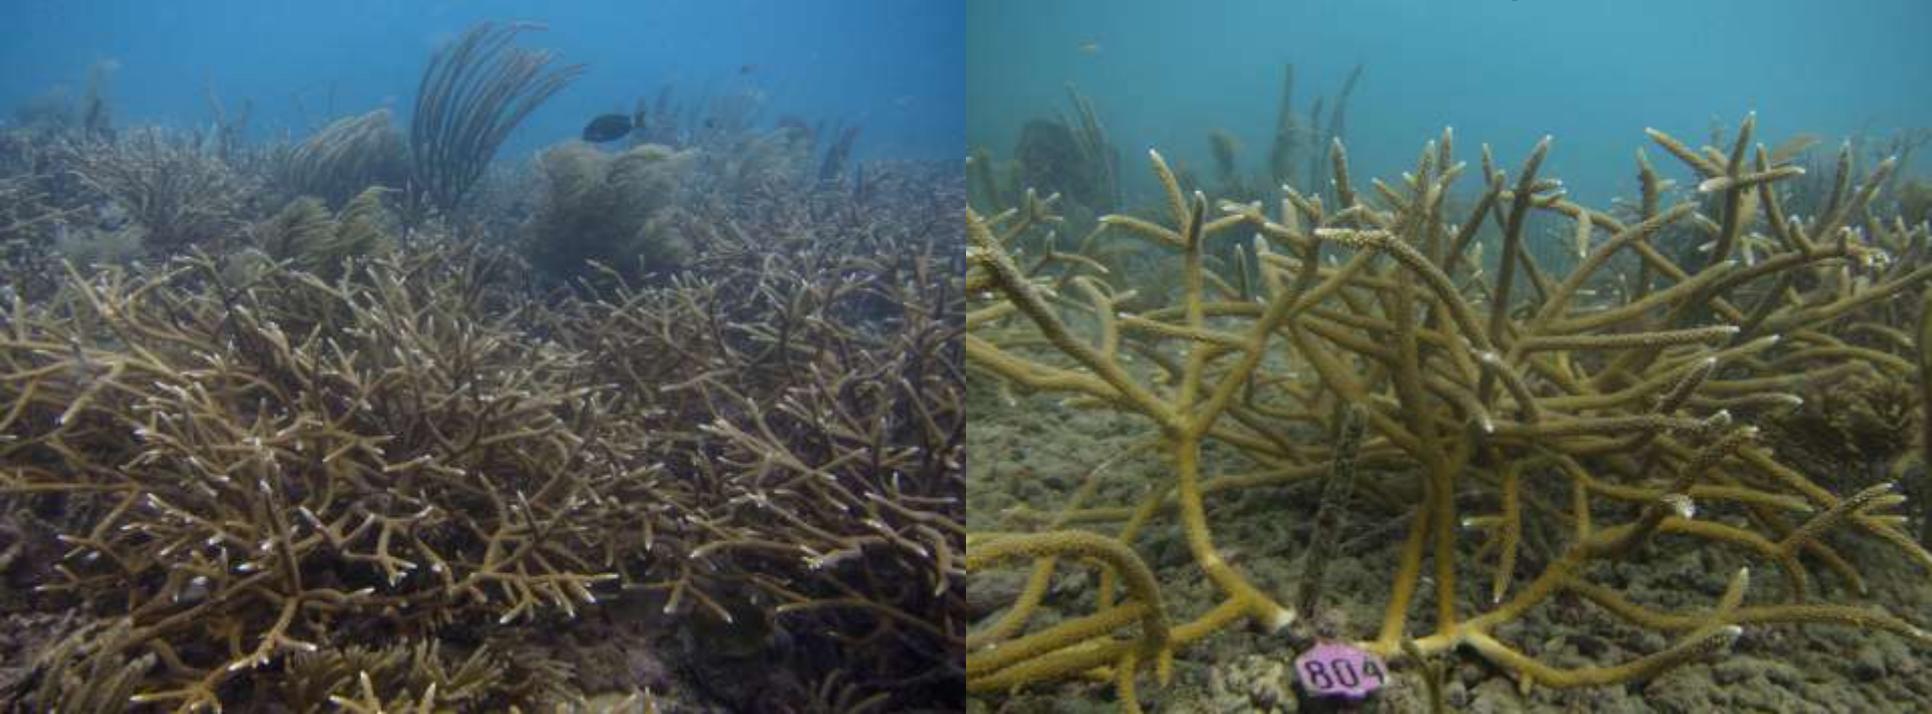
Outplanting

Size of outplants	40 cm diameter
Outplant densities	4 – 8 colonies/m ²
Survival	>90%
Size at 1.5 yrs	60 cm – 1 m

- Combination of nails, cable ties, and epoxy

-15-25 Pilot Outplants

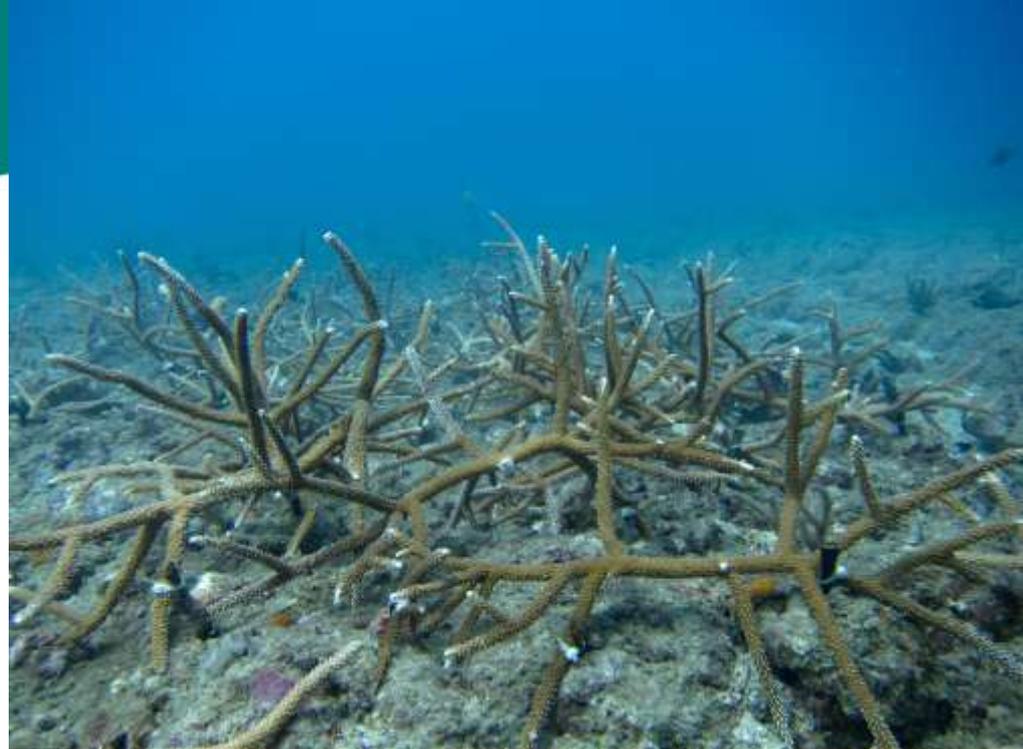
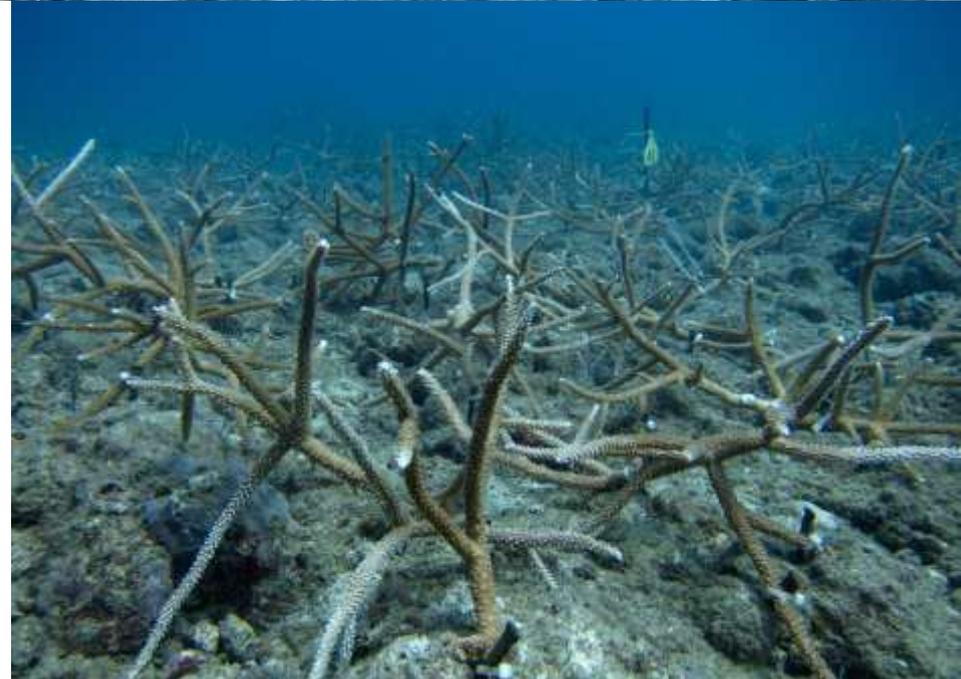
2013 Outplanting

- 1,200 corals outplanted
- 3 “thickets” (10m x 6m) were created using 400 colonies in each
- Fish monitoring using RVC method in thickets, impact and reference area

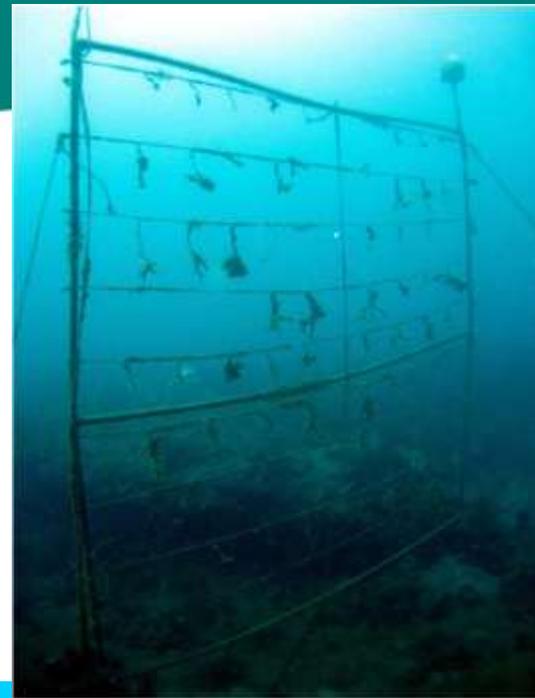
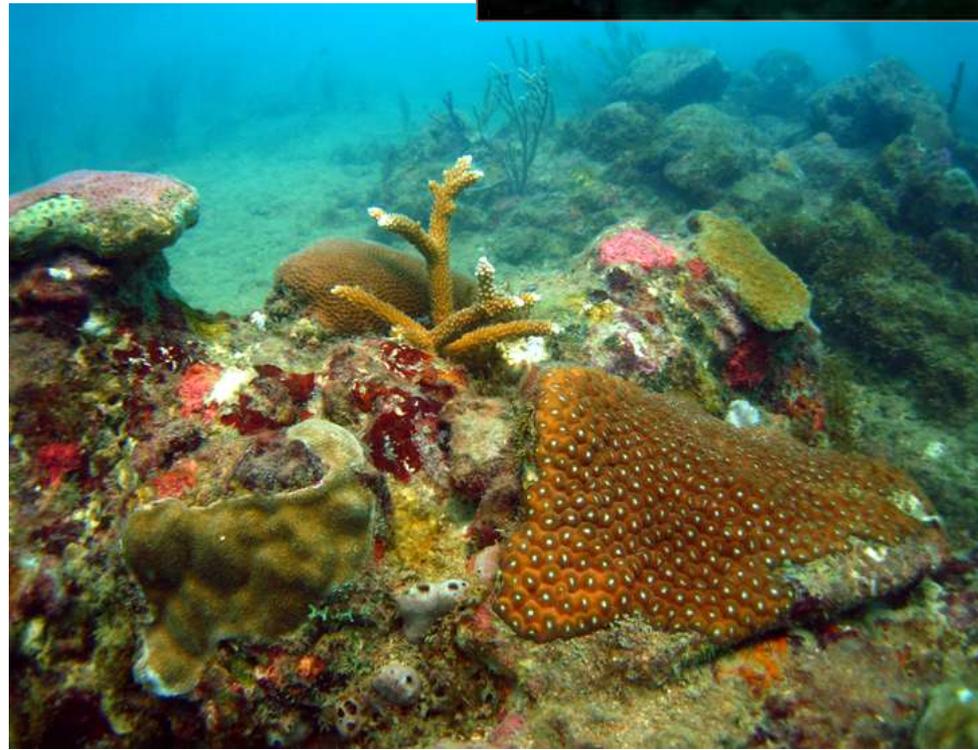
Temporary Line Nurseries

- Acropora fragments placed on line nurseries during Emergency Restoration
- Fragments reattached after restoration completed
- Replanted colonies showed higher growth and lower partial mortality than control reference colonies.
