HISTORICAL DEVELOPMENT OF THE MUNICIPAL LANDFILL IN THE EASTERN BORDER OF THE LUIS PEÑA CANAL RESERVE IN THE MUNICIPALITY OF CULEBRA, PUERTO RICO AND ITS POTENTIAL IMPACT ON THE RESERVE

Final Report submitted to the Department of *Natural and Environmental Resources*
of the Commonwealth of Puerto Rico in fulfillment with Task CRI-9 PR CORAL
REEFS AND WATERSHEDS STRATEGY of the *Conservation and Management*
of Puerto Rico Coral Reefs proposal

José Norat, Ph.D.

September, 2007

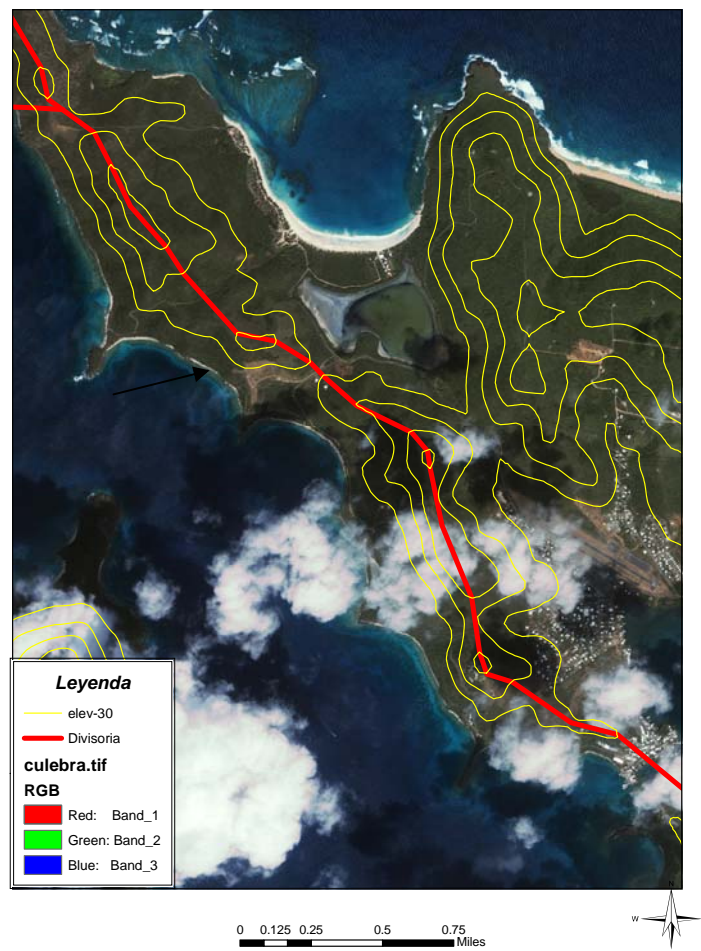
Landfill site is located near Punta Tamarindo in the southwest of Culebra Island. The landfill site is located near the 30 meter contour elevation according to a map prepared by Rodríguez, 2007. Also, it is located near main drainage line (divisoria-red line) of the Island (see figure below). This topographic characteristic may produce major runoff occurring during major rainfall events that may transport material and sediments from the landfill site to the Punta Tamarindo shoreline and south west shoreline areas.

Topographic contour lines designed and prepared by Rodríguez, C., 2006

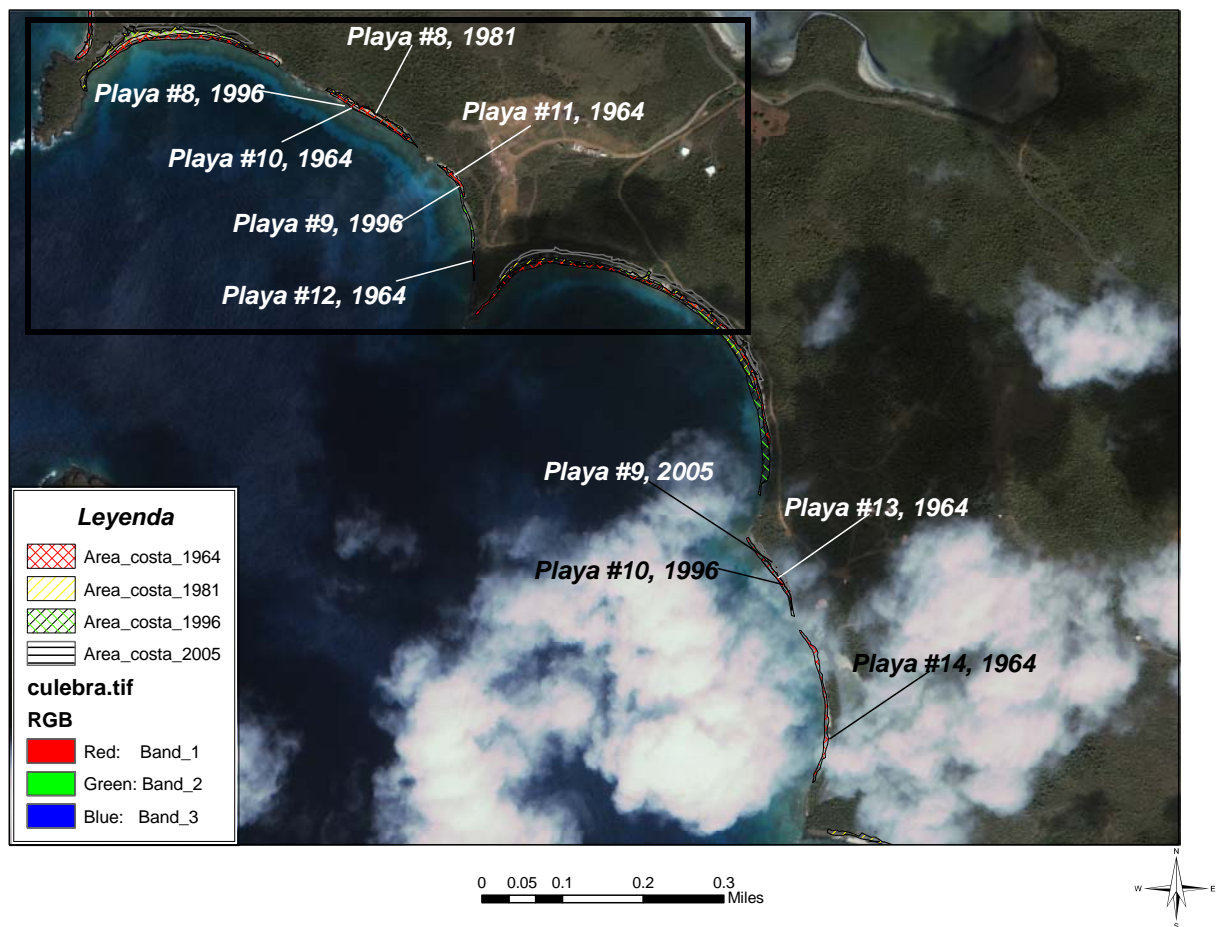
Two intermittent beaches were observed from Punta Tamarindo Grande to Punta Tamarindo (Playa # 8 and Playa # 9) (see Figure below). These were located to the east site of Punta Tamarindo Grande and in the shoreline area near the landfill site.

Intermittent beach plains identified from Punta Tamarindo Grande to Punta Tamarindo (see selected area included in a box, Playa #8, #9, #10, #11, #12) (1964 to 2005). An intermittent beach (Playa # 12) is located southward from landfill site. Map designed and prepared by Rodríguez, Cielomar, 2006.

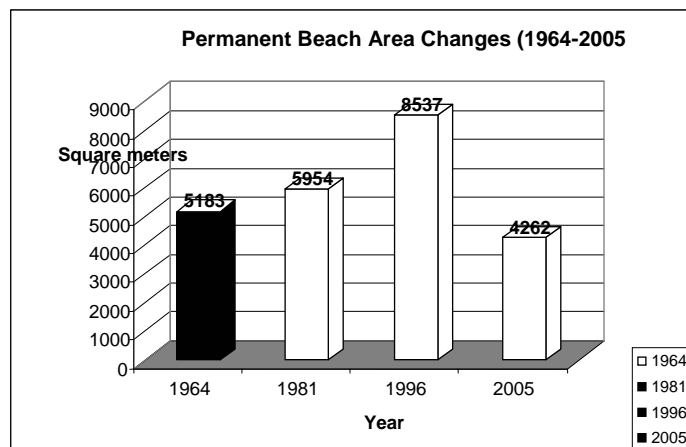
Playa #4 (1964-2005)

A permanent beach plain was identified eastward from Punta Tamarindo from 1964 to 2004. This beach showed changes in the subaerial plain extension during these periods (see figure below). An increase in beach plain was measured from 1964 to 1996. Major erosion was observed in 2004 (see figure below). The beach is located to the east side of landfill site. Beach changes may be related to an increase in storm occurrence in the area, and possibly with lack of sediment and/or decrease in biogenic sediment production in the nearshore area. Biogenic sediment production can be reduced by storm effect, sediment runoff from land, man-made activities as land cover changes caused by landfill activities.

Historical beach changes (permanent beach-Playa # 4) identified eastward from Punta Tamarindo. Graph designed and prepared by Rodríguez, Cielomar, 2005, unpublished undergraduate thesis.

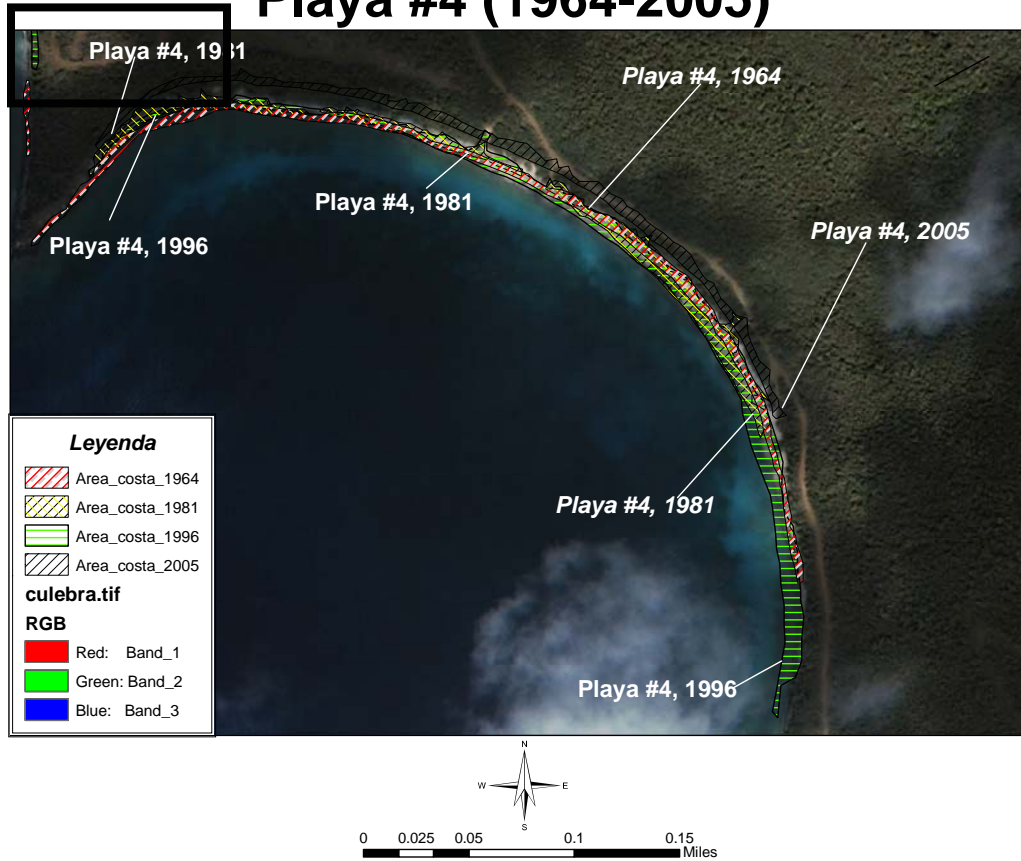
Permanent beach delineation located eastward from Punta Tamarindo (1964 to 2005). Landfill site is located in the box area northward Punta Tamarindo. Map designed and prepared by Rodríguez, Cielomar, 2005.

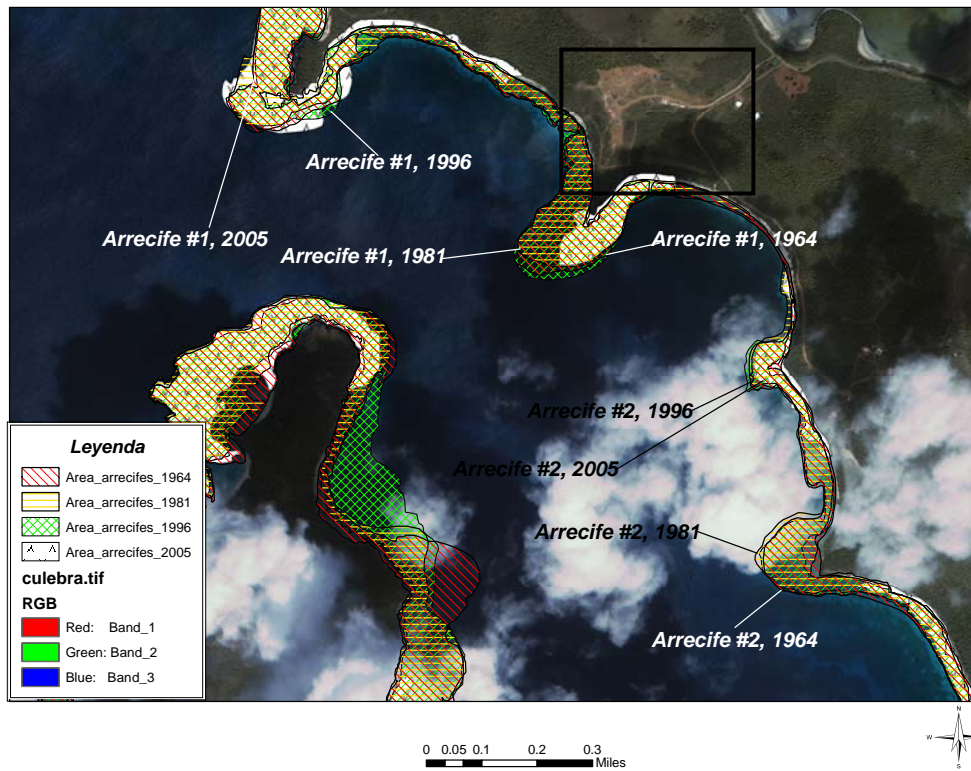
Reef Structure Changes from Punta Tamarindo Grande to Punta Tamarindo, Culebra, Puerto Rico. Map prepared by Rodríguez, Cielomar, 2006. (see landfill site defined in the box)

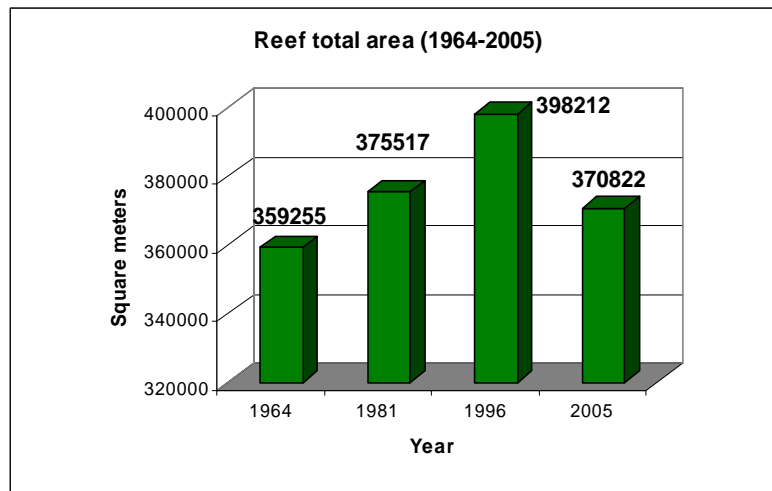
Reef structure total area calculated from polygons defined in aerial photos done by Rodríguez, Cielomar, 2006. Subaerial reef structure area was calculated from Punta Tamarindo Grande to Punta Tamarindo.

Reduction of reef structure in 2005 at Punta Tamarindo near landfill site may be related with high sediment concentration in the nearshore come from land sources that can not permit distinguish reef structure in the east side of Punta Tamarindo.

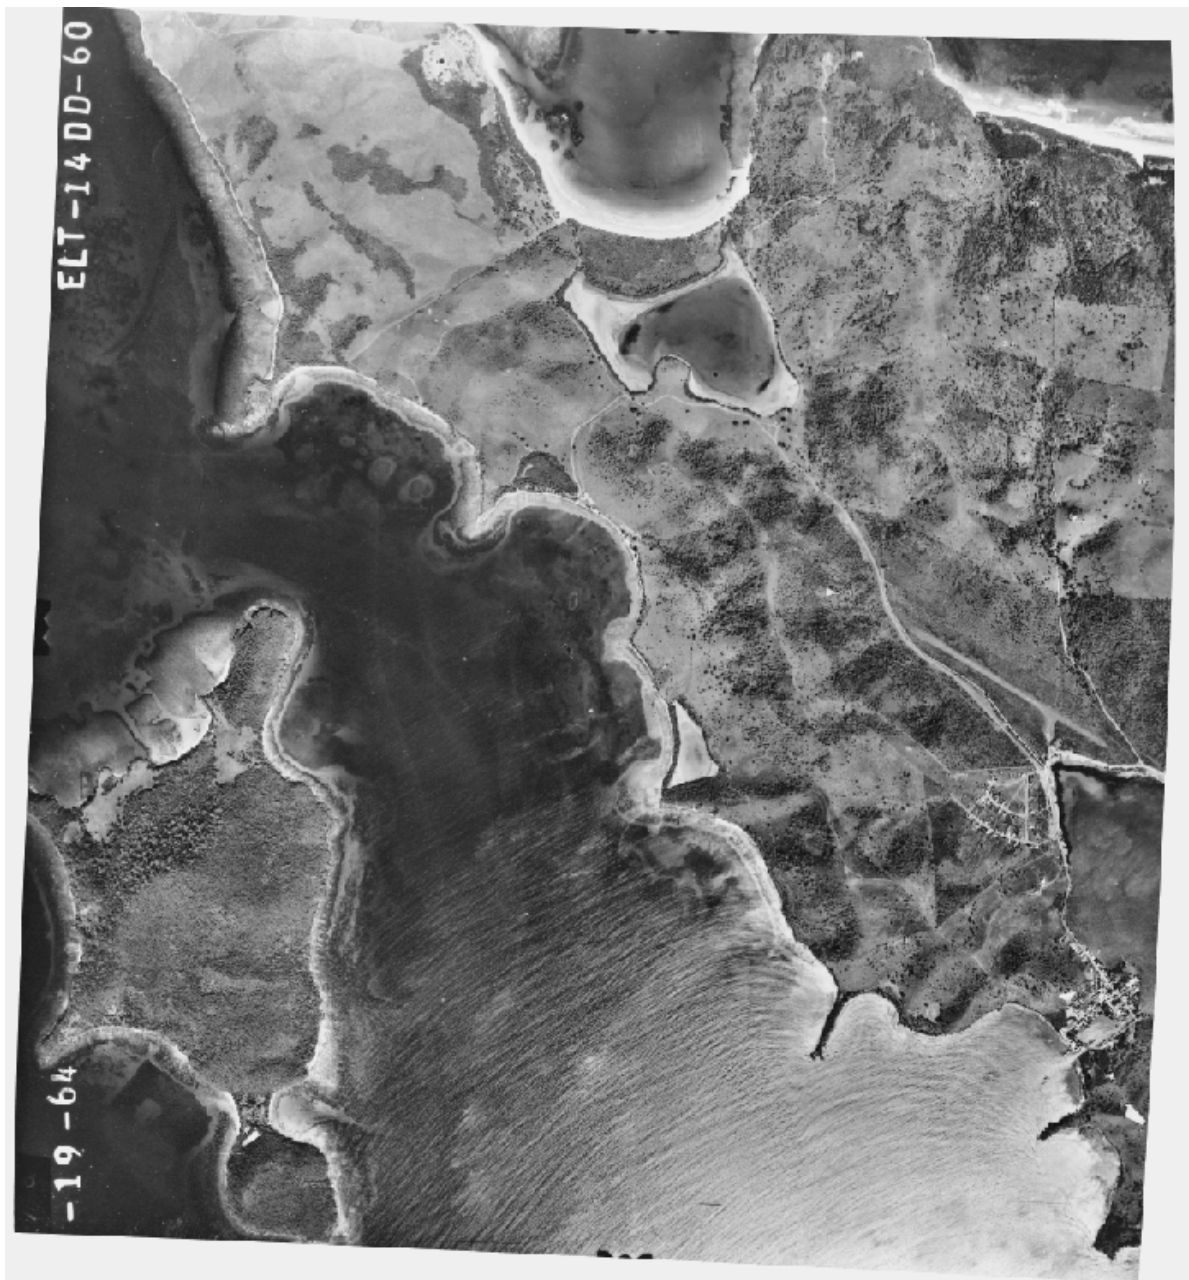
Culebra 1964

The landfill site is not found in the 1964 aerial photograph (see aerial photo from 1964). Aerial photography showed low density vegetation cover in the future landfill site. Low vegetation cover was also observed in the main drainage line located near the proposed landfill site. No major barren land cover was found at the site. A main road that extended from the Flamenco beach site to the proposed landfill site was found in the aerial photo for this period.

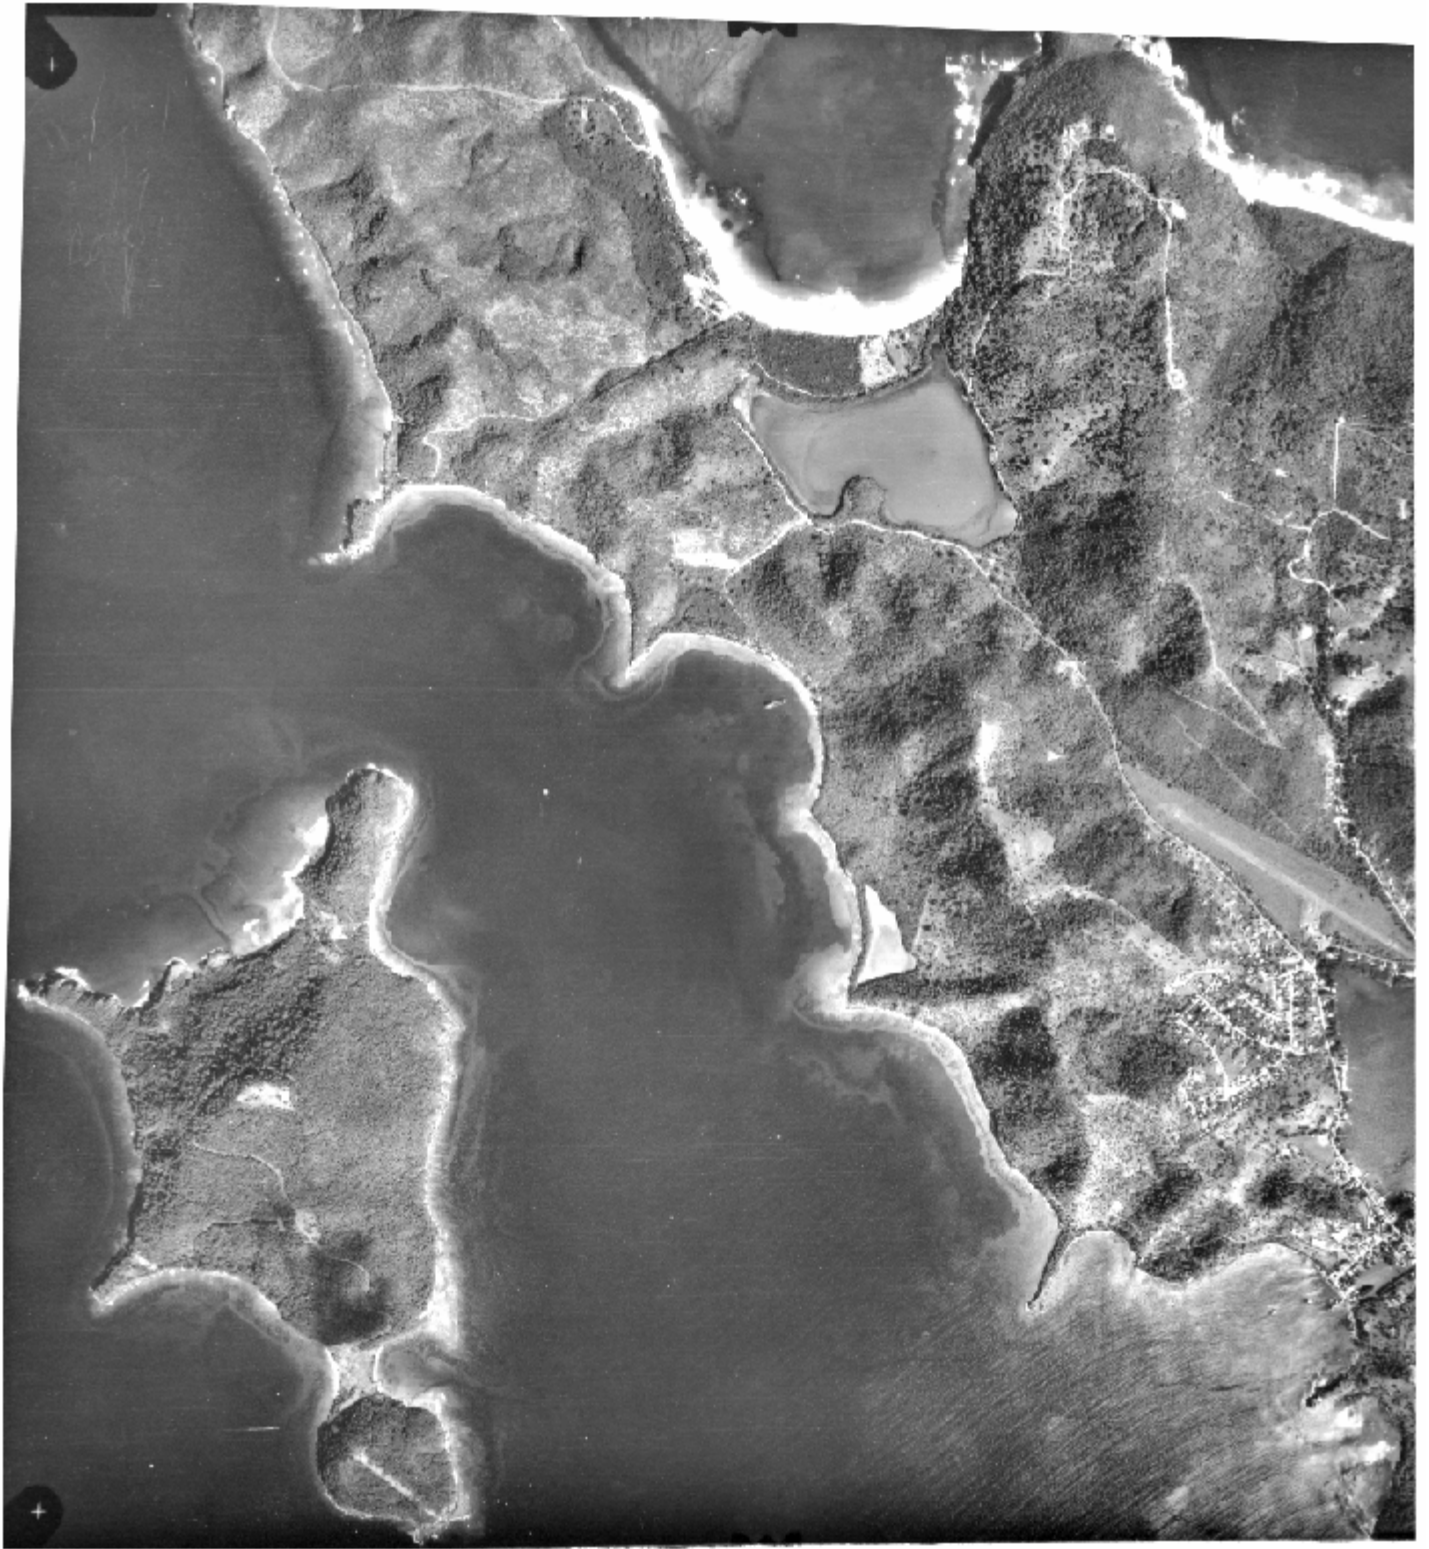
Culebra 1981

Landfill site is found in the 1981 aerial photograph. According to the data the landfill site was opened during the first part of the decade of the 80's. The landfill site is oriented to the north of the main drainage line. An additional barren land was observed in the south site from the main landfill site. This barren land cover is not connected with the main landfill site. It is not clear if this new barren land area is caused by human activities, landslide or fire events (see aerial photo from 1981).

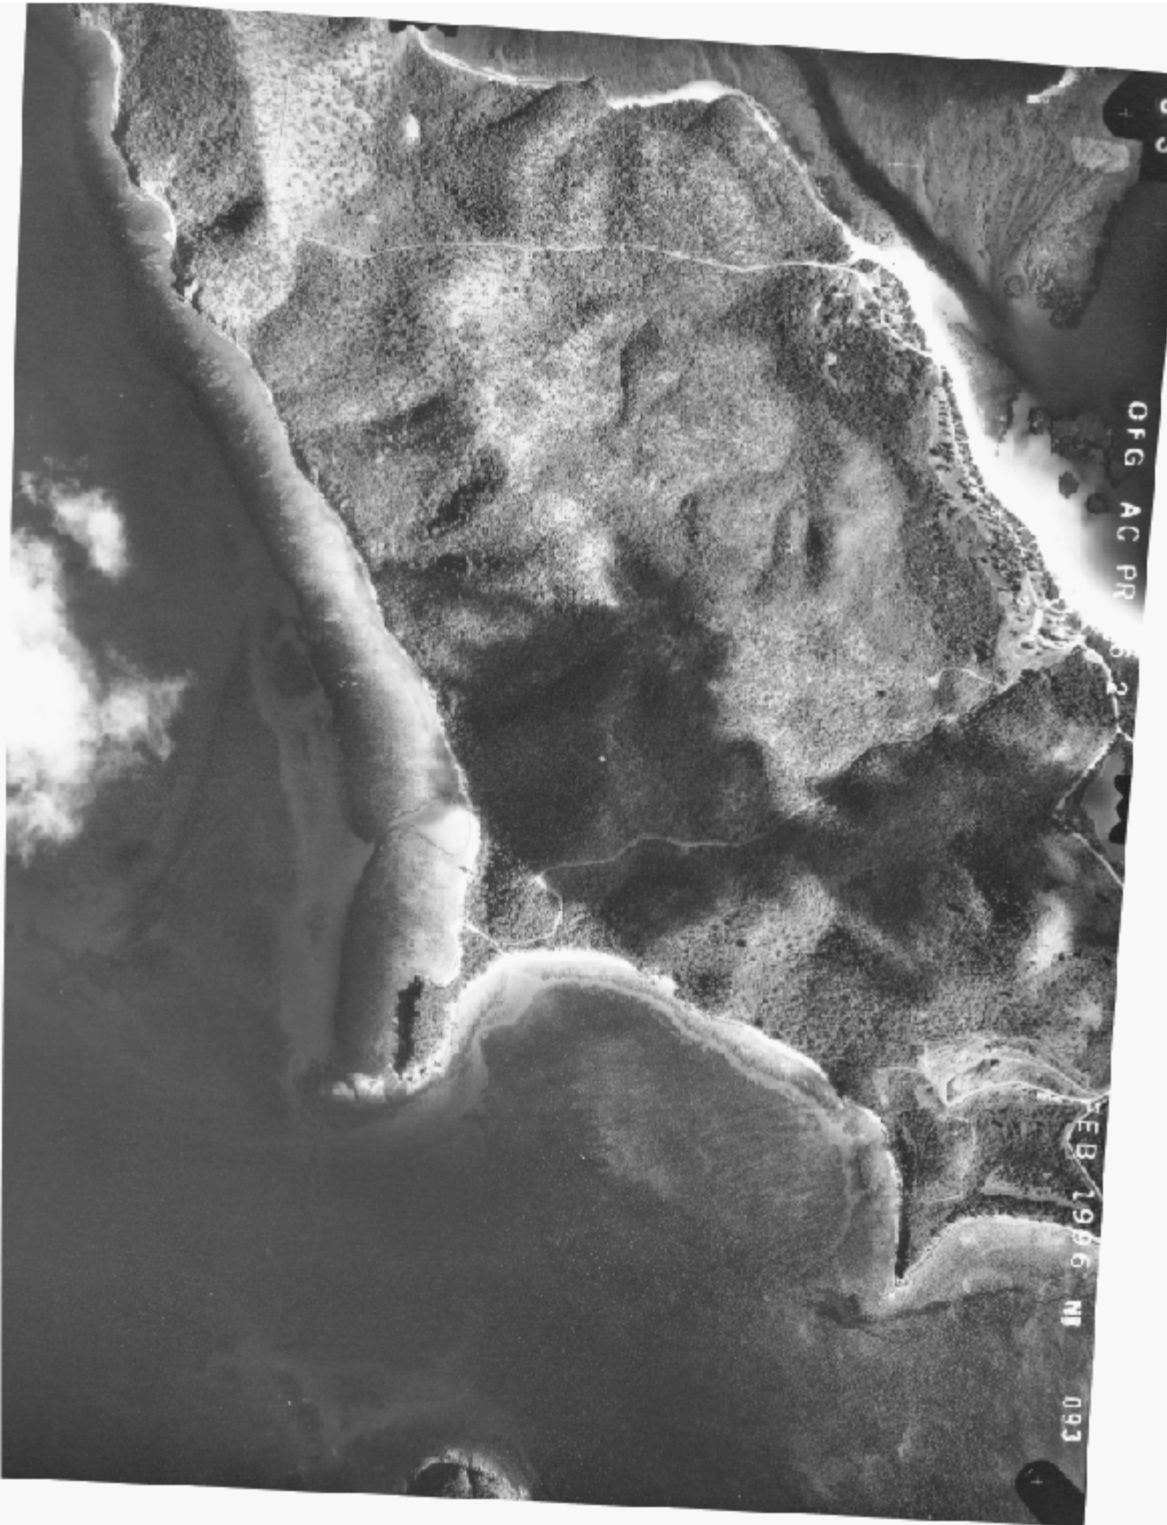
Culebra 1996

The landfill site showed an orientation more to the south in this period compared with 1981 landfill location. Landfill site showed more extension to the southwest area. A barren land that appeared in 1981 aerial photo located near to Punta Tamarindo does not appear in the 1996 photo. Low density vegetation is observed in this area in 1996. Apparently a re-forestation event occurred in this site during the 1981 to 1996 period. New roads were observed from the main landfill site to the shoreline near Punta Tamarindo (see aerial photo from 1996).

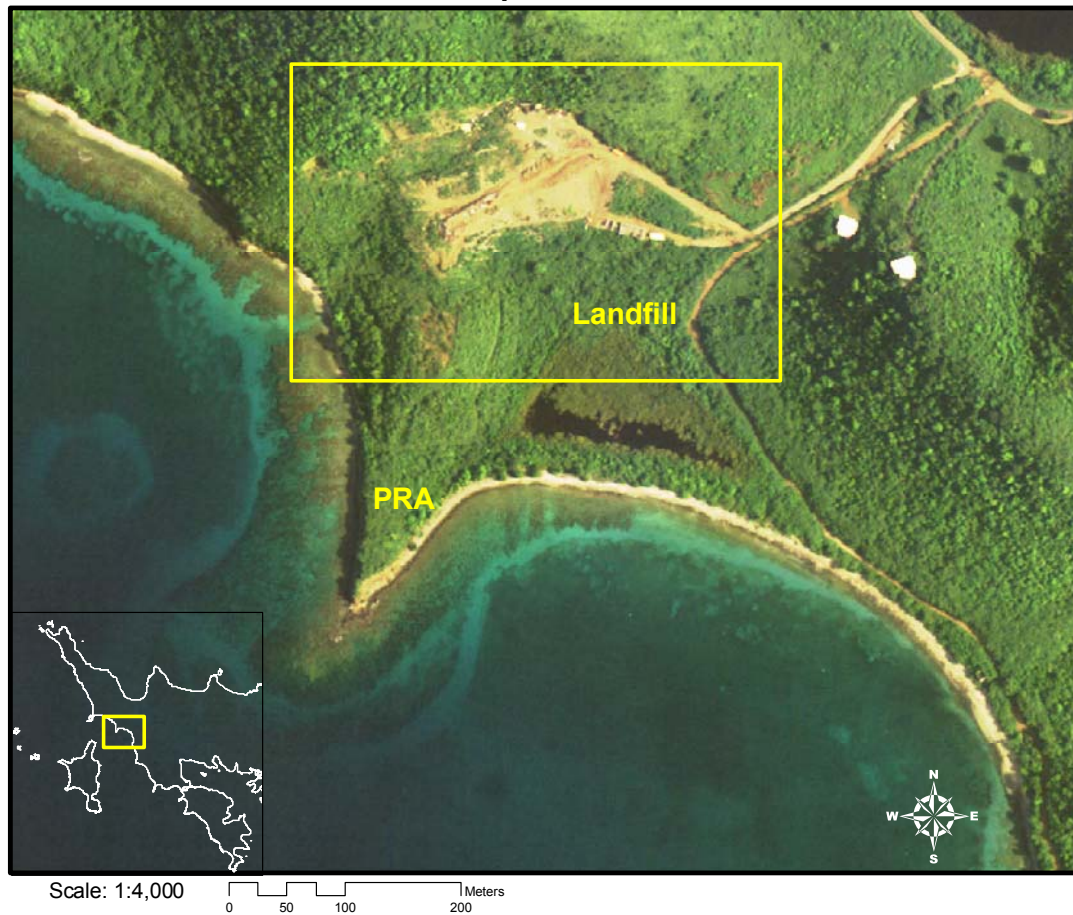
FIGURE 2. Detail of Culebra Island municipal landfill and its adjacent marine communities at Punta Rompeanzuelo (PRA). Note the presence of linear reefs, colonized pavements, colonized bedrock, continuous seagrass, sandy bottoms, rocky shores and sandy beaches. Also, note the wetland area between the landfill and the shoreline.

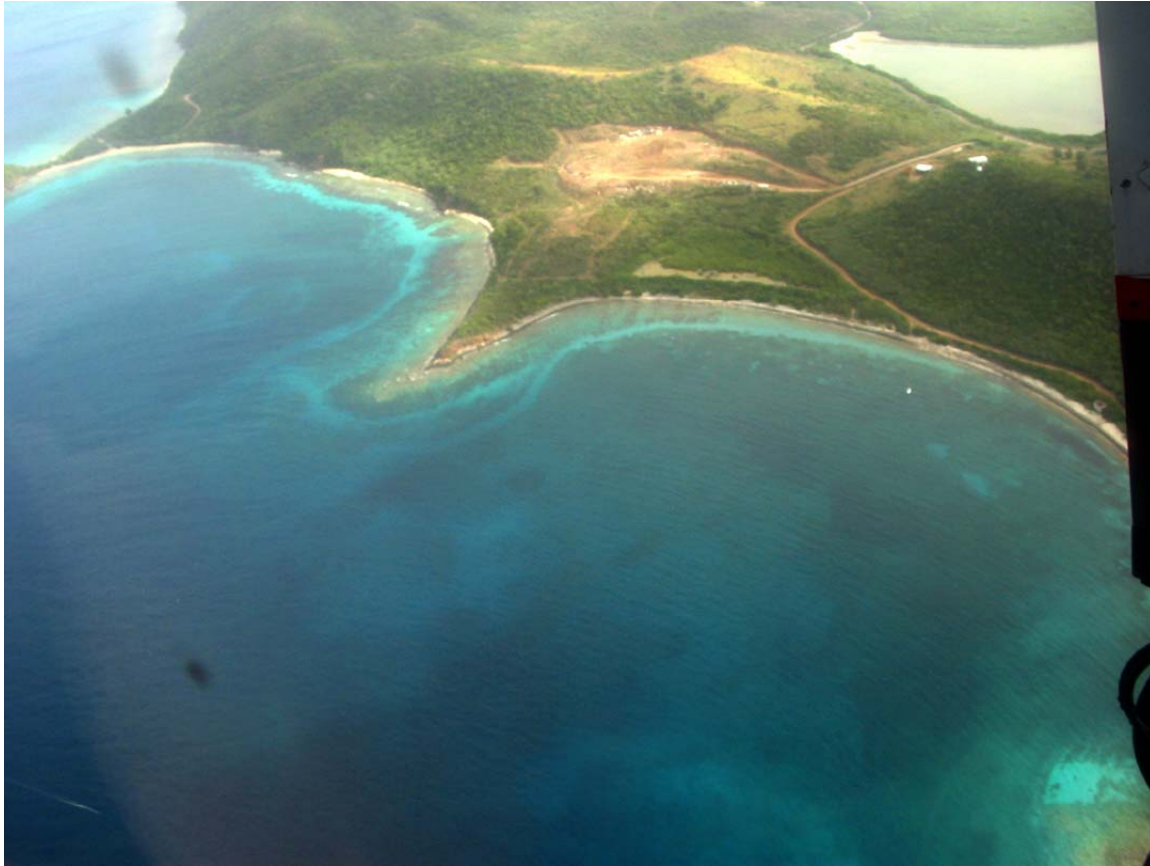
FIGURE 5. Bahía Tamarindo, northern (left) and southern segments (right). Punta Rompeanzuelo is located right in the center of the image, with Culobra Island landfill in the background. Note dirt trails and roads accessing the coast from the landfill (western face). Also, note wetland between the landfill and the shoreline in its southern face.

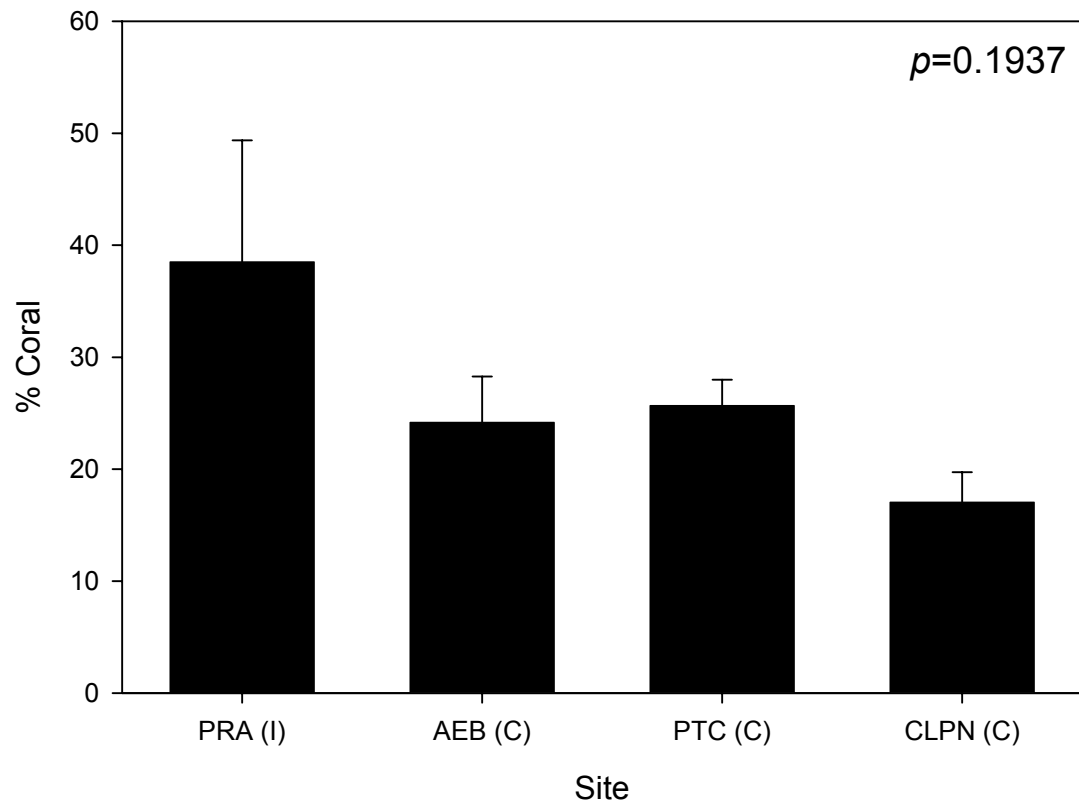
Although % coral cover averaged 38.5% at the surveyed areas of PRA, with lowest values at CLPN (17%), this difference was not significant due to high between-transect variation (Figure 18). The highest frequency of scleractinian corals (74%) and hydrocorals (22%) was documented at AEB, with the highest frequency of octocorals (42%) occurring at the impact site in PRA (Figure 19). However, differences among sites were not significant for any of the coral groups.

FIGURE 18. Percent living coral cover. I= impacted reef; C=control reef.

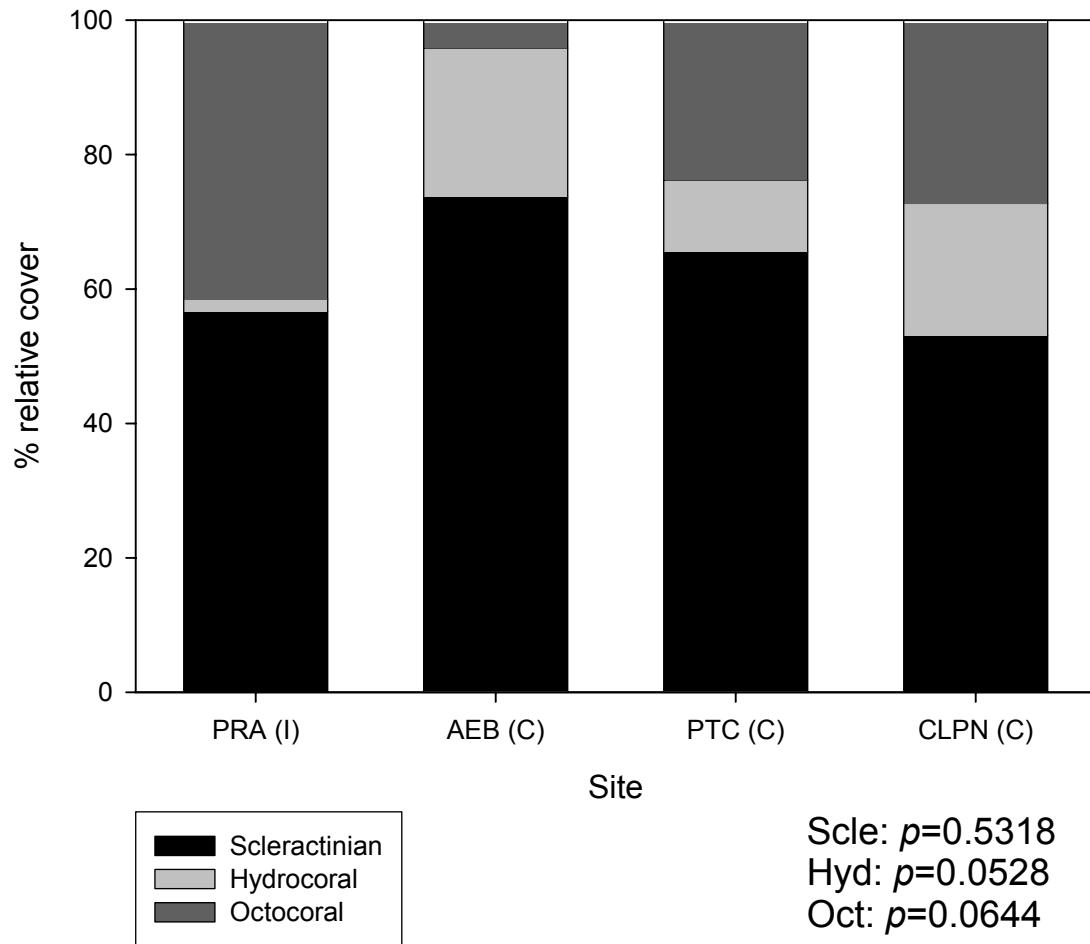
FIGURE 19. Percent relative coral cover. I= impacted reef; C=control reef.

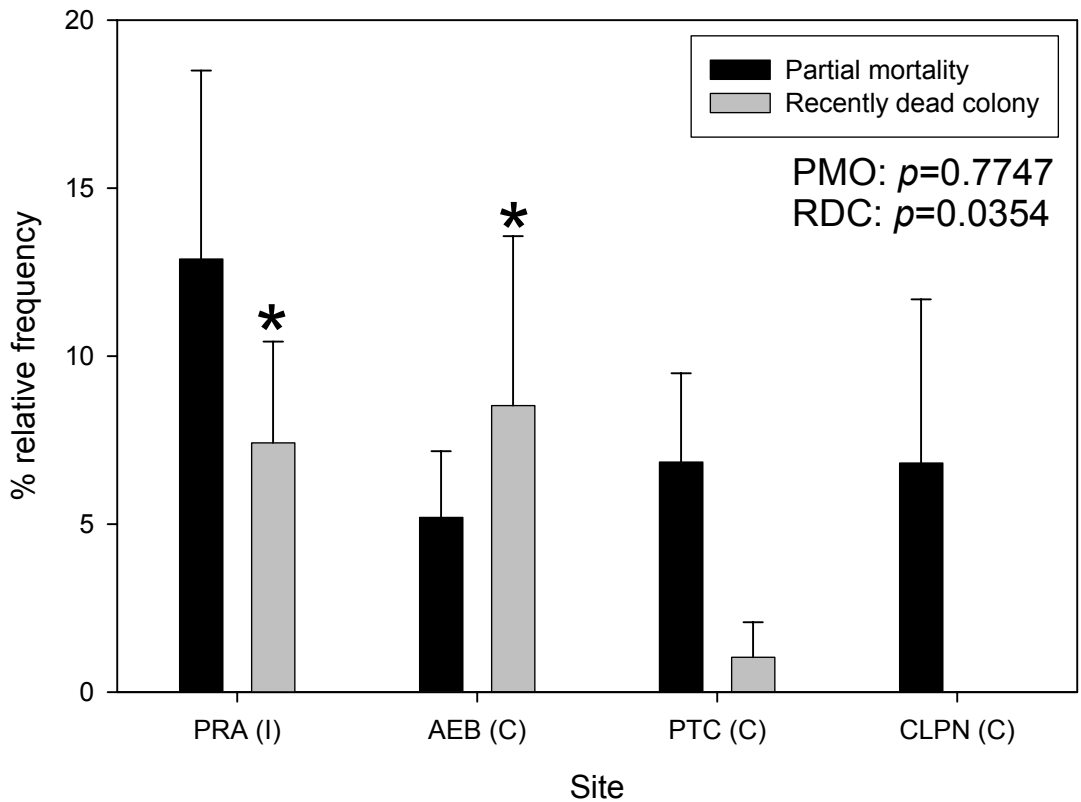
Percent partial colony mortality was not significant among sites (Figure 20), but percent recent colony mortality was significantly higher ($p=0.0354$) at AEB (8.5%) and the impacted site at

FIGURE 20. Percent relative frequency of hard coral partial colony mortality and recently dead colonies. I= impacted reef; C=control reef.

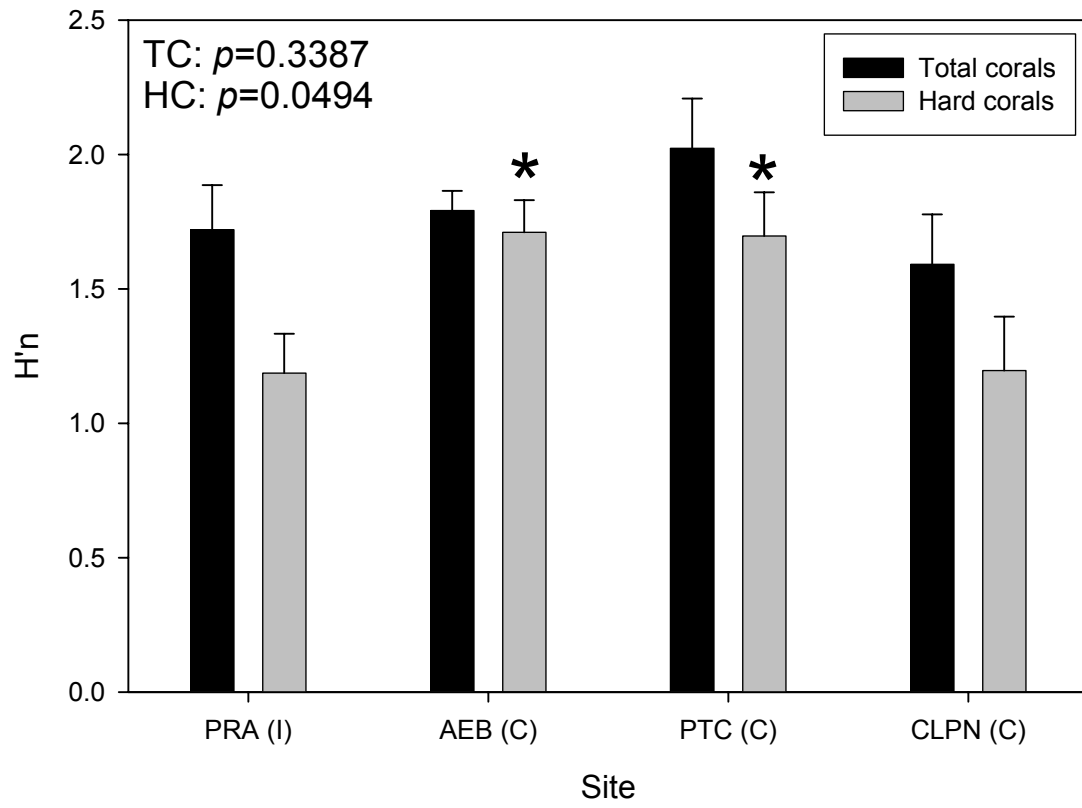
PRA (7.4%). There was no significant difference in total coral species diversity index ($H'n$) (Figure 21). However, hard coral $H'n$ was significantly at AEB and PTC ($p=0.0494$). No significant differences were either detected in total or hard coral species evenness ($J'n$) (Figure 22). There was no significant difference in % zoanthid cover, but % sponge cover was significantly higher ($p=0.0074$) at AEB (Figure 23).

FIGURE 21. Species diversity index of total and hard corals. I= impacted reef; C=control reef.

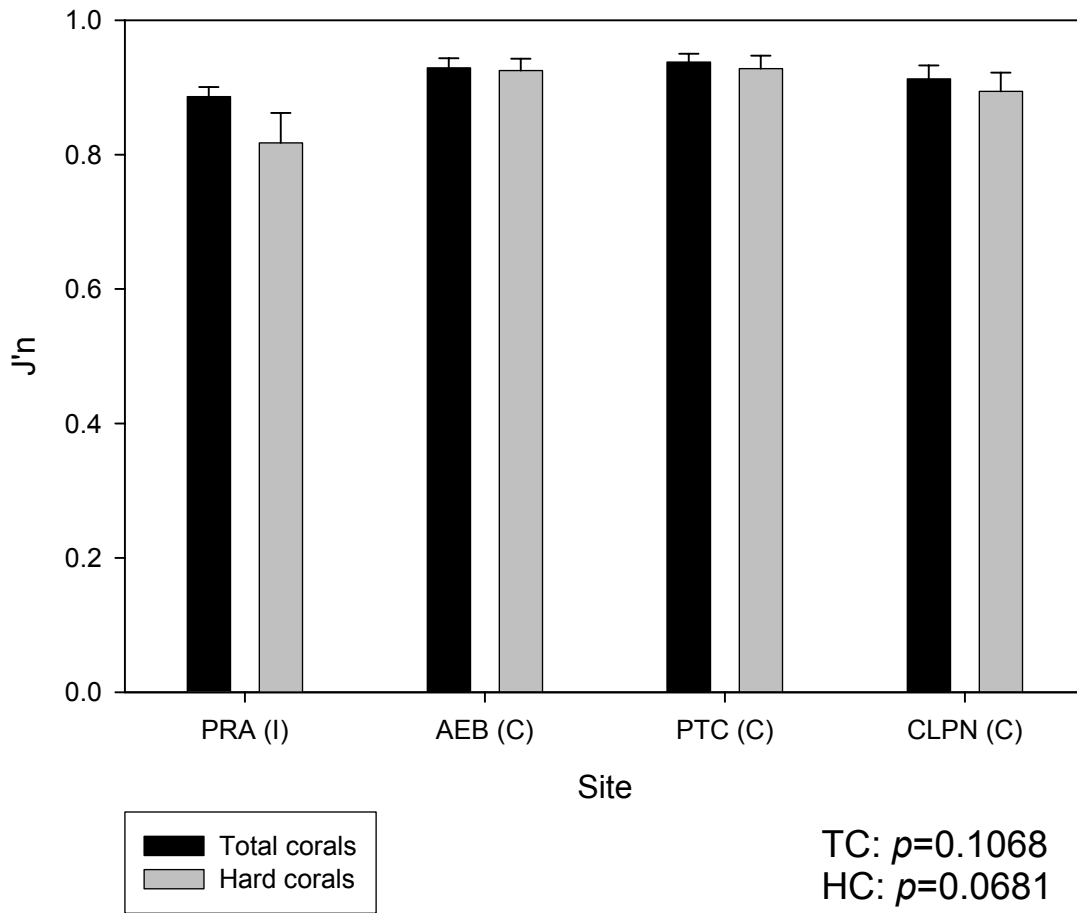
FIGURE 22. Species evenness of total and hard corals. I= impacted reef; C=control reef.

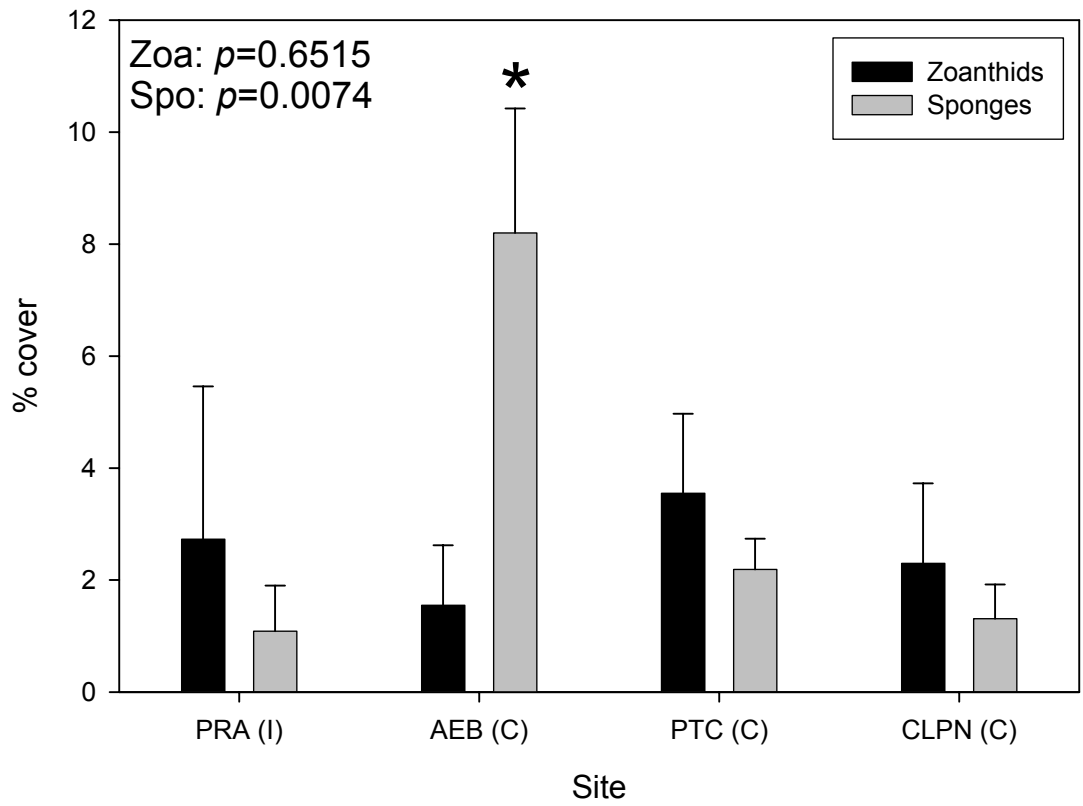
FIGURE 23. Percent zoanthid and sponge cover. I= impacted reef; C=control reef.

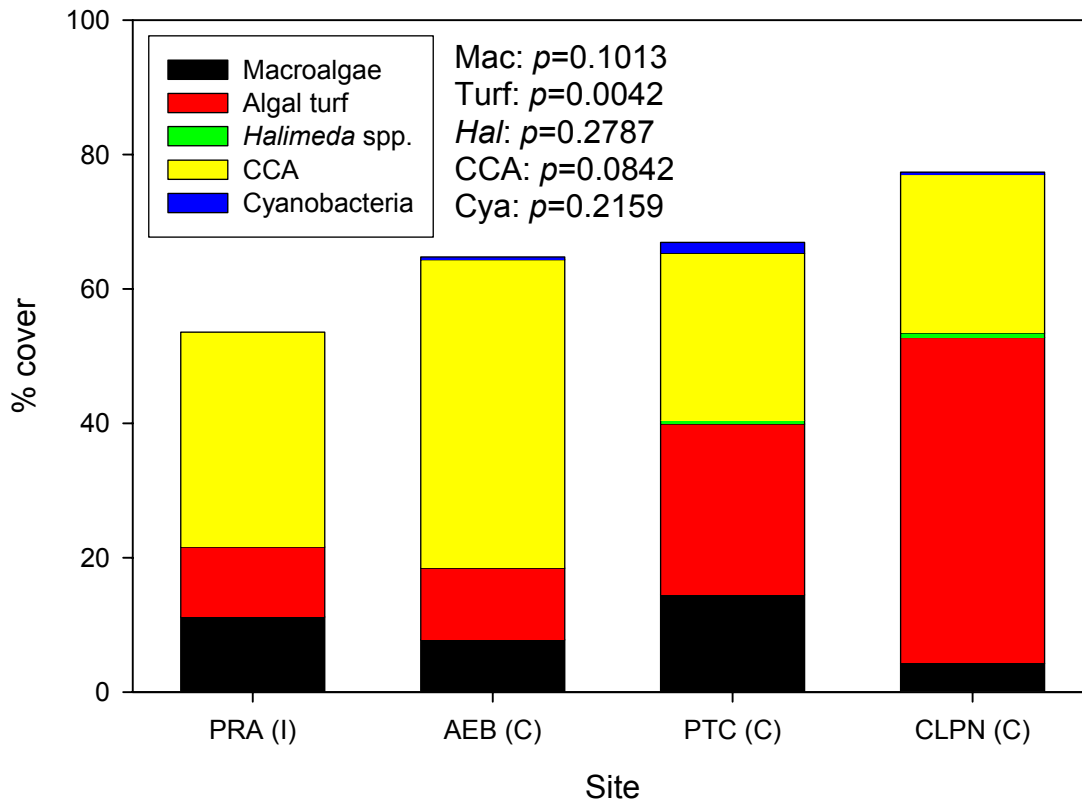
FIGURE 24. Percent algal and cyanobacterial cover. I= impacted reef; C=control reef.

Overall, algal cover was not significantly different among sites (Figure 24). At the functional group level, macroalgal, *Halimeda*, crustose coralline algal (CCA), and cyanobacterial % cover were not significantly different among sites. However, % algal turf cover was significantly higher at CLPN ($p=0.0042$). However, there was a tendency of higher % macroalgal cover at PTC and impacted site at PRA, with moderate values at ABE, and lower at CLPN. Percent cover of bare substrates, rubble and sand showed no significant differences among sites (Figure 25).

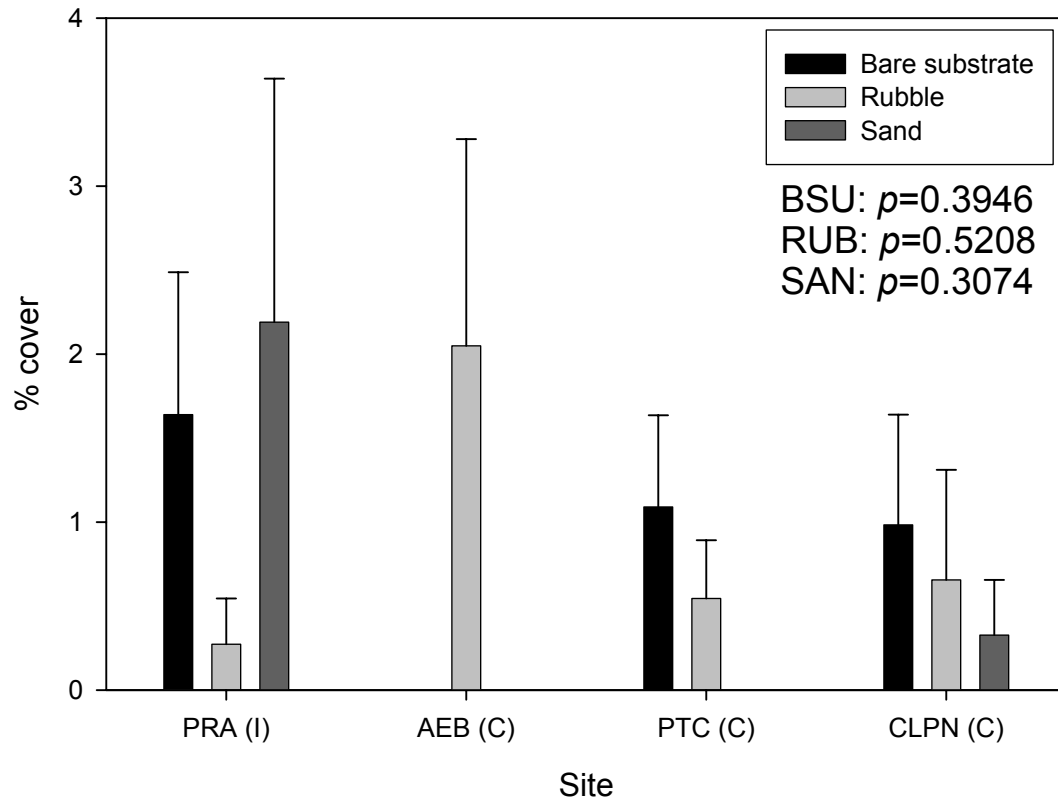
FIGURE 25. Percent cover of other benthic components (bare substrate, rubble, sand). I= impacted reef; C=control reef.

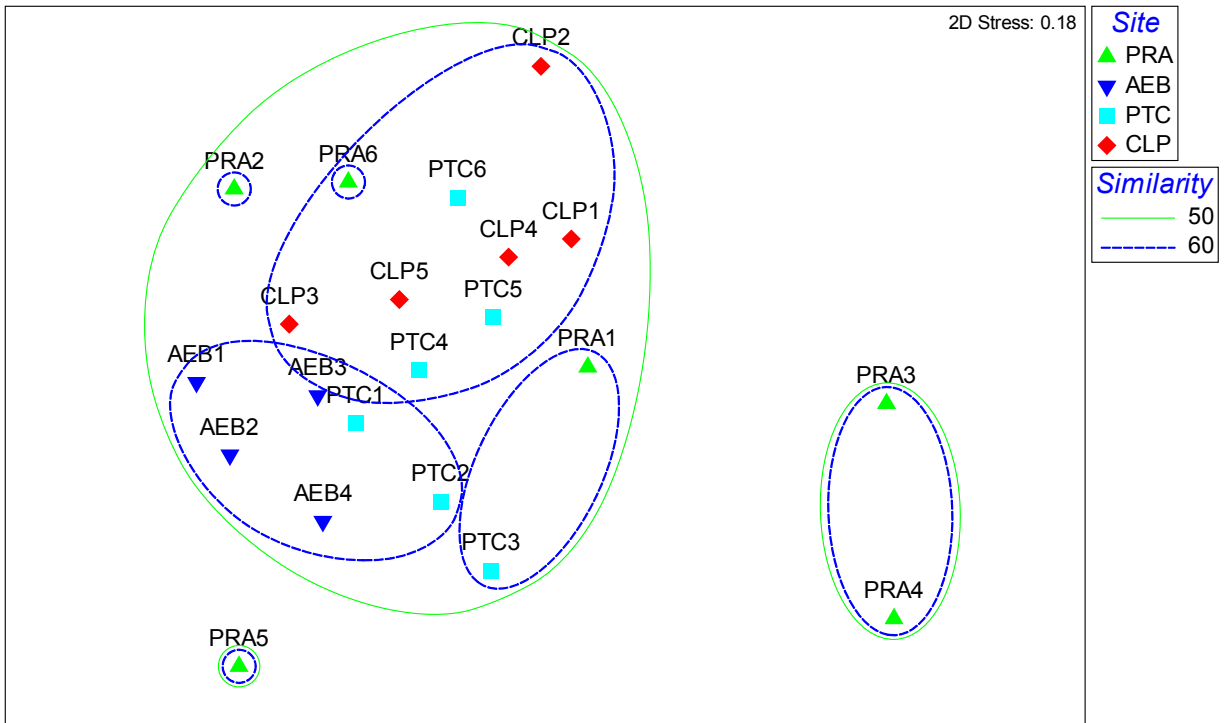
FIGURE 26. Multi-dimensional scaling analysis of the community structure of shallow-water coral reef benthic communities among sites. Data shows three basic clustering patterns at the 50% community similarity cutoff level with PRA5 transect forming an independent group, PRA3 and PRA4 forming a second independent group, and then a cloud of the rest of the sites. Seven different cluster patterns emerged at the 60% community similarity cutoff level, including individual clusters formed by PRA2, PRA5, PRA6, and PRA3-PRA4. Also, there was a cluster formed by PRA1 and PTC3, a moderate-sized cluster formed by AEB and PTC1-PTC2, and the remaining cluster formed by CLP and several PTC transects.

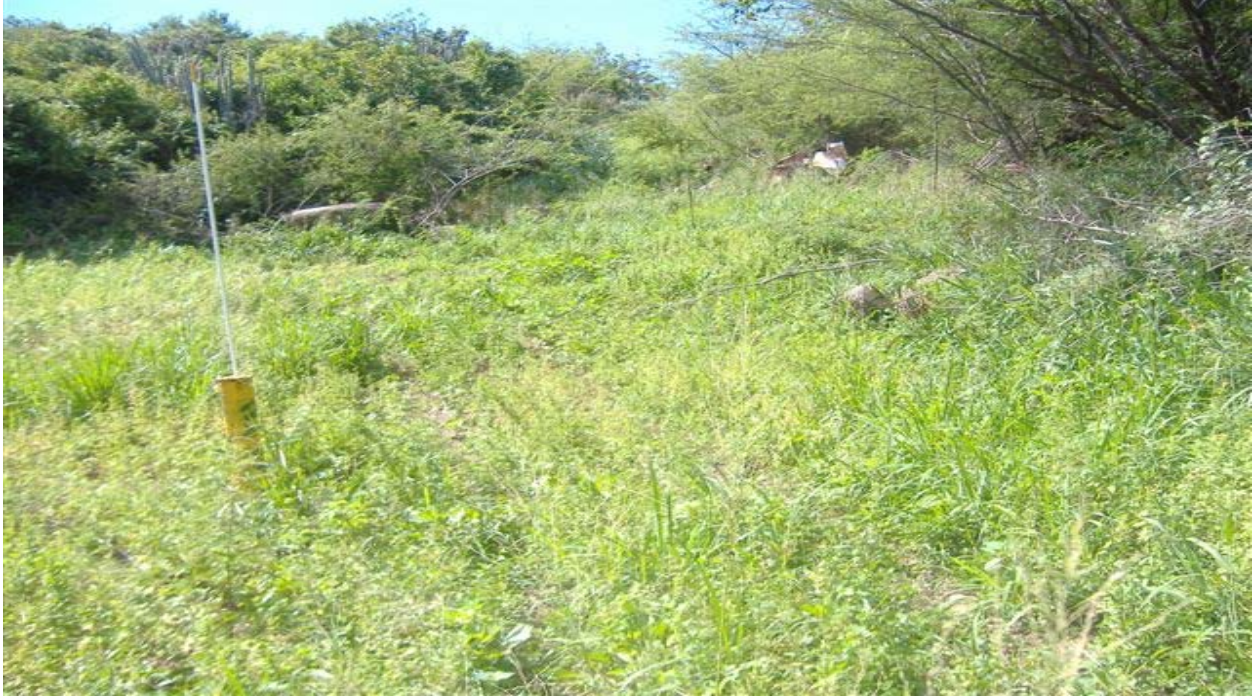
Photograph No. 7- Location of Monitoring Well MW-5 (water monitoring well). Looking to the southeast
