HISTORICAL DEVELOPMENT OF THE MUNICIPAL LANDFILL IN THE EASTERN BORDER OF THE LUIS PEÑA CANAL RESERVE IN THE MUNICIPALITY OF CULEBRA, PUERTO RICO AND ITS POTENTIAL IMPACT ON THE RESERVE

Final Report submitted to the Department of *Natural and Environmental Resources*
of the Commonwealth of Puerto Rico in fulfillment with Task CRI-9 PR CORAL
REEFS AND WATERSHEDS STRATEGY of the *Conservation and Management*
of Puerto Rico Coral Reefs proposal

José Norat, Ph.D.

September, 2007

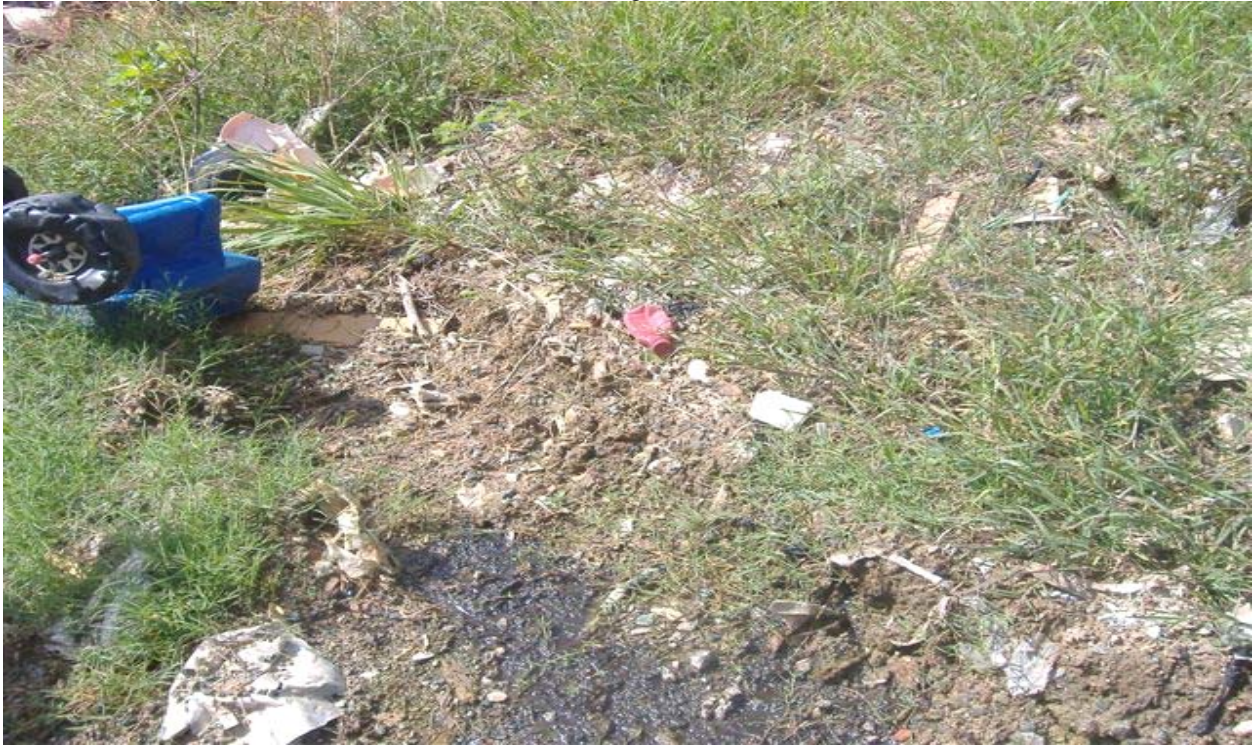
Photographs No. 17- Looking to the northwest. After a heavy rain event occurring a day before our visit. Stagnant waters mixed with leachate was observed along this zone of the landfill. This is part of Leachate Zone Z-1

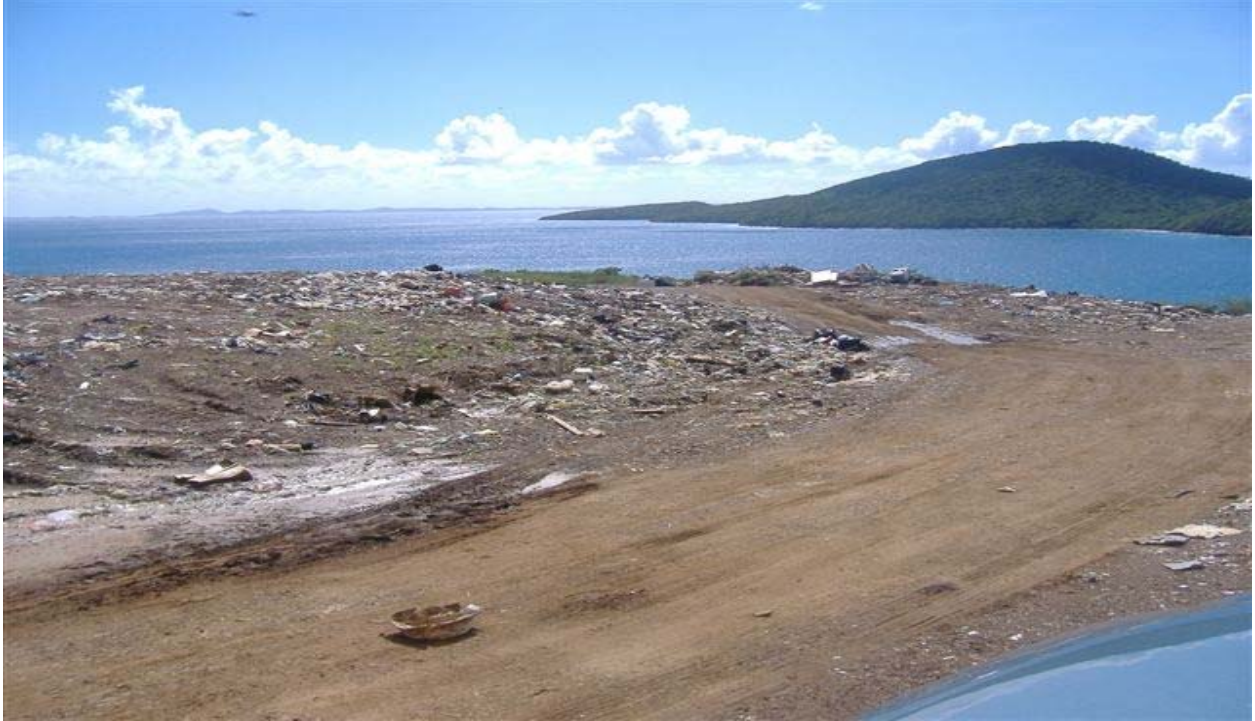
Photographs No. 24 & 25- Looking to the west to the Luis Peña Canal from the top of the landfill. Cayo de Luis Peña is observed at the distance.

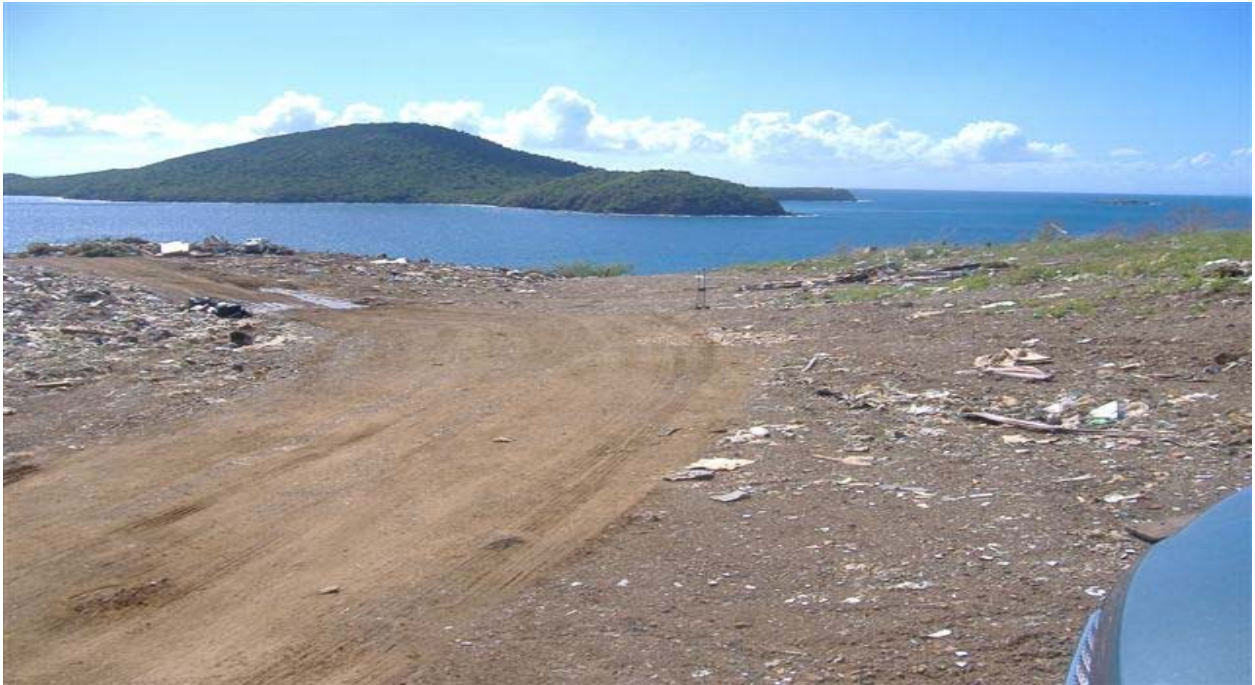
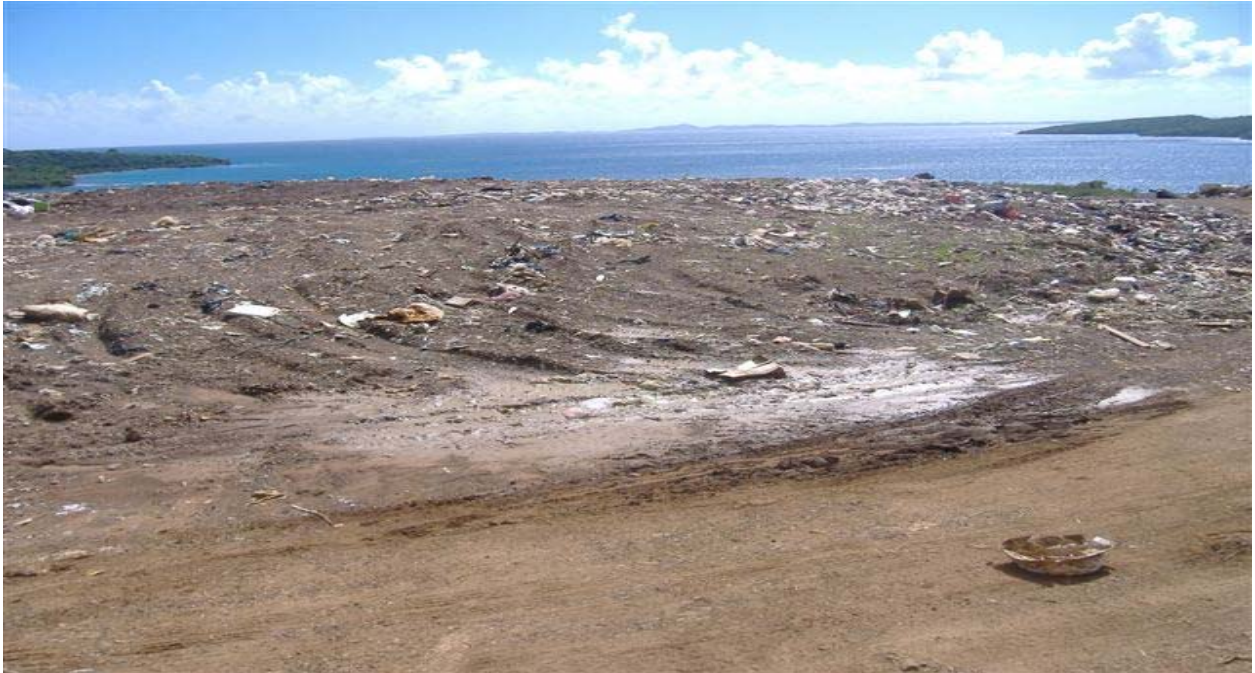
Photographs No. 26 & 27- Looking to the southwest from the top of the landfill. Vieques Island is observed at distance.

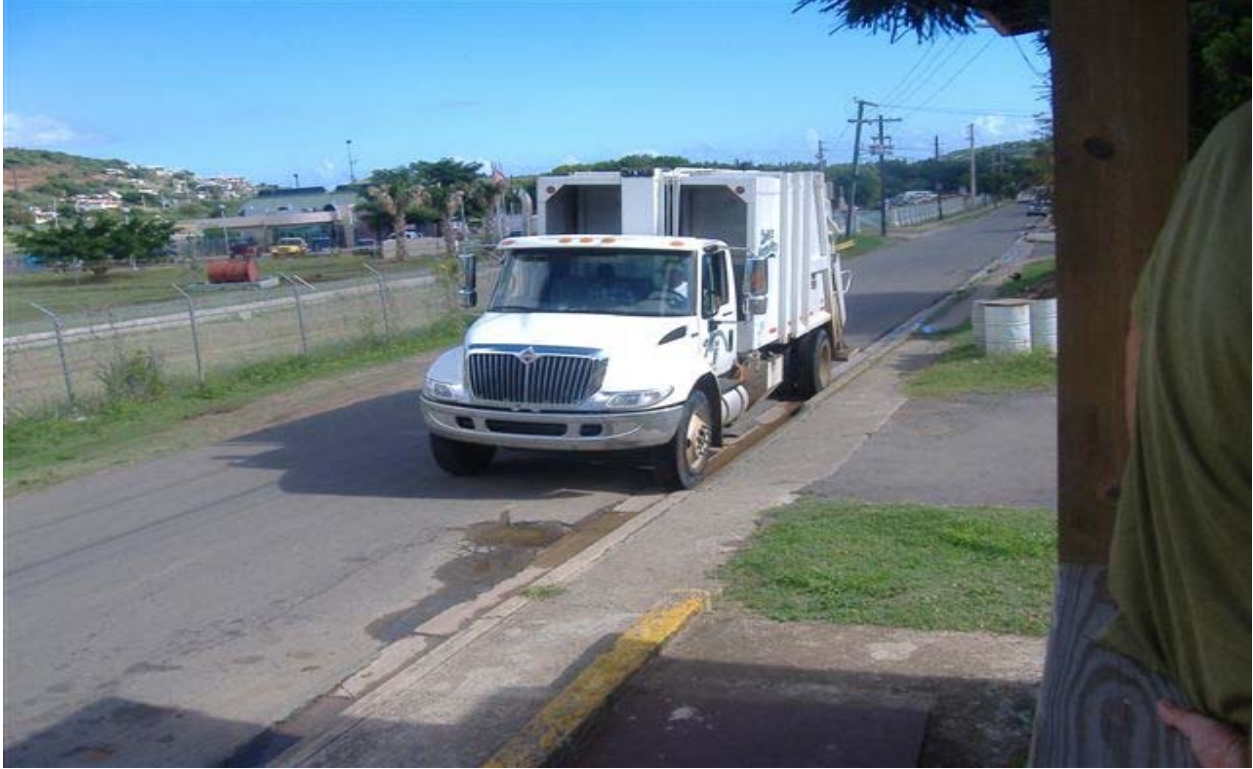
Photographs No. 28- Looking to the south. A rear-loaded garbage truck property of the Municipality of Culebra.
