**PRIMARY RESTORATION PLAN AND
ENVIRONMENTAL ASSESSMENT
FOR THE 2006 T/V MARGARA GROUNDING
GUAYANILLA, PUERTO RICO**

The Puerto Rico Department of Natural and Environmental Resources
and
the National Oceanic and Atmospheric Administration

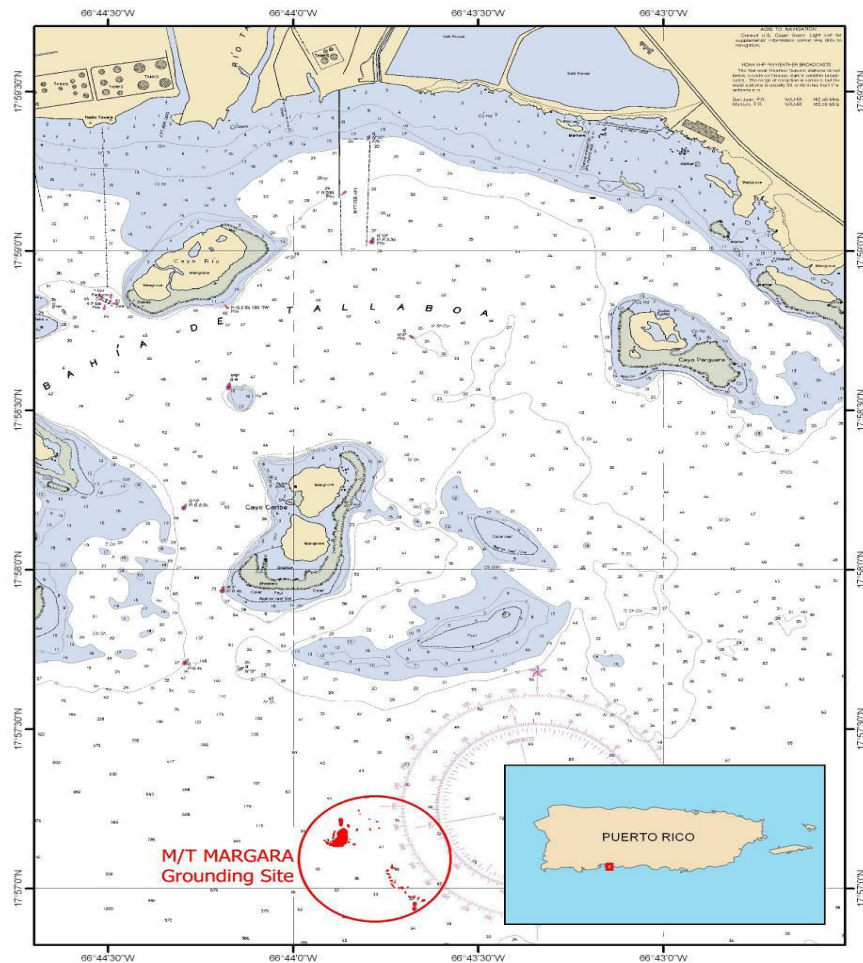
On or about April 27, 2006, the T/V MARGARA , a 228-m (748-ft) Cayman Islands-flagged tanker, went aground on a hard bottom formation three miles south of Tallaboa, Puerto Rico, in waters approximately 10.5 m (34 ft) in depth (Figure 1). The vessel was carrying over 300,000 barrels of #6 fuel oil. The vessel was ultimately refloated and removed from the grounding location on April 28, 2006 without discharging oil into the environment. However, the response efforts to refloat and remove the vessel in an effort to prevent an oil spill moved the vessel a considerable distance and caused impacts to the sea floor at multiple locations.

Figure 1: T/V MARGARA grounding site relative to Bahía de Tallaboa in southern Puerto Rico.

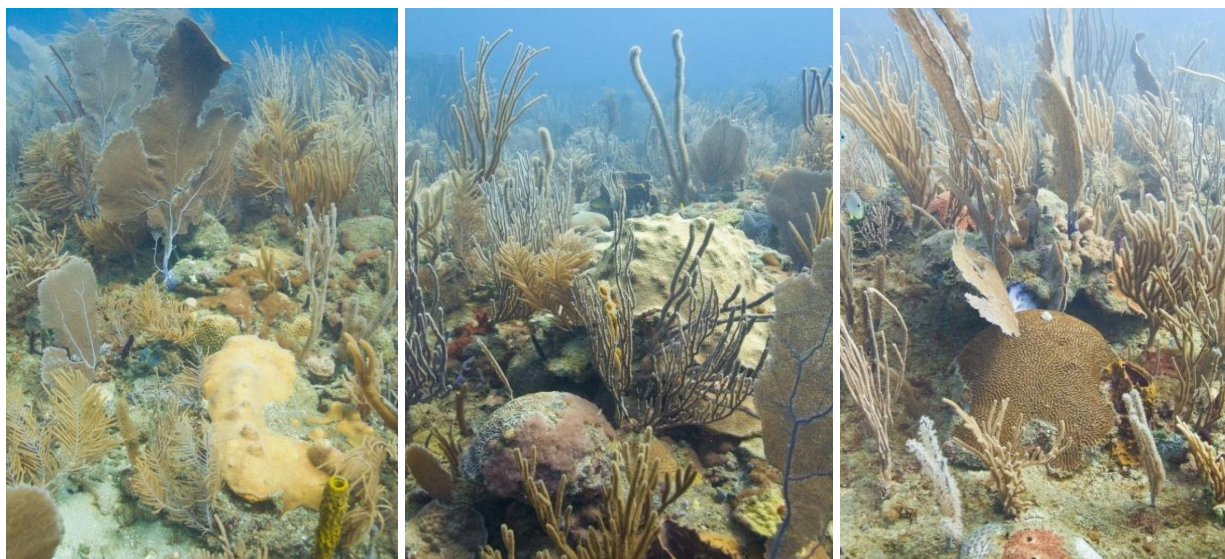
Figure 4: Photos of un-impacted reef adjacent to the MARGARA site. Photos by NOAA Restoration Center, December, 2008.

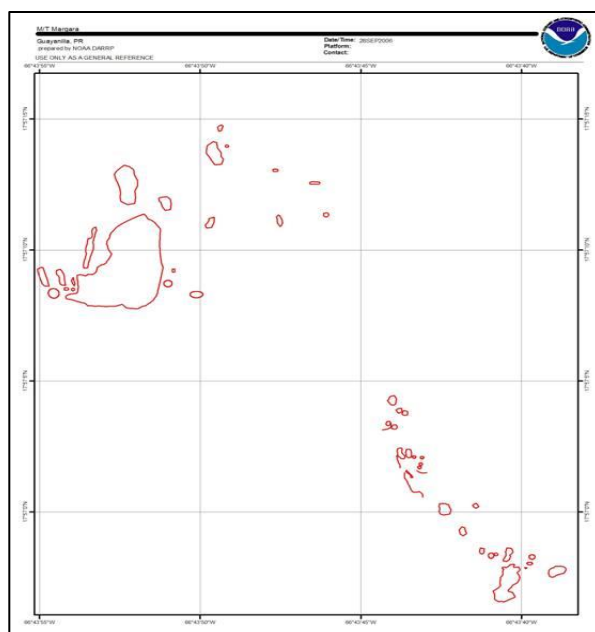
In the period immediately following the Incident, the site was mapped using information provided by an underwater mapping system that involved divers communicating via an underwater wireless communications system and surface buoys with GPS. This effort resulted in the map in Figure 5.

Figure 5: First map of MARGARA impact site from information provided by divers in 2006 using an underwater wireless communications system and surface buoys with GPS.

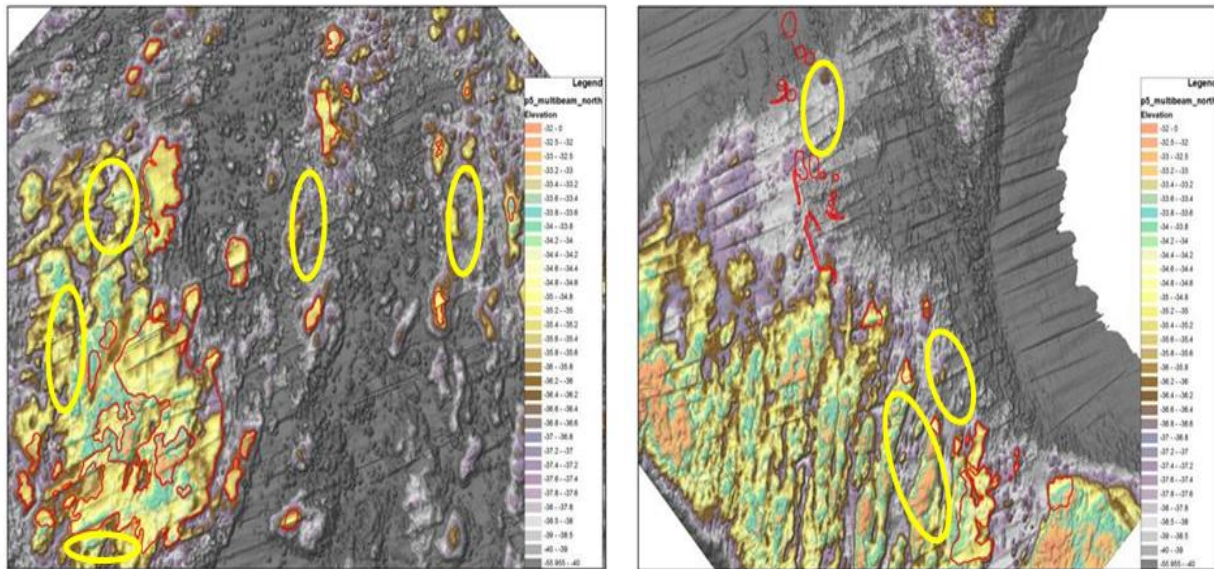
Figure 10: Location of reference transects (yellow polygons) adjacent to MARGARA site (impacted areas delineated in red).

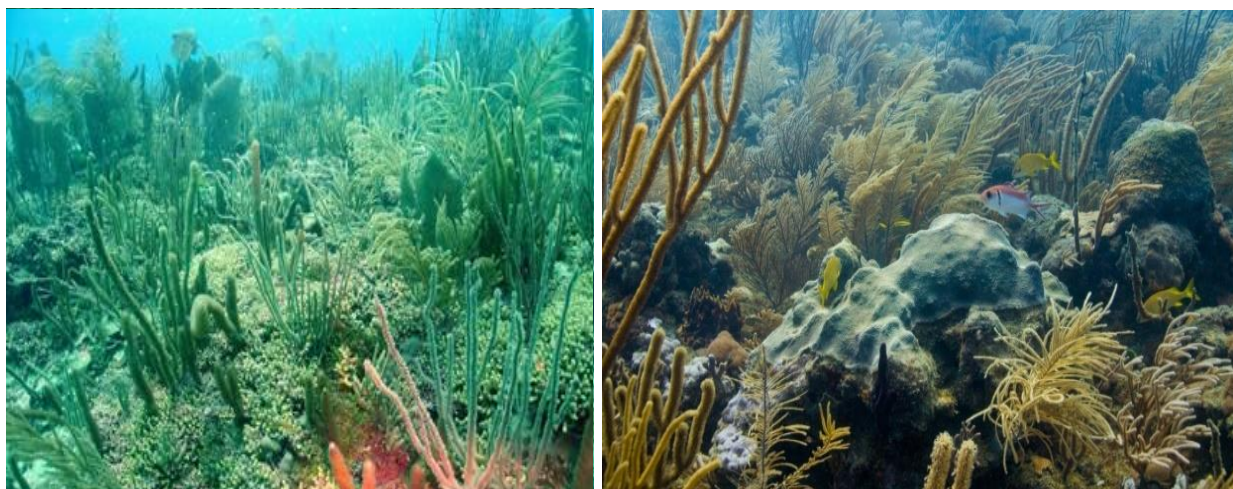
Figure 11: Photos of un-impacted reef adjacent to the MARGARA site where reference transects were conducted. Photos by NOAA Restoration Center, December 2008.

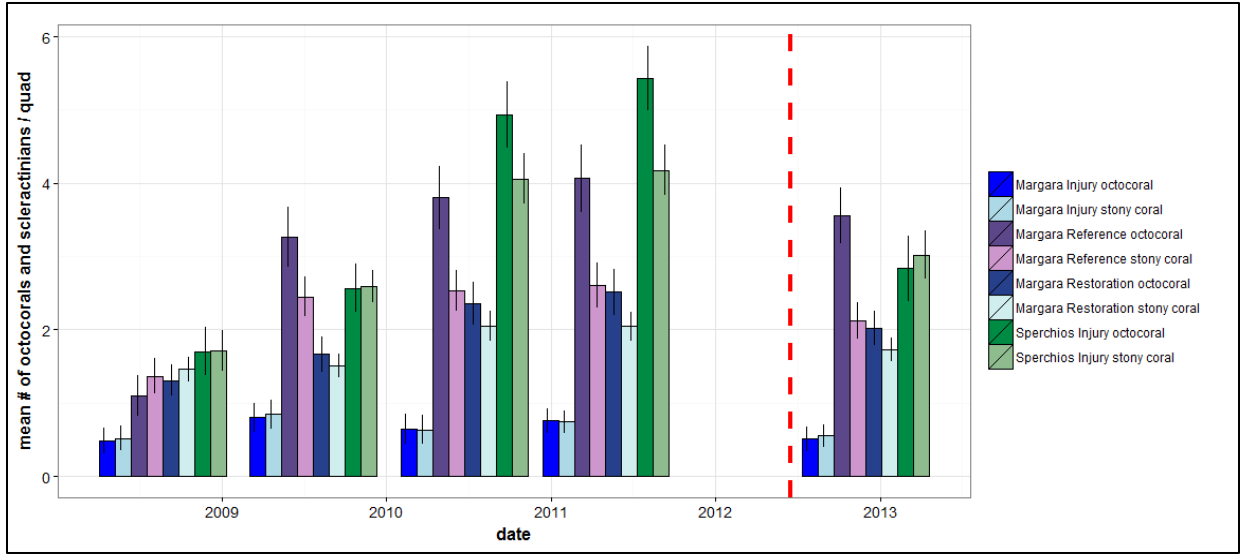
The recruitment monitoring data at the T/V MARGARA site from 2008 through 2012 shows that coral recruit survival in the rubble fields is on average between 0-18% compared to survival rates of 58-65% in the reference area and 49-56% in the restored areas. Scleractinian (stony coral) recruitment survival rates were 0% in rubble compared to 83-100% in the reference area and 40-42% in the restored areas. Octocoral recruitment survival was 8-18% in rubble, 58-65% in the reference area and 49-56% in the restored areas. Figures 12 and 13 show the change over time in mean number of corals in the monitoring quads and belt transects at the T/V MARGARA site (injury, restored area and reference) as well as at the nearby T/V SPERCHIOS grounding site (which does not have rubble present like at the T/V MARGARA site). The graphs in Figures 12 and 13 show how the T/V SPERCHIOS site is recovering with time while the T/V MARGARA rubble fields have limited to no recovery seven years after the Incident. In the belt transects, recovered octocoral densities are an order of magnitude greater at T/V SPERCHIOS than at the T/V MARGARA site, and recovered Scleractinian densities are two orders of magnitude greater at the T/V SPERCHIOS than at the T/V MARGARA site. There are almost no Scleractinians present in the rubble at the T/V MARGARA site, and densities of coral recruits at the site are below the 2008 Post-Hurricane Dean levels. The data shows that recovery in the rubble fields at the T/V MARGARA site is not occurring.

Figure 12: Mean number of scleractinians and octocorals per recruitment quad at the T/V MARGARA site, the T/V SPERCHIOS grounding site, restored areas and reference areas. Initial recruitment quadrats (25 cm x 25 cm) were established in August, 2008 (year following Hurricane Dean). The red dotted line represents Tropical Storms Ernesto and Isaac where swells reached 20' in August, 2012. Error bars represent standard error of the mean.

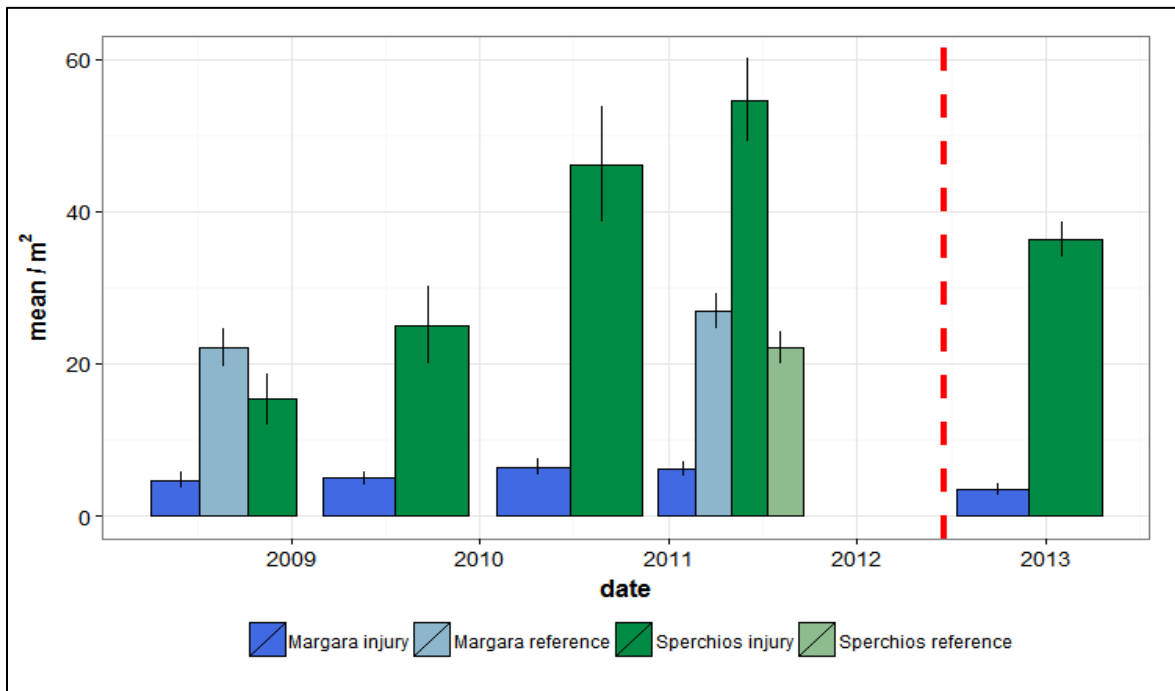
Figure 13: Mean number of corals in belt transects at the T/V MARGARA site, the T/V SPERCHIOS site and in reference areas. Permanent belt transects (1m x 10m) were established in August, 2008 (year following Hurricane Dean). The red dotted line represents Tropical Storms Ernesto and Isaac where swells reached 20' in August, 2012. Error bars represent standard error of the mean.

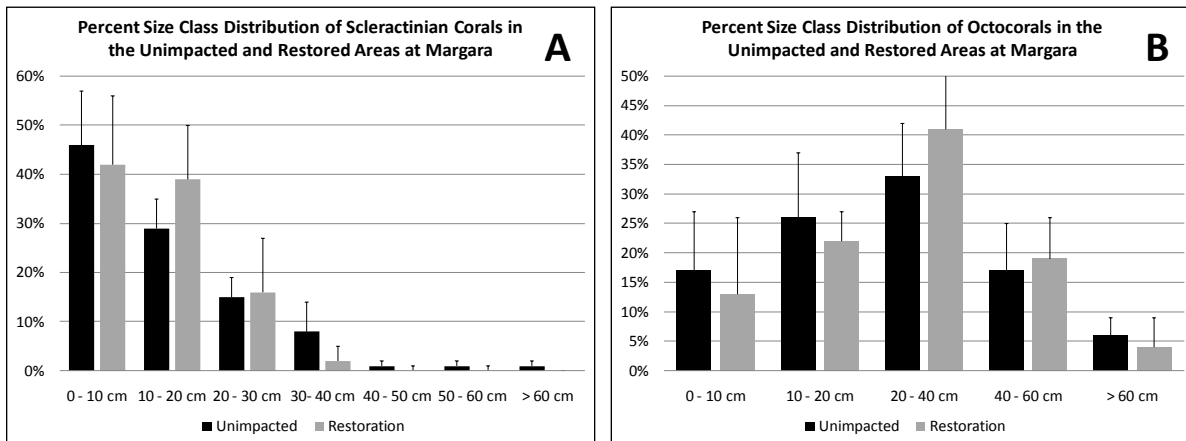
Figure 3 below provides a comparison between the size classes of corals found in the un-impacted reef area adjacent to the T/V MARGARA site and the size classes of the corals that were reattached during the emergency restoration. A higher percentage of scleractinians in the 10 – 20 cm size class range were reattached during the emergency restoration than were found in the adjacent reef, and a lower percentage of corals greater than 30 cm were reattached compared to the size distribution of scleractinians found in the reference area. For octocorals, a higher percentage of corals in the 20-40 cm size class were reattached. Size class distributions were similar (within 5% of each other) for the other size classes for both reference and restored areas.

Figure 3: Percent size class distributions of scleractinians (Graph A) and octocorals (Graph B) in the un-impacted reef adjacent to the T/V MARGARA site (black bars) and in restored areas after emergency restoration (gray bars).
