Assessment of Urban Coastal Wetlands Vulnerability to Hurricanes in Puerto Rico

**Benjamin Branoff MSc, Elvira Cuevas PhD, & Elix Hernández BSc
University of Puerto Rico-Río Piedras**

**With contributions from:
Jon Fripp, PE, Natural Resource Conservation Service
Barry Southerland, PhD, USDA Natural resource Conservation Service**

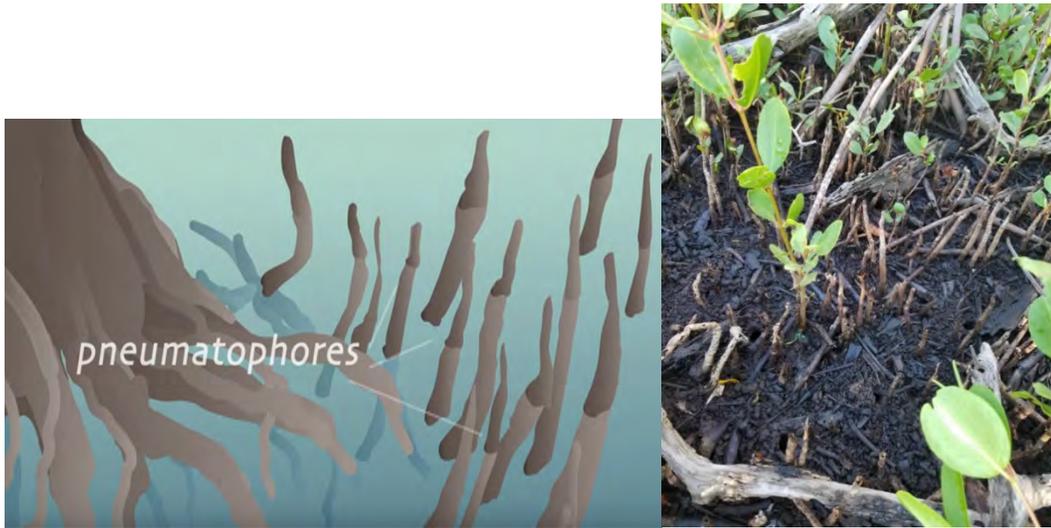
Figure 2: White mangrove pneumatophores next to Suarez River, Puerto Rico.

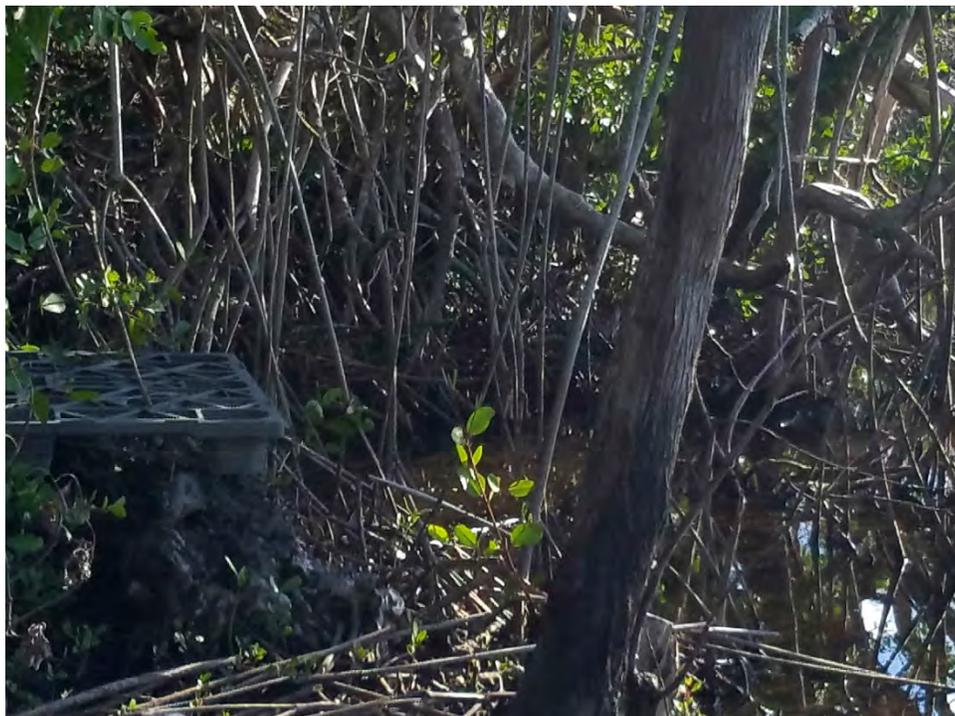
Figure 3: Red Mangrove community at Piñones Reserve, Puerto Rico.

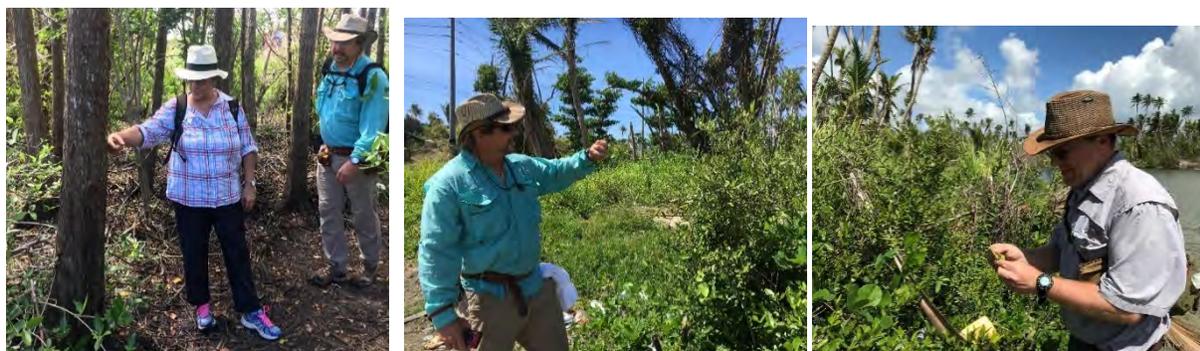
Figure 7: Vegetation condition and recovery were assessed. The current state of vegetation as well as estimate of flooding were discussed at each site.

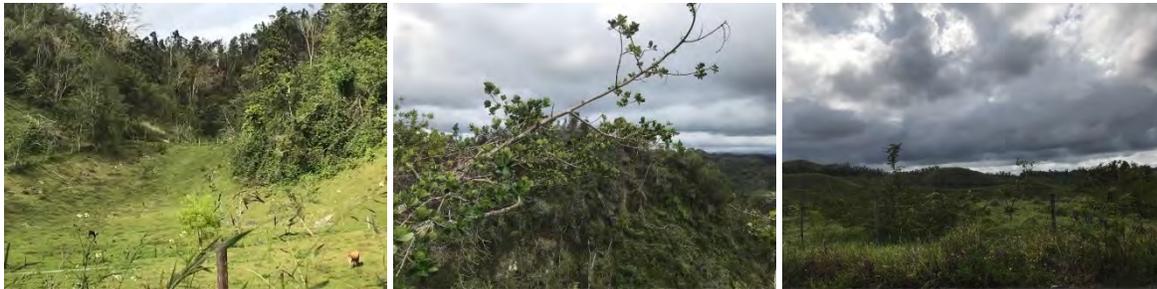
Figure 8: Areas in the upper watershed were reviewed. Much of the area is steep and developed, yet vegetation appears to be recovering

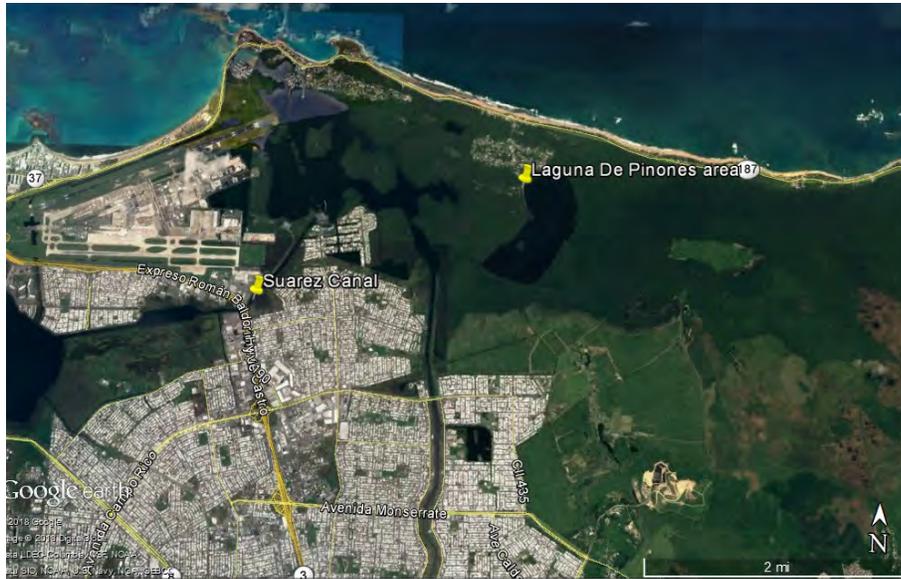
Mr. Branoff reported that the area in the Laguna De Pinones had been inundated for approximately 2 weeks after Hurricane Maria but the efficient city drainage system had allowed waters to evacuate before flooding damage had been significant. Water gages installed and monitored as part of Mr. Branoff's research indicate that the hydro-period had largely returned to the pre-storm conditions.

The team noted that some interior drainage structures such as culverts likely reduce some of the natural flows in the lower portion of the system, but the roads are low and likely frequently overtopped. The tree species appear to have adapted to the current system. Mr. Branoff also noted that the high winds had stripped leaves from the black mangroves which had resulted in some mortality. Mr. Branoff noted that there is concern by some stakeholders that the bridge opening at the Baldorioty Expressway (on the Suarez Canal) may restrict some of the tidal exchange but the team did not observe or measure evidence of this at the time of the site visit.

Figure 12: Google Earth image of Torrecillas/Pinones site. Pins indicate visited locations. Date of image is 7/2017, before the storm.

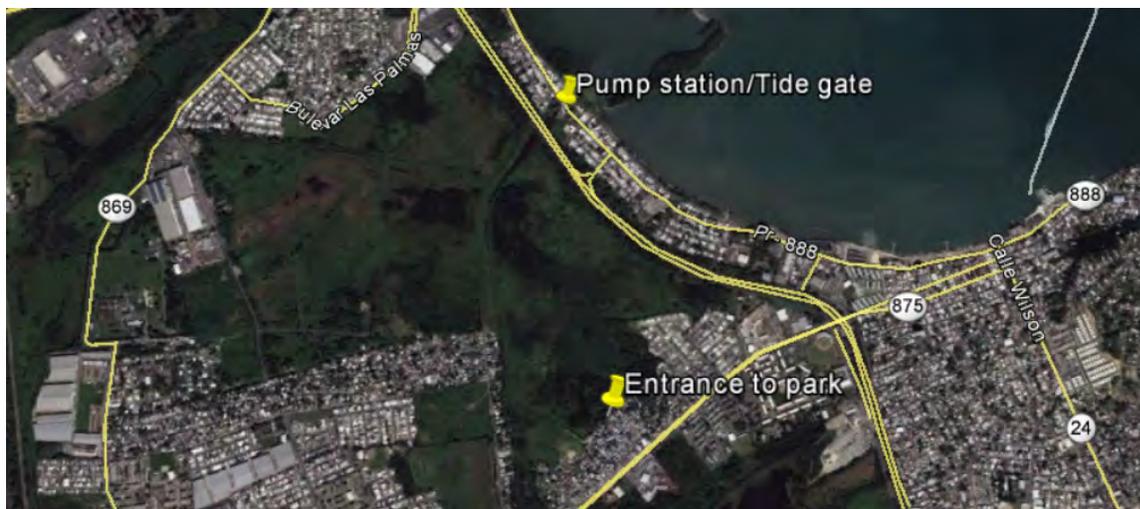
Figure 14: Google Earth image of Cucharillas/ Malaria Channel site. Pins indicate visited locations. Date of image is 1/2016. Later images had cloud cover

There was one pump station operator on duty at time of the site visit. No maintenance or operational logs were present at the site but the operator was very helpful and freely shared what he knew about the history and operation of the installation. The team was informed that the pump station was reportedly constructed in the late 1940s by the US Army Corps of Engineers but has been turned over to operation by Department of Public Works (DRNA). The pumps are used to remove water upstream of the station when the tide gates are shut. Their effective operation reduces the potential for upstream flooding. Installation of the pumps is for three 200 hp pumps but, at time of the visit, the team observed that one pump was missing, one was in-operative and one was working but in poor condition. The operator on site informed the team that single working pump could only be run for 20 to 30 minutes, three times a day. This operational pump was briefly turned on during the site visit but sounded like the pump operation sounded like there was a need for immediate maintenance. Therefore, the pump was shut down after a few minutes. The team observed portable pumps upstream of the site. The operator believed that they were used during the storm. The team noted that they appeared to be inadequately maintained. The apparent limited operational capacity of the pump station may result in upstream flooding and a risk to life and property.

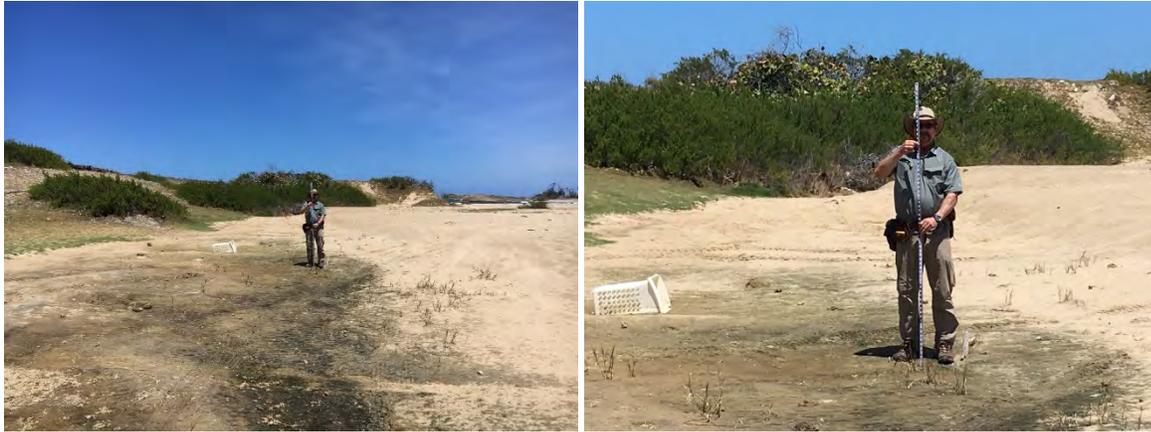
Figure 19: Photographs of team conducting a survey of remnant channel and ponding areas for possible alignment of channel. The team located and discussed a variety of potential channel alignment configurations that could be constructed.

The team proposes that the area could also be restored by **reestablishing a channel through the bridges to the ocean**. The most appropriate bridge opening is located approximate location N 18-30.833 W 67-02.983. It is near the center of the mangrove wetland, closest to the ocean, and does not appear to have any dunes or significant vegetation between it and the ocean. The team was also able to observe geomorphic evidence of ponding and potential channel between it and the ocean. Photographs of the potential area for a reestablished channel are shown in Figure 19. This area was surveyed, and an approximate channel alignment was discussed. Excavation to a pre-storm elevation would be necessary. However, the team noted that this would not be to a low tide elevation. The team conducted a quick, concept design in the field and estimated the total length of the proposed channel to be approximately 600 feet with a sinuosity of 1.25. The excavated channel would be 10 feet wide and 2 feet deep. Further analysis is suggested that would make use of stable analogs and especially mapping of pre-storm channel conditions. An aerial map of the site is shown in Figure 20.

Regardless if the treatment is excavation of the deposition under the bridges or a constructed channel, a specific O&M plan should be developed for the site. Debris from the dead woody material as well as sediments pushed by storms can alter the hydraulic connectivity. To reduce the potential for a repeat of the ponding induced impacts to the site, work will need to be accomplished in site. The team suggests that an **MOU be established with USACE regulatory and other stakeholders to allow future maintenance** as needed.

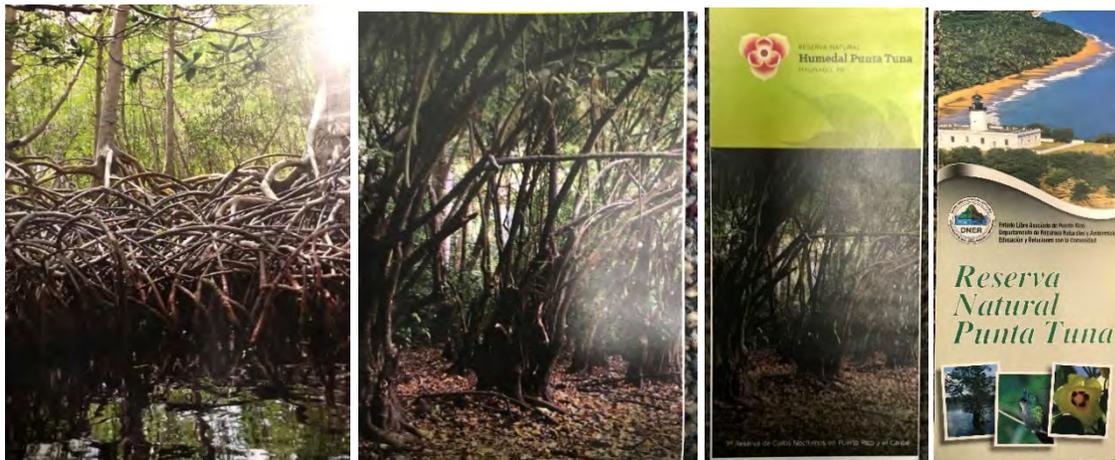
Figure 21: Photographs of the area from brochures provided at the park. These pictures as well as the photographs on the signage indicate that it had been a healthy mangrove system as well as an attractive area that was well used by tourists

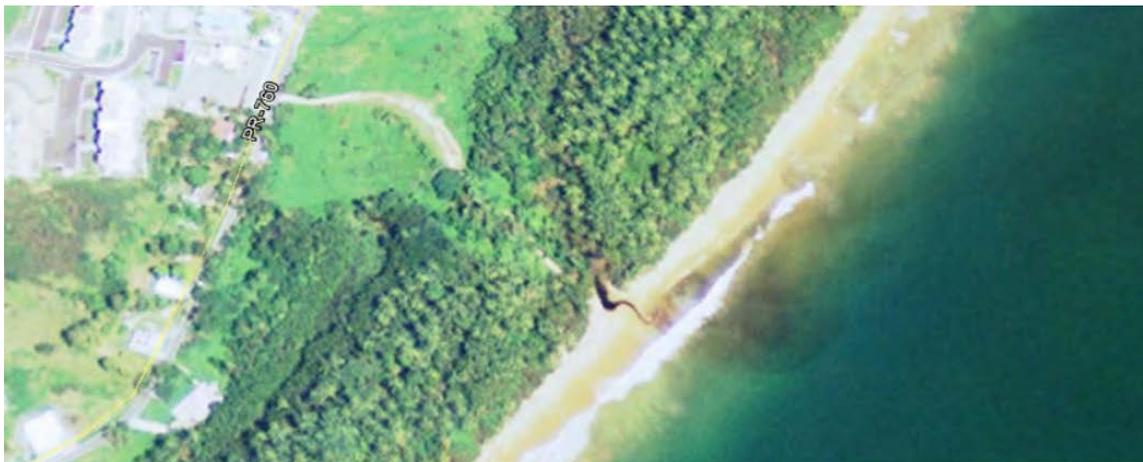
Figure 25: Google Earth image of old exit channel for the Punta Tuna_site. Date of image is 10/2004.

The area had had natural drainage through the beach before the storm. An aerial map showing what the team believes to be this channel is provided in Figure 25. Storm surges had closed the cut and caused an elevated pool in the mangrove area. The team was told that water had also backed up sufficiently to impact some houses in the community, but the team did not directly observe evidence of this situation. The team was also told that local stakeholders had requested permission to reopen the cut but this had been denied by the US Army Corps of Engineers via a phone consultation. As a result, the ponding stayed for four to five months. In addition, as some of the water evaporated, salinity levels were raised.

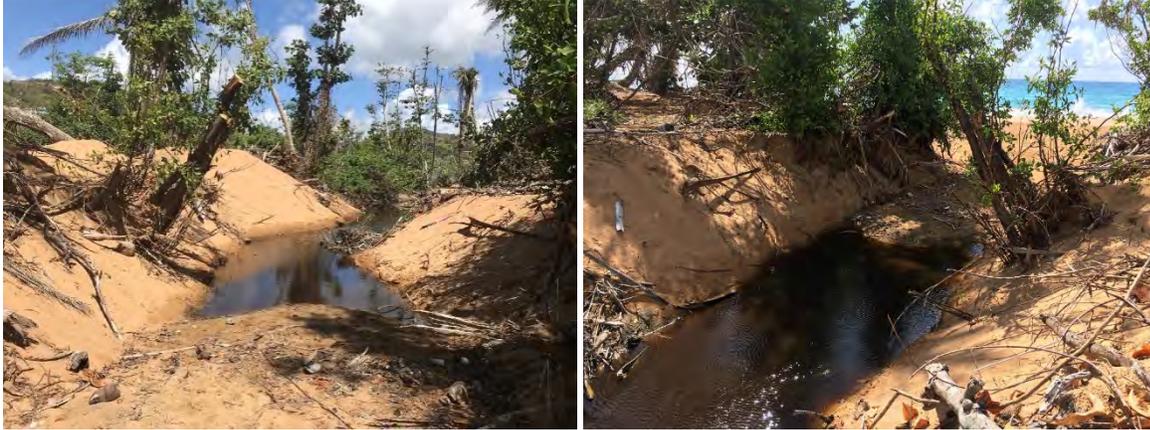
The team was informed that when a USACE representative visited the site approximately one month ago, permission was granted to open the channel. The excavated channel is approximately 10 feet wide at the invert, 4-foot-deep, and 20 feet wide at the top. Photographs of the current channel are provided in Figure 26. The water in the mangrove area took 3 weeks to drain.

Figure 26: Photographs of the re excavated channel

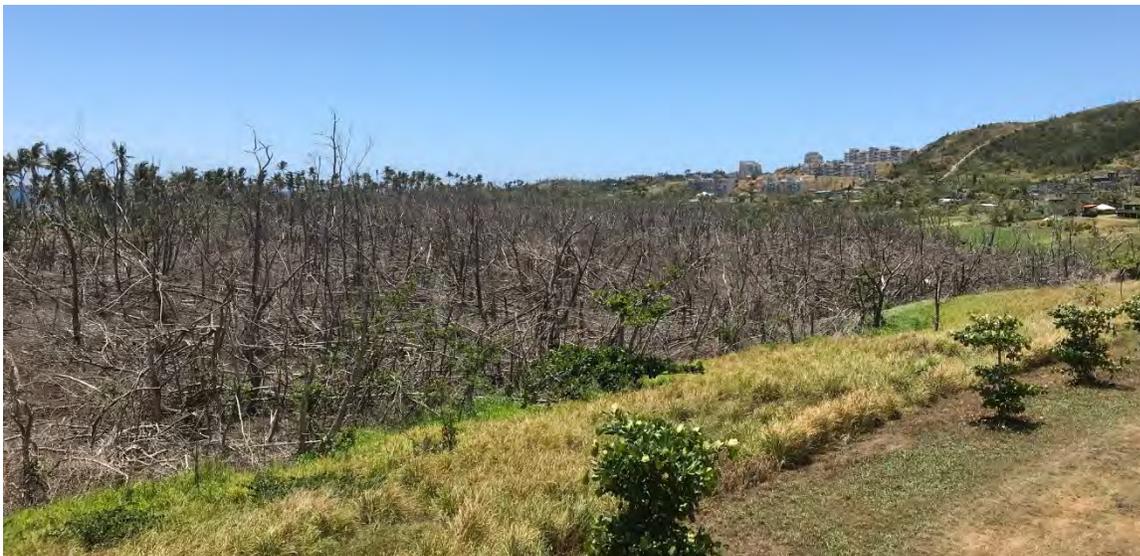
At this point, much of the mangroves appear to have been drowned by the prolonged inundation. The team estimated that upwards of 99% of the mangroves appear to be dead. Aesthetics and habitat has been impacted. A photograph is provided in Figure 27. If this mangrove loss is nearly 100%, natural reestablishment will be very slow. **Planting of mangrove seedlings may be necessary to reestablish the system.**

Figure 27: Photograph of the site taken from the Reserva Natural Humedal Punta Tuna. Note condo units at upper right.

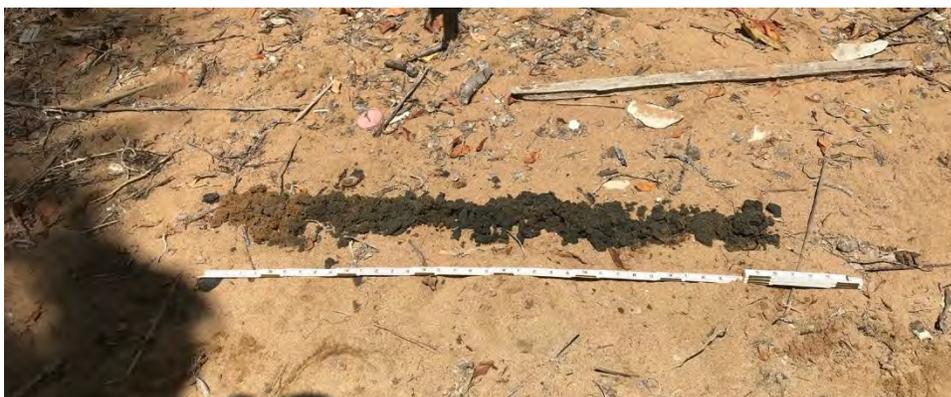
The team excavated several auger holes over the course of the two site visits in the re excavated channel. Organic soils were observed a few inches below the surface (Figure 28). The team believe that this indicates that the excavated channel is probably to near the original grade and is suitable. However, the team did discuss that some adjustment in to the channel could be undertaken to improve stability. The team noted that a section that was not recently modified was 32 feet wide at the invert and 65 feet wide at the crest. This may indicate that the currently constructed channel is overly narrow. However, the team did note that such channels in this geomorphic landscape should be expected to be variable and dynamic in section and pattern. Regardless, debris from the wetland (especially due to the large number of dead trees) may clog the channel and additional sands may deposit in the channel during storms. Maintenance is needed to maintain any channel.

Figure 28: Photographs of auger sample in excavated channel

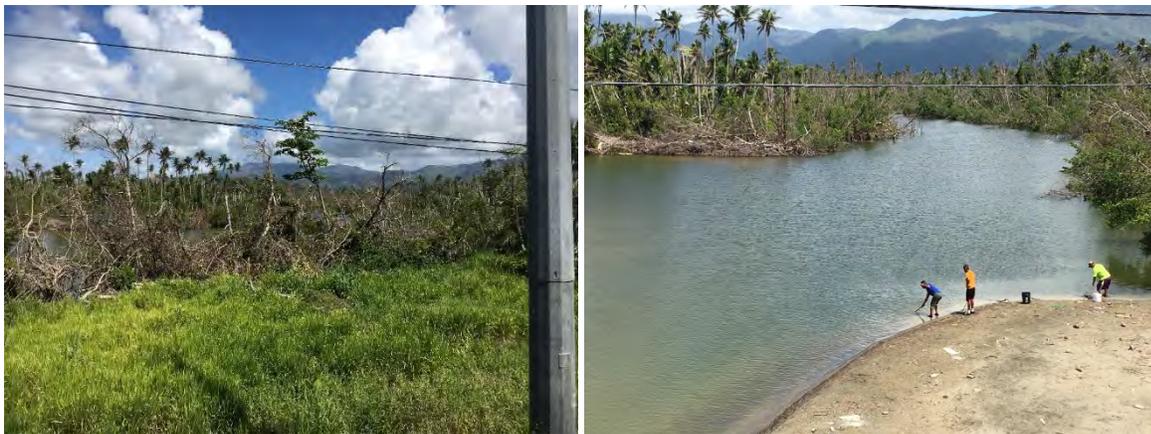
Figure 32; Photographs of the Punta Santiago site

The area was where the Hurricane Maria first made landfall and the damage to infrastructure in the area is significant (Figure 31). The trees in the wetland area show significant wind damage and high-water/debris lines marks indicate that flooding may have been from 3 to 5 feet into the mangrove area. Photographs of the mangrove wetland are provided in Figure 32. However, the bridge opening is apparently sufficient to allow rapid draining of the storm surge and there does not appear to be significant deposition in the mouth of the outlet to restrict hydraulic connectivity. The vegetation appears to be recovering. While large trees were toppled, smaller ones are sprouting. Photographs of the bridge are provided in Figure 33.

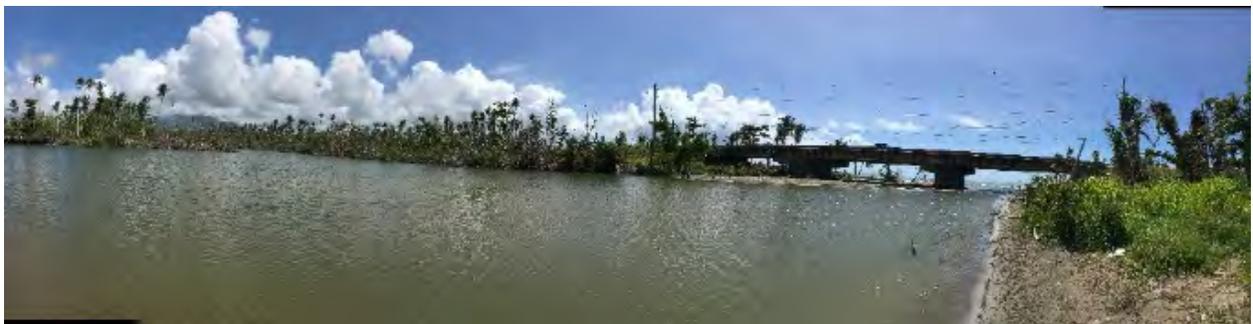
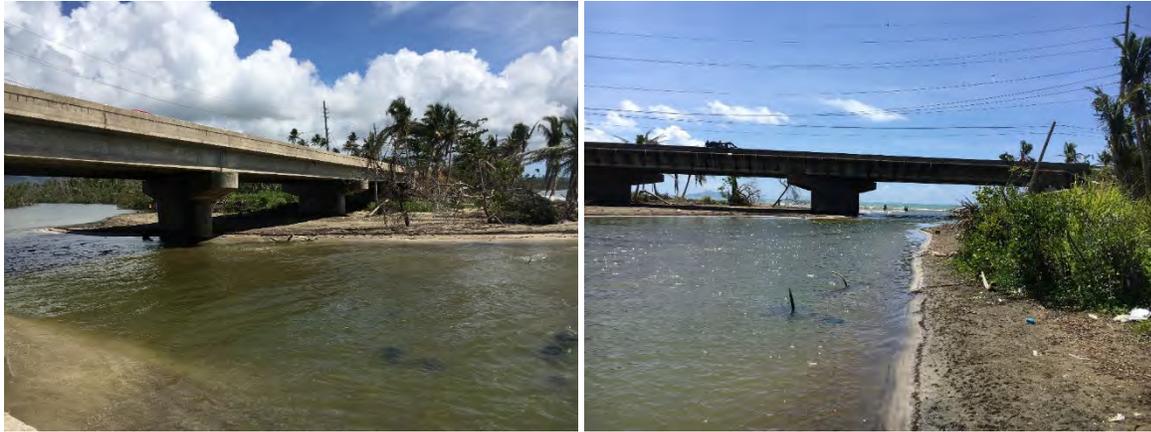
Figure 33: Photograph of the bridge

Water quality tests showed total chlorine of 0.5 to 0.6 ppm indicating that there may be impacted infrastructure leaking water in the watershed. However, spot E. coli tests showed lower levels of contamination (1 to 3 colonies per ml) and coliform was negative. Nitrogen contamination showed trace. The bridge does not appear to significantly impact tidal exchange and the salinity measurements in the wetland and in the ocean are the same. Recreational fishing and crabbing were observed in the area.
