**FINAL
PRIMARY RESTORATION PLAN AND
ENVIRONMENTAL ASSESSMENT
FOR THE 2006 T/V MARGARA GROUNDING
GUAYANILLA, PUERTO RICO**

T/V MARGARA aground with tugs alongside on April 27, 2006. Photo courtesy of Puerto Rico Department of Natural and Environmental Resources

The Puerto Rico Department of Natural and Environmental Resources
and
the National Oceanic and Atmospheric Administration

April 2015

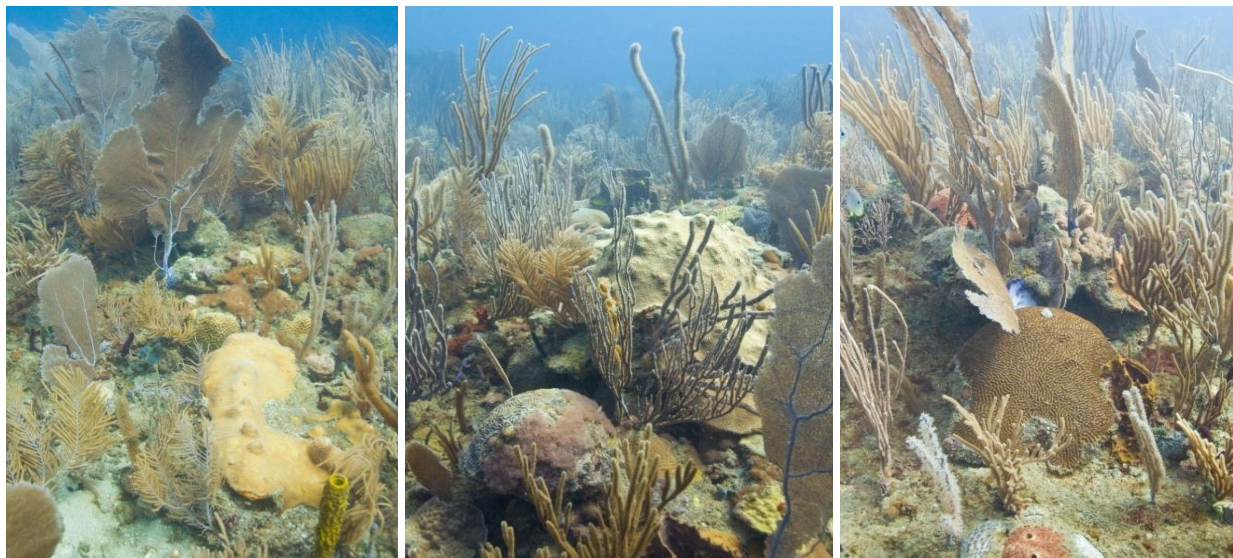
Figure 4: Photos of un-impacted reef adjacent to the T/V MARGARA site. Photos by NOAA Restoration Center, December, 2008.

The T/V MARGARA site is situated along the outer portion of a carbonate platform south of Bahia de Tallaboa on the south coast of Puerto Rico and is designated as coral reef habitat (NOAA, 2001). Water temperatures in this area range from 24° - 30°C. Depths along the upper shelf in this area range from emergent reefs inshore down to 100 feet along the shelf edge. Coral reef formations in the area are a combination of patch reefs and spur-and-groove reef formations built by Scleractinian corals over thousands of years. Scleractinian corals are also known as hard or stony corals and they are the primary reef builders in the ocean. The upper part of these reefs is around 10 meters deep, and the depth of the channels between the reefs averages 12-15 meters deep. The structure of these formations is composed of a calcium carbonate mantle that is on average 20 cm thick overlaying loose relic *Acropora cervicornis* fossils. The grounding destroyed this mantle in many areas and exposed loose rubble that had been stabilized and sealed in by the crust. The coral reefs affected by the T/V MARGARA Incident within this setting ranged from 10-15 meters deep and supported an epifaunal assemblage visually dominated by soft and hard corals and sponges (Figure 4).

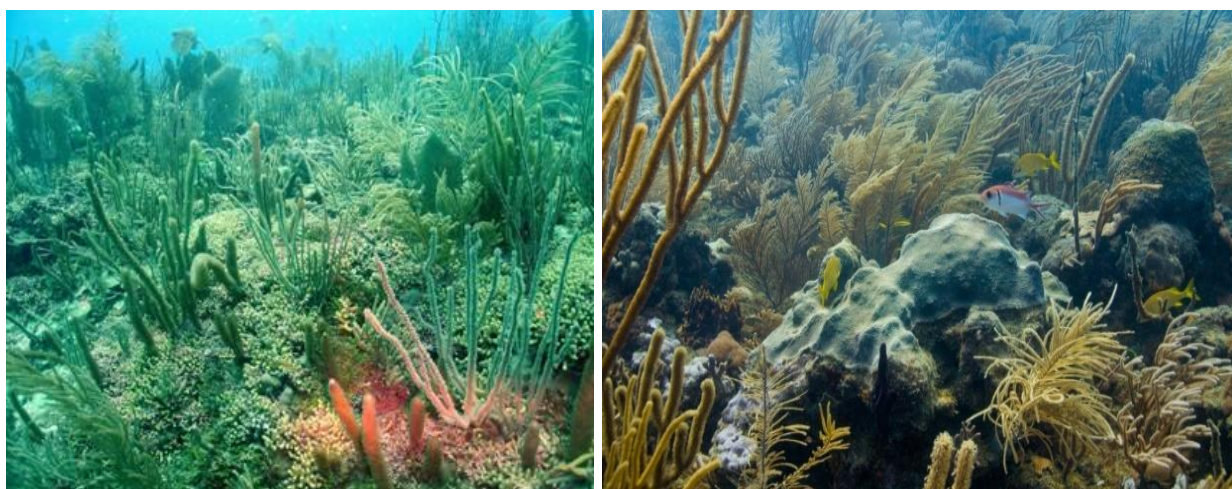
Figure 11: Photos of un-impacted reef adjacent to the T/V MARGARA site where reference transects were conducted. Photos by NOAA Restoration Center, December 2008.

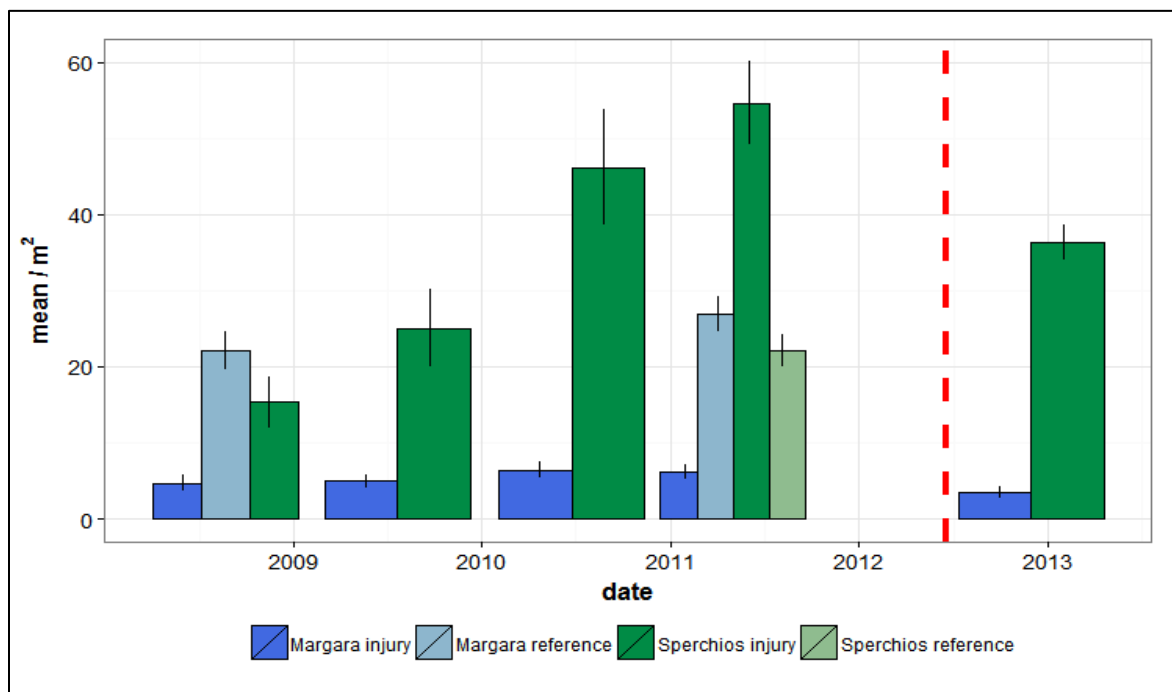
Figure 13: Mean number of corals in belt transects at the T/V MARGARA site, the T/V SPERCHIOS site and in reference areas. Permanent belt transects (1m x 10m) were established in August, 2008 (year following Hurricane Dean). The red dotted line represents Tropical Storms Ernesto and Isaac where swells reached 20' in August, 2012. Error bars represent standard error of the mean.

The recruitment monitoring data at the T/V MARGARA site from 2008 through 2012 shows that coral recruit survival in the rubble fields is on average between 0-18% compared to survival rates of 58-65% in the reference area and 49-56% in the restored areas. Scleractinian (stony coral) recruitment survival rates were 0% in rubble compared to 83-100% in the reference area and 40-42% in the restored areas. Octocoral recruitment survival was 8-18% in rubble, 58-65% in the reference area and 49-56% in the restored areas. Figures 12 and 13 show the change over time in mean number of corals in the monitoring quads and belt transects at the T/V MARGARA site (injury, restored area and reference) as well as at the nearby T/V SPERCHIOS grounding site (which does not have rubble present like at the T/V MARGARA site). The graphs in Figures 12 and 13 show how the T/V SPERCHIOS site is recovering with time while the T/V MARGARA rubble fields have limited to no recovery seven years after the Incident. In the belt transects, recovered octocoral densities are an order of magnitude greater at T/V SPERCHIOS than at the T/V MARGARA site, and recovered Scleractinian densities are two orders of magnitude greater at the T/V SPERCHIOS than at the T/V MARGARA site. There are almost no Scleractinians present in the rubble at the T/V MARGARA site, and densities of coral recruits at the site are below the 2008 Post-Hurricane Dean levels. The data shows that recovery in the rubble fields at the T/V MARGARA site is not occurring.

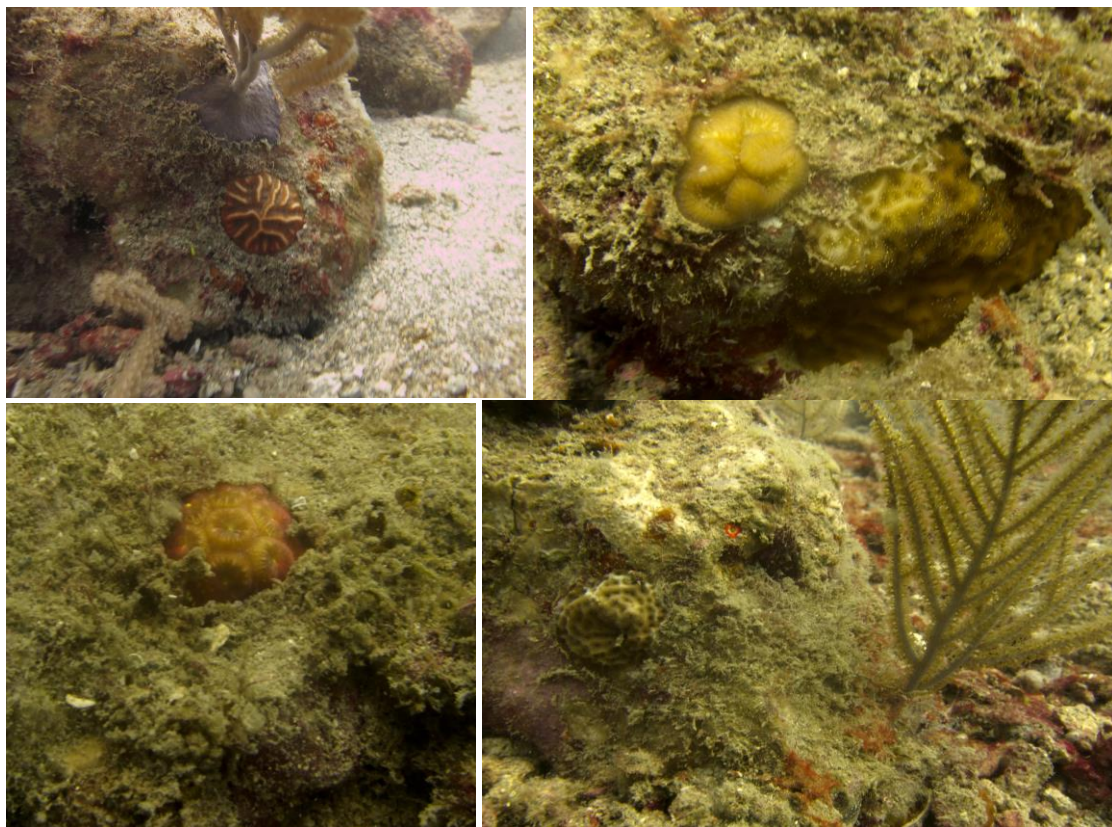
Figure 14: Photos of scleractinian and octocoral recruits on limestone deployed at T/V MARGARA site in 2010. Photos by NOAA’s Restoration Center, 2013.

The quarried limestone rocks that are identified for use are the same material as the coral reefs and were themselves coral reefs at one time. Therefore, the material has similar properties to what was present at the site before the grounding occurred and is a more comparable reef material than foreign materials like ceramic, cement only, cement modules or other materials.
